# 東日本大震災・津波の記録

Record of 2011 Great East Japan Earthquake/Tsunami

March 2015 年 3 月

Joint Project by 政策研究大学院大学・建築研究所共同事業  
National Graduate Institute for Policy Studies (GRIPS) DM  
Program & International Institute of Seismology and Earthquake  
Engineering (IISEE) of the Building Research Institute (BRI), JAPAN

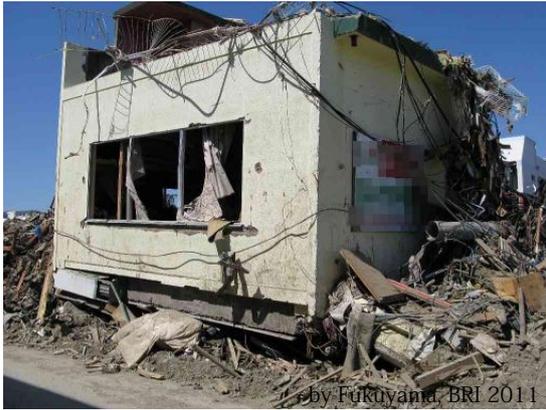
A case where column capitals and bases on the first floor in a building were subject to bending failure and subsequently to story collapse was seen in 2-story buildings (Photo 2-1).

These buildings have column-to-beam frames. The first floor has a relatively small number of walls, but many concrete block walls are placed on the second floor. The first and second floors of the building in Photo 2-1 are used as shop and dwelling, respectively. The relevant buildings are estimated to have structural characteristics of low strength and stiffness on the first floor.

As an opening on the second floor is not large, it is assumed that the second floor suffered a large tsunami wave pressure and the shear force acting on the first floor exceeded the lateral load-bearing capacity, resulting in the collapse of the building. Story collapse of the first floor has not been observed in 3-story or higher buildings in the investigations. In 3-story buildings, in general, reinforced concrete walls are often used for the first floor. Therefore, the strength of the first floor of 3-story buildings is considered to have been larger than that of 2-story buildings.

Photo 2-1: Story collapse of a 2-story reinforced concrete building (left)

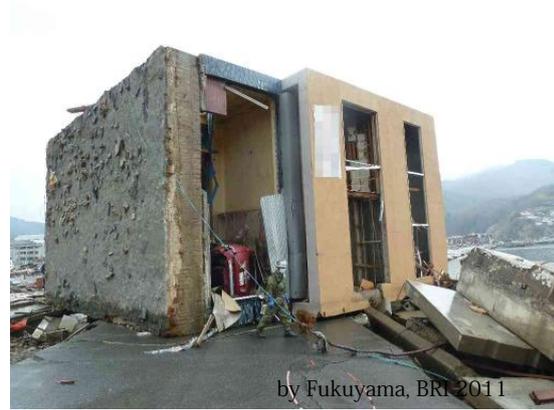
Photo 2-2: Overturning of a 3-story reinforced concrete building (right)

Overturning was observed in 4-story or lower buildings. In all overturned buildings, the maximum inundation depth exceeded their height. Overturning types include building that fell sidelong (Photo 2-2) and buildings that turned upside down. Most of the overturned buildings are of mat foundation. In some overturned buildings on pile foundation, piles were pulled out.

Overturning cases were often seen in 4-story or lower buildings with relatively small size of openings. However, there were many cases where 4-story or lower buildings with large size of openings were not overturned. Consequently, the size of opening on an exterior wall is considered to have greatly affected overturning.

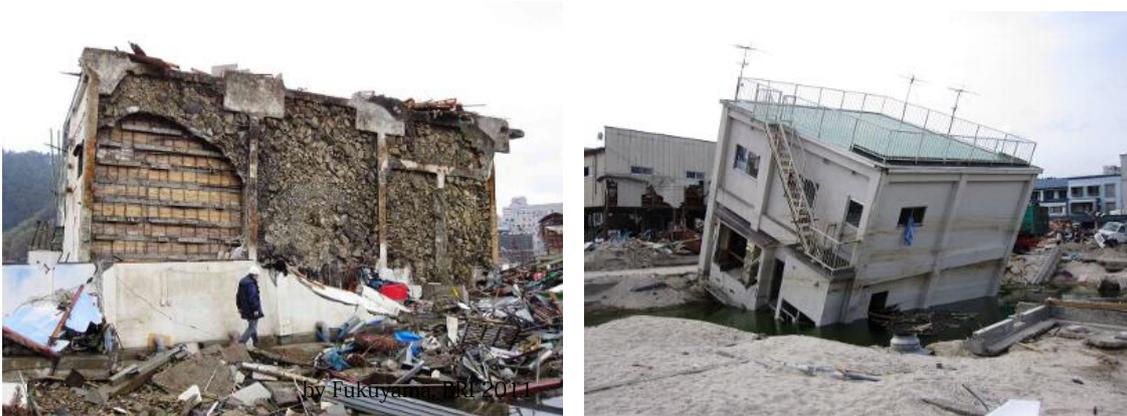
Most of the overturned buildings were moved from their original positions. It is estimated that large buoyancy acted on the buildings. Moved and overturned buildings left no dragged traces on the ground. One of the buildings moved over a concrete block fence with about 2m height on an adjoining land without destroying the fence (Photo 2-3).

The building seems to have floated up by buoyancy. Some of the 2-story apartment houses with the same shape that were overturned were washed away and missing. A buoyancy and large horizontal force seem to have acted on these buildings.

Photo 2-3: A 2-story RC building that moved over the fence and overturned  
 Photo 2-4: A 2-story RC building that was tilted by scouring (right photo)

When tsunami acted on a building, a strong stream was generated around the corner of the building, resulting in many large holes on the ground that were bored by scouring. In one case, a building on mat foundation fell into a hole bored by scouring (Photo 2-4).

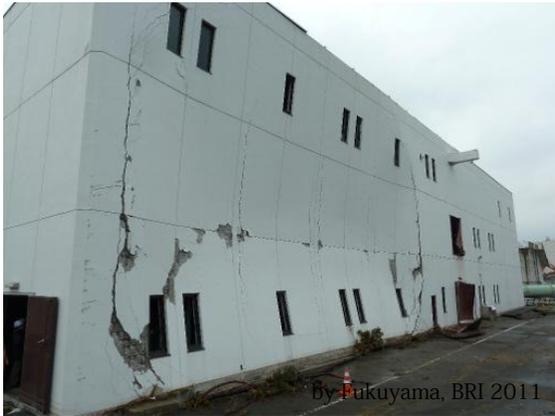
A case where such wall reinforcement was fractured is often seen in wall members with single layer bar arrangement. In one damaged building (Photo 2-5), a 300 mm-thick shear wall with double layer bar arrangement and a support span of more than 10 m and without the second and third floor slabs was bent inside by tsunami wave pressure.

However, a shear wall in an area (Photo 2-5 Back of the building, right-hand side), where there is a floor on the second story and a support span is not long in the same building, was not bent.

Photo 2-5: Out-of-plane fracture of RC shear wall without floor (left)  
 Photo 2-6: Wall opening generated by debris impact (right)

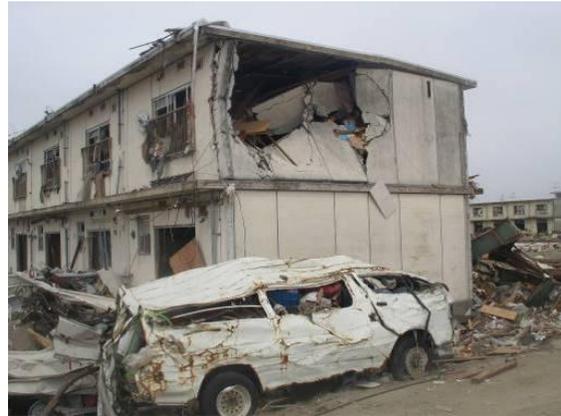
Debris impact was seen in most of the non-structural members such as window and ceiling materials. The number of cases of clear damage to skeletons was not large, but in one observed case, a multi-story wall in an apartment house was probably bored by debris impact (Photo 2-6).

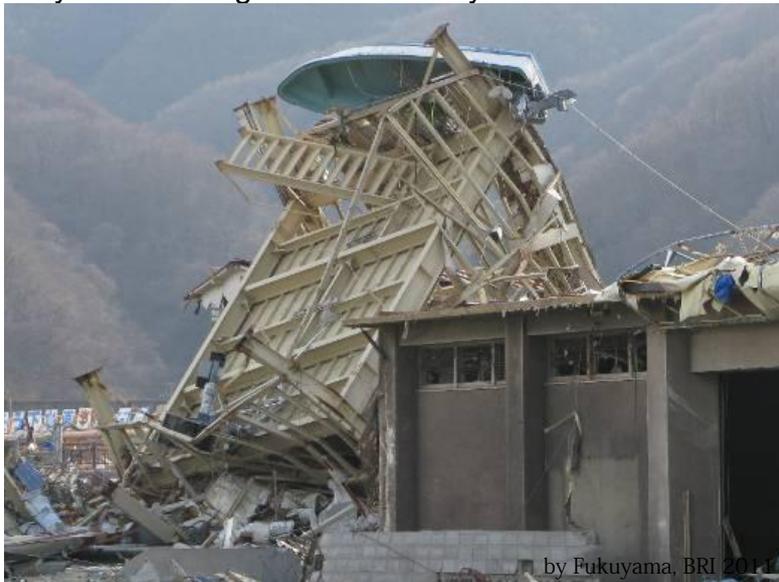
A typical case of building movement and washout is that a building moved and flew due to the fracture of anchor bolts and/or base plates at steel exposed column bases and the fracture of a weld between the column and the base plate (Photo 2-7). In most cases, a foundation and some column bases were left in a site, but the body of a building was moved beyond the site or missing.

Photo 2-7: Steel building overturned by fracture of column base anchor bolts

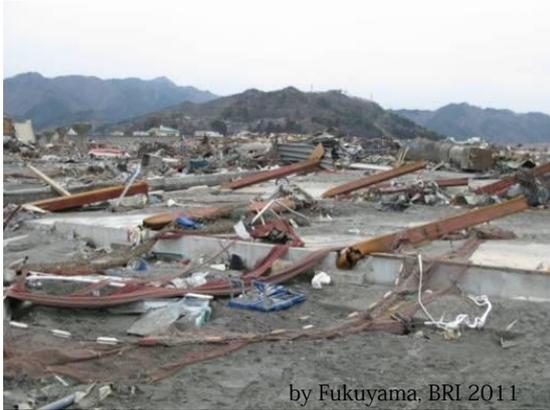
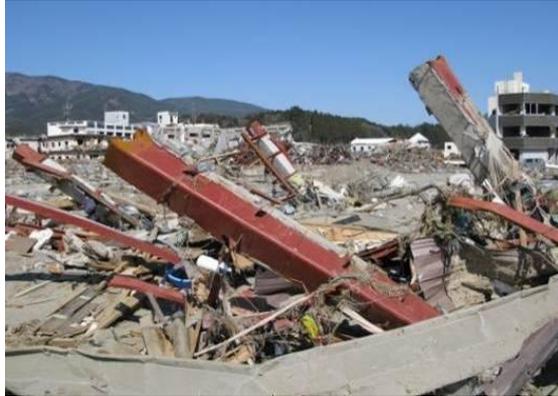
In damage cases relatively often seen a capital connection on the first or second floor in a building was fractured, then the building was moved and washed away. When a column base has a large strength like concrete encases type or embedded type, this type of fracture is considered to occur. In one case (Photo 2-8), foundation in a building, and several columns on the first floor (or up to the second floor) were left on the site, and the columns fell in the same direction.

In most cases, welds between diaphragms with lower flanges and the first-floor columns were fractured and the sections of the columns were exposed. In one building, flanges of the second-floor H-shaped beams were torn. Based on the deformation states near the column bases, it is estimated that a tensile force acted on the first-floor columns, and then the first-floor capital connections were fractured after the first floor was greatly tilted to the same extent as the inclination of the remaining columns.

Photo 2-8: First-floor columns falling in the same direction

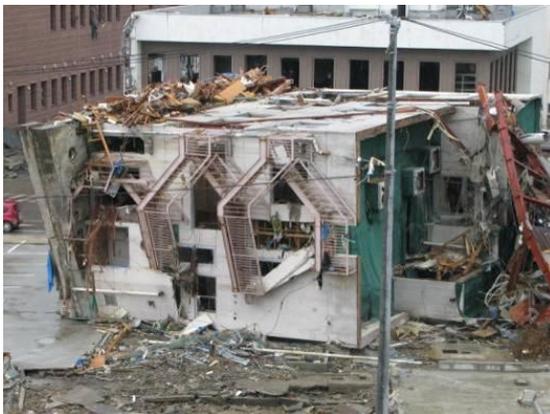
One case, in which a whole building including foundation is overturned, was confirmed. Most of the AAC panels of claddings were left (Photo 2-9).

Photo 2-9: Overturning of a 3-story steel building

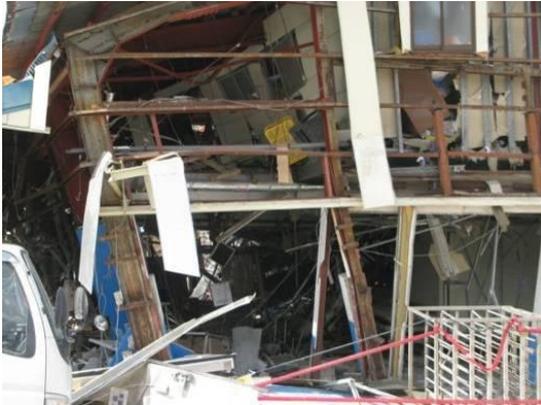
Slight tilting was often observed with remaining their skeletons in steel buildings. In one case (Photo 2-11), a gabled roof frame building did not

collapsed despite large residual deformation.

Photo 2-11: Tilted gabled roof frame

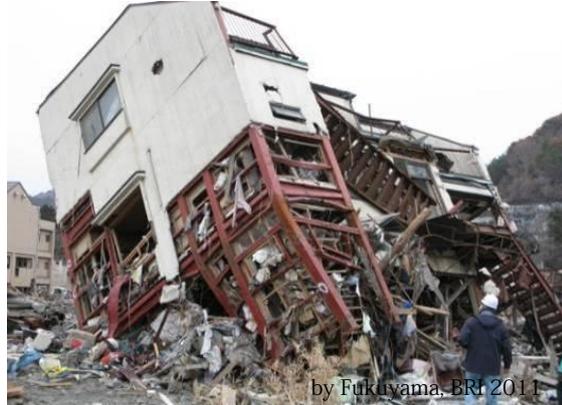
Photo 2-12: Tilted frame

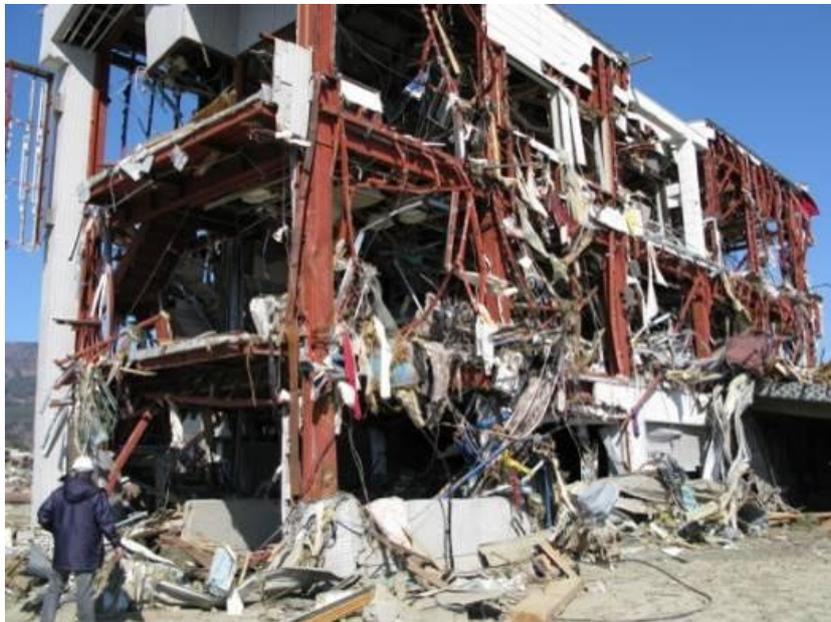
Cladding materials such as AAC panel were almost fully fractured and washed away, and then a steel frame as a skeleton was remaining. This case was often observed (Photo 2-13). It is considered that an external force that acts on the skeleton became small due to early washout of the cladding materials. In the remaining building, slight tilting of the skeleton, member deformation on the face affected by tsunami, or members locally damaged possibly by debris impact, were observed.

Photo 2-13: A remaining 3-story steel building

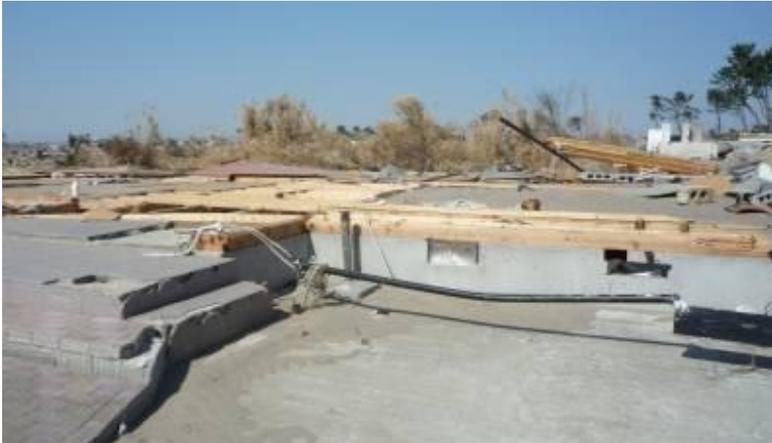
super structure was washed away although the base and foundation was remained (Photo 2-14), or foundation was also washed away and only RC base was remained.

Photo 2-14: Remained base without upper structure

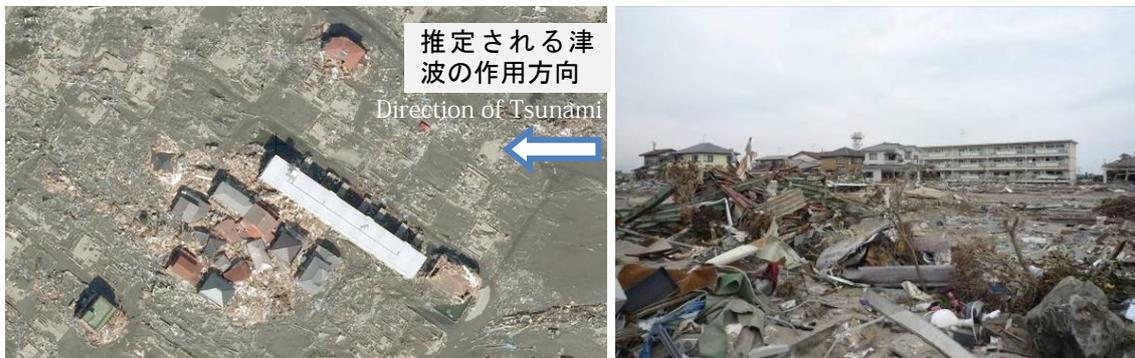
Photo 2-15: Remained housed behind a remained building

If the maximum tsunami depth was between 2m and 4m, partial remainder case of wooden structure was confirmed. When a withstood building or structure existed in front of wooden structure towards the direction of tsunami wave, some of back side wooden structures were remained. This is the case that acting tsunami wave force was greatly reduced because of the remaining building.

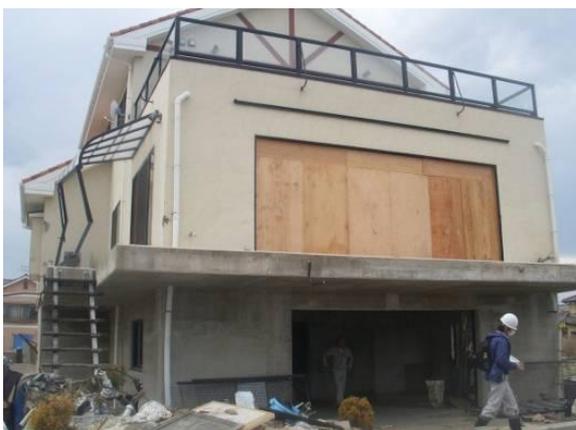
In addition, vertically mixed structure with RC and so on in the 1<sup>st</sup> floor was also confirmed to be remained in some cases. (Photo 2-16)

Photo 2-16: Case of wooden house with 1<sup>st</sup> story RC structure
