## **Appendix 1 – Photographs**

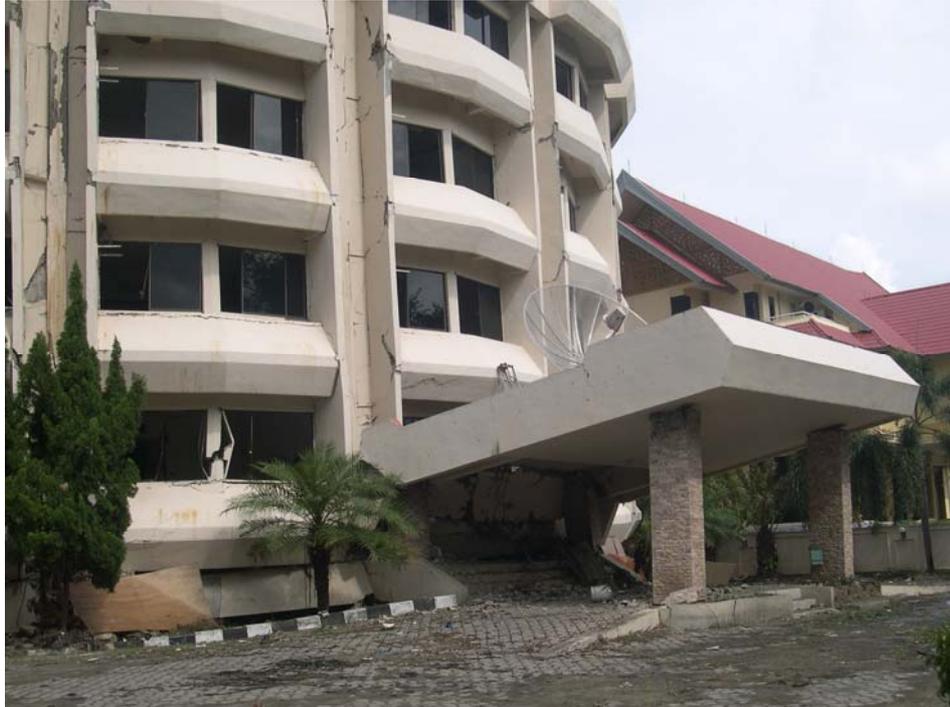
Photograph 1- Kuala Tripa Hotel, Banda Aceh. An example of a soft storey.  
Refer Recommendation No. 16.

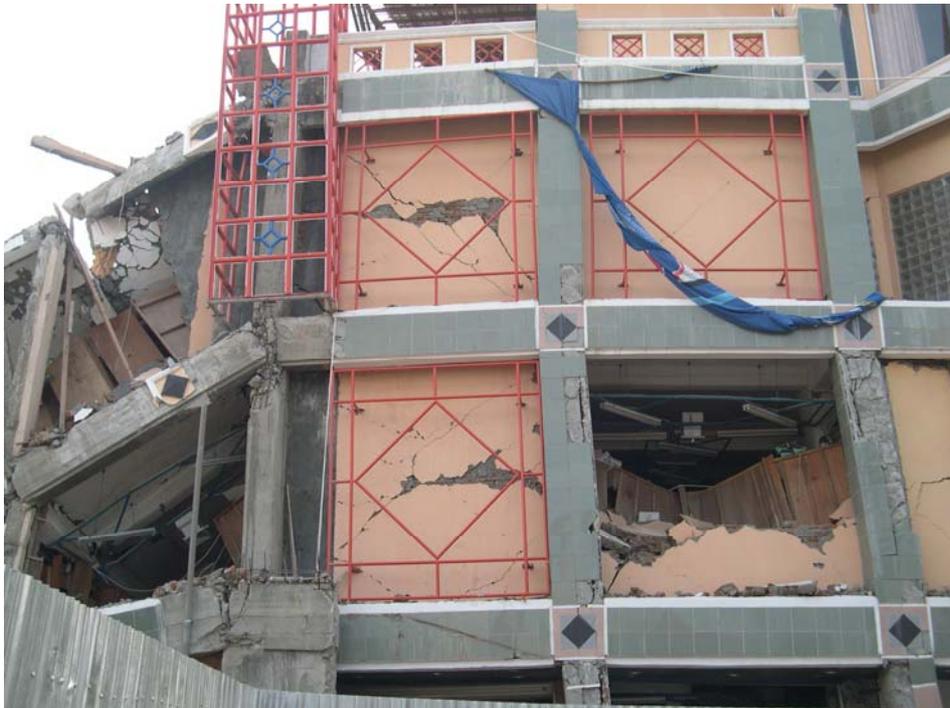
Photograph 2- Reinforced concrete building, Banda Aceh. An example of poor beam-column joints. Refer Recommendation Nos. 10 & 19.

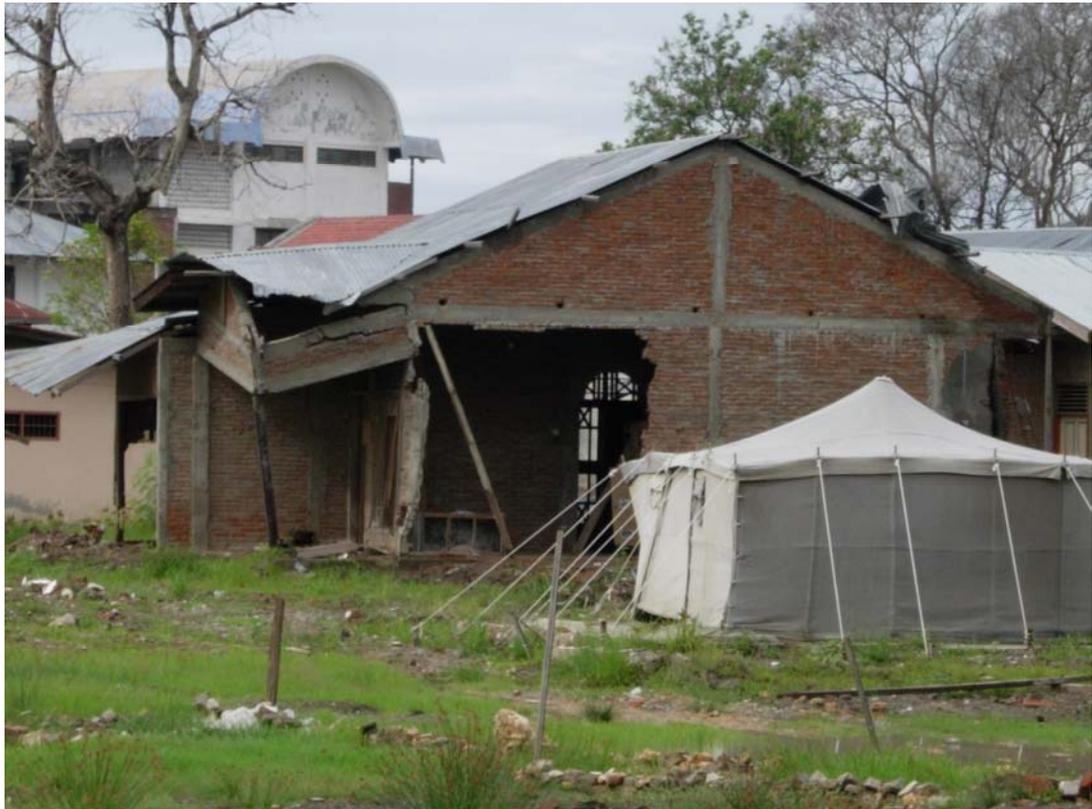
Photograph 3- Confined brick masonry building, Banda Aceh. When walls collapsed practical columns were overloaded. Refer Recommendation Nos. 15 & 18.

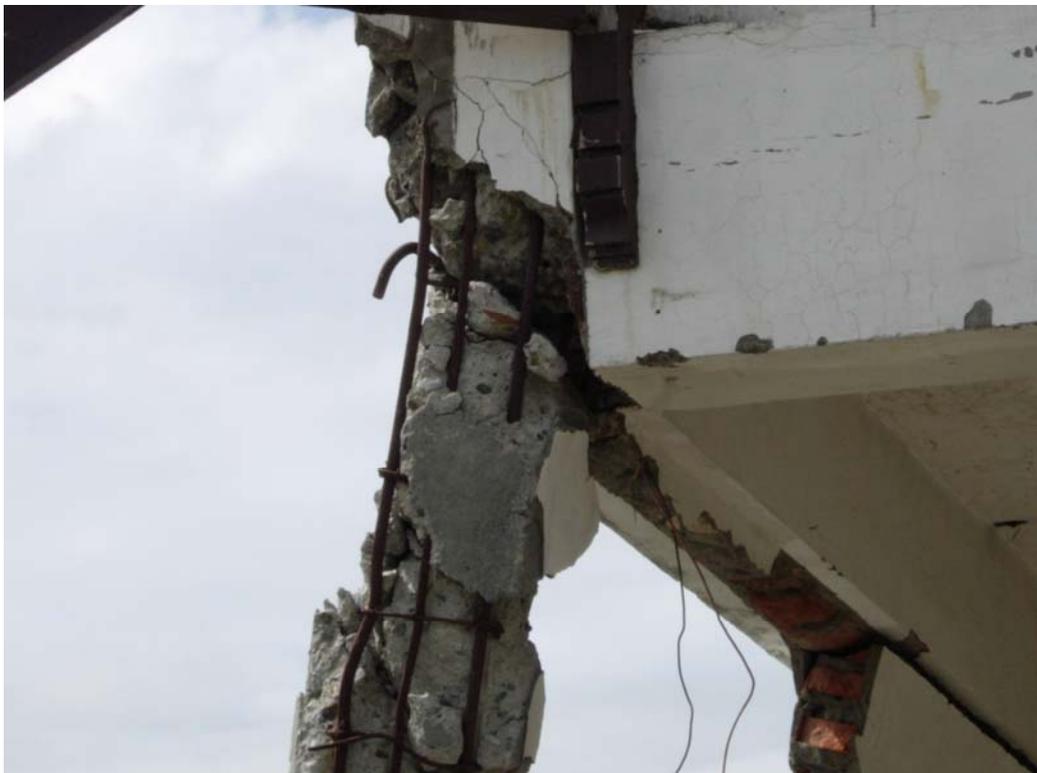
Photograph 4- Reinforced concrete building, Banda Aceh. Ties are too small and too widely spaced. Column has failed. Refer Recommendation No. 19.

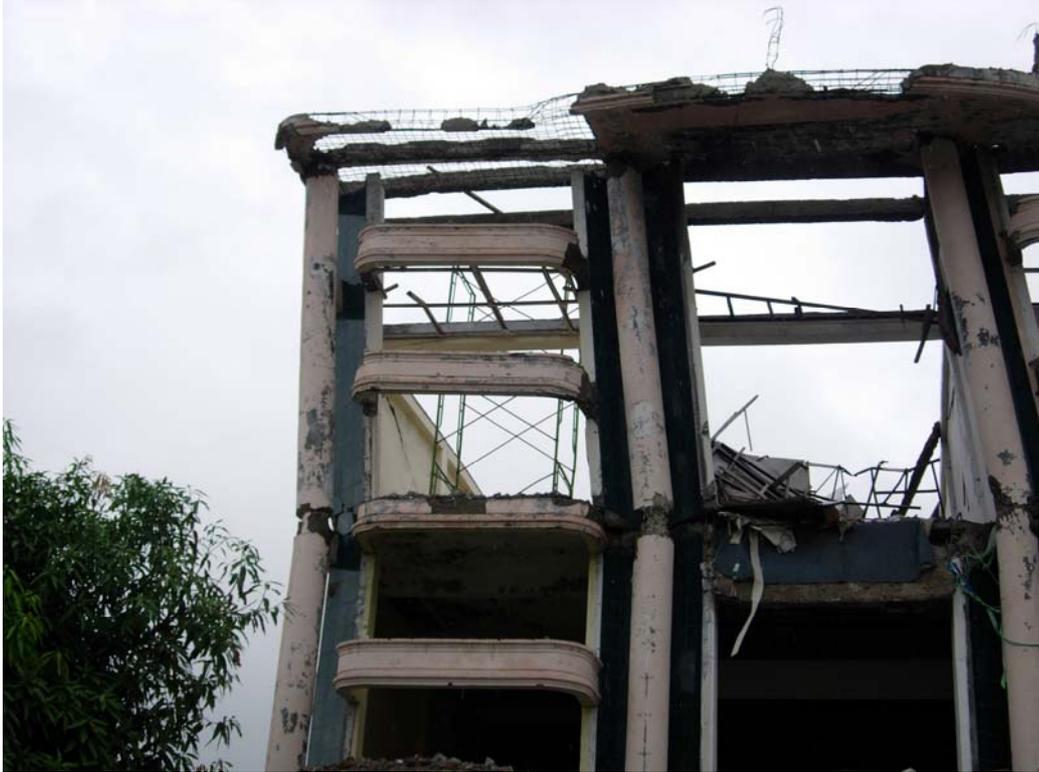
Photograph 5- Reinforced concrete Hotel, Banda Aceh. Failure of beam column joints.  
Refer Recommendation Nos. 10 & 19.

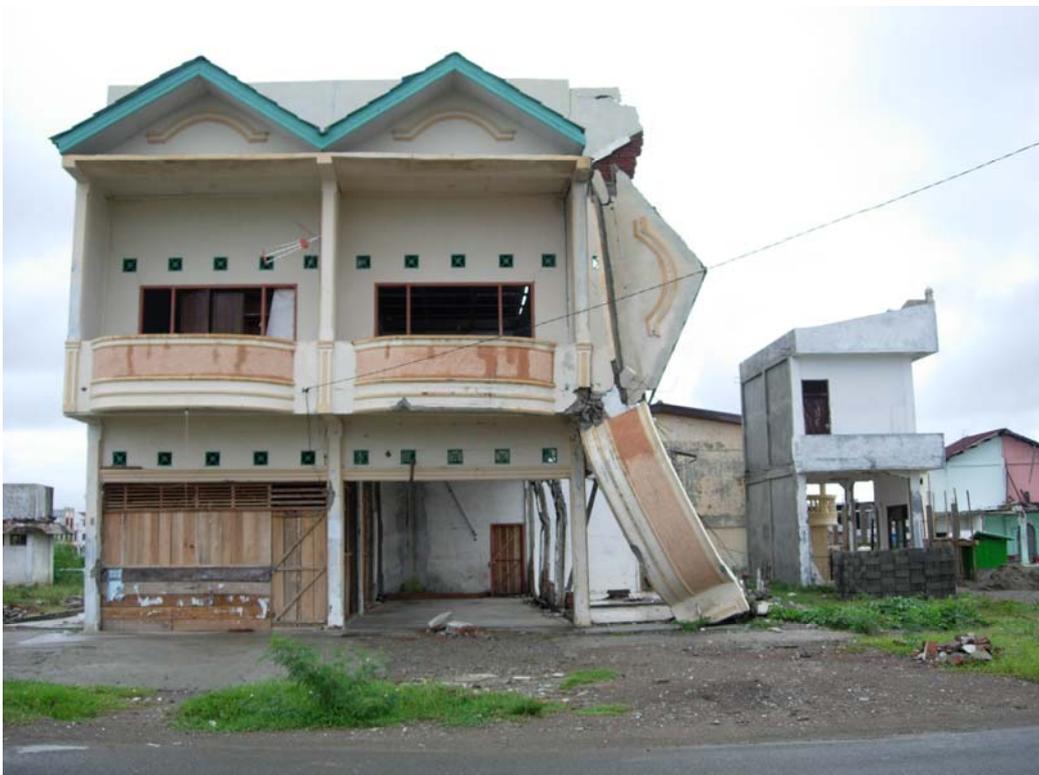
Photograph 6- Typical Building, Banda Aceh. Failure of heavy architectural elements.  
Refer Recommendation No. 14.

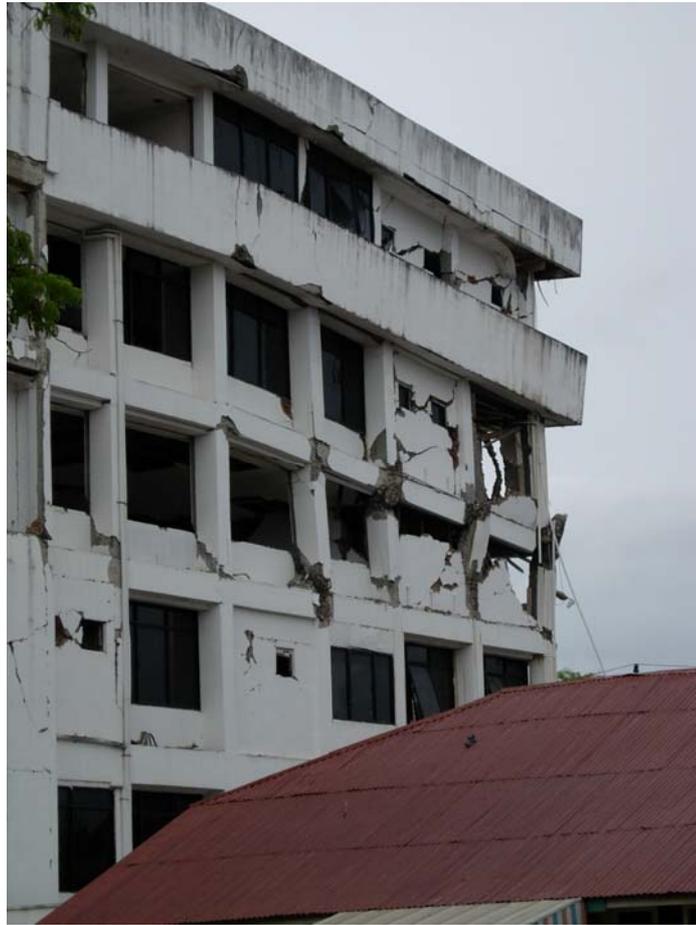
Photograph 7- Reinforced concrete moment resisting frame building, Banda Aceh.  
Failure of beam column joints. Refer Recommendation Nos. 10 & 19.  
Failure of infill wall panels. Refer Recommendation No. 15.
