# **BUILDING PERFORMANCE: HURRICANE ANDREW IN FLORIDA**

**OBSERVATIONS, RECOMMENDATIONS,  
AND TECHNICAL GUIDANCE**

**FEDERAL EMERGENCY MANAGEMENT AGENCY  
FEDERAL INSURANCE ADMINISTRATION**

**DECEMBER 21, 1992**

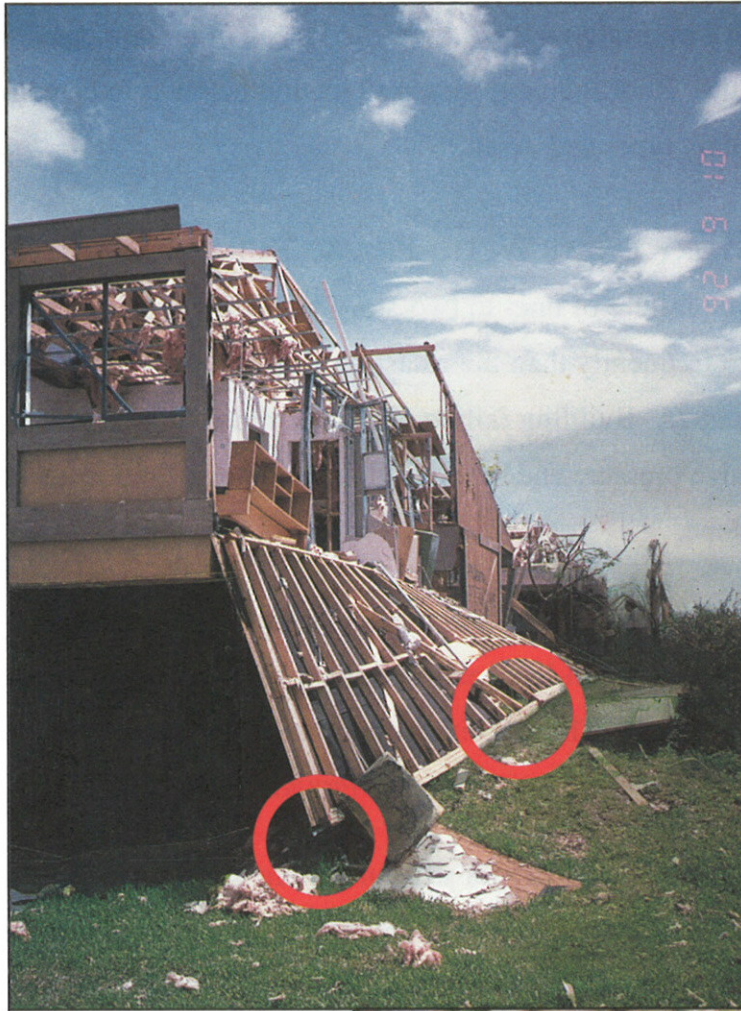
FIGURE 4.  
*Exterior wood-frame  
non-loadbearing wall.  
Transfer of wind forces  
from wall to adjoining  
structure was not  
sufficient.*

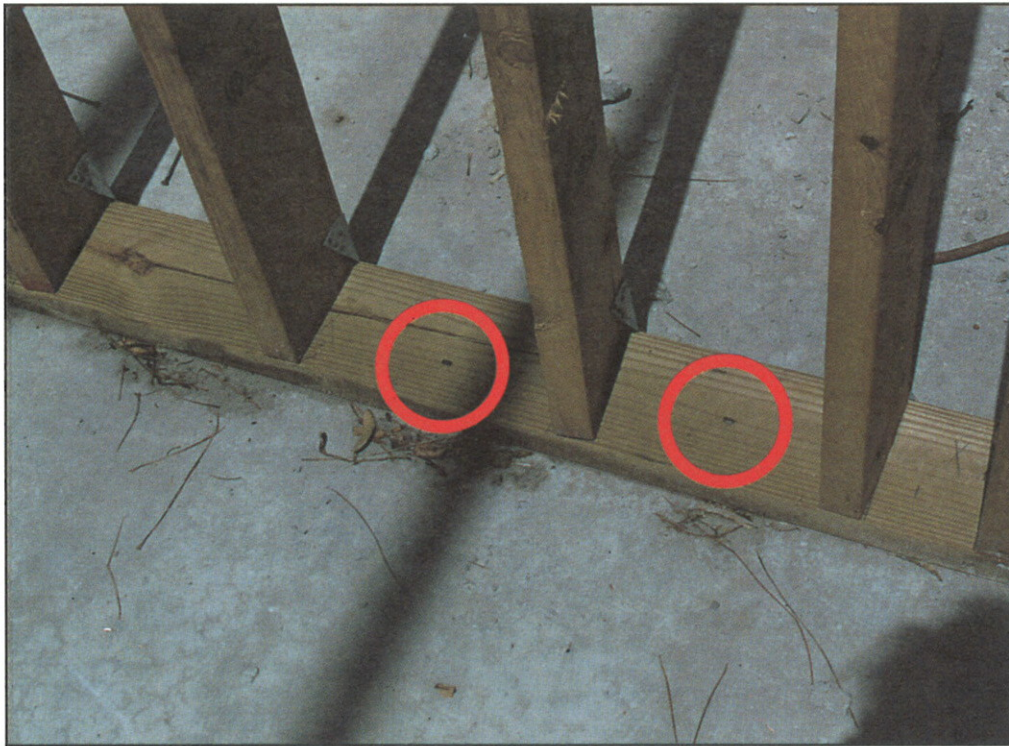
FIGURE 8. *Bolts not used in sill plate. Cut nails had no capacity to prevent pullout.*

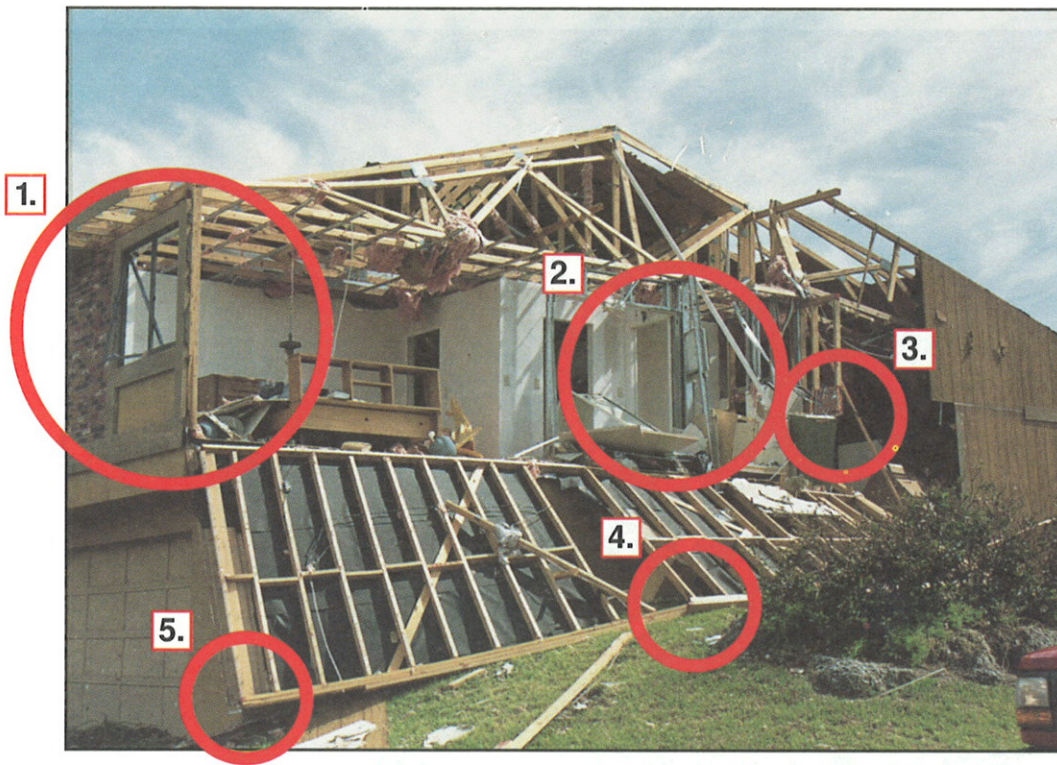
FIGURE 9. *Failure of non-loadbearing wall. Connections of exterior wall were not adequate.*

- 1. End column separated from roof.*
- 2. Load transfer from outside wall to interior shear wall inadequate.*
- 3. Beam separated from beam seat/connector.*
- 4. Improperly spliced composite tie-beam/connector.*
- 5. End of top plate connection inadequate.*

1. Designers and plan reviewers should pay greater attention to lateral load transfer mechanisms because of high lateral loads generated by hurricane winds (SEE FIGURES 9, 10, AND 54-58).
  2. At the construction stage, greater attention must be paid to the proper installation of all lateral load transfer mechanisms inherent in conventional building framing, especially hurricane straps and clips (SEE FIGURES 59-62).
- Manufacturers of metal connectors for wood framing currently provide on-site demonstrations and workshops for training purposes. These workshops should be structured to provide certificates of participation to builders and should be encouraged by the home-buying community.

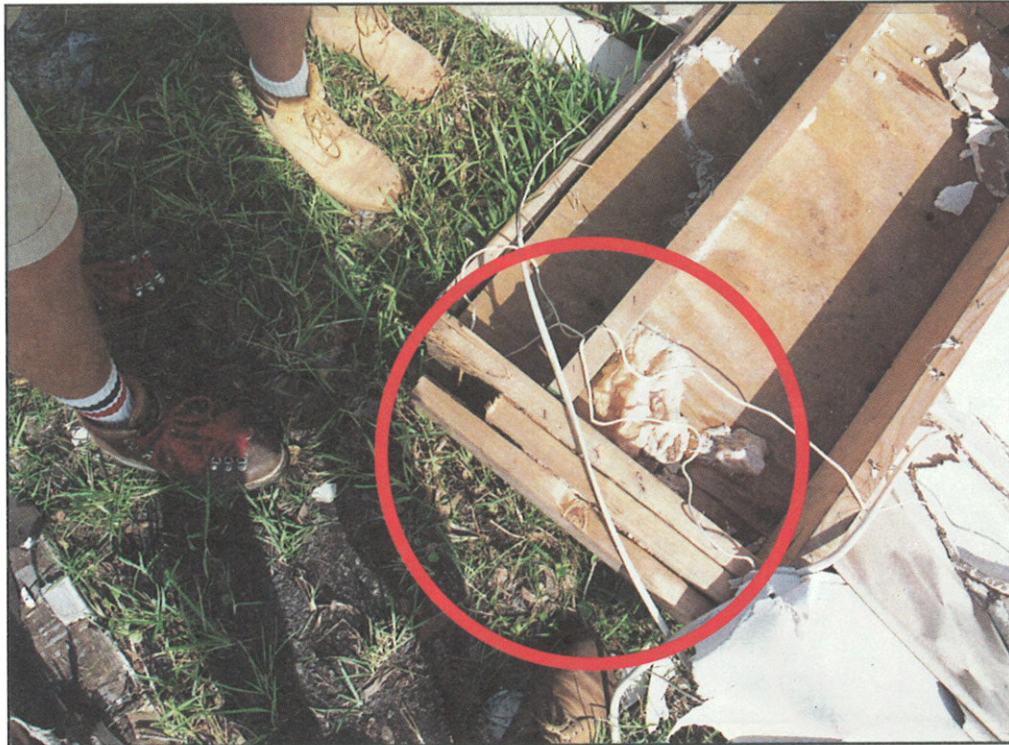
FIGURE 10. *Top plate splice not able to transfer horizontal loads.*

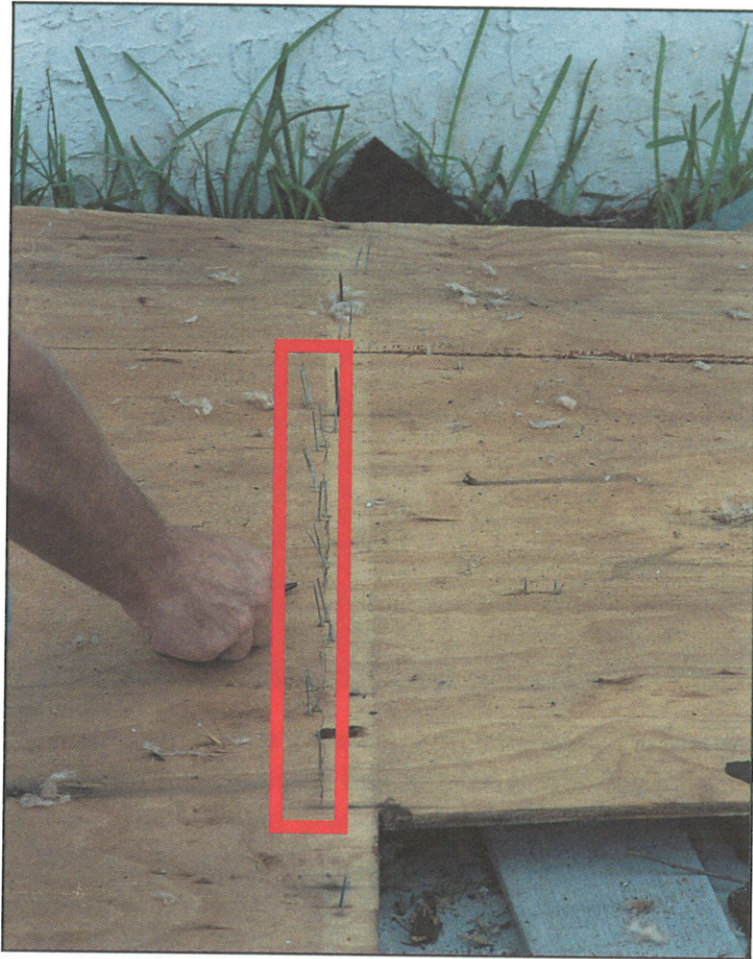
The roof framing systems observed were composed typically of prefabricated light wood trusses and plywood sheathing. While the trusses were found to have performed well under the wind forces, the connection of the sheathing (which forms the horizontal diaphragm of the building system) to the trusses was inadequate. Substandard workmanship in the anchoring of sheathing to trusses (by either improper stapling or improper nailing) was evident (SEE FIGURE 11).

**FIGURE 11.**  
*Roof sheathing found in debris. Staples were off-line and therefore not connected to supporting truss top chord.*

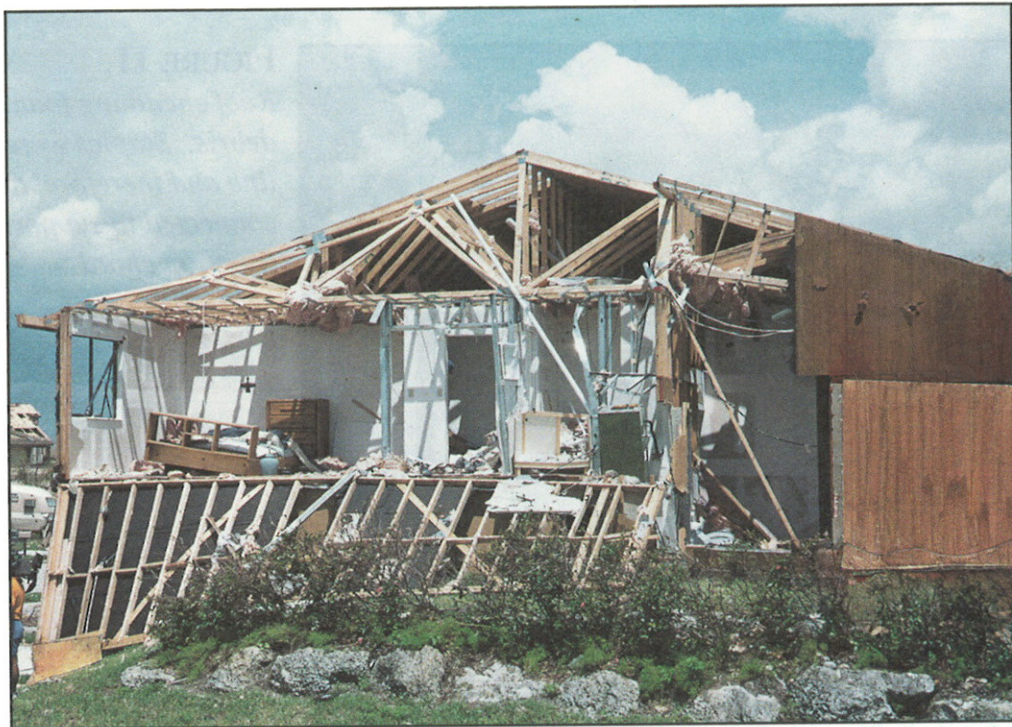
The lack of adequate truss bridging, improper system-wide lateral bracing, inadequate cross-bracing at end trusses, and the lack of stiffening of gable ends were determined to have compromised the integrity of the structural roof systems. It is the opinion of the assessment team that reliance on sheathing for truss-roof bracing, and the corresponding loss of the sheathing, was a major cause of the total damage of the building systems. (SEE FIGURES 12, 13, AND 14.)

FIGURE 12. *End wall failure of typical first floor masonry/second floor wood-frame building. Truss bridging and lateral bracing, and adequately installed roof sheathing, would have greatly reduced the likelihood of such a failure.*

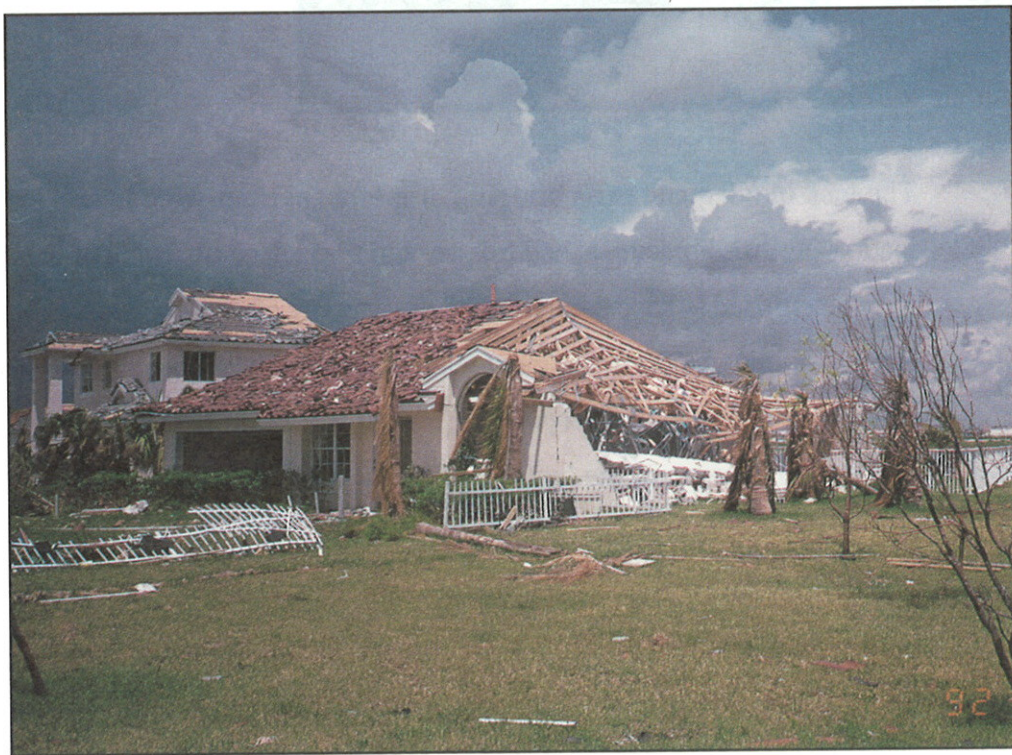
FIGURE 13. *Roof structure failure due to inadequate bracing.*

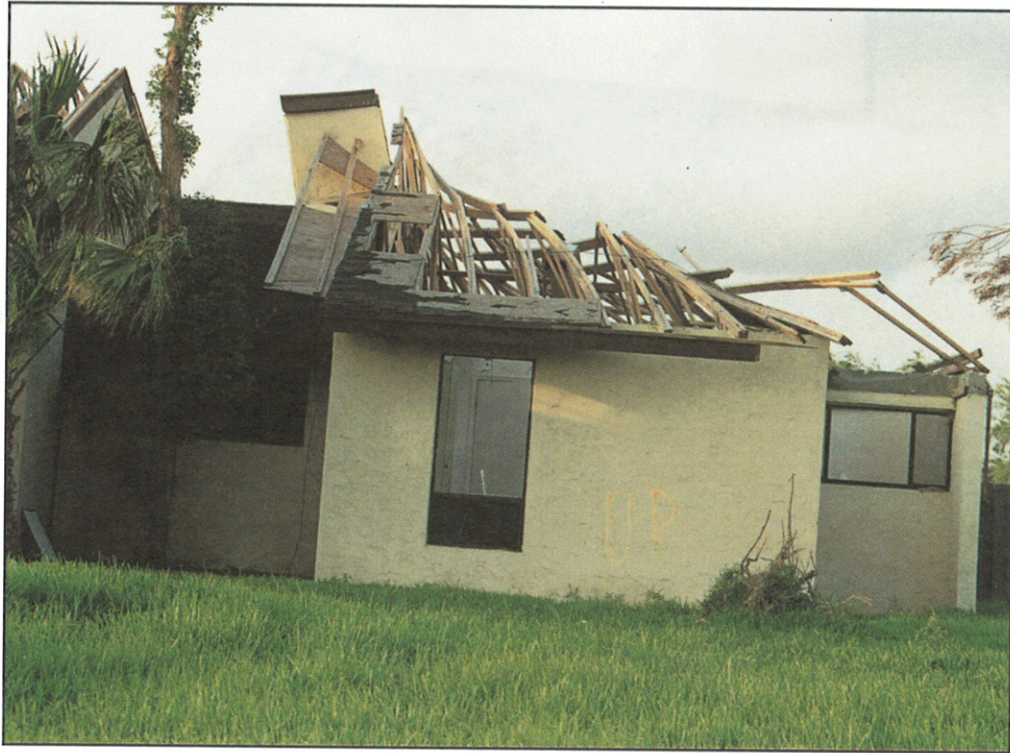
FIGURE 14. *Roof structure failure due to inadequate bracing.*

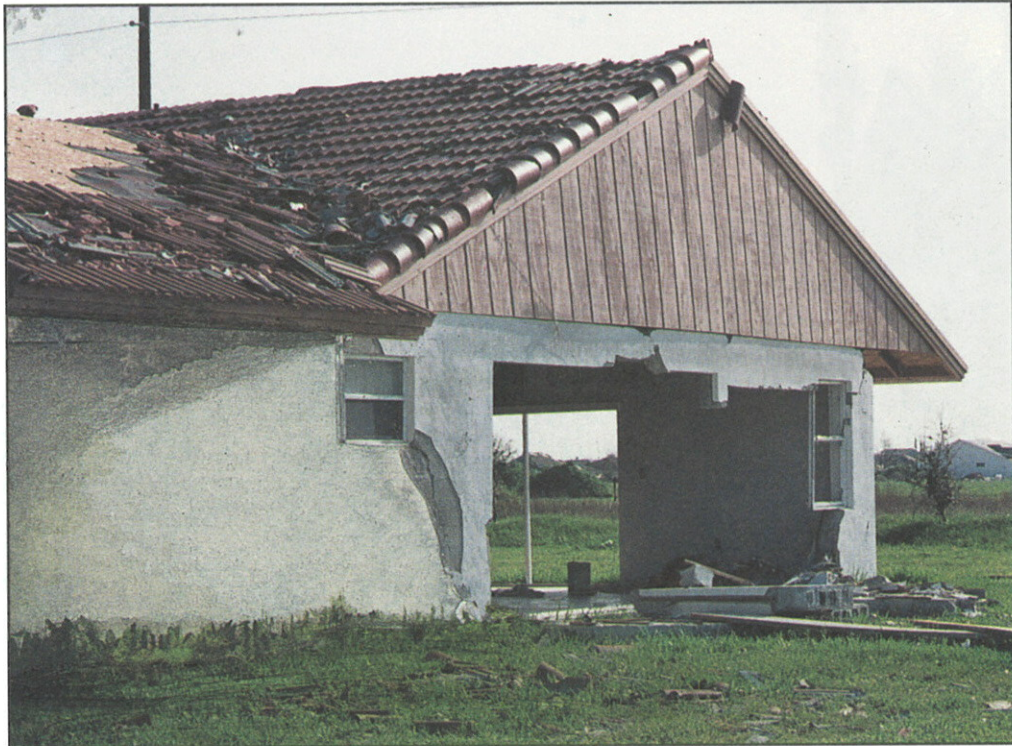
The main cause of failure of masonry buildings was a lack of vertical wall reinforcing (SEE FIGURE 15). Typically, concrete block and stucco (CBS) systems performed much better than all-wood-frame construction. This was due primarily to the heavier mass of the masonry walls and the tendency of a continuously constructed system to be less prone to failure from a lack of attention to design and construction details.

FIGURE 15. *Masonry construction building. Wall separated from building envelope due to inadequate vertical wall reinforcing in connection to horizontal tie-beam.*

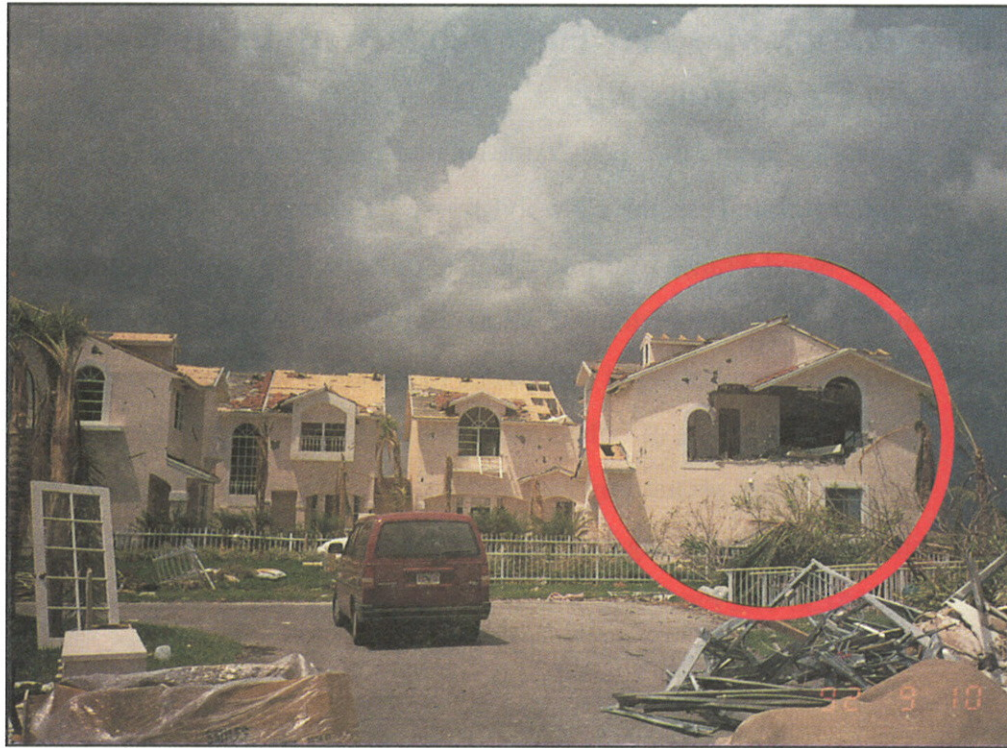
FIGURE 16. Two-story masonry buildings. Lack of continuous tie-beam led to failure of wall that was already weakened in design by window openings.

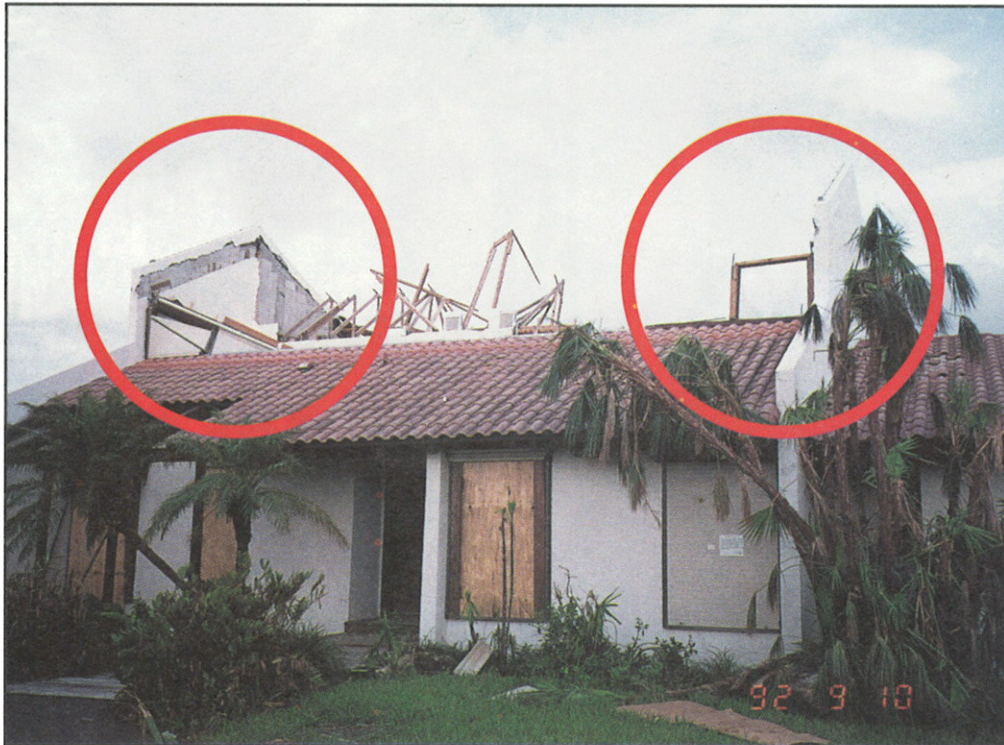
FIGURE 17. Two-story masonry building. While forces were sufficient to blow off entire roof structure, continuous masonry gables held.

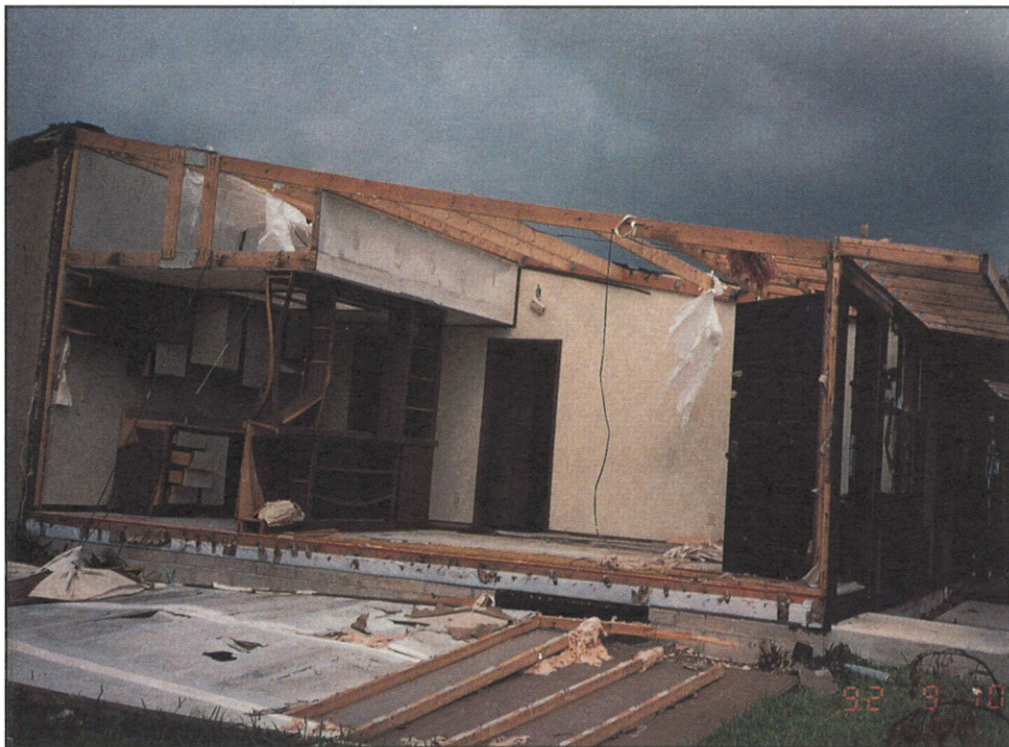
Two end-wall (end wall of end modules) failures were observed in a modular home subdivision. Poor connection of the tops of the walls to the roof diaphragms was evident in these instances. Some roof sheathing was observed missing from rafters, judged to be due either to building envelope breach (window and/or door failure) or to external wind and debris. Generally, the rafters themselves were left entirely intact, because of the inherent rigidity developed by the relatively short spans and secure connections. (SEE FIGURES 19 AND 20.)

FIGURE 19. *Modular home. End wall of end unit separated from unit; withdrawal of nails along eave line and roof sheathing failure were also observed.*

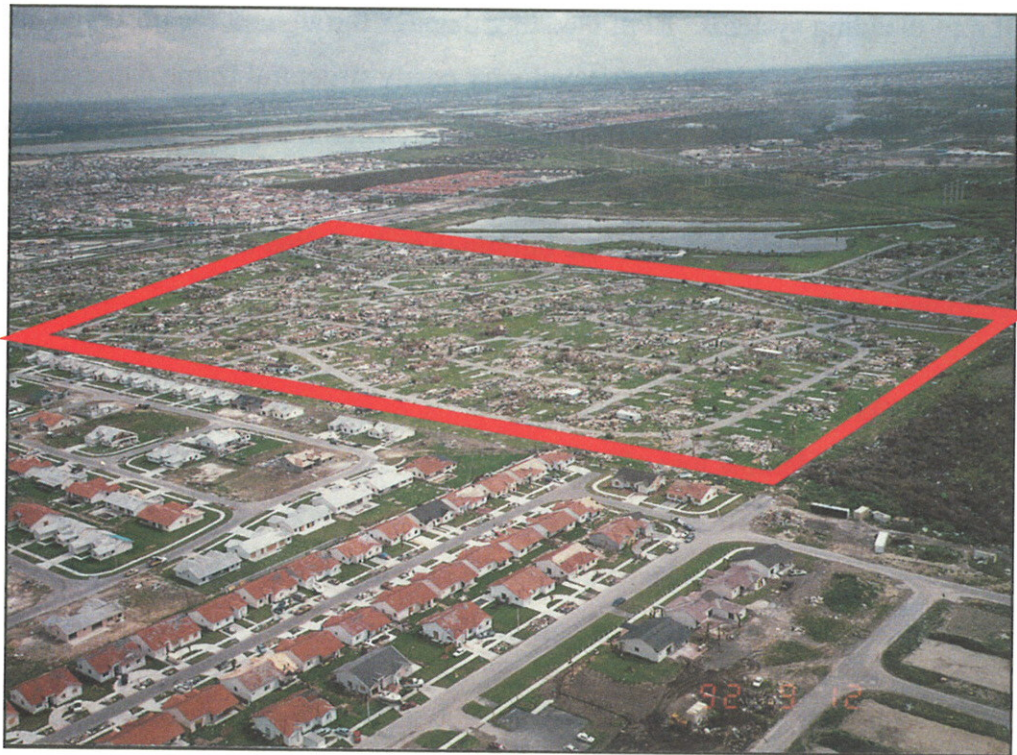
FIGURE 21. Aerial photo of damage area. Shows building performance difference between manufactured homes (outlined in center) and conventional residential buildings (lower left).

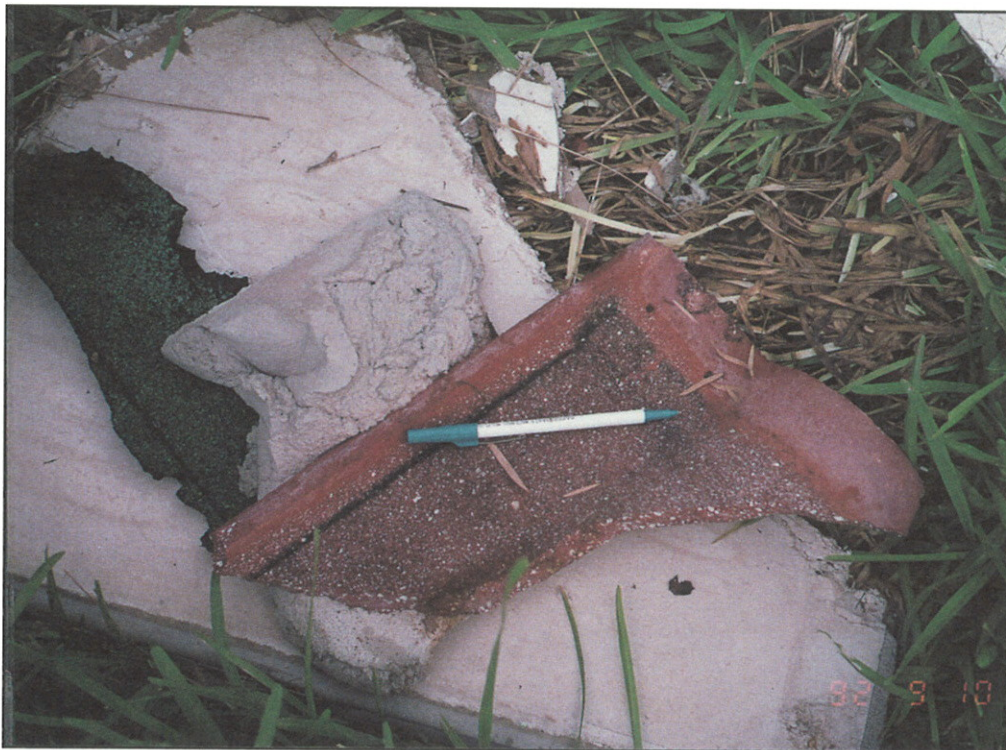
FIGURE 22. *Typical failure of roof sheathing-to-underlayment attachment. (Bond between underlayment and mortar pad, and between mortar pad and tile effective.)*

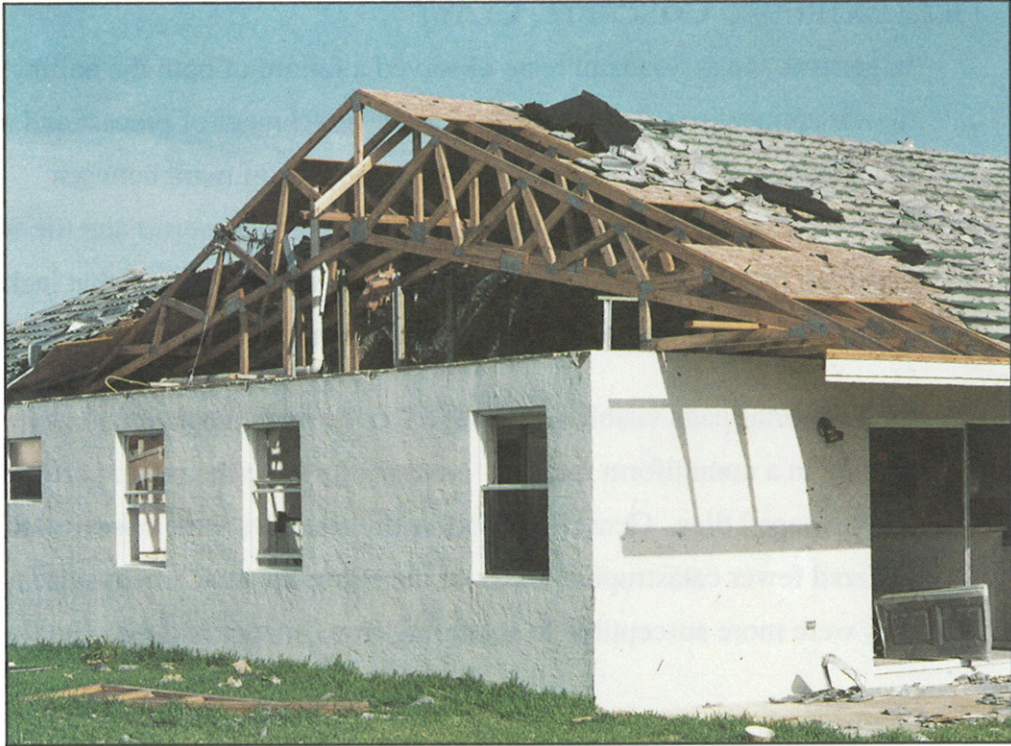
FIGURE 23. *Typical roofing failure. Failure of sheathing, underlayment, and extruded concrete tiles.*

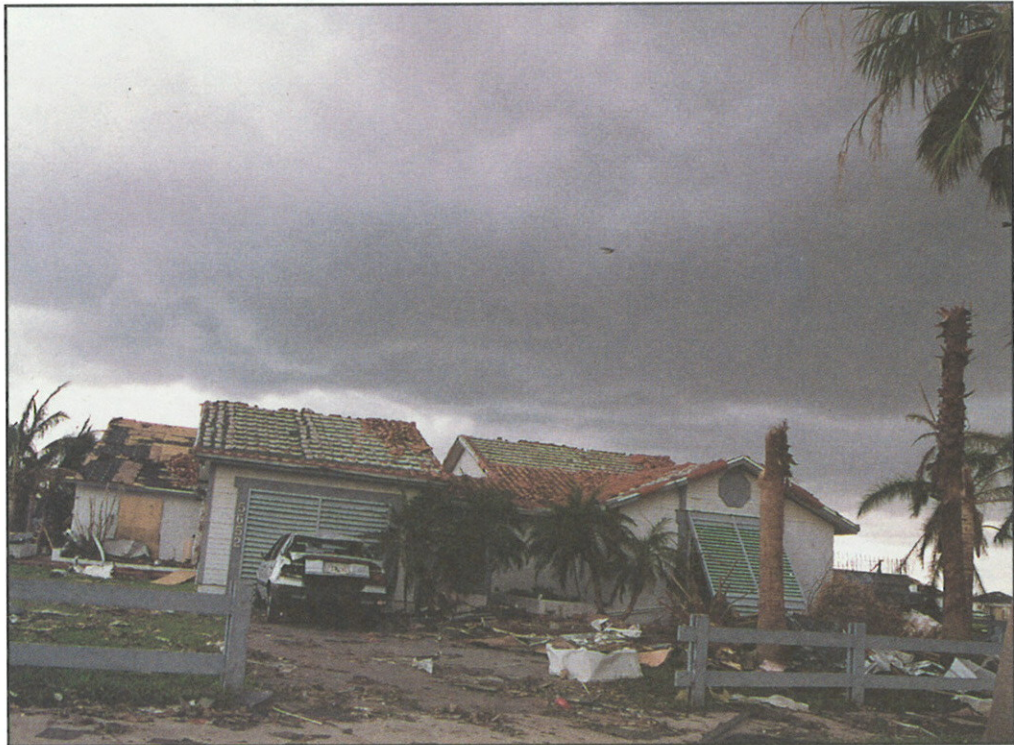
FIGURE 24. *Typical roofing failure. Failure between tiles and mortar pads.*

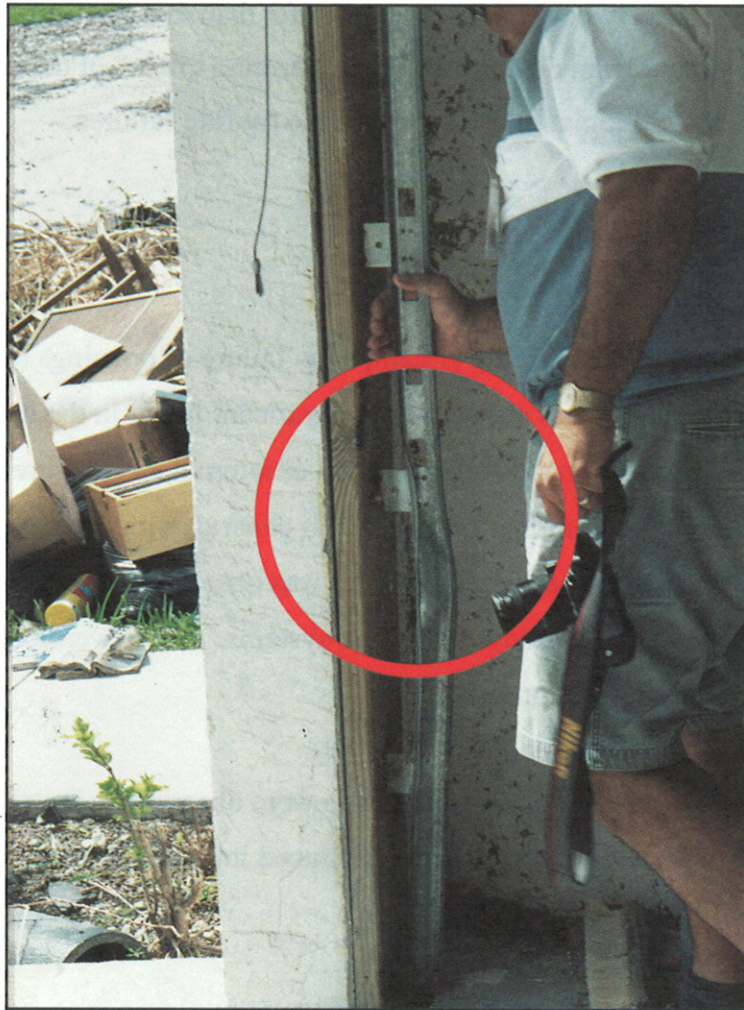
FIGURE 25. *Garage door failure. Rotation of track, and pullout of brackets at wall support.*

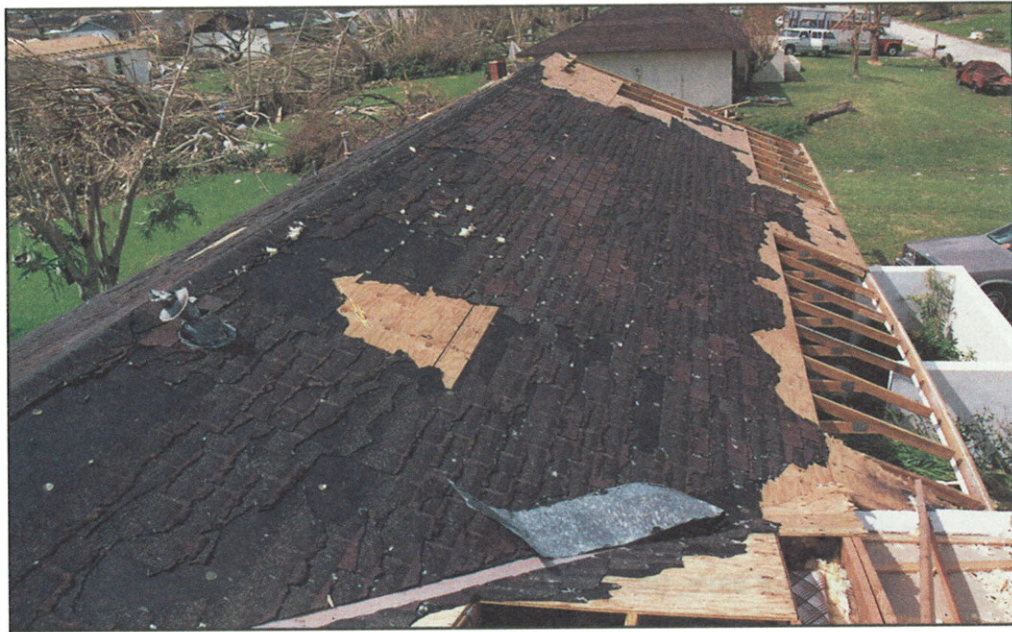
FIGURE 30. *Composition shingle and underlayment failure.*

2. Composition shingles should be manufactured and rated as satisfactory for high-wind areas. In the absence of this, a water-resistant membrane, e.g., a hot-mopped underlayment, should be installed to provide protection from the water infiltration that may result from the loss of roofing material during high-wind storms (SEE FIGURES 30 AND 31).
  3. Manufacturers of roof tile products should provide testing and verification of tile performances under realistic conditions (as addressed by the Code).
- Manufactures should verify that mortar used with extruded concrete tiles can be installed to Code requirements.

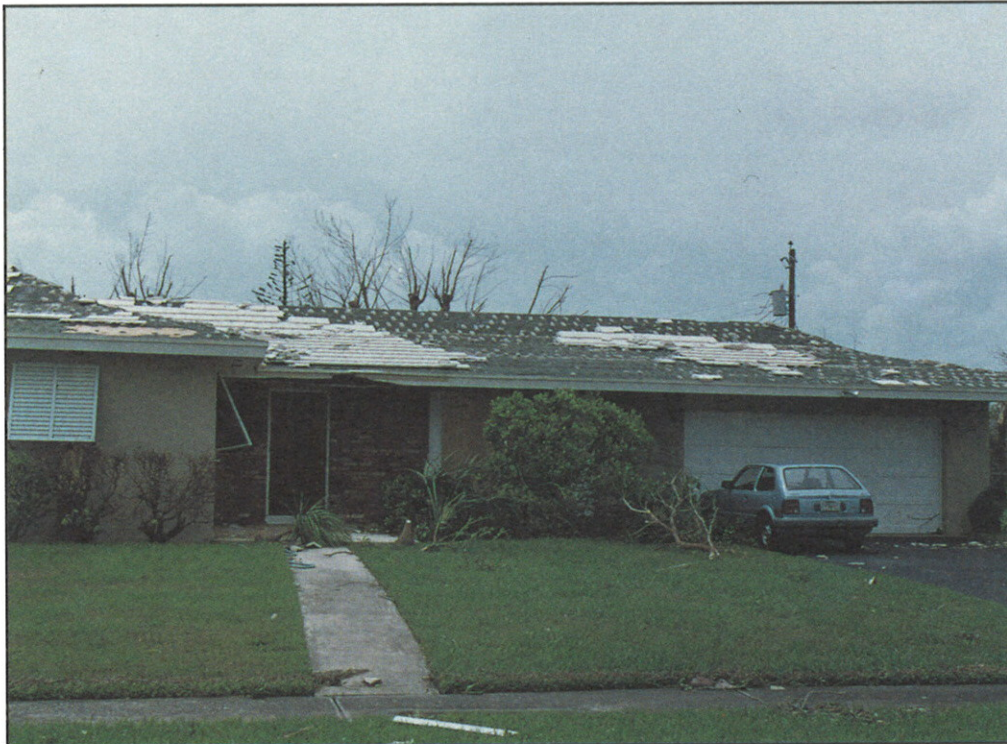
FIGURE 32. *Failure of extruded concrete flat tile roofing. Bond failure between tile and mortar and between mortar and underlayment was observed.*

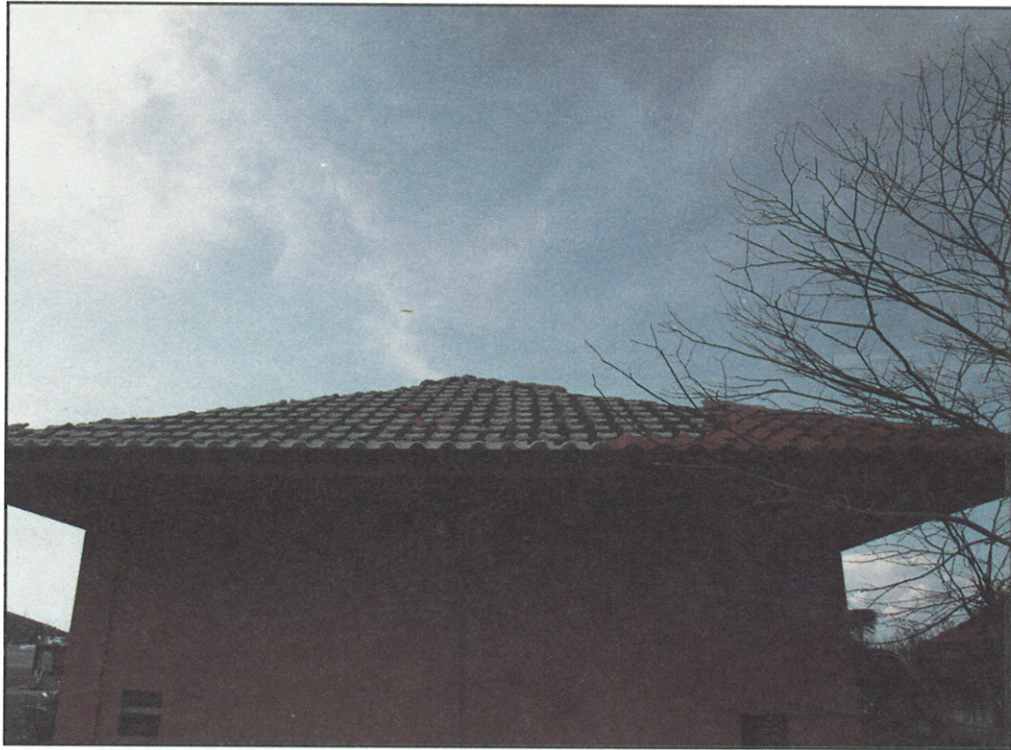
FIGURE 34. *Failure of "S" tile roofing. Bond failure between mortar and tile was observed.*

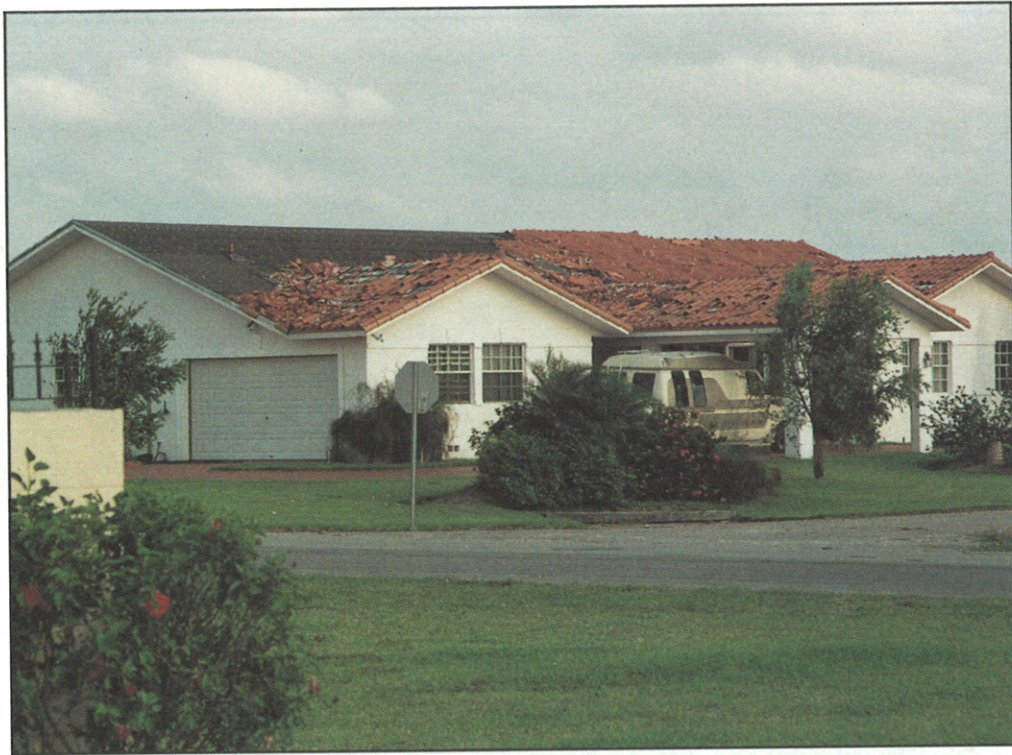
FIGURE 36. *Failure of barrel tile roofing. Bond failure between underlayment and mortar and between mortar and tile was observed.*

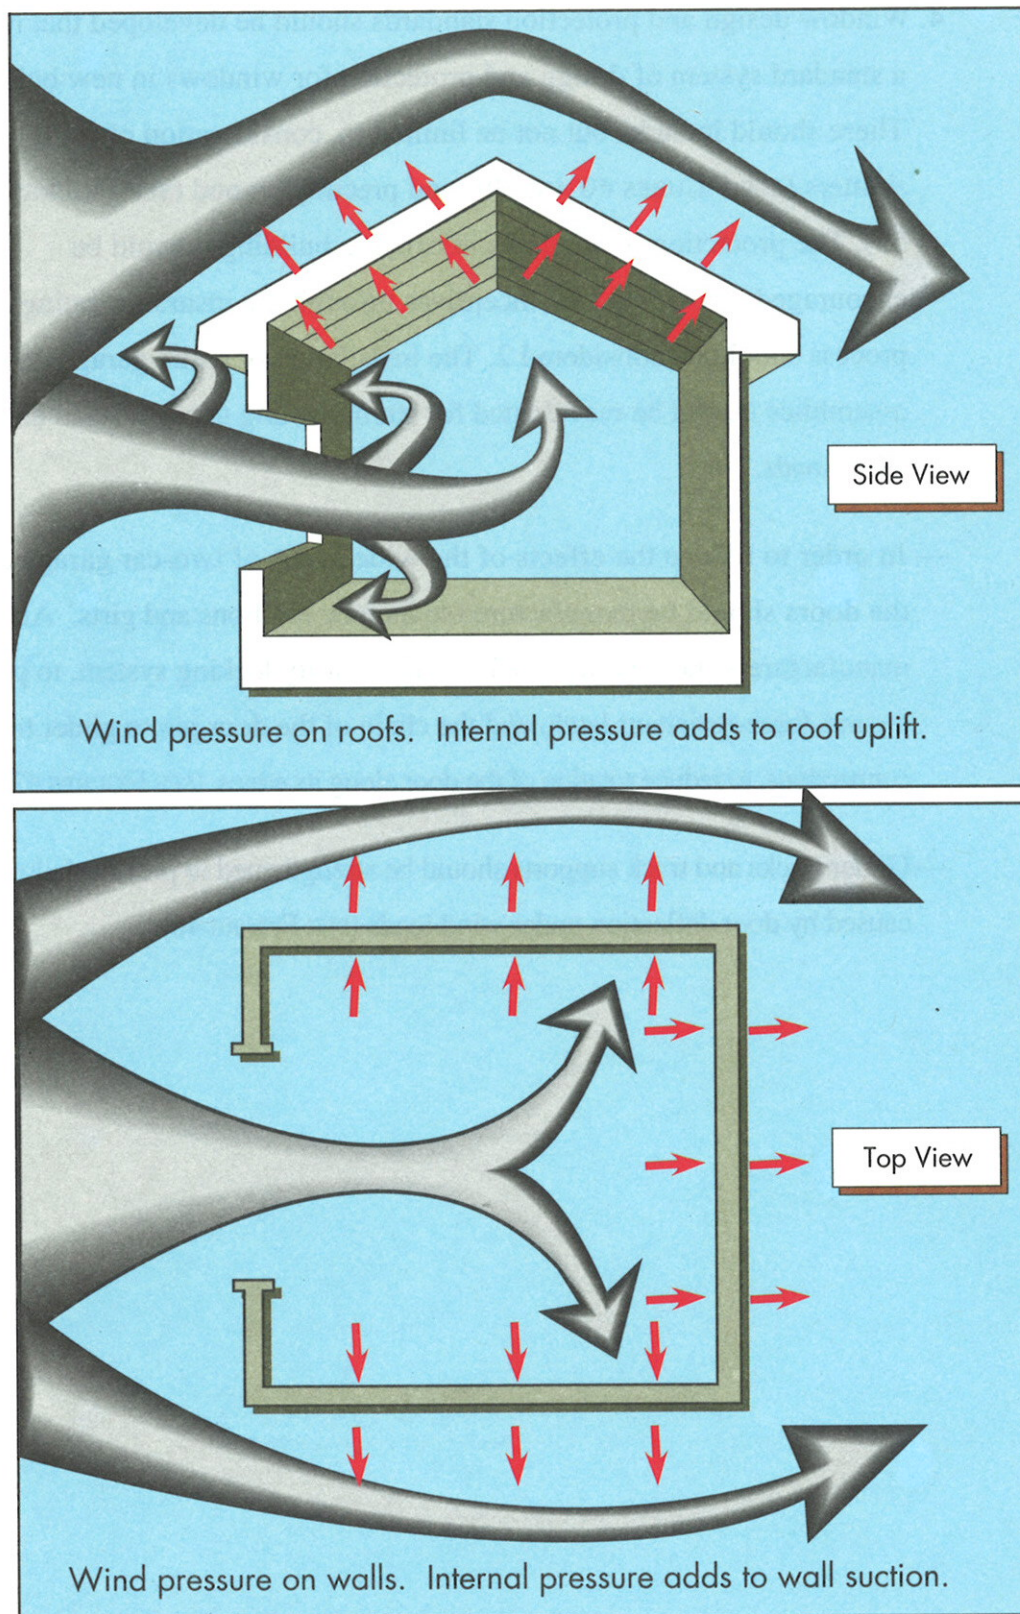
FIGURE 41. Results of building envelope breach due to failure of external doors and windows.

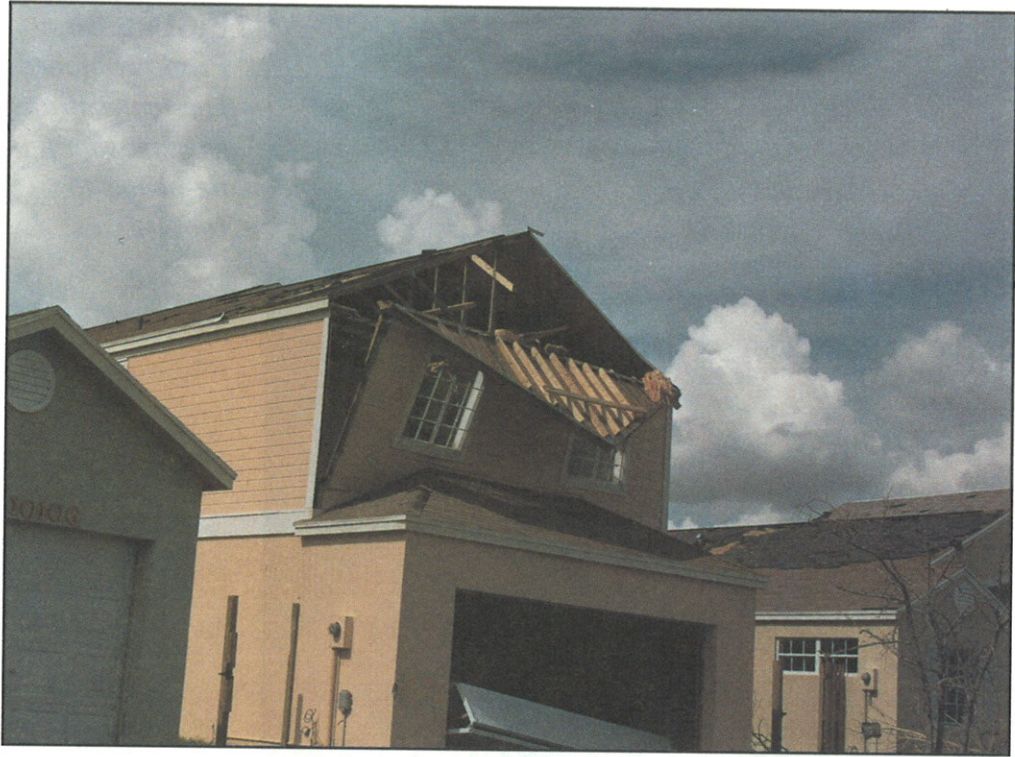
FIGURE 58. *End wall failure. Example of lack of load transfer capacity after separation.*

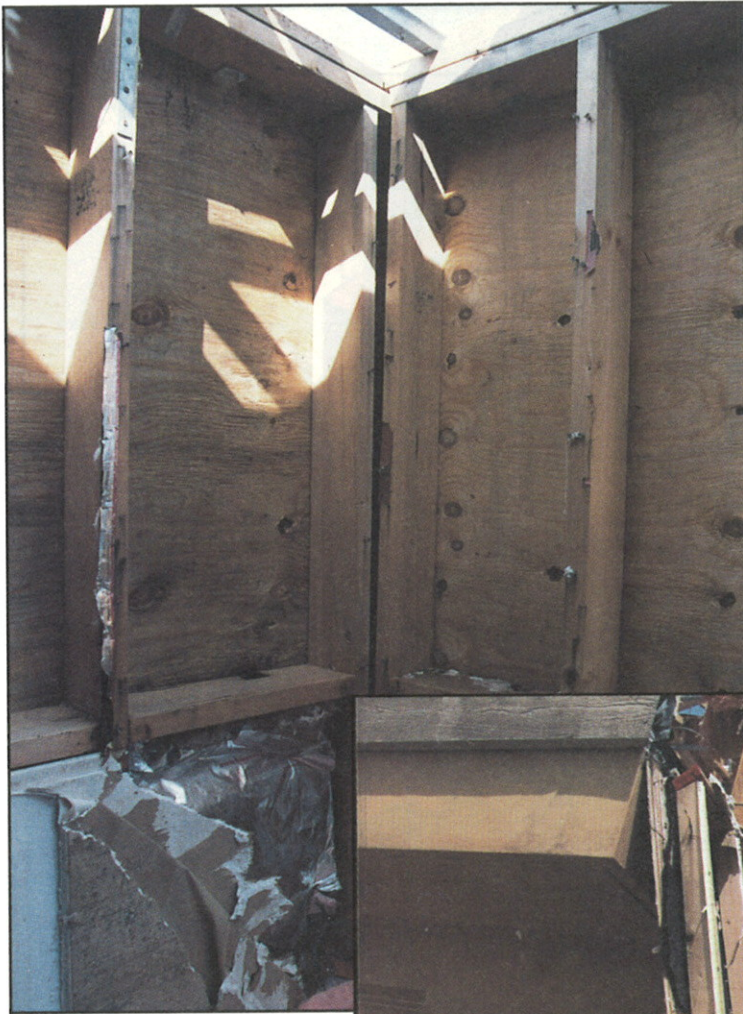
FIGURE 59.  
*End column/corner post  
missing from  
wall.*

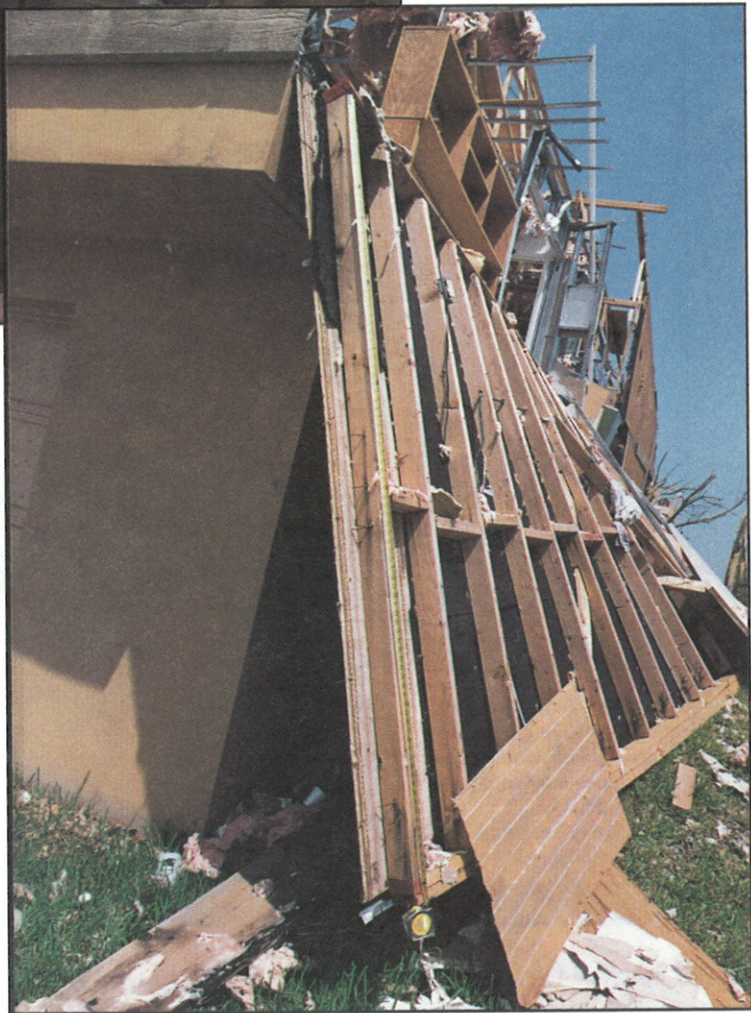
FIGURE 60.  
*Side wall failure. Side  
wall has no lateral load  
transfer capacity due to  
inadequately built-up  
corner post.*

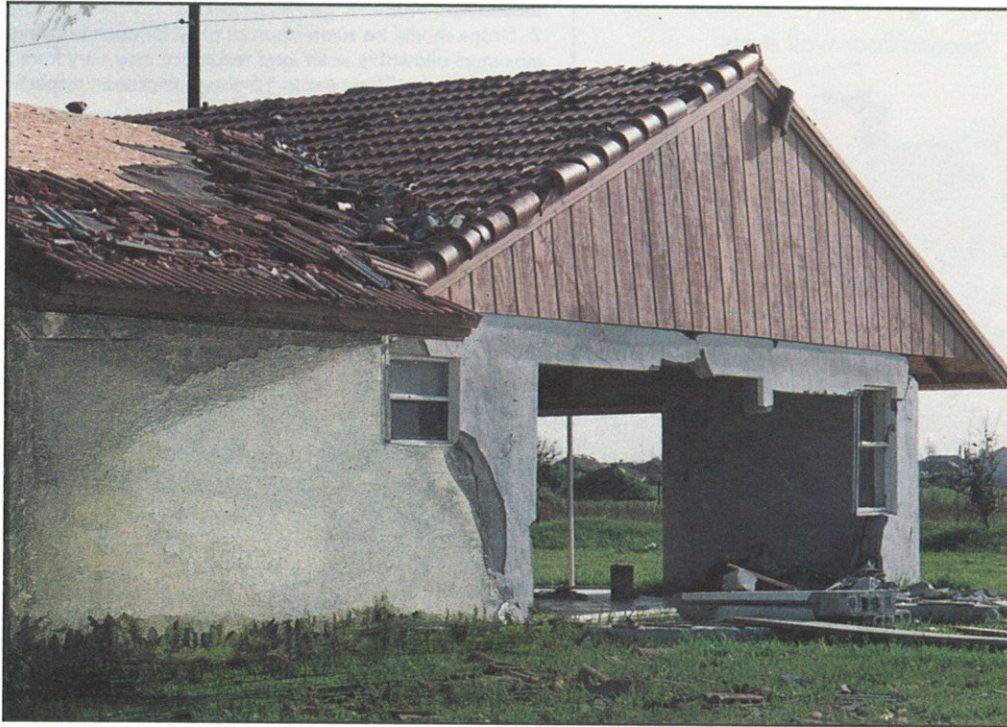
FIGURE 63. *Example of masonry construction. Wall separated from building envelope due to inadequate vertical wall reinforcing in connection to horizontal tie-beam.*

— The Code requirements for tie-beams/tie-columns, or alternative reinforced masonry construction, should be reviewed and enforced (SEE FIGURES 63 AND 64).

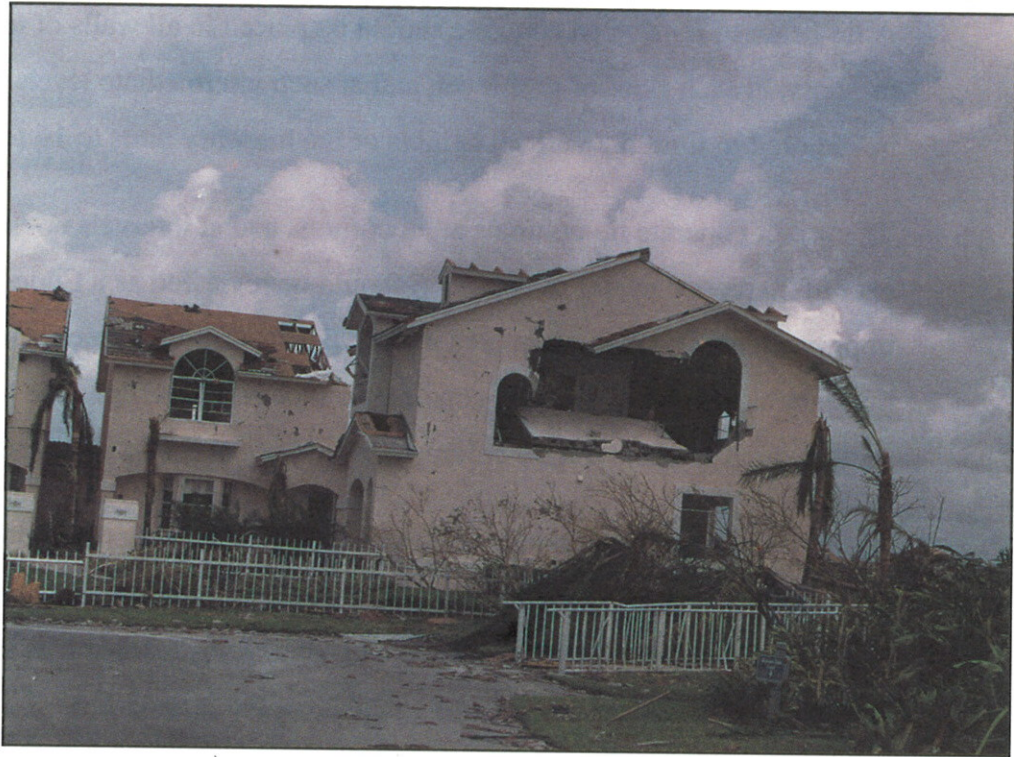
FIGURE 65. *End wall failure. Freestanding concrete masonry wall has discontinuous tie-beam.*
