# **BUILDING PERFORMANCE: HURRICANE ANDREW IN FLORIDA**

**OBSERVATIONS, RECOMMENDATIONS,  
AND TECHNICAL GUIDANCE**

**FEDERAL EMERGENCY MANAGEMENT AGENCY  
FEDERAL INSURANCE ADMINISTRATION**

**DECEMBER 21, 1992**

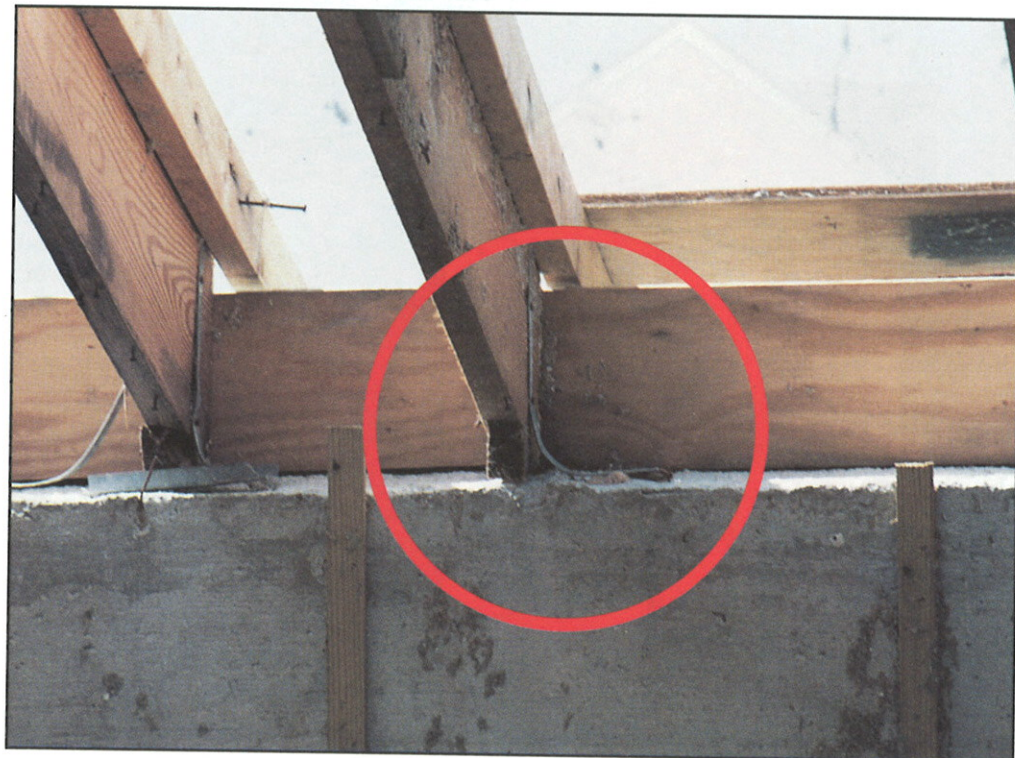
FIGURE 70. Improperly located masonry-wall-to-wood-frame straps.

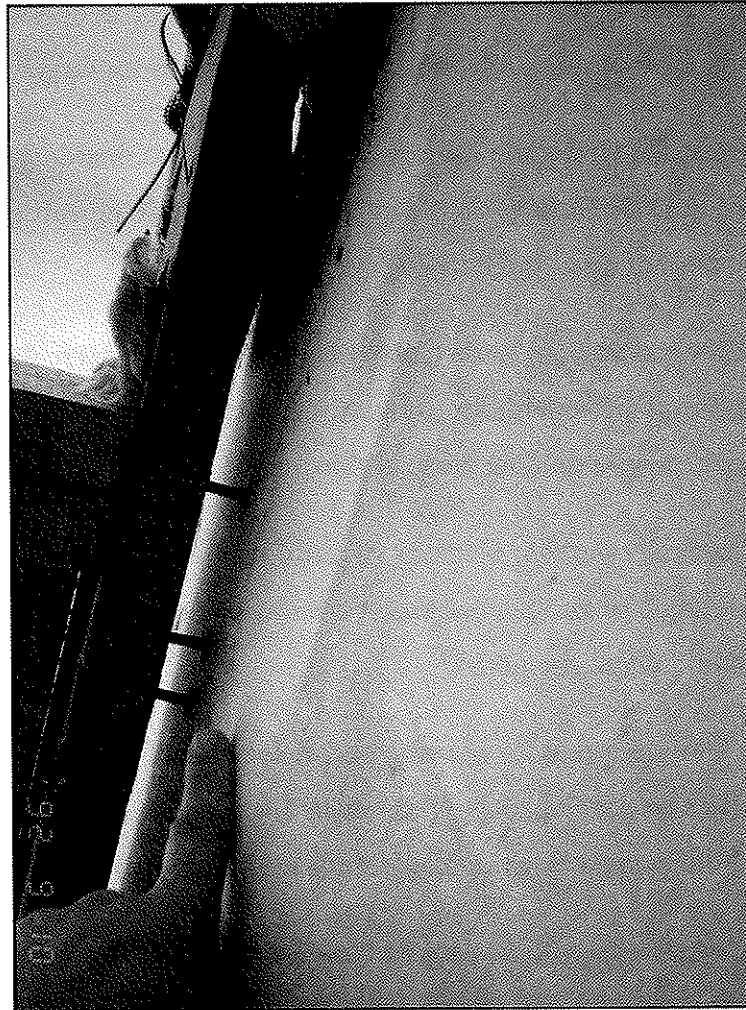
FIGURE 71. *Modular home. Partial separation of end panel (right) from roof structure (left). Evidence of failure due to nail withdrawal.*

3. Although the modular systems (SEE FIGURE 18) generally performed well, possible alternatives to the detailing and construction of weaker components of the systems should be reviewed. Most notably, the end-panel connections of end units, and roof sheathing should be reevaluated (SEE FIGURE 71).
