Event Report

# Kocaeli, Turkey Earthquake

August 17, 1999 3:01 a.m. M7.4 40.7N 29.9E 17km depth

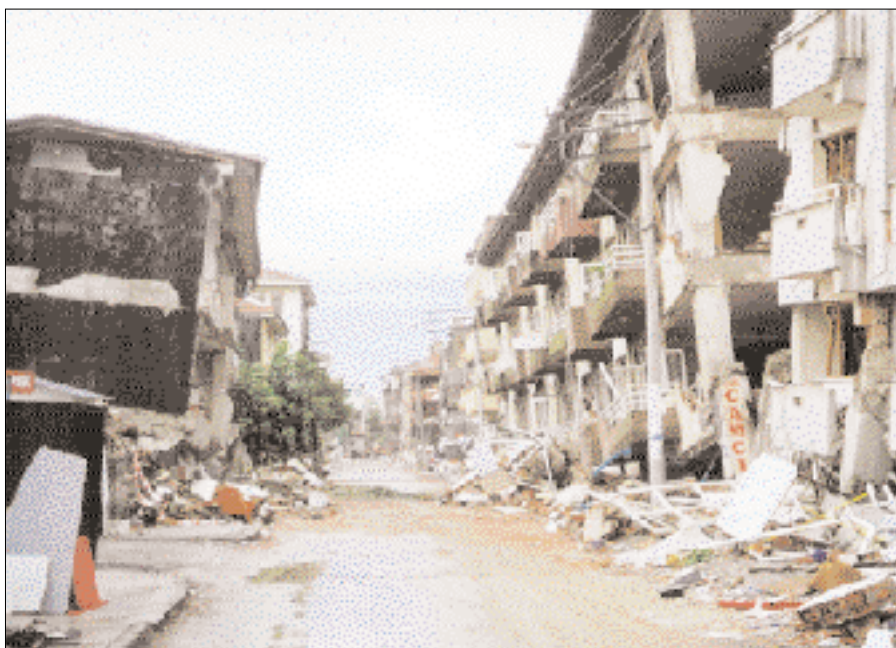
*As seen here in Golcuk, the neighborhood fabric has been completely destroyed in some of parts of the region's hardest hit towns, as nearly every building suffered either partial or total collapse.*

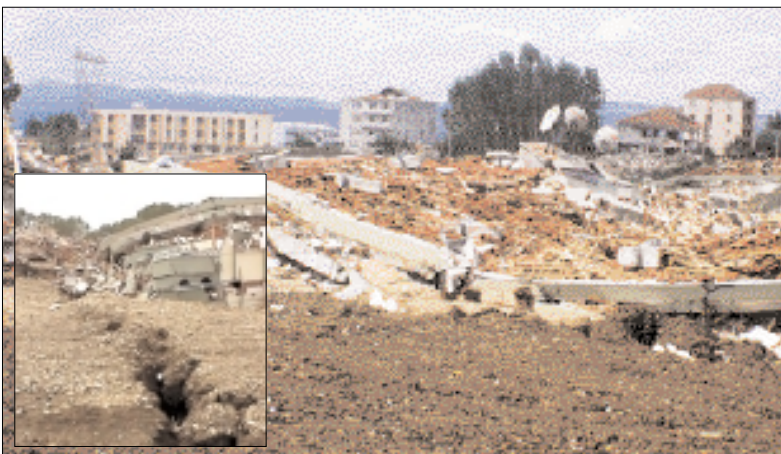
*The fault ruptured through this recently built but unoccupied 180-unit vacation development near Kular, completely destroying 7 of 8 buildings. The remaining building and all surrounding structures were also heavily damaged.*

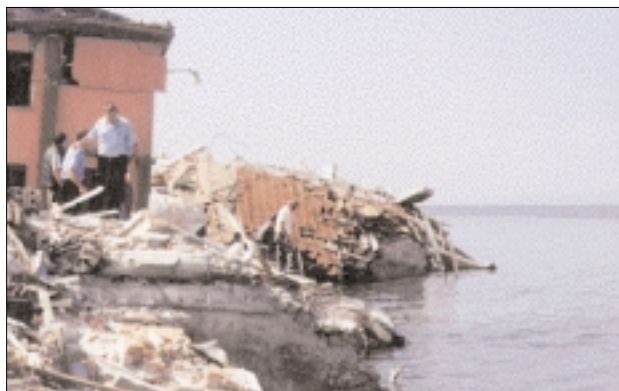
*Several city blocks of streets and buildings were submerged when the Marmara Sea coastline at Golcuk and Degirmendere suffered severe subsidence of about 3 meters (10 feet). The shoreline shifted inland 100 to 300 meters (330 to 980 feet) along the stretch of coastline, as shown here.*

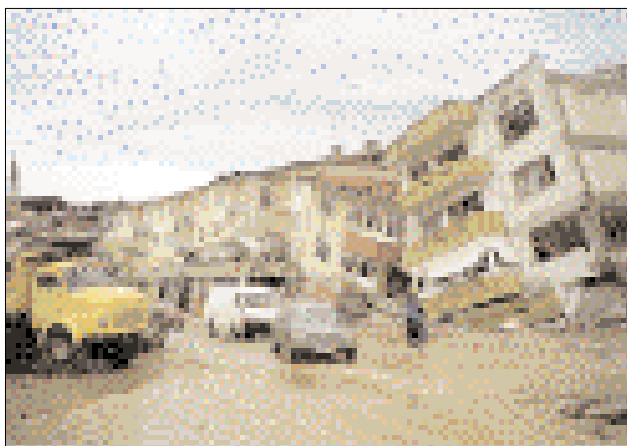
main street in Adapazari's city center was completely destroyed. Buildings punched through the highly saturated soil layer that liquefied in the earthquake, sinking by more than 1 meter (3.3 feet), and often collapsing as a result. Some structures with adequately reinforced mat foundations stayed intact, saving the occupants and some building contents, but earthquake-induced differential settlement caused them to slowly sink or lean onto their sides.

*Adapazari means "island market" and the city center was settled in the last century as residents moved from adjacent hills and filled in the swampy lands of an old riverbed near a new railway and roads. As shown here, much of the city center's buildings and infrastructure were heavily destroyed in the August 17 earthquake. An earthquake similarly destroyed Adapazari's center in 1967, and efforts to redirect development into the hills gave way to urbanization pressures of the past 30 years.*

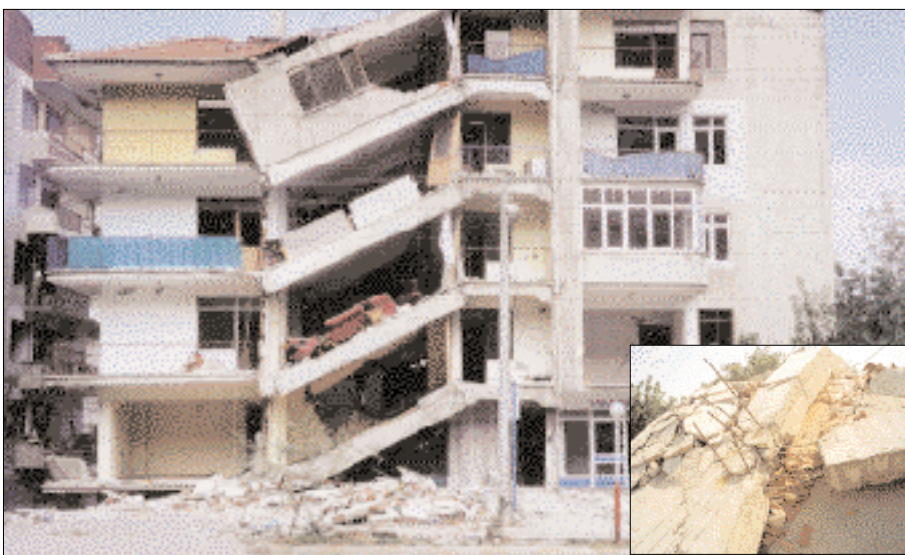
Most buildings collapsed because the columns lacked adequate transverse steel reinforcement to resist lateral loads. Shear failures occurred in the structural columns and at the beam-column connections. Many buildings were also designed with an open ground floor to accommodate other uses, such as parking, and the soft story conditions exacerbated the non-ductile failures.

Commonly seen throughout the epicentral region, a portion of this reinforced concrete building's first floor was partially destroyed. As shown in the inset, columns generally lacked an adequate amount of steel reinforcement.

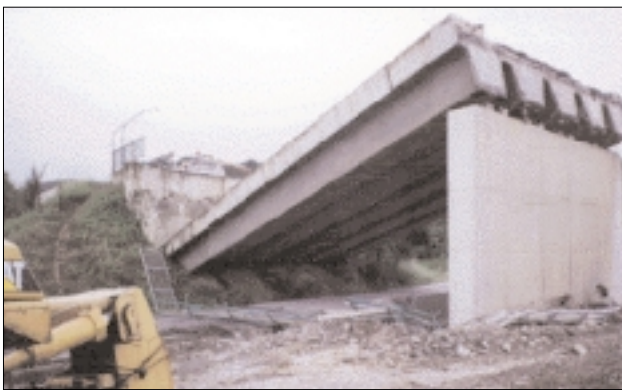
The fault rupture also caused a freeway overpass to collapse on the main motorway between Izmit and Ankara. Additional heavy damage along a 50-kilometer (30-mile) section of the motorway hampered relief vehicles for more than a day, until the roadway was cleared and temporarily repaired. The railway track between Adapazari and Istanbul was also warped by the fault rupture and had to be replaced.

*The fault rupture severed this bridge from its approach, along the Istanbul-Ankara motorway.*

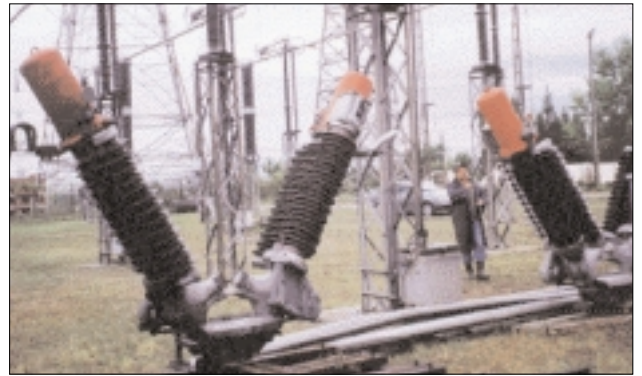
The earthquake severed power lines throughout the epicentral region, and damaged many transmission towers and two main electrical substations. Because the country's power grid was built with redundancy in the main transmission lines, power authorities were able to reroute the grid to restore

*Repairs to damaged equipment at this substation in Adapazari were well underway less than one week after the earthquake.*

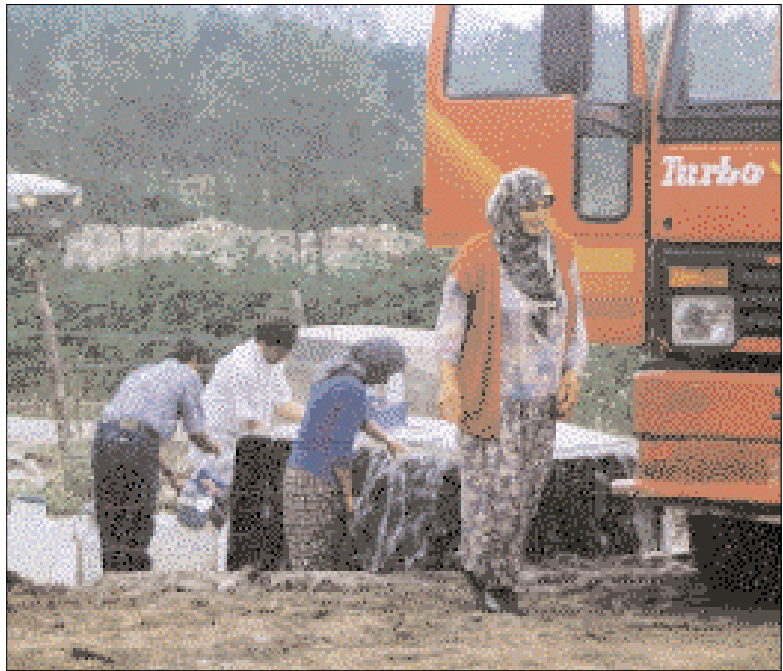
damage, but the fault rupture near Kular severed the main trunk line leading from the regional water treatment plant to the distribution network circling Izmit Bay. Water reservoir distribution sites throughout the region were drained empty by leaks in heavily damaged local distribution systems. Water had to be trucked from reservoirs to damaged towns, and repairs are expected to take considerable time and resources.

*Underground water piping systems sustained heavy damage, and water trucks made several trips a day delivering water from the Izmit treatment plant to epicentral communities. Local residents also took advantage of water leaking from damaged washouts along the region's main trunk line.*

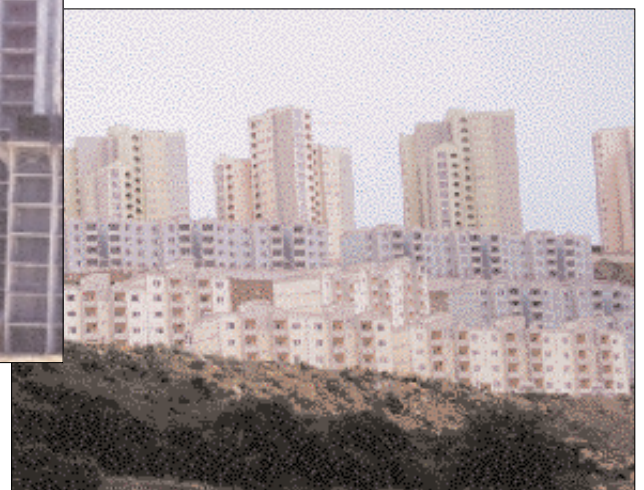
*Housing development pressures continue, and recently built structures vary greatly in seismic quality and code compliance.*
