Izmit, Turkey Earthquake of August 17, 1999 (M7.4)

AN EQE BRIEFING

GENERAL OVERVIEW

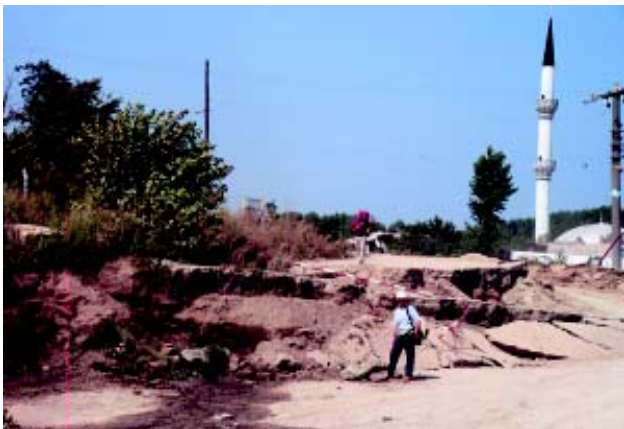
A 2-meter high escarpment along the North Anatolian fault, east of Gölcük. Note the leaning minaret.

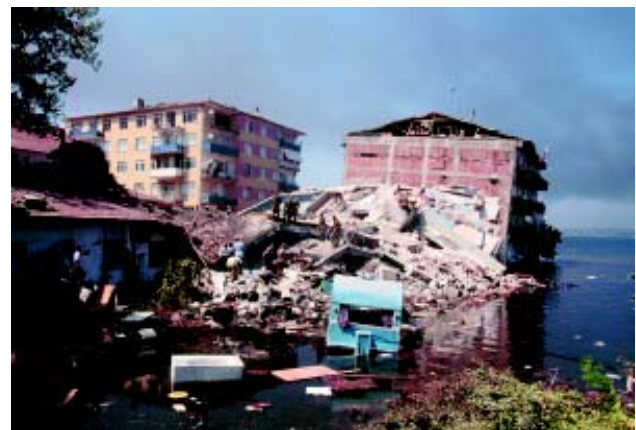
The North Anatolian fault system is one of the most studied and best-understood fault systems in the world. This earthquake produced spectacular right lateral faulting over at least 37 miles (60 km) of the fault. Our team observed offsets greater than 8 feet (2.5 m) in the region of Gölcük, along the coast of the Gulf of Izmit. Significant vertical offsets along the fault were also observed. In the vicinity of a new automobile assembly plant being constructed east of Gölcük, the vertical offset was about 6 feet (2 m). Typically, the ground to the north of the fault dropped with respect to the ground to the south. This vertical movement or drop, and accompanying ground settlement and lateral ground flows in soft soils caused extensive and permanent flooding of large areas along the coast. The bottom photo shows flooded areas along the coast in Gölcük.

Collapsed and damaged buildings along the waterfront of Gölcük along the Sea of Marmara. The inundation is caused by a down drop of several meters along the North Anatolian fault (behind the building), combined with settlement and other ground failures.

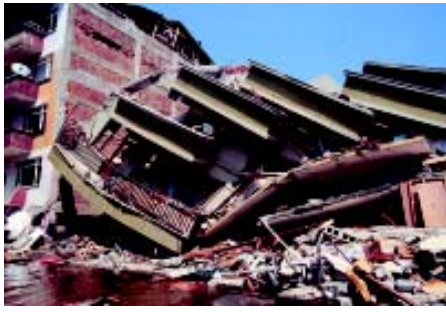
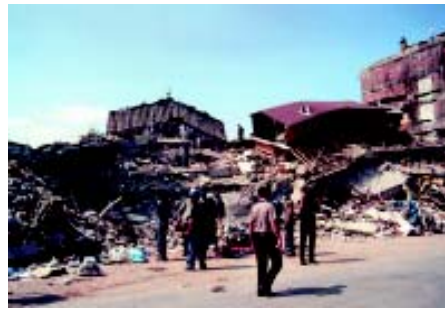
A typical, collapsed 7-story reinforced concrete commercial building in Gölcük, near the shoreline. Rescue operations in this area are in progress (middle photo). Practically undamaged shear wall building under construction in the heart of the damaged area of Gölcük (right photo).

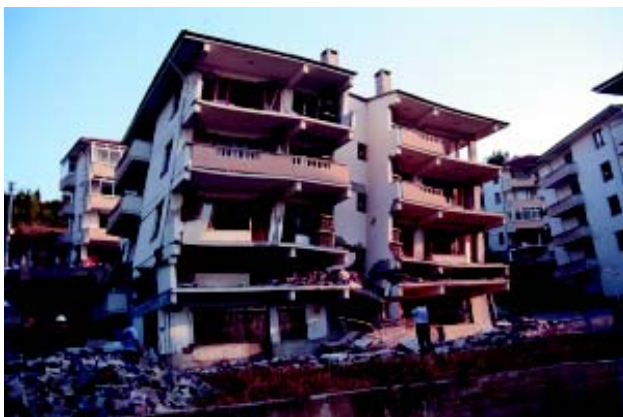
Partial collapse of and damage to new reinforced concrete apartment buildings between Gölcük and Yalova.

with architectural (non-structural) unreinforced masonry infill walls. A large percentage of the severely damaged and collapsed buildings were typically in the 6- to 8-story range, either under construction or built within the last few years.

These buildings, like all recent construction in Turkey, are supposed to be designed and built to a code which incorporates sophisticated earthquake-resistant provisions. The code is an adaptation of the Uniform Building Code in California. Therefore, most of the collapsed multistory buildings were believed to be highly earthquake resistant. They were not for some or all of the following reasons:

1. Most of the buildings did not meet the design requirements of the code and included details that are not earthquake resistant. Those include inadequate vertical and horizontal reinforcing steel and the widespread use of smooth (as opposed to deformed) reinforcing steel.

2. Typically, the design structural engineer, who is an employee of the contractor, does not inspect the ongoing construction to verify that the contractor has built the building according to the intent of the design drawings. This lack of construction oversight by the design engineer allowed for on-the-spot field design modifications and other measures to occur (i.e., no checks and balances), which compromised the earthquake resistance of the buildings.

3. Many of the buildings were built with poor and inappropriate construction materials and utilized poor workmanship.
4. Many buildings were knowingly allowed to be built on active faults and in areas of high liquefaction potential.

5. Many buildings were not engineered, but built according to past experience.

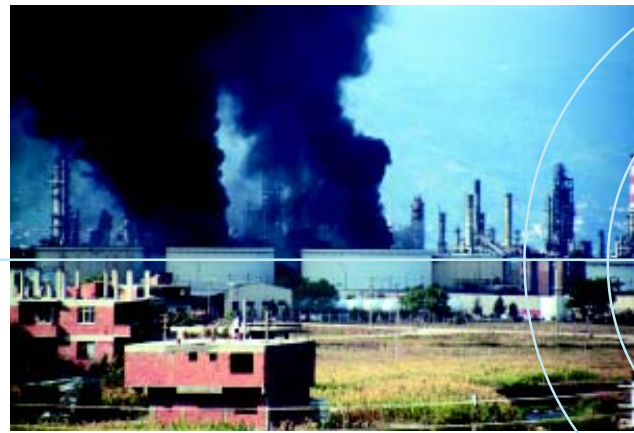
A fire in the tank farm burned out of control for several days, prompting the evacuation within a 3-mile radius, for fear of explosions. A 300-foot (90 m) high reinforced concrete heater stack catastrophically collapsed, destroying one crude unit and knocking down equipment and pipeways, causing additional fires.

The burning Tüpras oil refinery at Korfez three days after the earthquake.

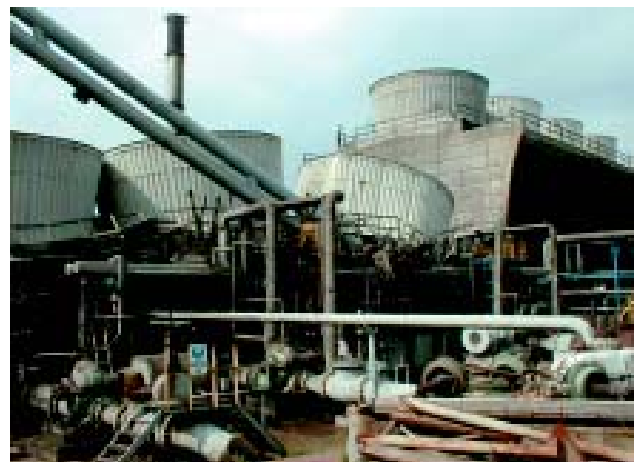
Collapsed cooling tower at Petkim petrochemical plant.

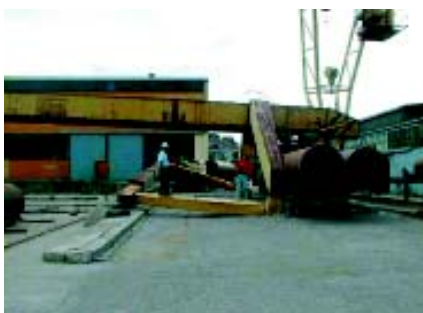
One of two collapsed cranes at the steel pipe factory in Izmit (left photo). Partial collapse of the structure caused extensive downtime at a tire manufacturing plant in Izmit (middle photo). Stack collapsed in Crude Unit, Tüpras Refinery (right photo).

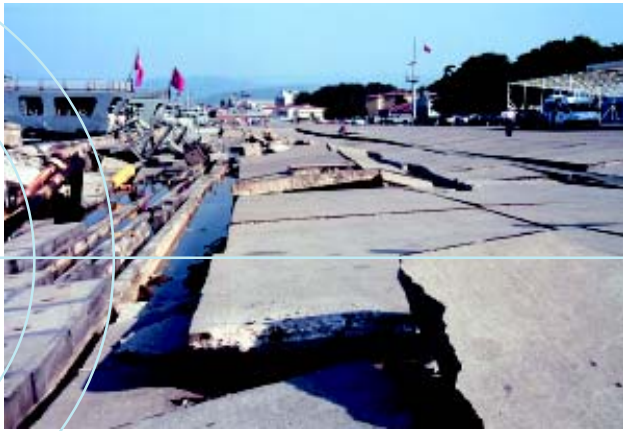
Damage due to faulting and lateral spreading at the main pier and seawall of the Gölcük Naval Base.

Ports: There was extensive damage at the Turkey Naval Base in Gölcük, with collapsed buildings killing several hundred military personnel, including senior officers. Several buildings were ripped apart by the fault, which bisected the base. Here, fault displacement was primarily right lateral approximately 2 to 3 meters with perhaps 30 centimeters of vertical displacement. The main docks just behind the sea walls were heavily damaged by the fault, and two large cranes were damaged by a combination of

lateral spreading of the soil below the supporting structures and spreading of the rails. Numerous other port facilities along the Gulf of Izmit suffered severe damage.

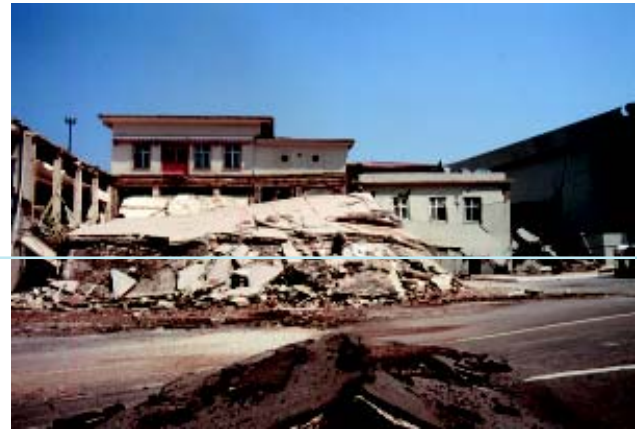
The collapsed Officer's Club at the Gölcük Naval Base. The building straddles the fault which displaced 2-3 meters. Note the faulting in the foreground.

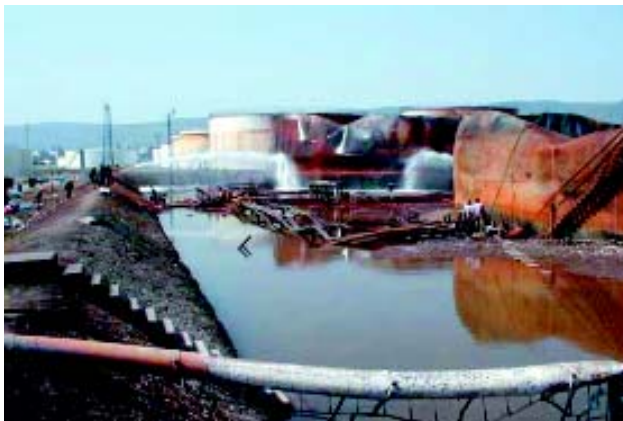
Firefighters containing tank fires at Tüpras Refinery.

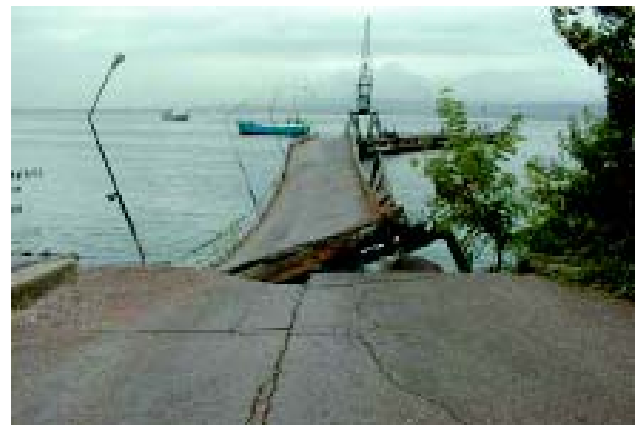
Damage to a bridge to the pier at the SEKA Paper Mill in Izmit.

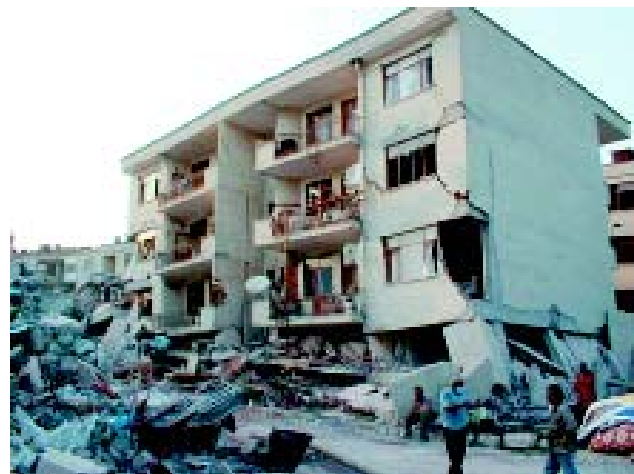
Collapsed and partially collapsed just completed 5-story buildings in Gölcük.

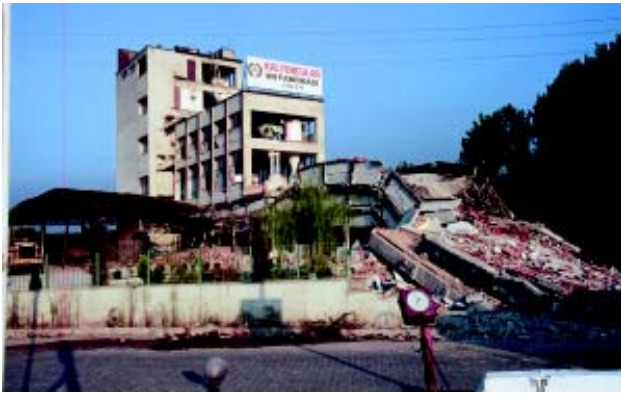
Reinforced concrete industrial building at Gölcük. The front third of the building has collapsed completely. The middle section has two floors collapsed.

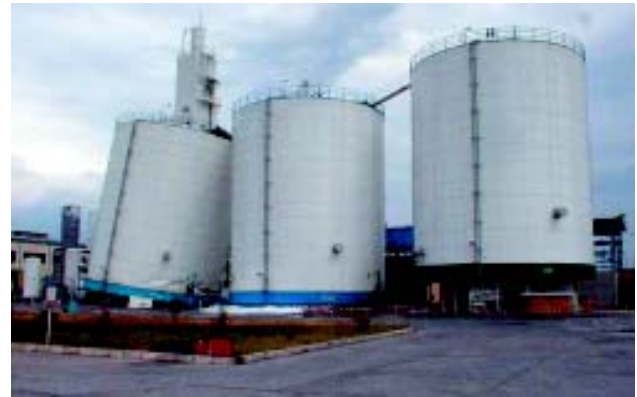
Identical liquid oxygen and nitrogen tanks at Habas facility in Izmit. Reinforced concrete supports collapsed on full tanks left and center, but not on 1/4 full tank on right.
