# THE BAM, IRAN EARTHQUAKE OF 26 DECEMBER 2003

*Field Investigation Report Prepared By:  
Dr. Ali Reza Manafpour, Halcrow Group Limited*

## The Bam Earthquake of 26th December 2003

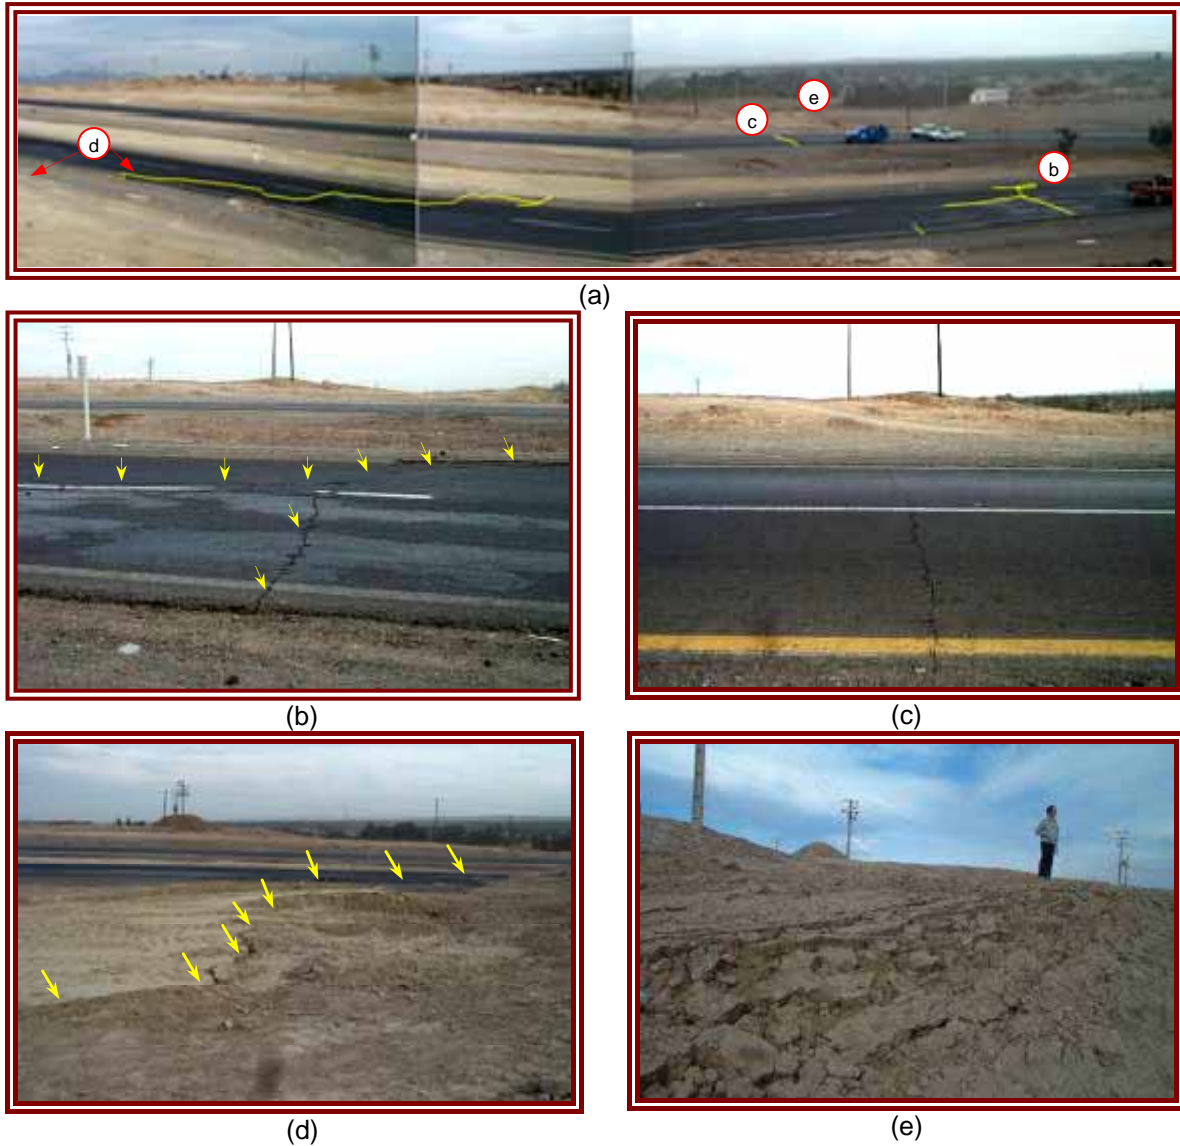
Ground failures and deformations were not significant in the Bam Earthquake. Ground movements were observed at the intersection (see Figure 6) of the Bam fault and Bam to Baravat main road that runs almost normal to the fault (see Figure 2). However, these movements were generally small and produced only surface cracks on the road and on the adjacent ground on either side.

**Figure 6: Ground movements along the Bam fault on the Bam-Baravat road and nearby ground (a) panoramic view on Bam-Baravat road from south with cracked areas highlighted (b), (c) Close up view of cracks in south and north band of the road (d) Cracking in the ground on the south side of the road (e) a shattered zone of fissures on the north side (Yellow lines and arrows show the location of cracks)**

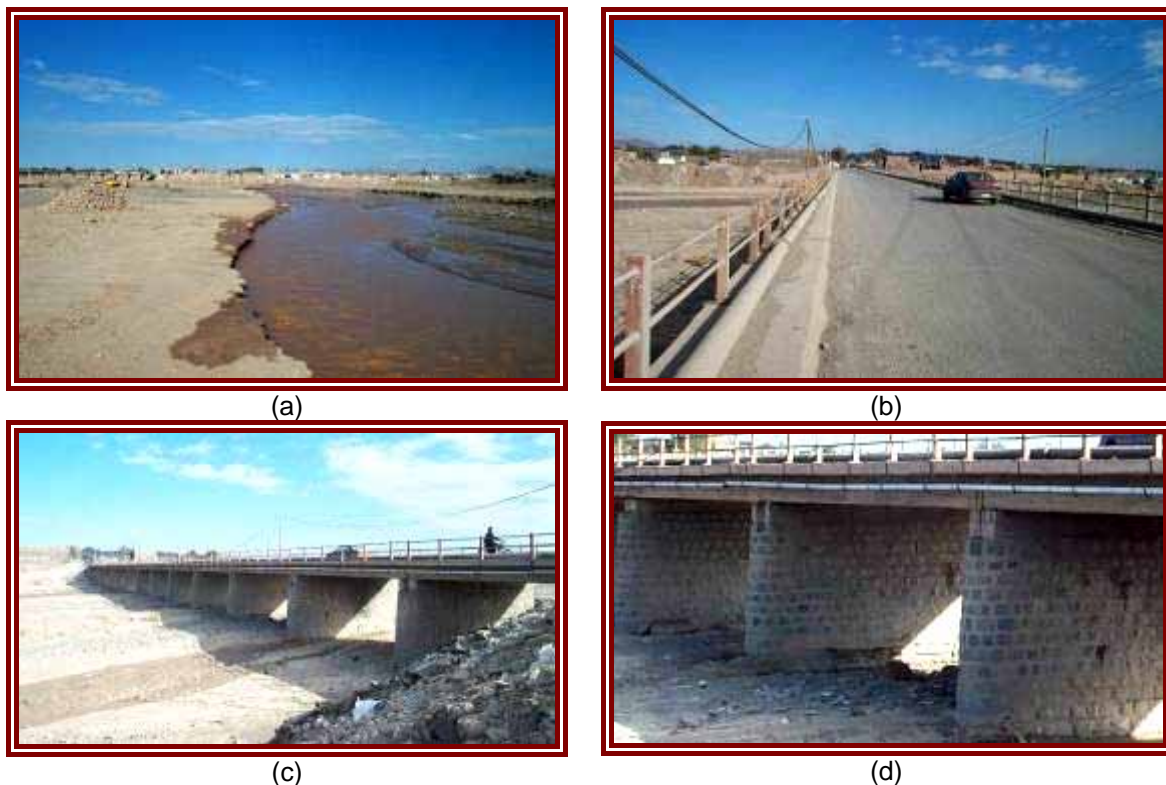
Figure 7 shows the main bridge in Bam which provides access to the satellite villages to the North of the city. Minor cracks on roads appeared near to the fault zone as seen in Figure 6. However, in the city itself, many streets and most of the alleys were blocked after the earthquake due to debris from the damaged buildings.

**Figure 7: Posht Rood seasonal river (a) and the main bridge in the north of Bam (b-d). No sign of damage to the bridge was observed. The pipeline beneath the deck (c,d) was displaced in a couple of points while the main pipeline on the deck appeared to be intact (b).**

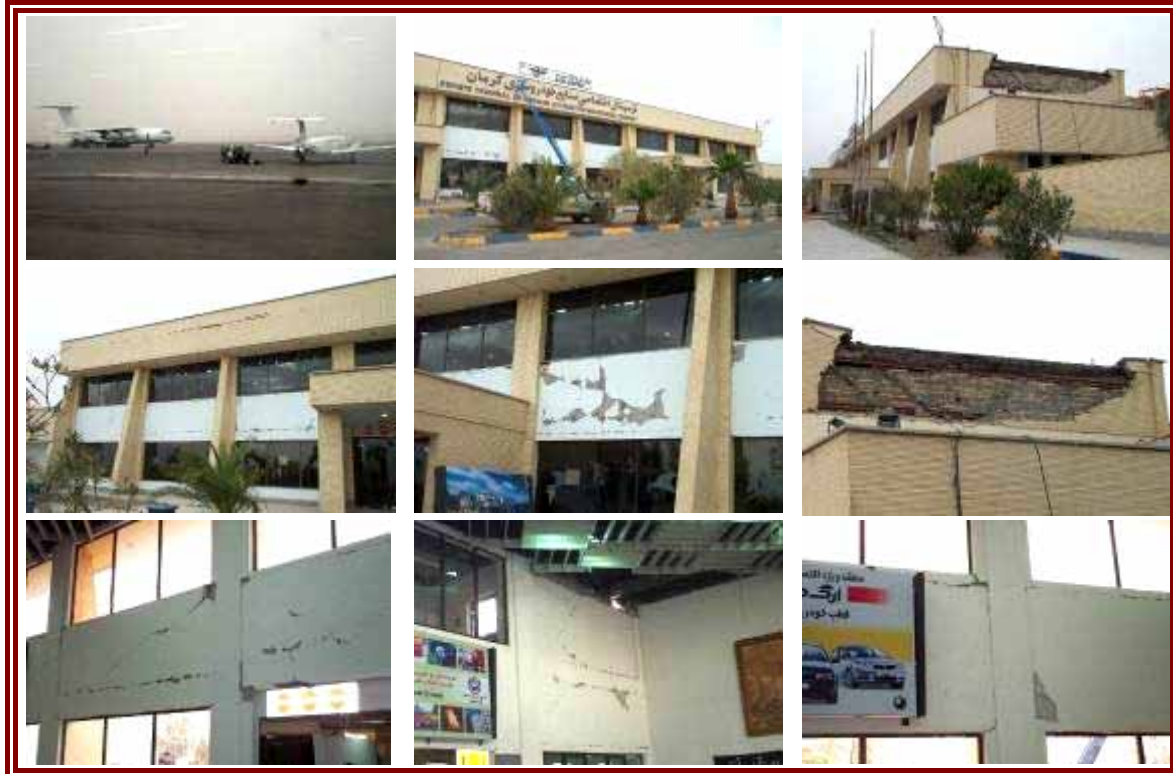
Damage to the airport building is shown in Figure 8. Part of the facade on the top of the building and sections of the false ceiling collapsed and cracks on the walls were observed outside and inside of the building. The airport was out of operation for a few hours after the earthquake due to damage to the airport control tower but later played a major role in the rescue and relief operations. Many flights from inside and outside the country landed in the airport in the early days after the earthquake.

**Figure 8: Bam Airport: Damage to the airport building in form of cracks and partial failure of non-structural fixtures. The first two rows show views from the outside of the building with the bottom row showing the inside of the building.**

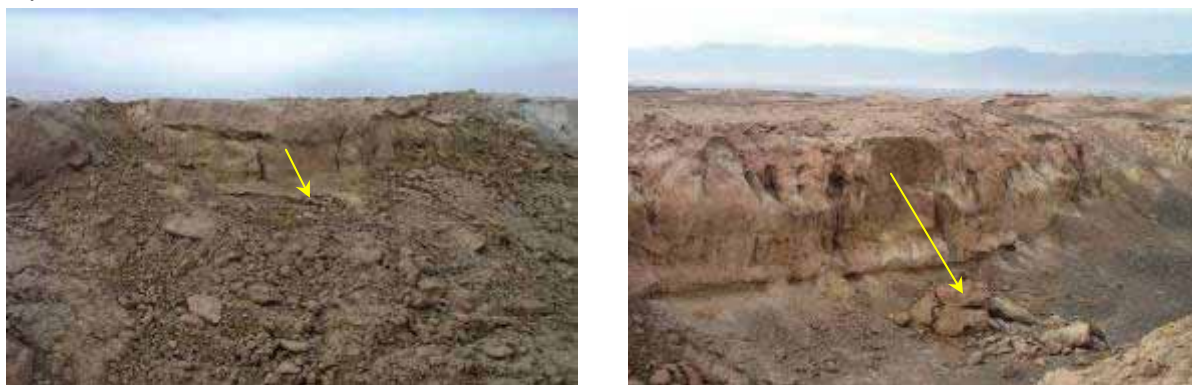
Some minor effects from landslides in the form of separated earth blocks and falls in dry natural drainage channels were observed in southeast of Bam and near to Baravat (Figure 13). Most of the banks of these natural drainage channels are already cracked due to the hot climate and are prone to separation or slide failures.

**Figure 13: A minor landslide and a fall in southeast of Bam, near to the Bam-Baravat main road**

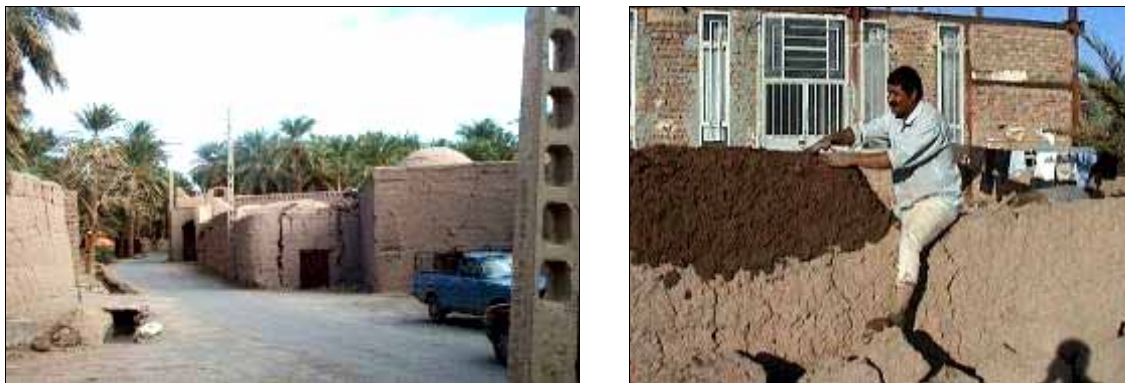
“*Chineh*” walls as part of courtyard wall (left) or bearing wall for houses (middle), Nartij Village

A man repairing his courtyard “*Chineh*” wall after the earthquake in Bam. The newly added layer can be distinguished by its darker colour.

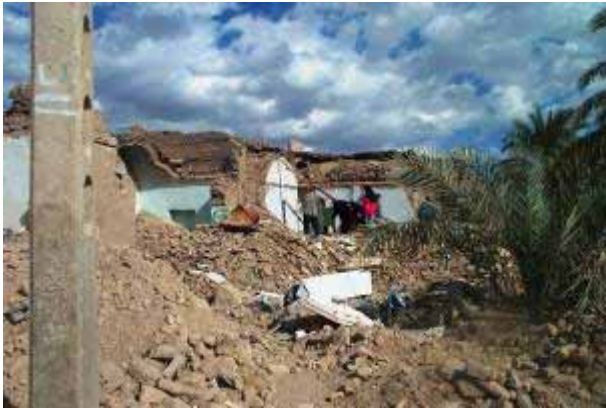
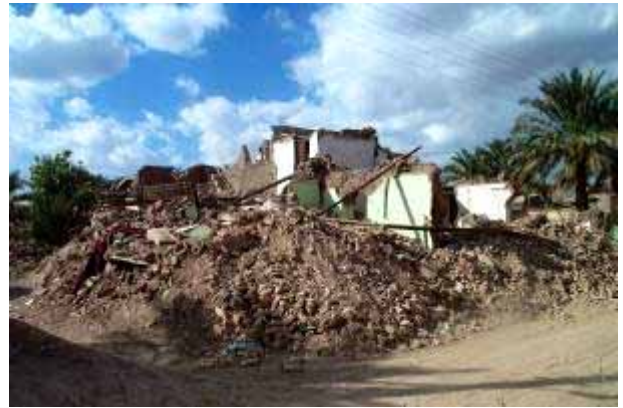
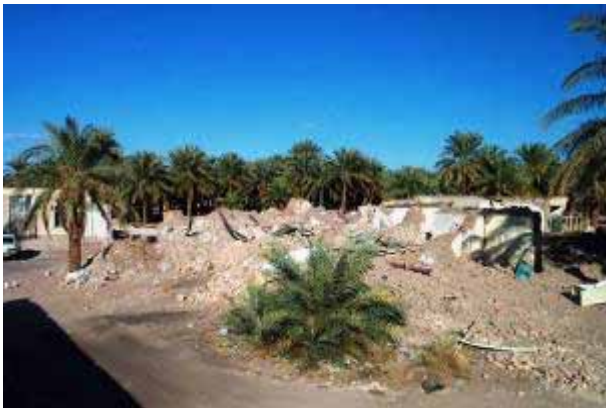
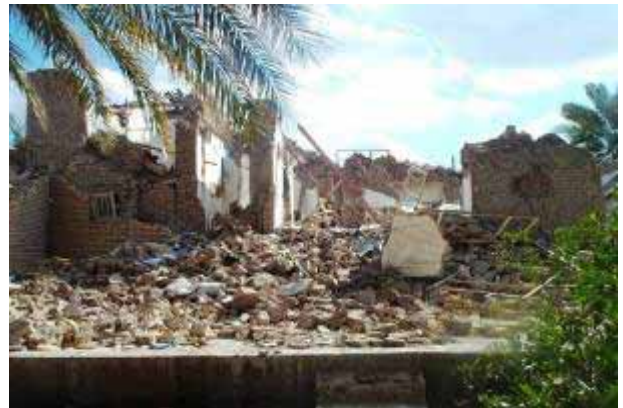
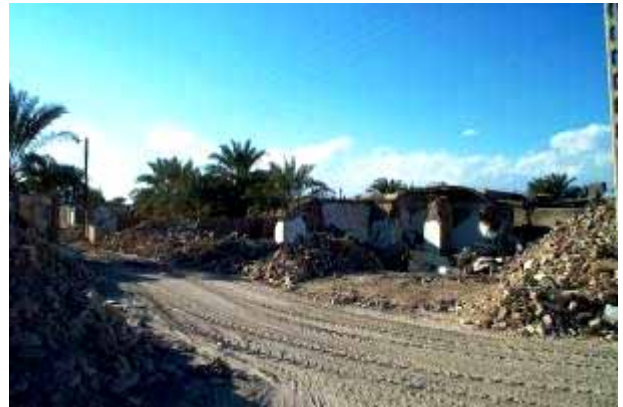
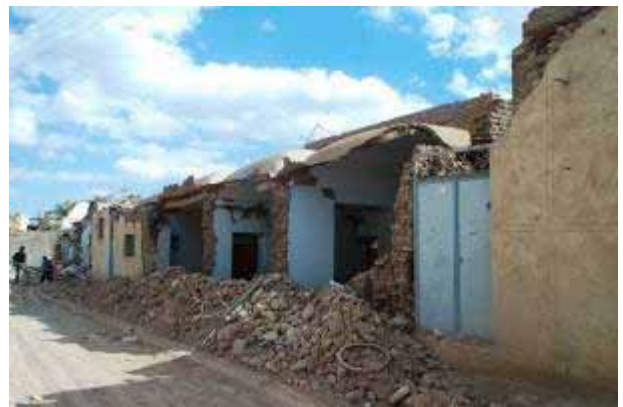
Figure 22: Bam's old district, examples of total collapse of mud-brick buildings

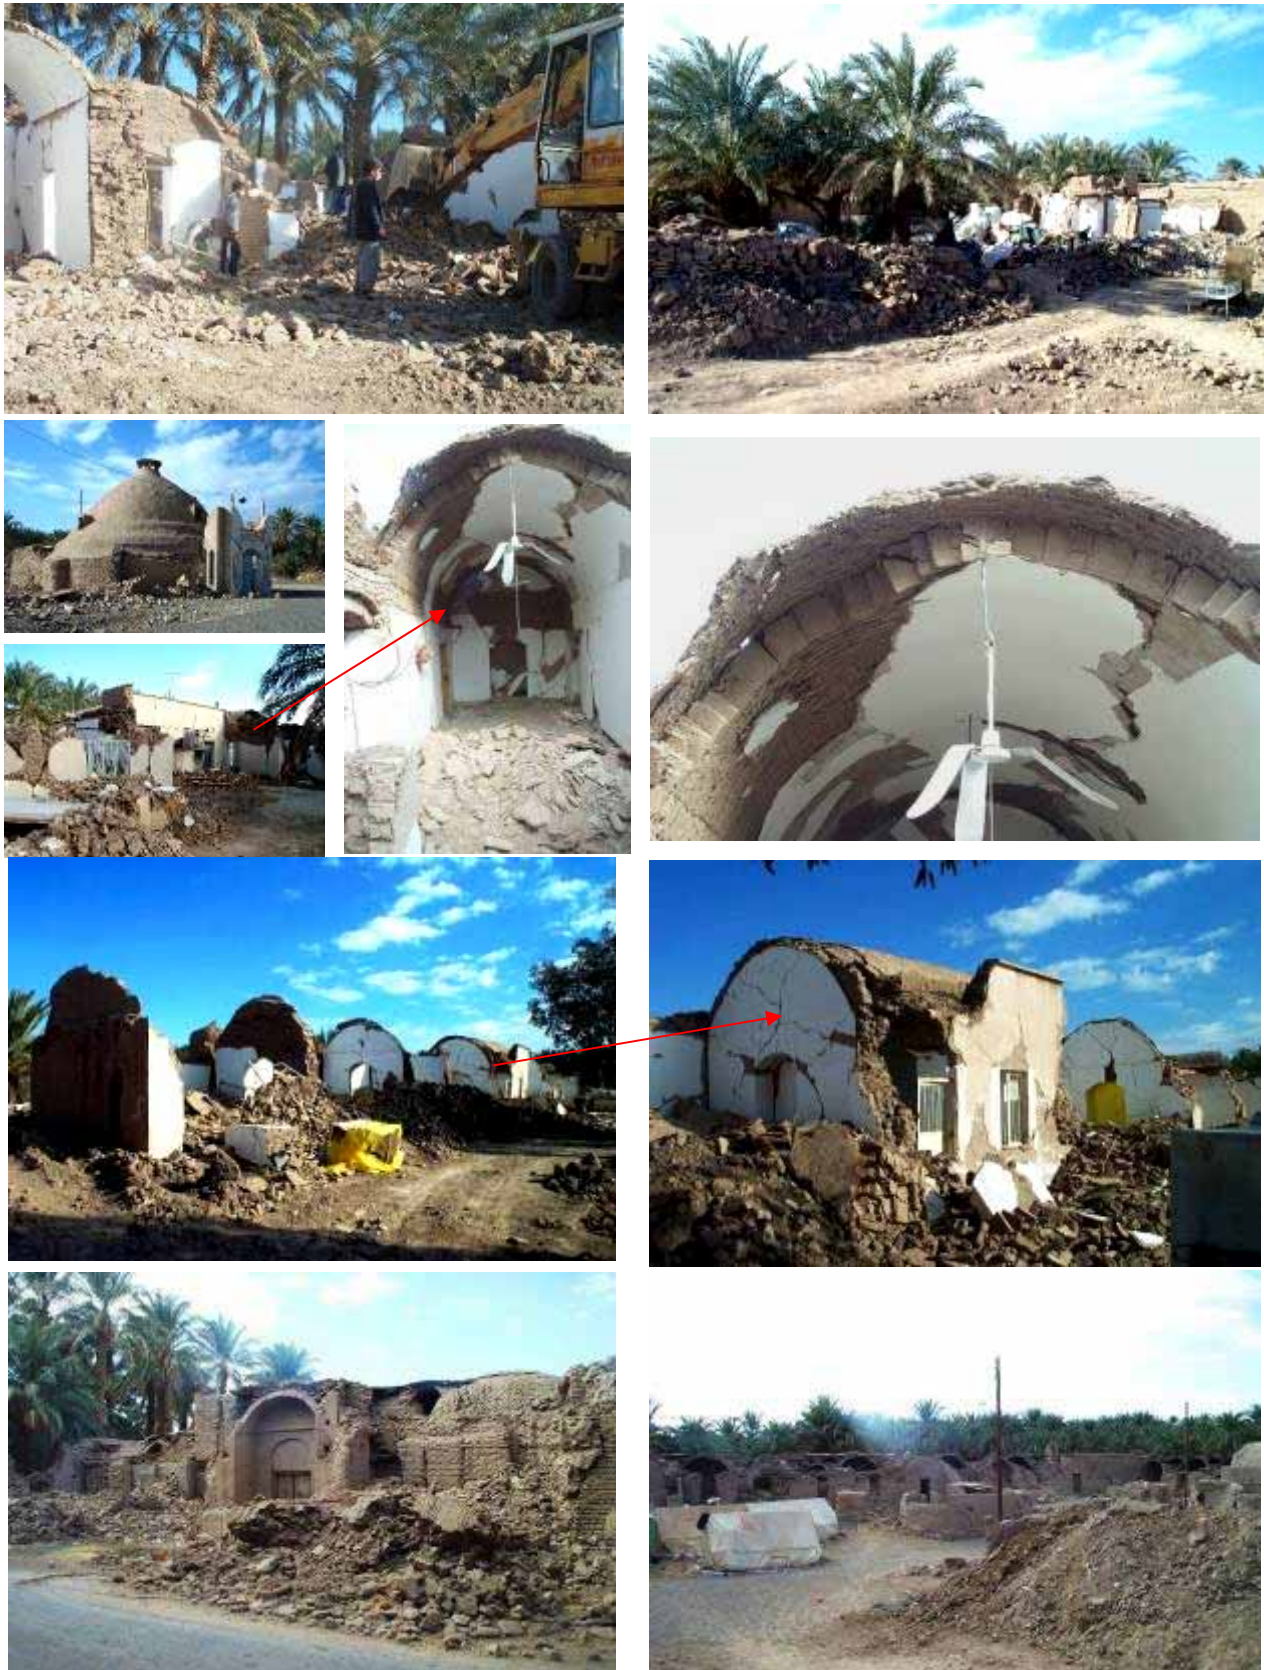
Figure 23: Damage to mud-brick building in villages-(Rows 1 to 3: Esfikan Village, North of the Bam) 1<sup>st</sup> row: total collapse, 2<sup>nd</sup> row: Traditional sport facility (Zoor-Khaneh) with cracked domed roof, a collapsed mud-brick house and details of barrel vaulted roof, 3<sup>rd</sup> row a part of boys Guidance School, 4<sup>th</sup> row: damage in Nartij Village, northwest of Bam

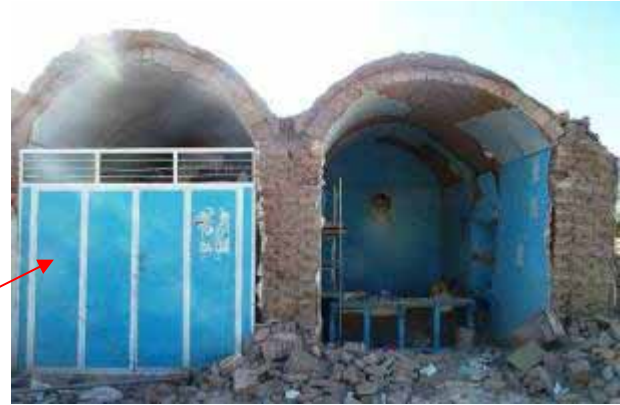
Local shop buildings in Bam, near to Emamzadeh Ali Ebn-Hassan, with a barrel vaulted roof system. The buildings are standing but all facades, made from fired bricks introduced later and covering the front of the thick walls and roof have separated from main mud brick structure and collapsed.

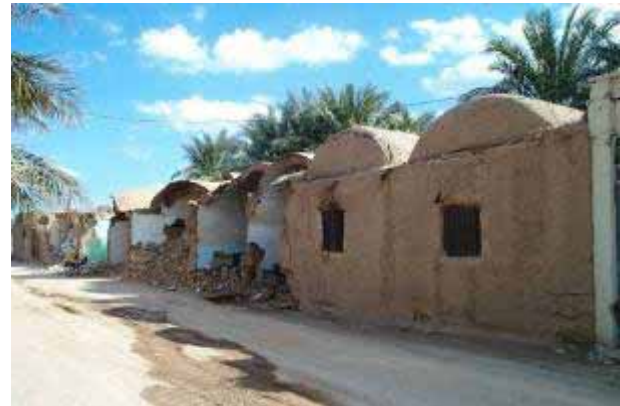
Another example of adobe building with double spanned vaulted roof, standing after the earthquake showing damage to the fired brick facade

**Figure 24: Apparent weakness of vaulted roof structural systems in Mud-brick buildings**

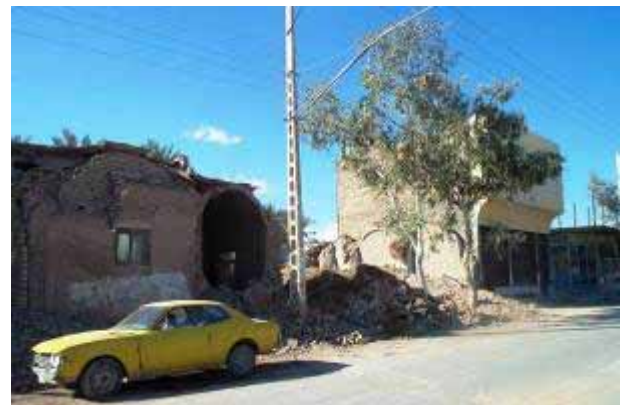
**Figure 25: Damage to adobe buildings in contrast to other types of construction in the old district of Bam (left: a modern masonry building standing without major damage. Right: a steel structure with braced frame system with minor non-structural damage).**

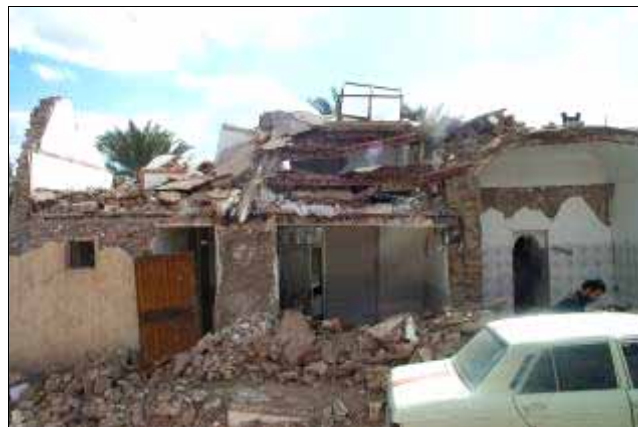
Figure 26 shows a good example of existing building practice in the city and lack of essential construction control. Apart from the poor materials adopted in the construction, the mixture of different structural systems has clearly contributed to the extent of damage.

**Figure 26: A combination of traditional and modern masonry construction materials and methods. Mud-brick walls (right) and fired brick walls (middle and left) has been extended in second floor by fired brick walls and vaulted roof (left) and jack-arch roof (middle). Second floor completely collapsed.**

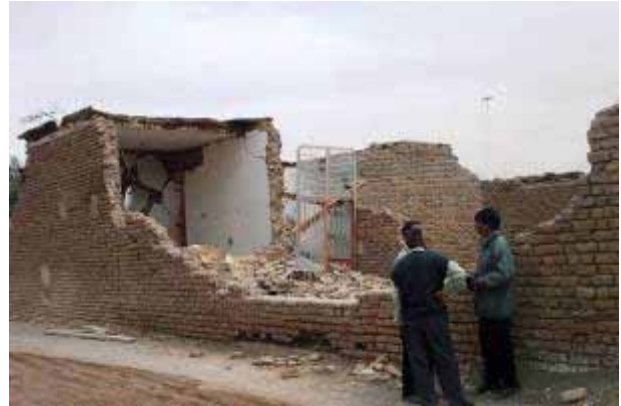
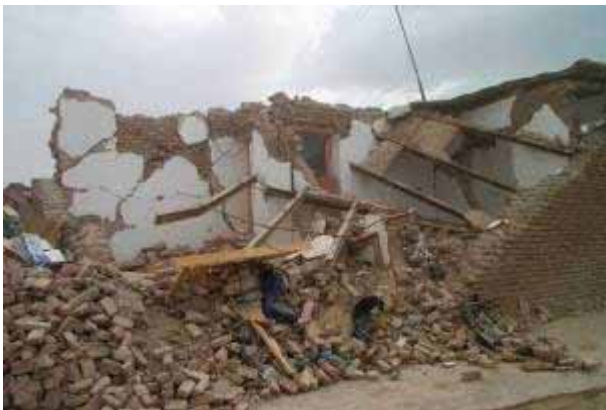
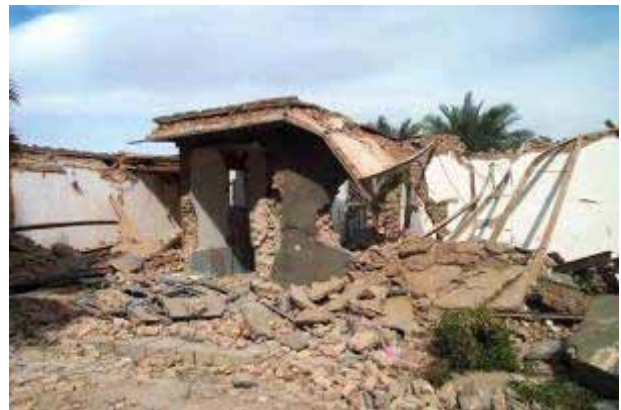
**Figure 28:** A residential masonry building without ties in Baravat in the same alleyway as Bagheri primary school in Figure 35. Construction finished about 6 months before the earthquake with a roof system of steel joists and brick arches with no structural system providing overall integrity. Heavy roof slippage over the walls resulted in collapse of walls and the whole structure. Poor materials and construction led to the collapse. The mortar used is lime-sand. Fortunately, the whole family escaped by being vigilant and sleeping outside after the initial pre-shock. Many other buildings of similar construction had completely collapsed in the same alleyway. Another example is shown in the lower right photograph.

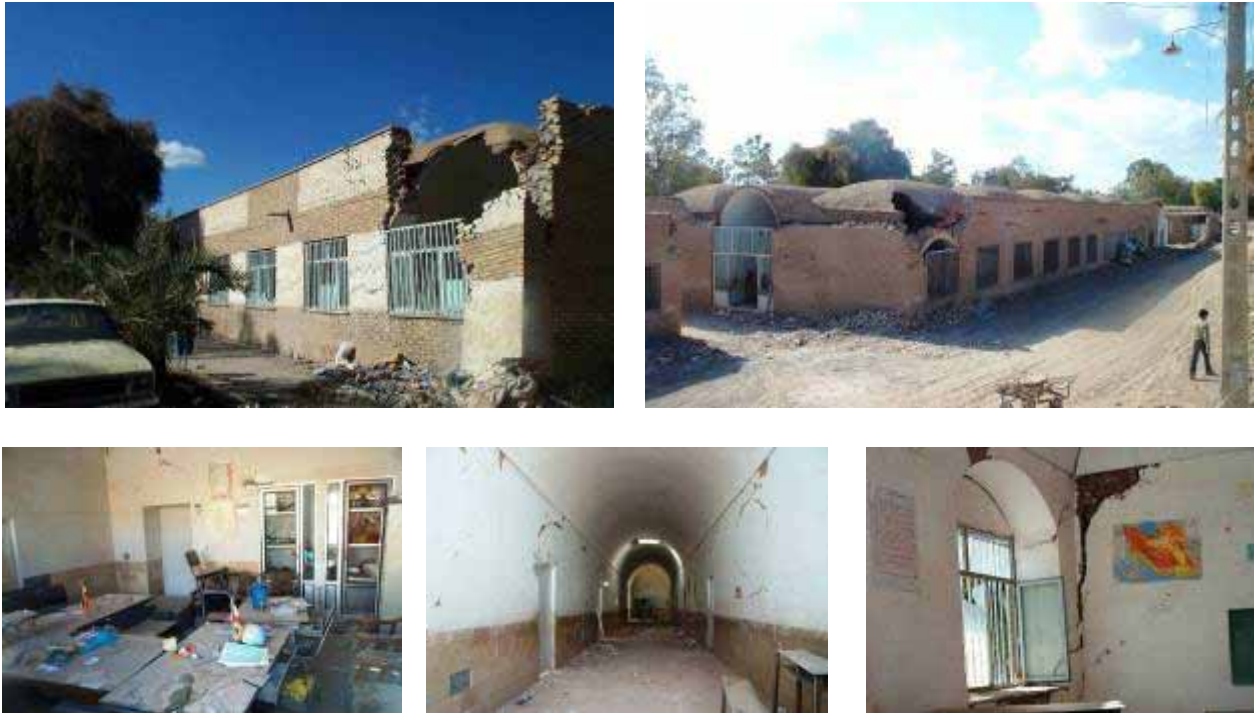
Figure 32: Adab girls' school in Bam city centre. A typical example of masonry buildings with fire brick vaulted roofs. This building has a double spanned vaulted roof at two sides and a barrel vaulted roof in the middle. Both roof corners and most of the parapet on the end wall collapsed, but elsewhere the building survived without collapse. Also, damage to walls and roofs from the inside of the building, mainly in form of minor to large cracks, were observed.

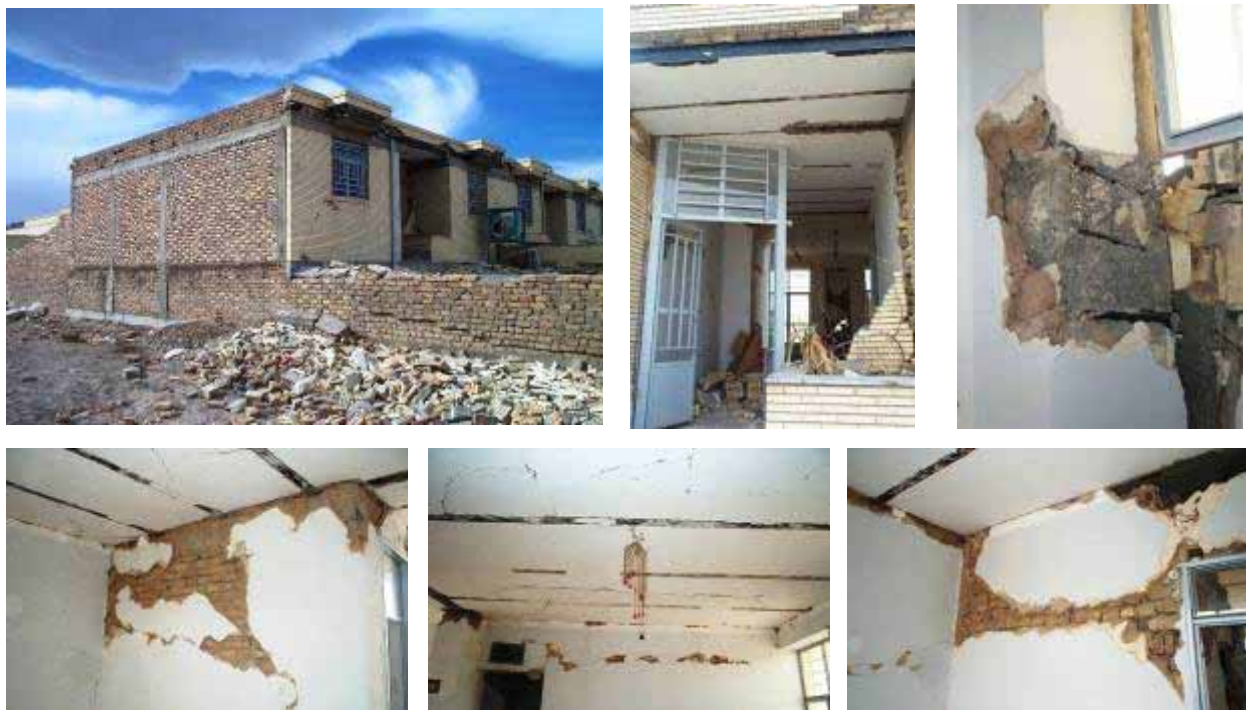
Figure 33: Bonyad Maskan houses for teachers in Baravat. The buildings have vertical and horizontal ties. Some of the vertical ties were observed not to start from foundation level (top left). Walls surrounding the courtyard collapsed. Although the structure did not collapse it suffered structural and non-structural damage in the form of large cracks in the walls and the roof magnified by the poor quality of building materials and construction.

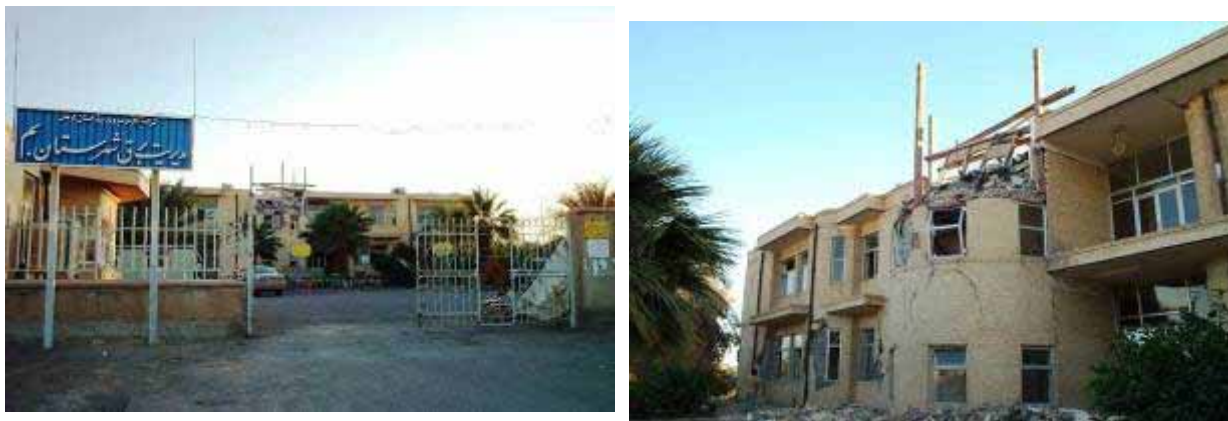
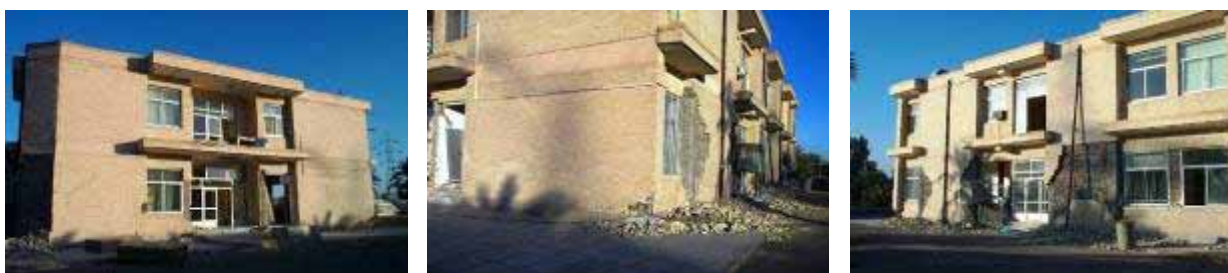
Damage to the building viewed from outside

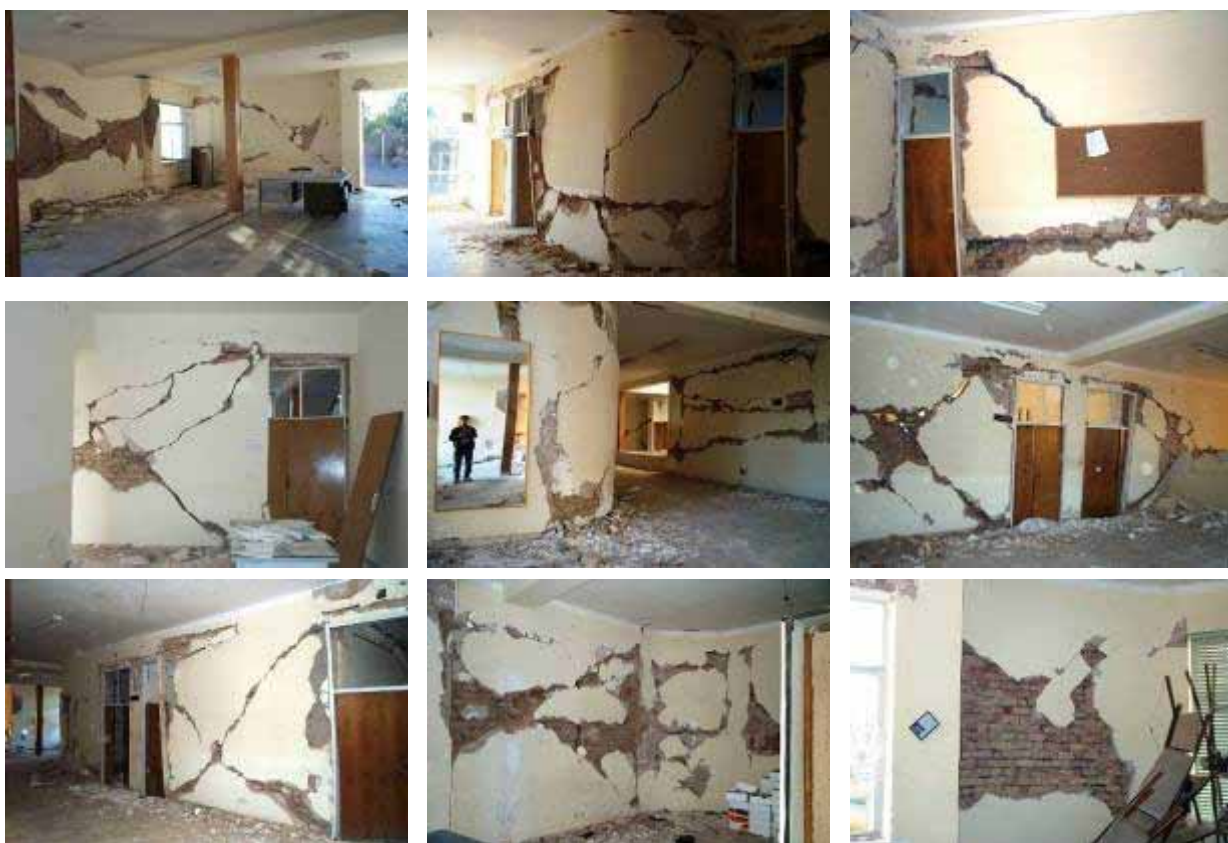
Damage observed from inside the building at the first floor level

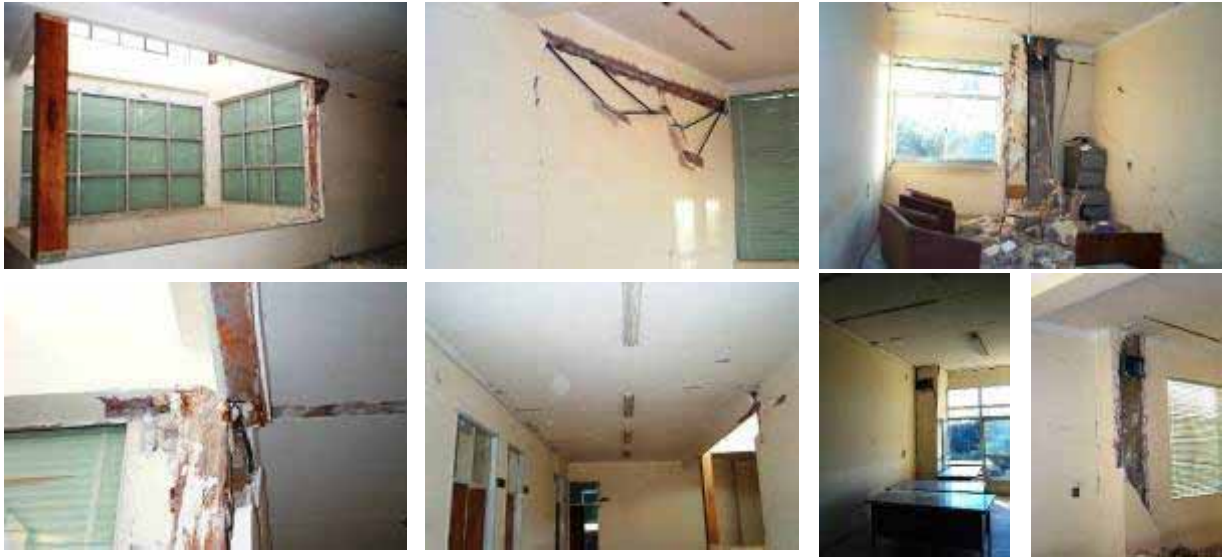
Damage in second floor

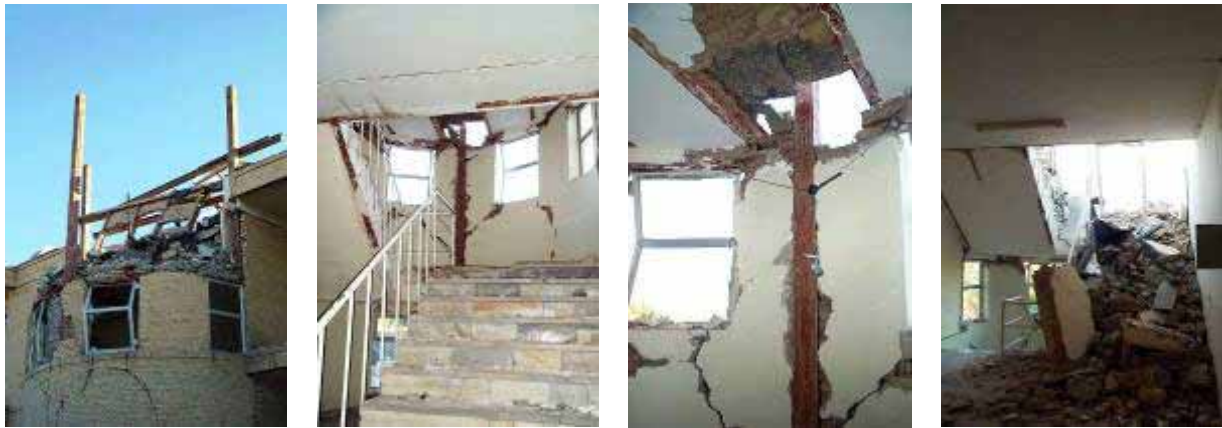
Damage to staircase viewed from outside and inside the building

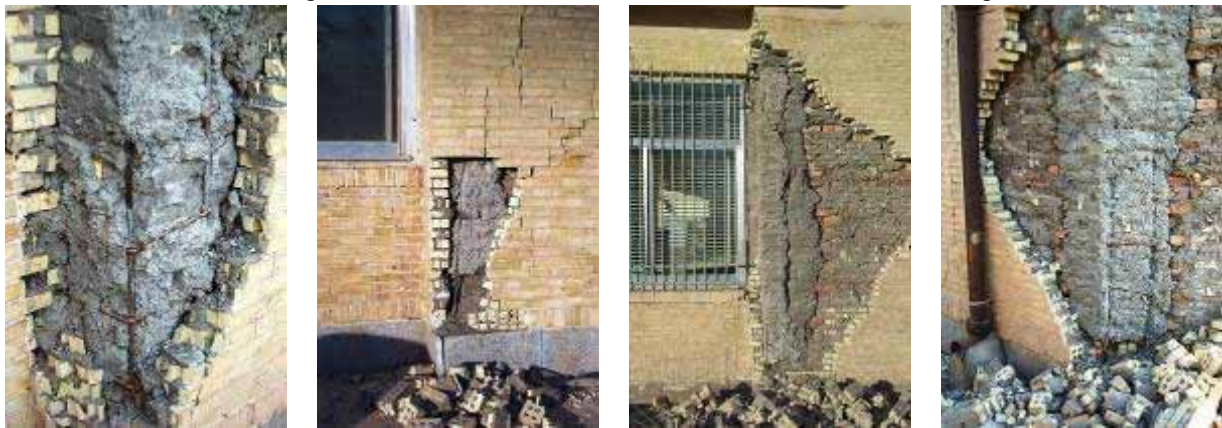
Details showing the poor concrete quality in vertical RC ties and generally bad workmanship

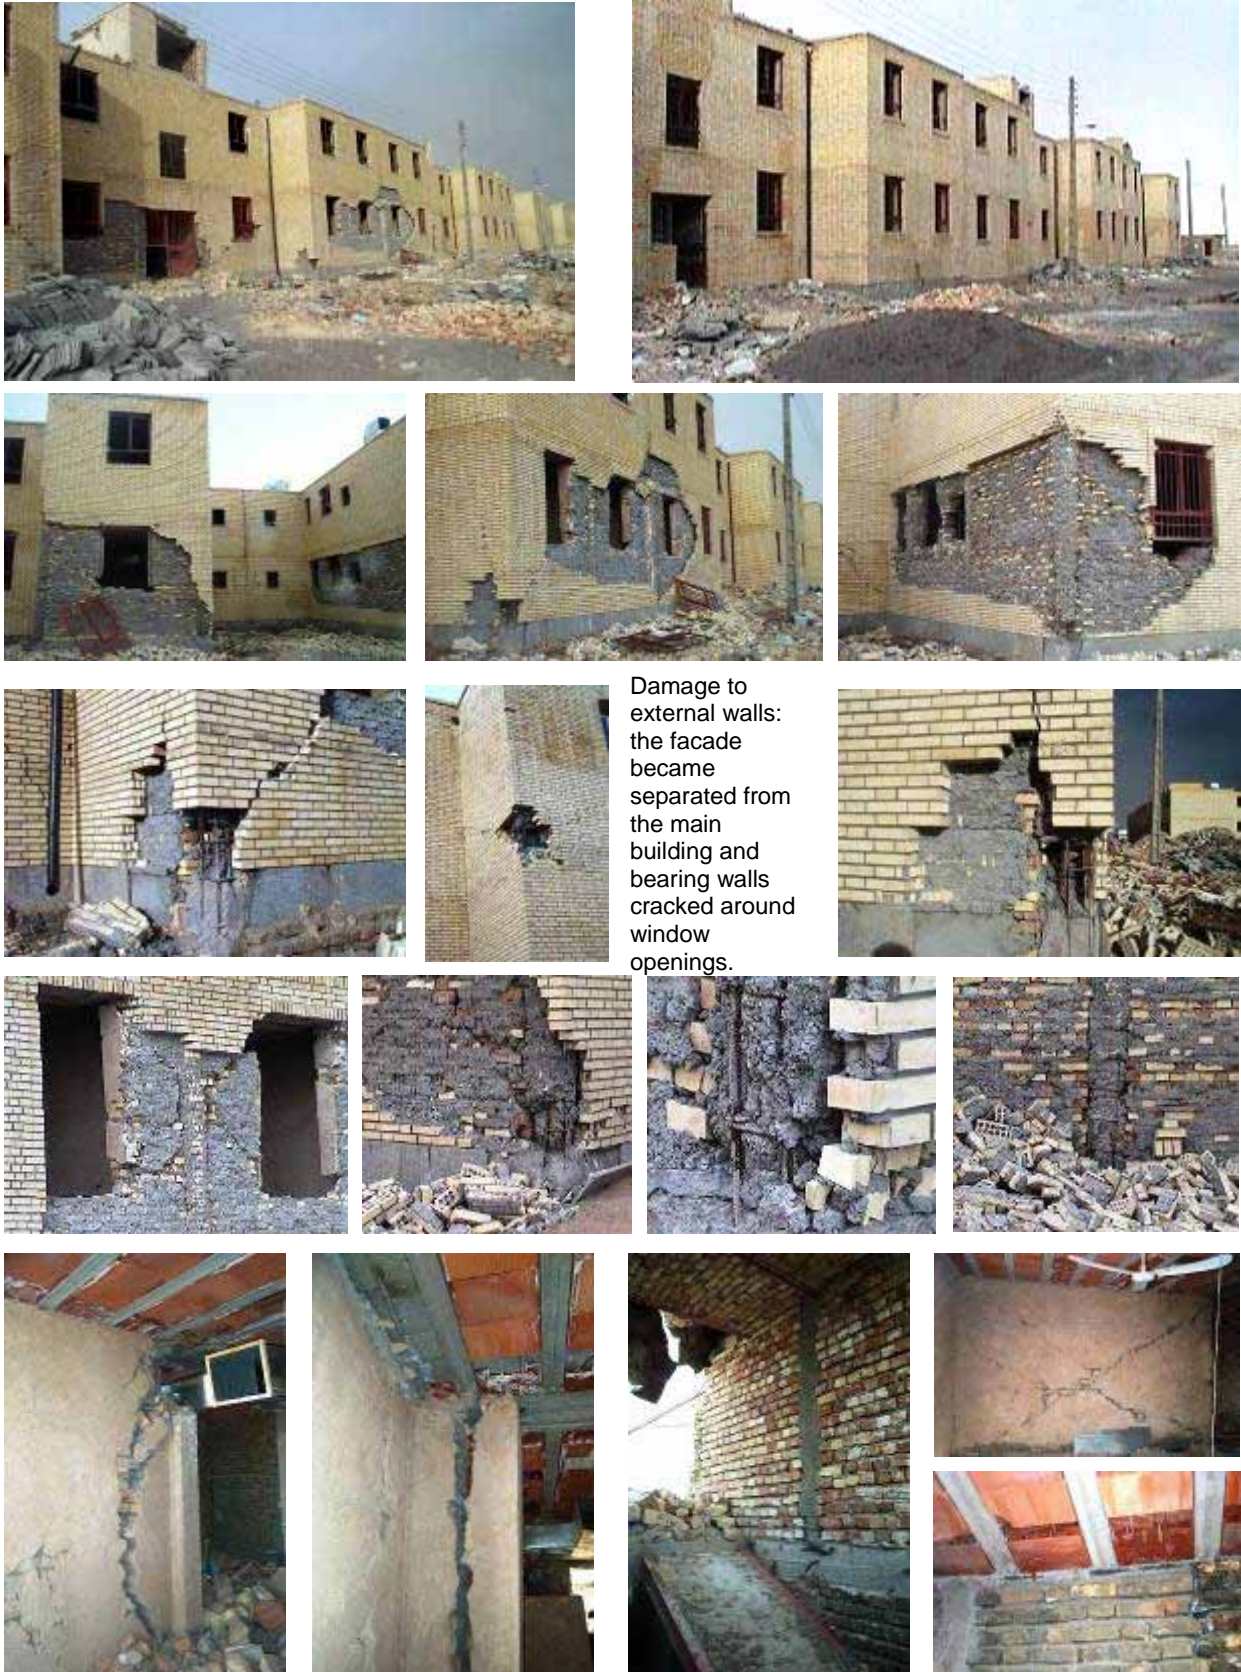
Damage to external walls: the facade became separated from the main building and bearing walls cracked around window openings.

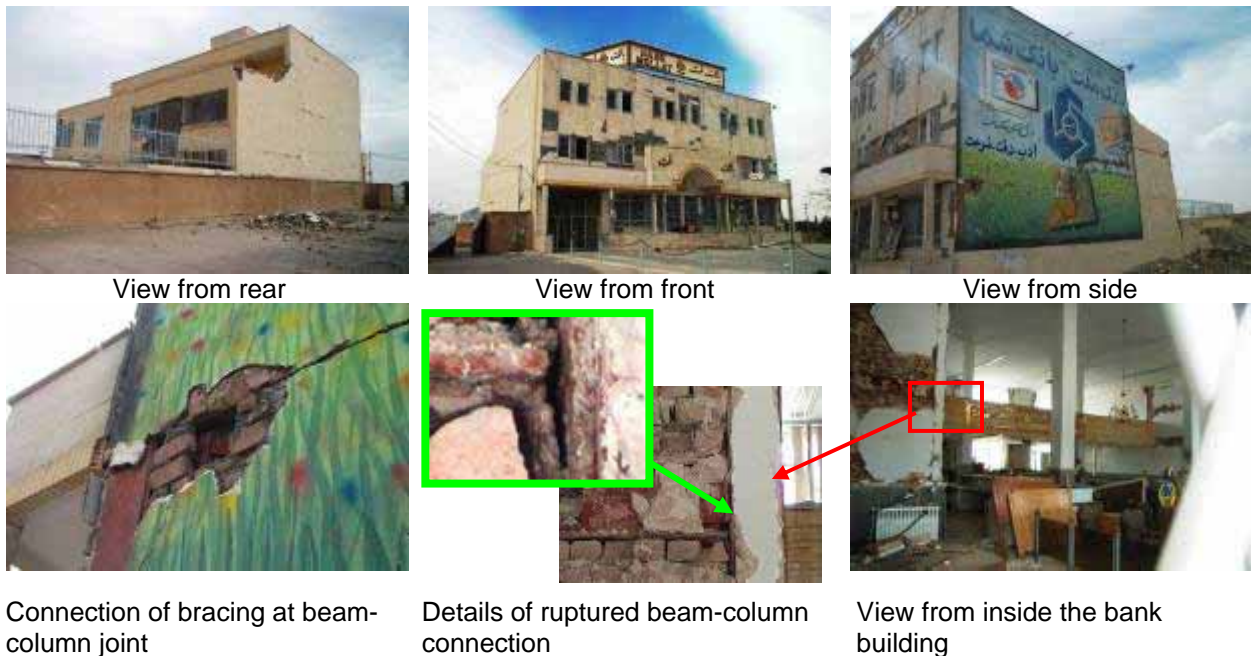
**Figure 39: Bank Mellat in Baravat of braced frame construction showing moderate structural damage and severe non-structural damage**

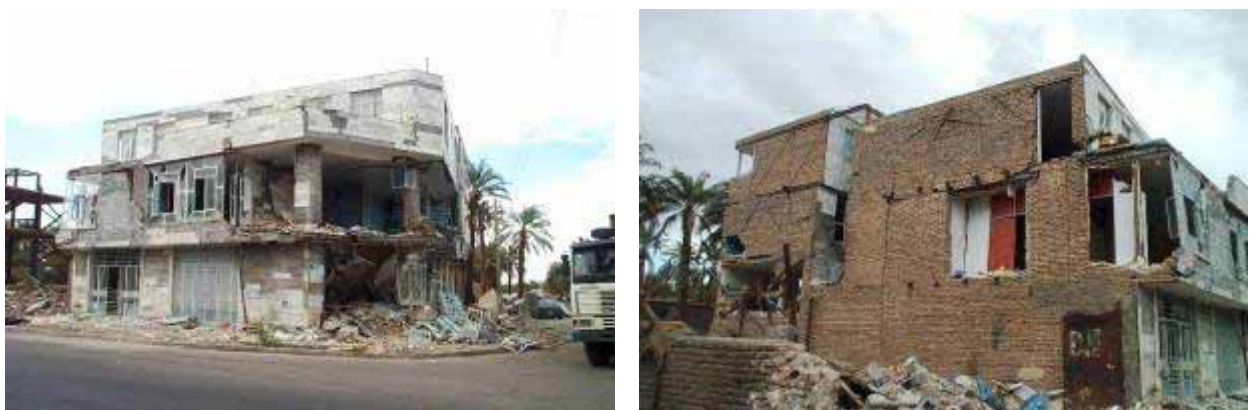
**Figure 40: An example of inferior construction of a steel structure located in the neighbourhood of Imam hospital in Bam. Note the irrational bracing configuration at the side of the building.**

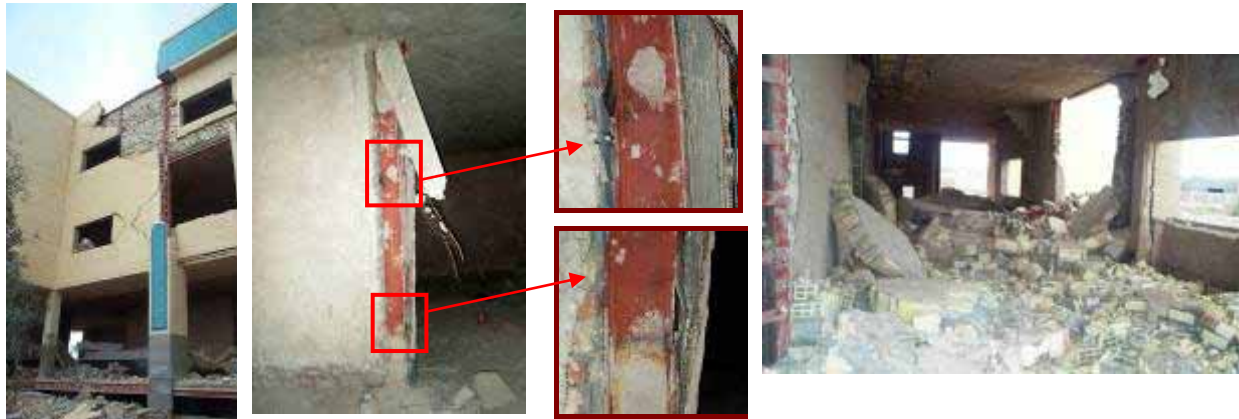
Damage to external walls

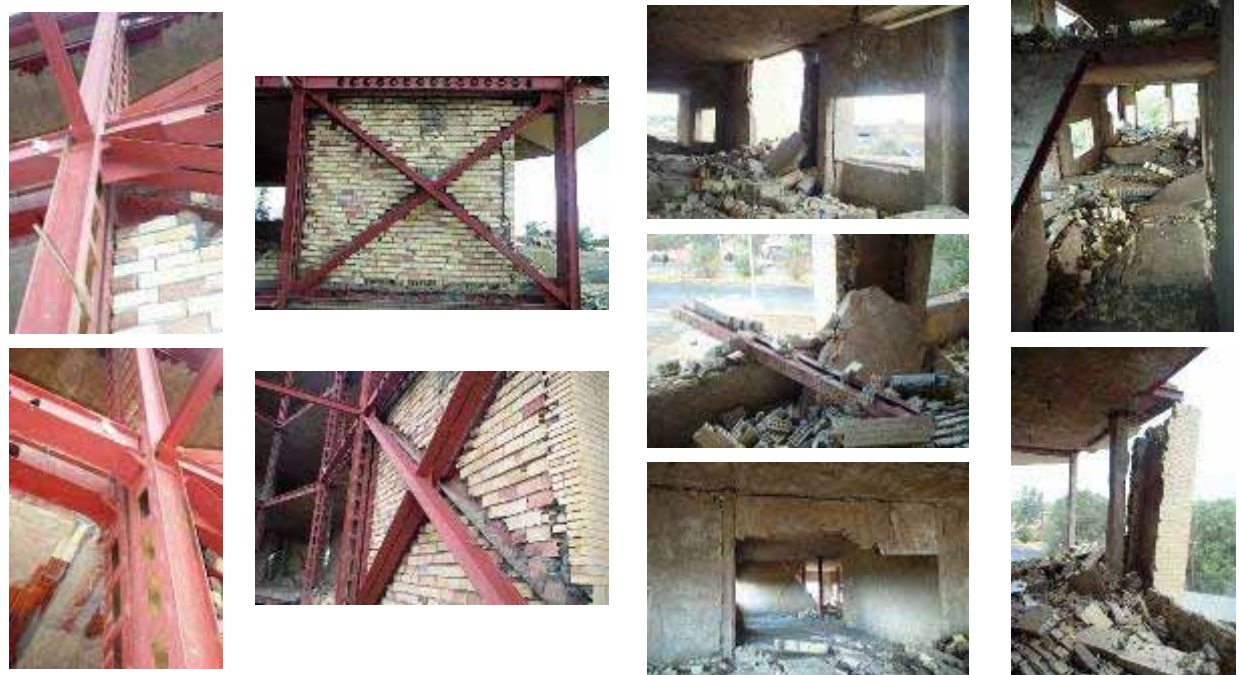
Severe damage to internal and external walls
