# THE BAM, IRAN EARTHQUAKE OF 26 DECEMBER 2003

*Field Investigation Report Prepared By:  
Dr. Ali Reza Manafpour, Halcrow Group Limited*

## The Bam Earthquake of 26th December 2003

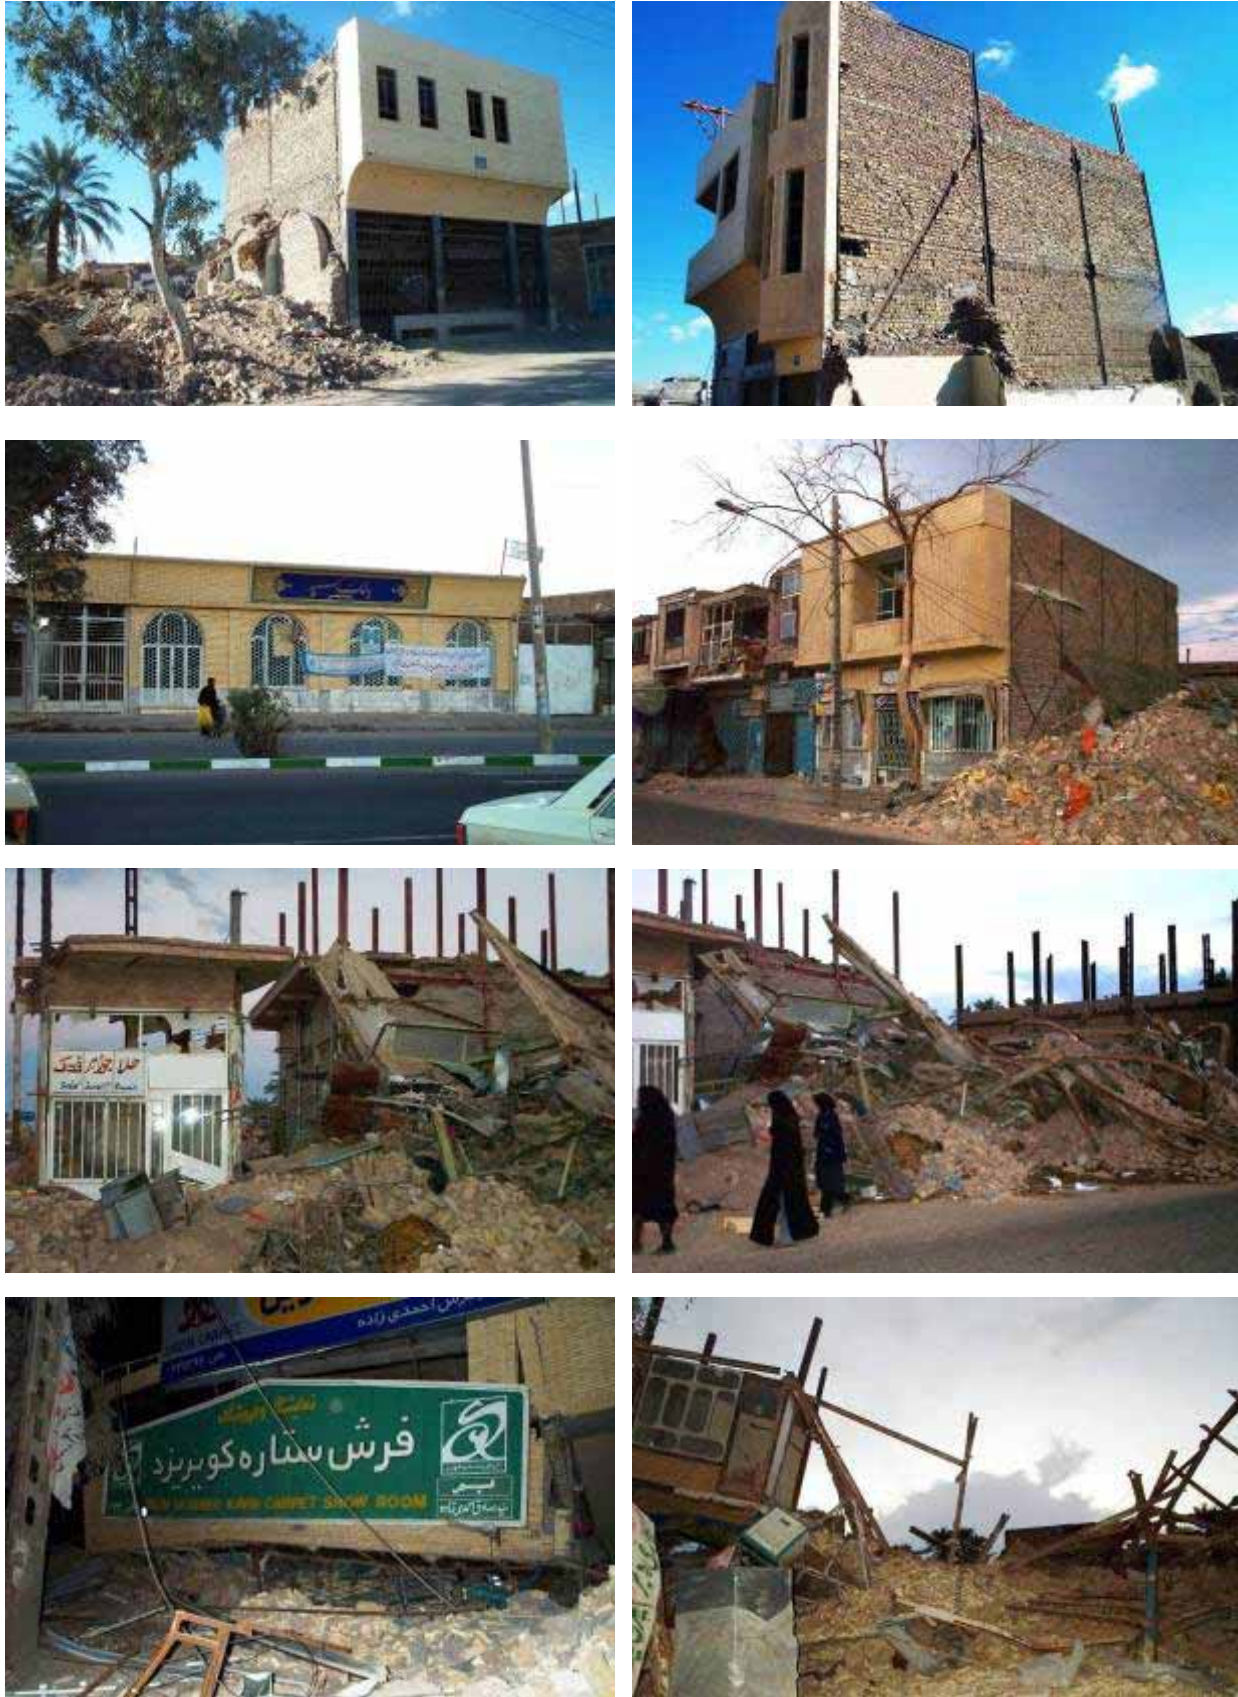
Figure 45: Performance of steel structures under Bam earthquake. Upper two rows: Braced frame structures that resisted major damage and collapse. Lower two rows: Unbraced and poorly constructed steel structures in jewellery market of Bam and surrounding area that suffered complete collapse.

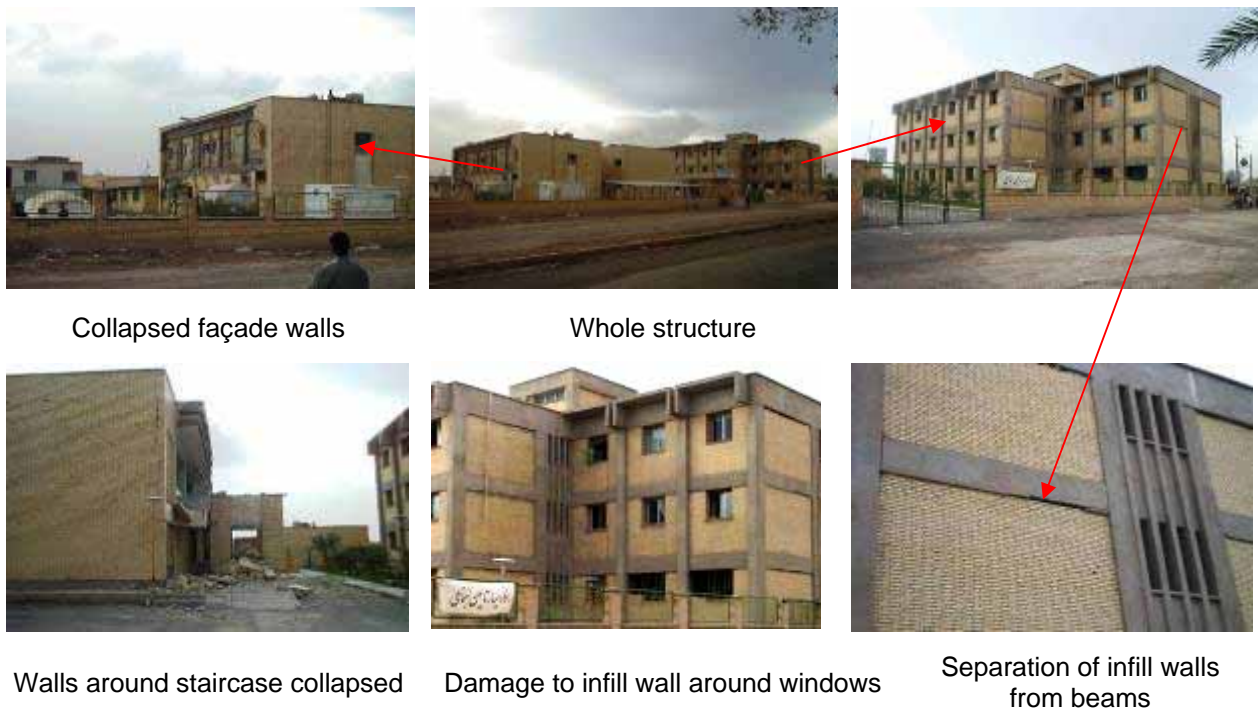
**Figure 46: Main office of Social Security Organization in Bam. Reinforced concrete structure with damage to facade, staircase, and infill walls around window openings in first floor (interior of the building was not visited).**

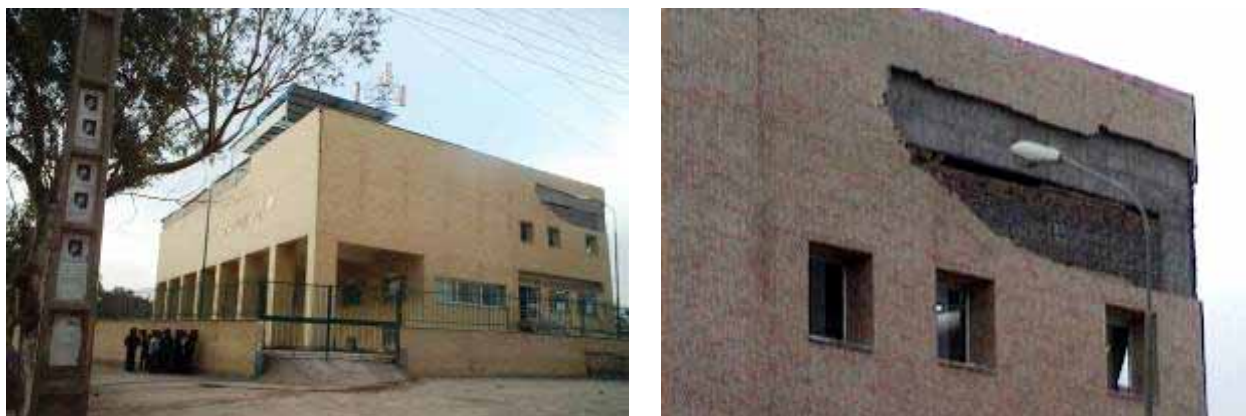
**Figure 47: Bam’s Emamat Telecommunication Complex in Zied square. RC frame structure with damage to facade at various locations. Otherwise the structure appeared to be intact. (interior of the building was not visited).**

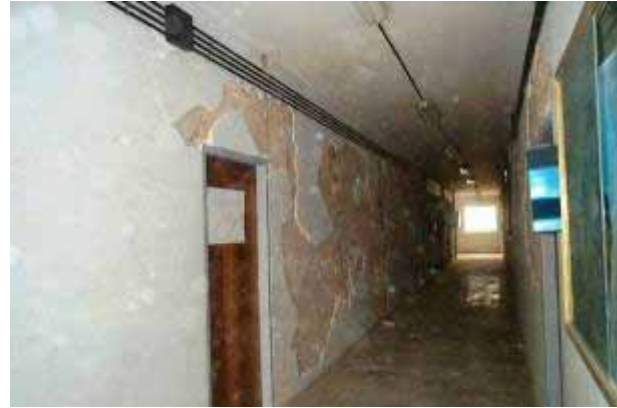
Interior corridor, damage to walls

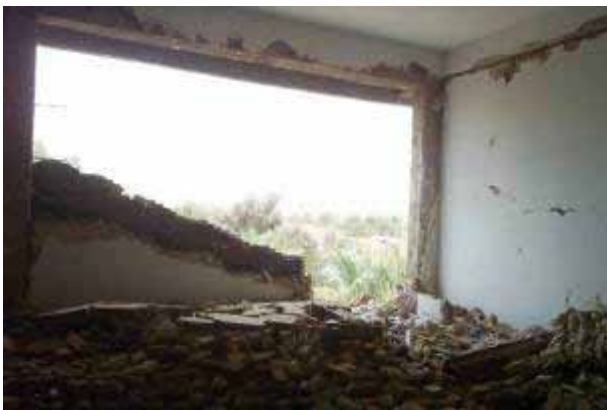
Inside view on upper floor showing collapse of infill wall next to a door opening

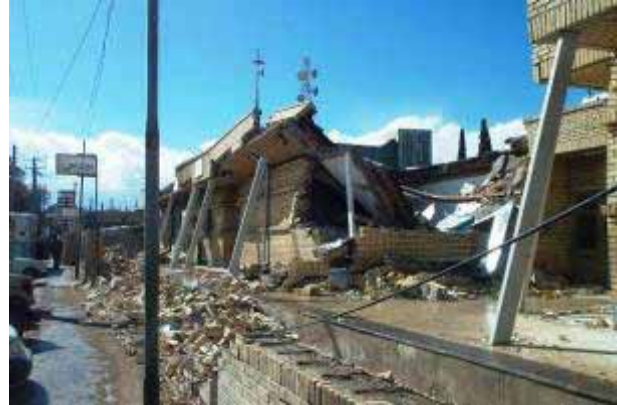
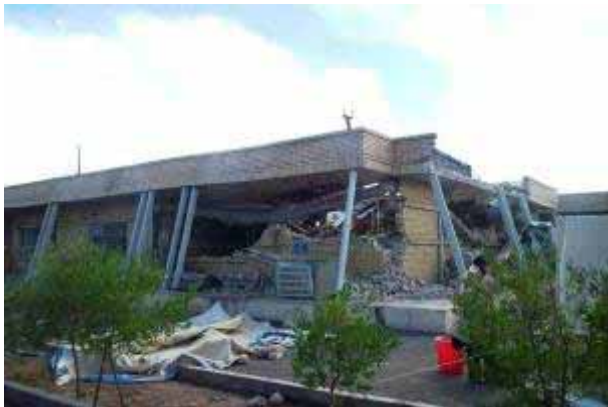
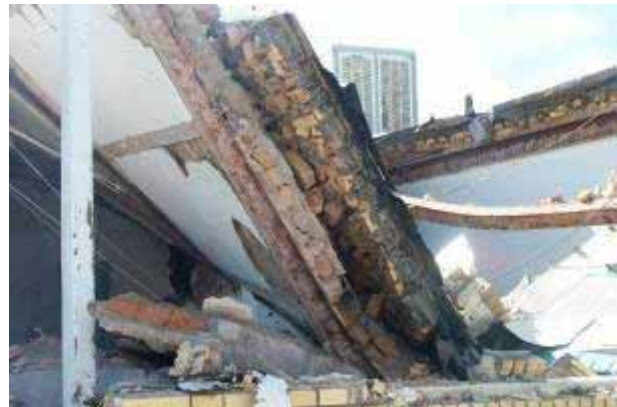
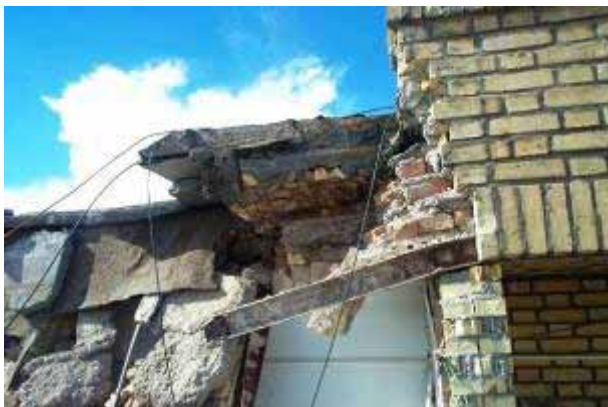
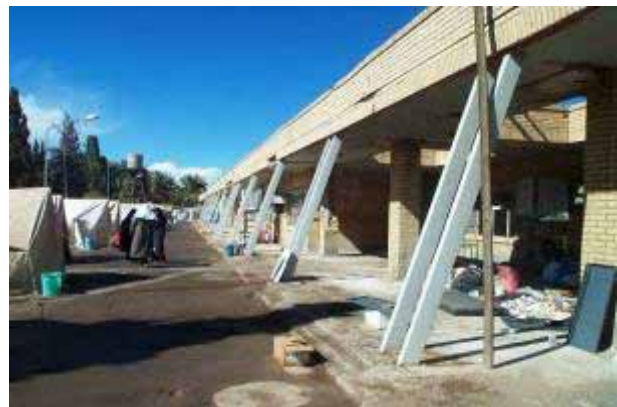
**Figure 49: Imam Hospital in Bam, a single storey masonry building with a jack-arch roof system and inclined steel columns on the perimeter. Most of the building collapsed or was severely damaged. The Accident and Emergency Building collapsed due to the disproportionately thick and heavy roof, that buckled the external wall (left in 1<sup>st</sup> and 2<sup>nd</sup> row). Three roof insulation layers can be seen (3<sup>rd</sup> row left).**

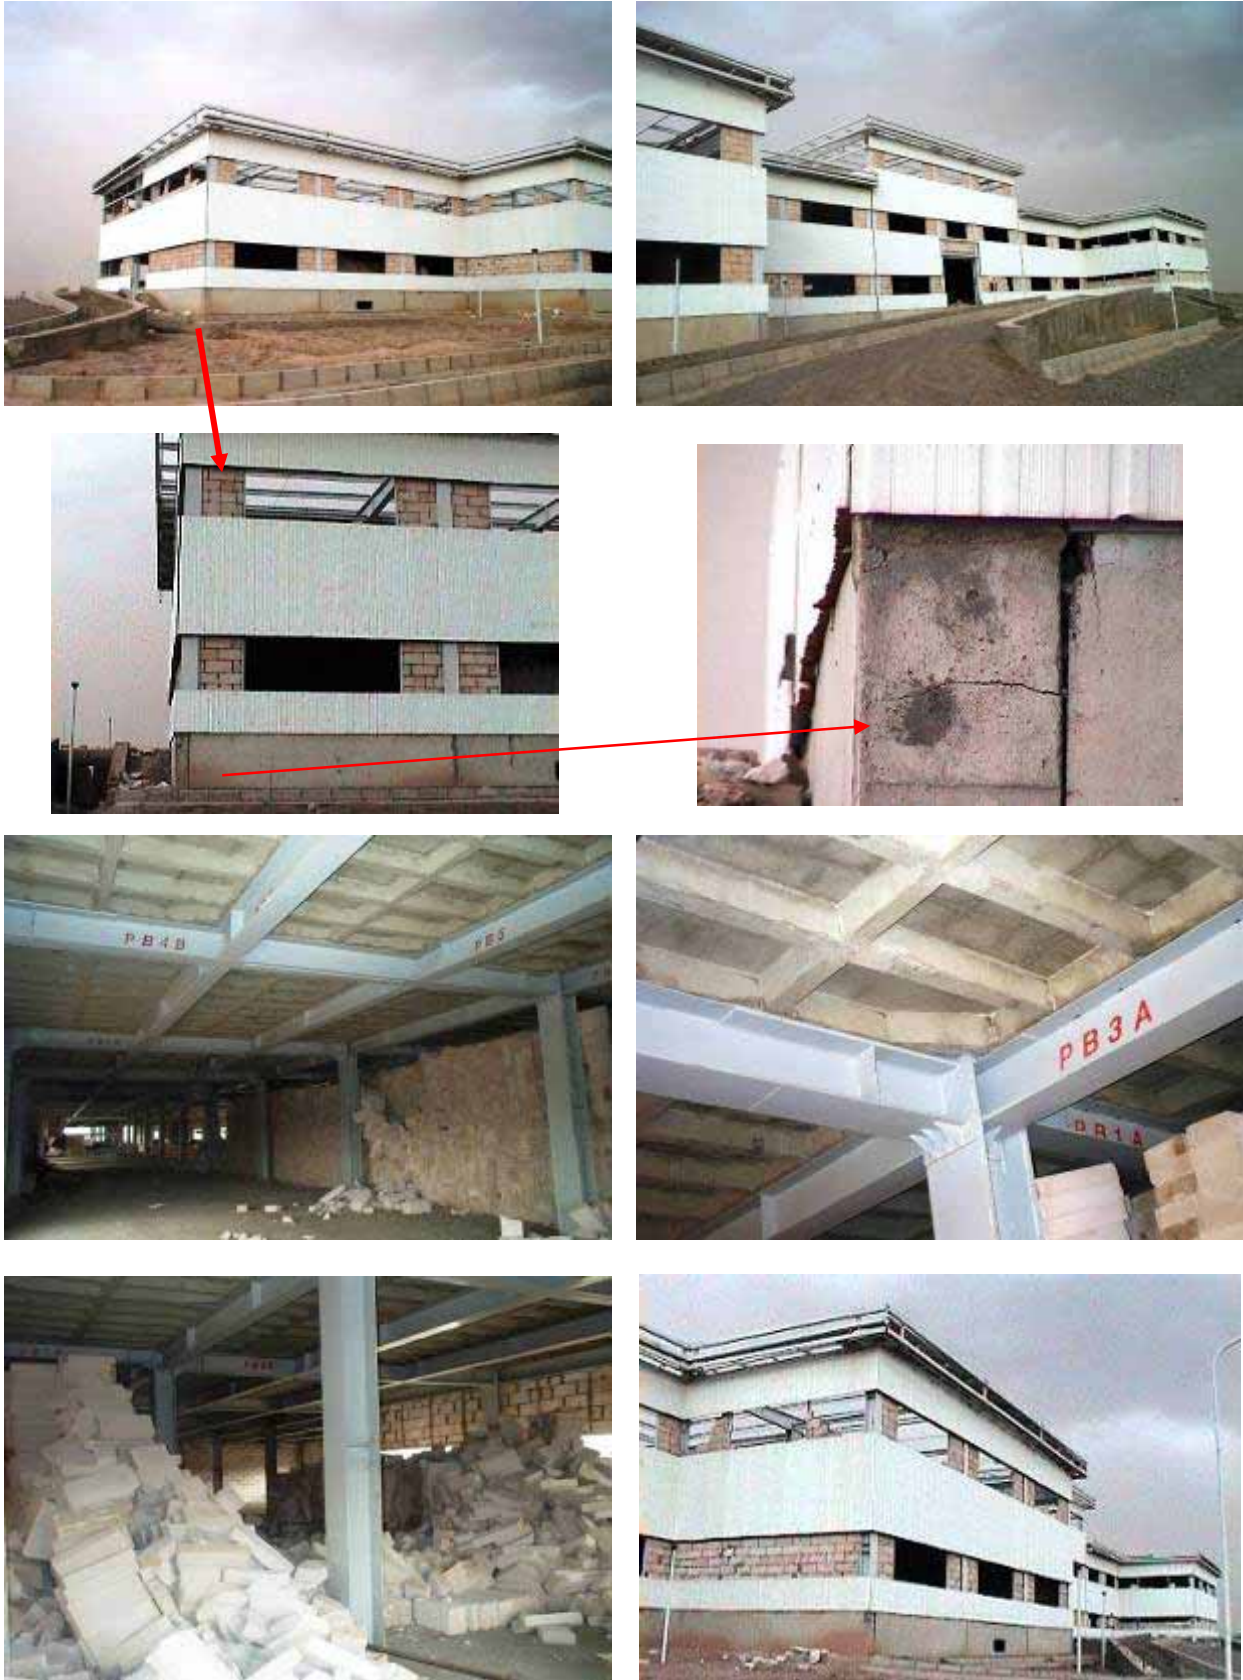
Figure 50: A new hospital under construction at the time of the Bam earthquake, about 1.5km to the west of the Bam fault line on the Bam-Baravat road. The structural system is steel frame with precast two way spanning ribbed concrete floors. Some concrete blocks of infill walls, mostly in the top floor, collapsed but no structural damage was observed.

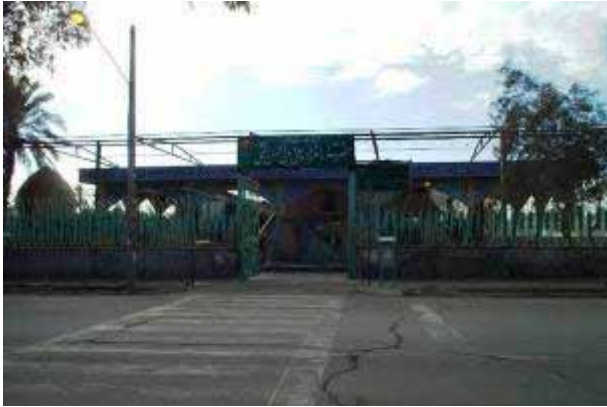
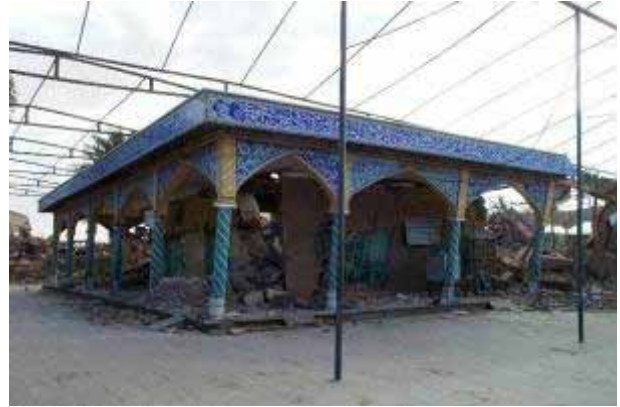
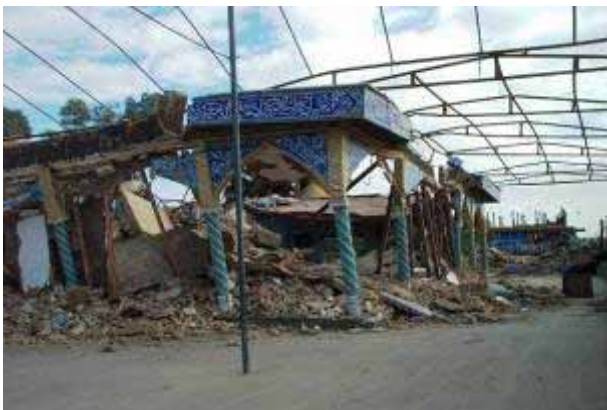
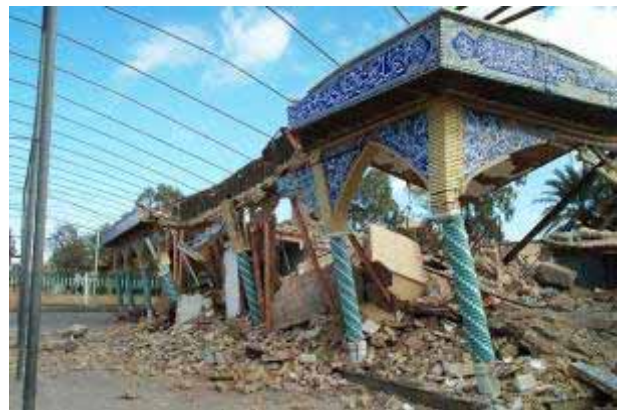
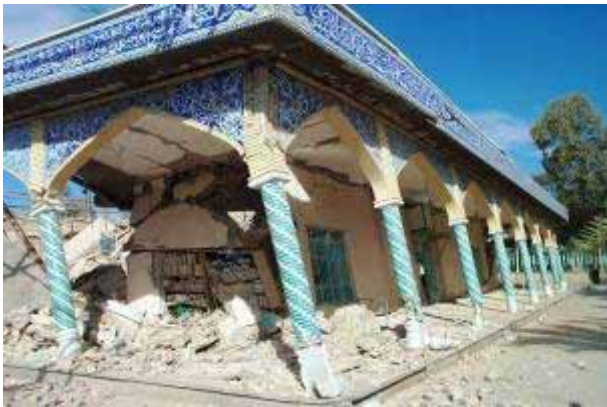
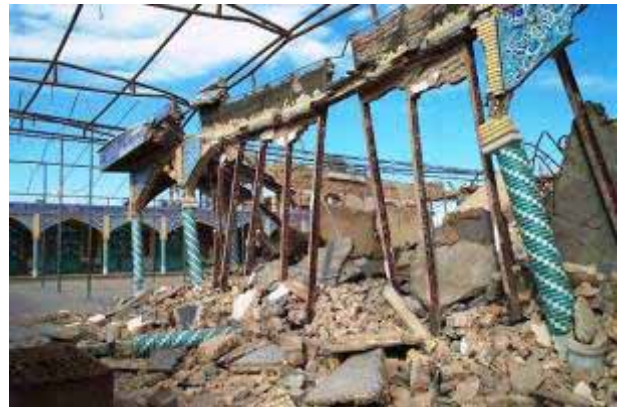
Figure 52: Mausoleum of Emamzadeh Ali Ebn Al-Hossain In Bam. Complete collapse of the main dome and its supporting old walls in the interior part of the mausoleum. These walls were mainly made from mud bricks. A steel frame envelops the building with a jack-arch roof system extending from the frame to interior masonry walls. The collapse of the main building appears to be the main cause of damage to the roof and external frame.

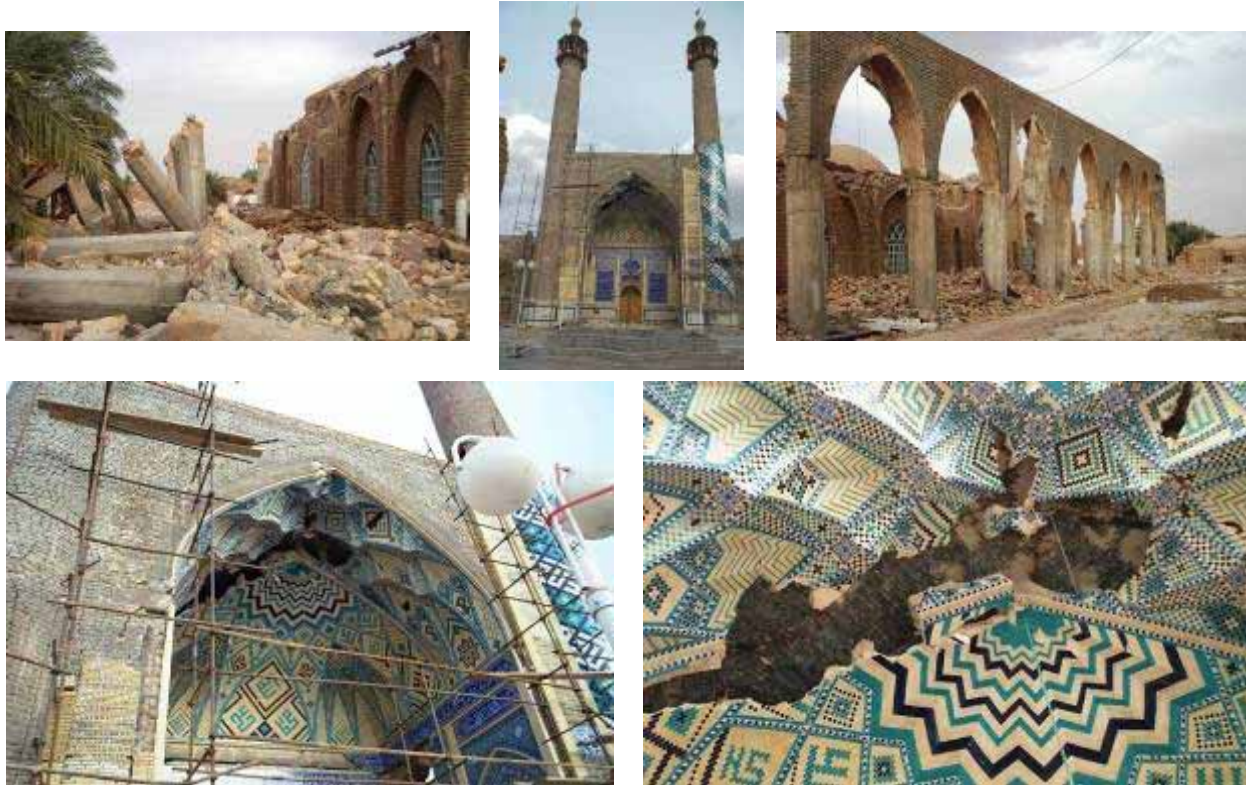
Figure 54: Emamzade Zied in Bam. Extensive damage to the sides of the main building which appear to be an extended part of an older section of the structure. The main building has not collapsed.

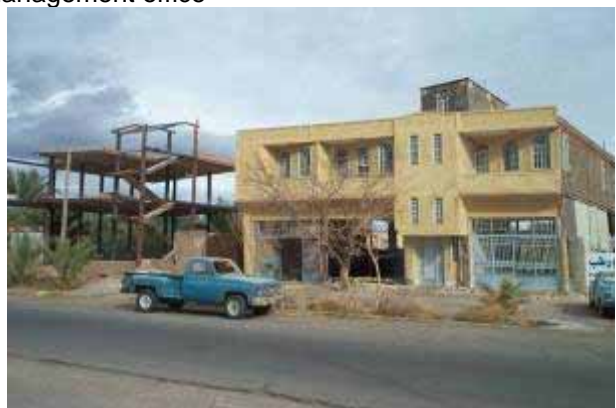
No apparent damage in a steel frame structure (the continuity with structural system in steel structures can be seen in the skeleton of another similar building under construction to the left)

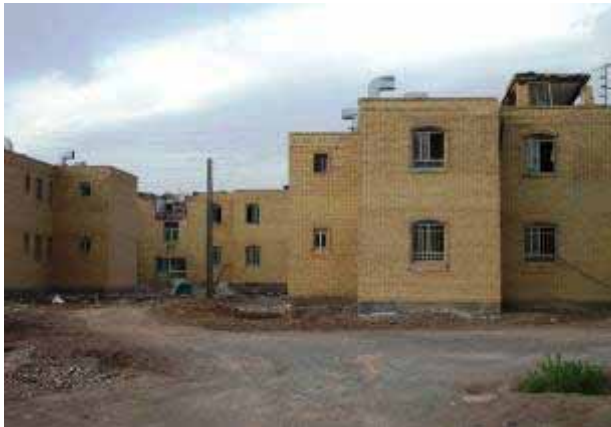
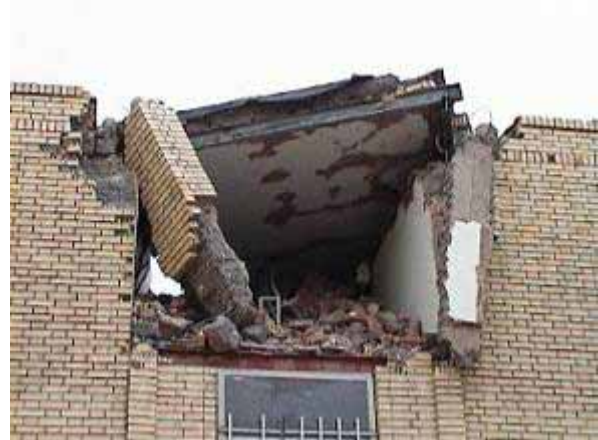
**Figure 58: Examples of the performance of staircase extension structures in Bam Earthquake for Masonry buildings: Housing and Urban Development Organization’s new ‘build to rent’ project. There were a large number of collapsed staircase extension structures in this project, only some examples are shown here.**

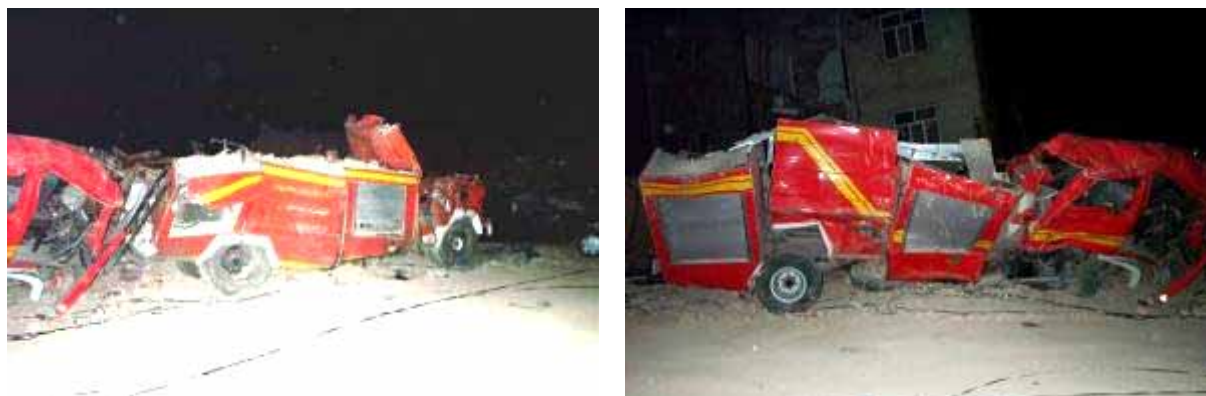
Figure 59: Bam's fire department and emergency response system after the earthquake
