MCEER SPECIAL REPORT SERIES  
Engineering and Organizational Issues Before,  
During and After Hurricane Katrina

Damage to Engineered Buildings and Lifelines  
from Wind, Storm Surge and Debris in the  
Wake of Hurricane Katrina

**Damage to Engineered Buildings and Lifelines from  
Wind, Storm Surge and Debris in the Wake of  
Hurricane Katrina**

MCEER-07-SP03

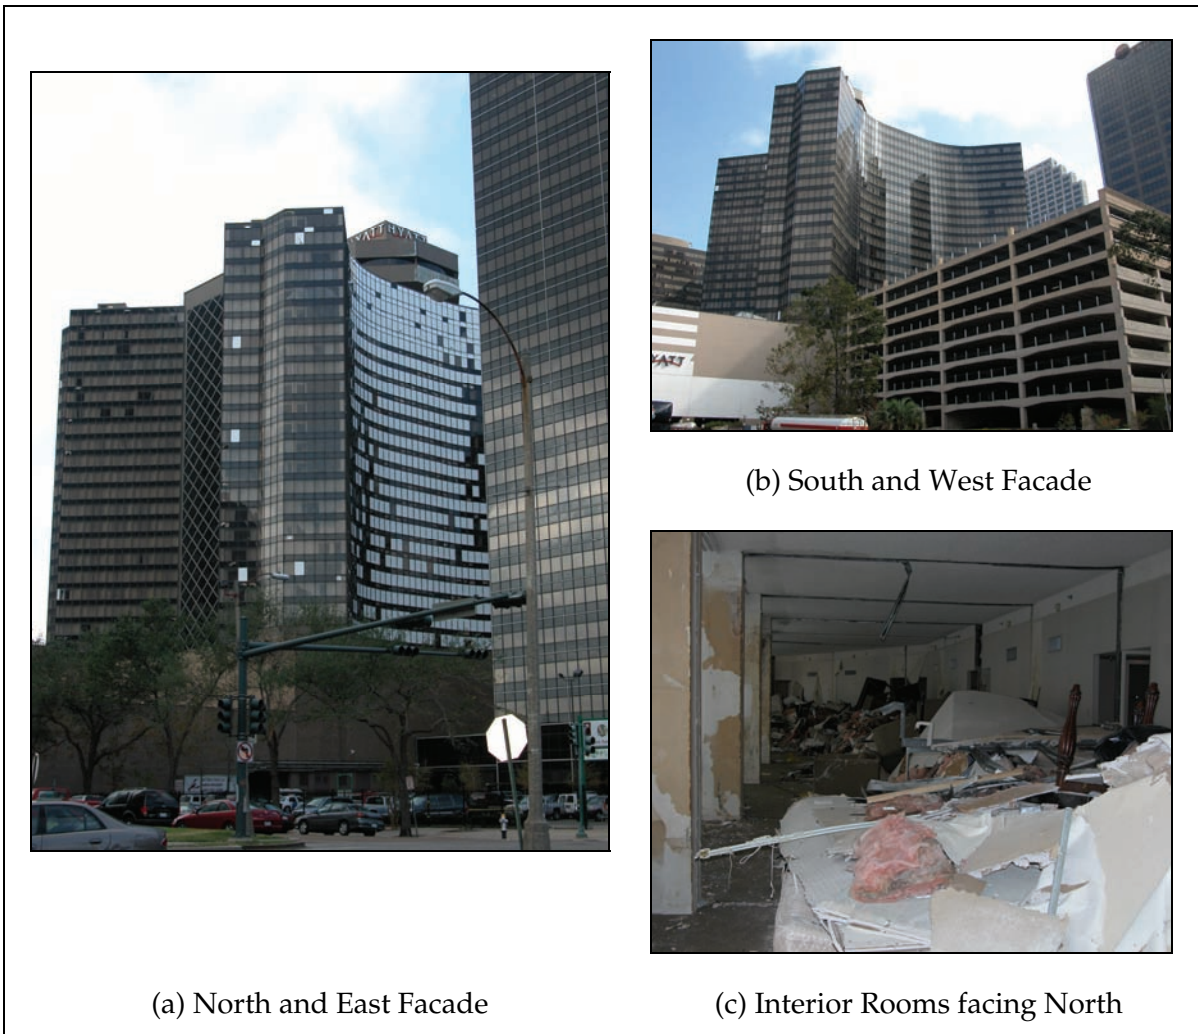
The Hyatt Regency 28-story reinforced concrete building suffered extensive window damage as well as some damage to its asphalt shingle roof, loss of some rooftop fans, and extensive damage to the soffit of a mushroom-shaped rooftop structure housing a bar. Three fourths of the glazing on the north facade curtain wall above the 5th floor broke during the storm as shown in Figure 3-2. The curtain wall comprises 1/4-in tempered single-pane vision glass, and 1/4-in non-tempered single-pane black spandrel glass. Wind, water and wind-born debris including pea gravel infiltrated several of the rooms on the north side, the gravel appeared similar that blown off of the tar and gravel roofing of one or more adjacent buildings north of the hotel. As a result of the damaged exterior, furniture, carpets and gypsum drywall that were dampened by the infiltrating water were infested with mold and were being removed at the time of investigation. This building has no basement and stands on a site slightly above the highest level of flooding. (One block to

*Figure 3-2. The Hyatt Regency Hotel in the New Orleans Business District had extensive window damage on the north facade (a) and limited damage on other sides (b). Broken windows allowed wind-driven rain and debris into the building causing additional interior damage (c).*

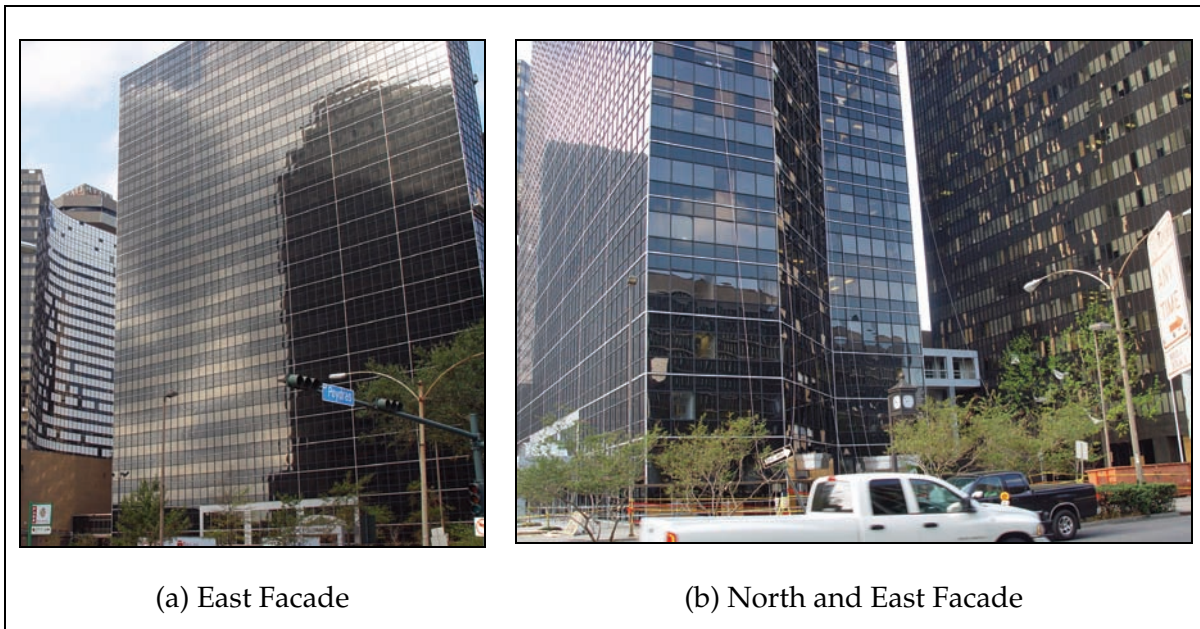
1250 Poydras is a 24-story building on the southwest corner of Poydras St. and Loyola Ave. and adjacent to the Hyatt and Amoco buildings. Although the east facade appears to have suffered no damage, the backside of the building adjacent to the Amoco building, had significant window damage as shown in Figure 3-4. Note the proximity of this building on the left of Figure 3-4(b) to the Amoco building shown on the right.

*Figure 3-4. This office building in the New Orleans Business District had extensive window damage on the west facade (a) and limited damage on opposite sides (b).*

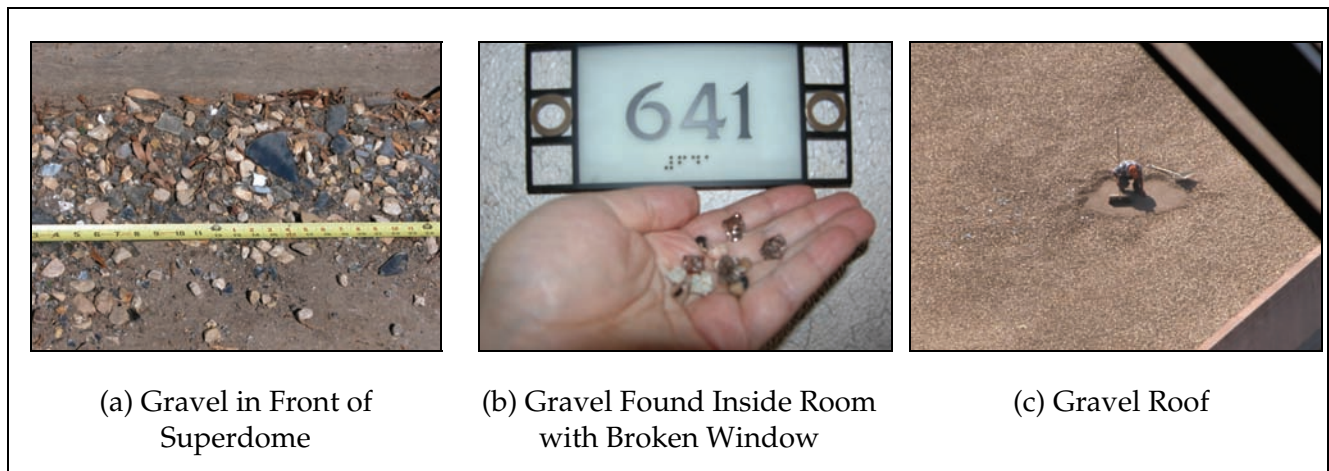
(a) Gravel in Front of Superdome

(b) Gravel Found Inside Room with Broken Window

*Figure 3-6. Gravel found on adjacent street curbs and inside substantially damaged buildings in New Orleans (a/b). Source of gravel was likely roofs from building upwind of damaged windows(c).*

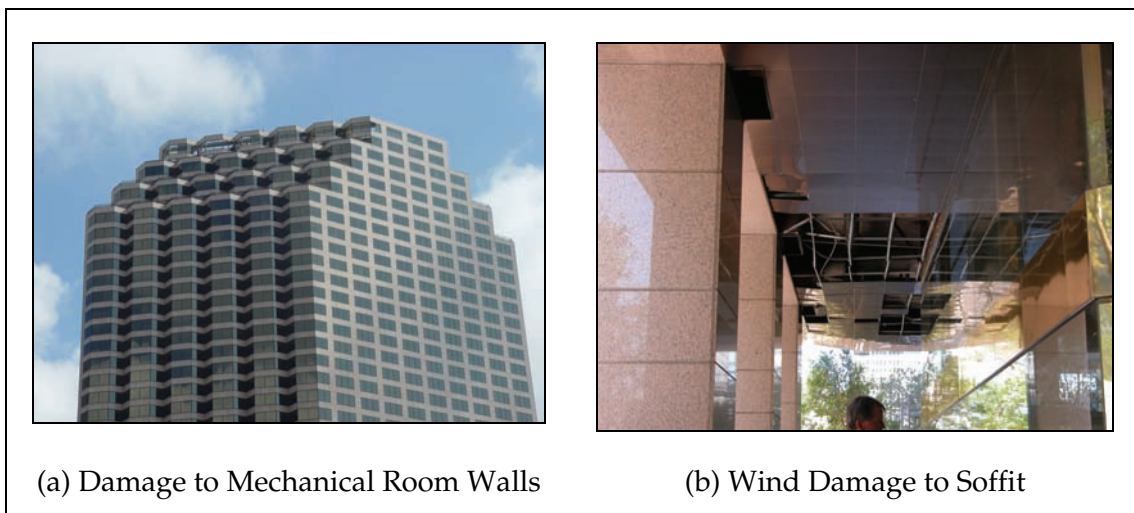
The Energy Centre, a 40-story building on the southeast corner of Poydras Street and Loyola Avenue, appeared to have relatively little damage and was in limited operation by mid-October 2005. The building, shown in Figure 3-7 (a), is located across Loyola St, to the east of 1250 Poydras. Four windows reportedly broke during the storm, but had already been replaced. The remaining visible damage consisted of broken windows on the two upper stories that housed mechanical equipment. Neighboring buildings to the east also appeared to have similar damage concentrated on the upper story mechanical rooms that were not fully enclosed. The main entry area of this building also had a few soffit tiles missing and damaged supporting grid as

(a) Damage to Mechanical Room Walls

(b) Wind Damage to Soffit

*Figure 3-7. Only visible damage to this building appeared to be broken windows on upper levels corresponding to mechanical rooms and soffit near the main entrance.*

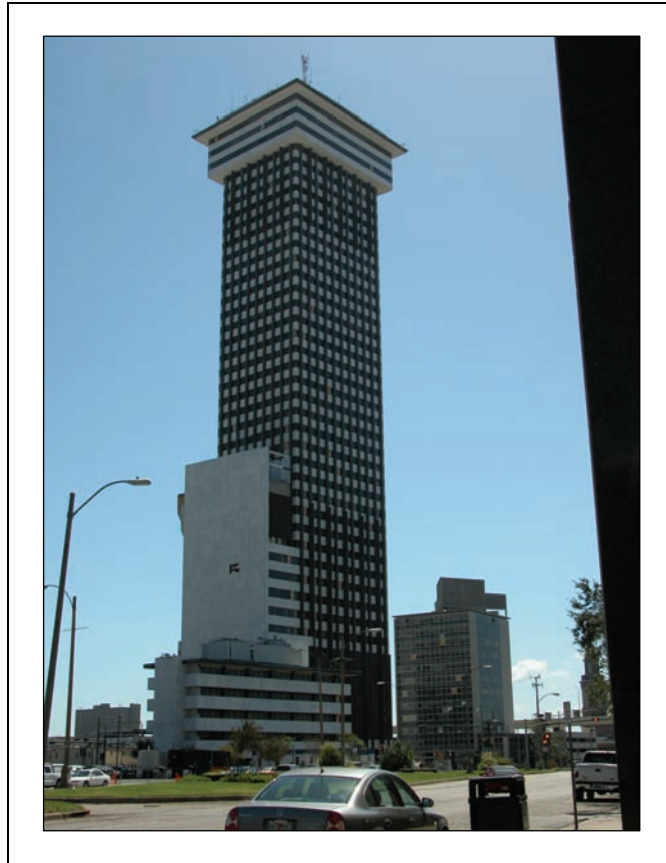
The 41-story Plaza Tower located at the intersection of Howard and Loyola is a reinforced-concrete-frame building with various vertical setbacks up to the 16th level and with a mushroom top extending the square footage of the top three stories. This high-rise building shown in Figure 3-10 was isolated from other tall buildings that could generate any rooftop debris by at least two city blocks. The south side of the building houses an eight-level parking structure with sheet metal cladding, where five of the metal sheets were missing. On the north facade, at least one precast cladding panel had been lost (note the spot around 10<sup>th</sup> floor level). Broken windows were spotted around the building, with the majority concentrated on the lower stories of the north and west facade. The building appeared closed at the time of investigation.

*Figure 3-10. Office building in the New Orleans Business District at a distance from other high-rise structures.*

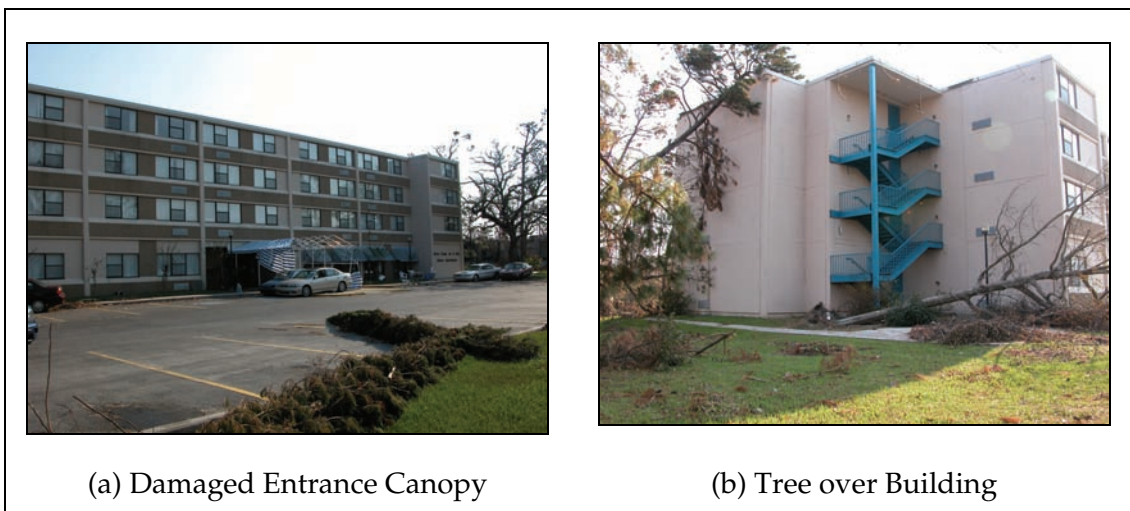
The “Notre Dame de la Mer Manor Apartments” suffered only minor damage despite being located in one of the areas hardest hit by Hurricane Katrina. The four-story reinforced-concrete shear-wall building shown in Figure 3-12 is located on US-90 about 0.5 miles west of the St. Louis Bay Shoreline. Powerful storm surge and winds in the area are evident by the displaced cars in the parking lot shown in Figure 3-12(a) and trees falling onto the building in Figure 3-12(b). The only damage readily apparent on the exterior on this building was one broken window in the rear of the building and a collapsed canopy at the main entrance. Windows in the upper stories of the building were open at the time of inspection, indicating that residents had returned to the building.

*Figure 3-12. Apartment building in Bay St. Louis.*

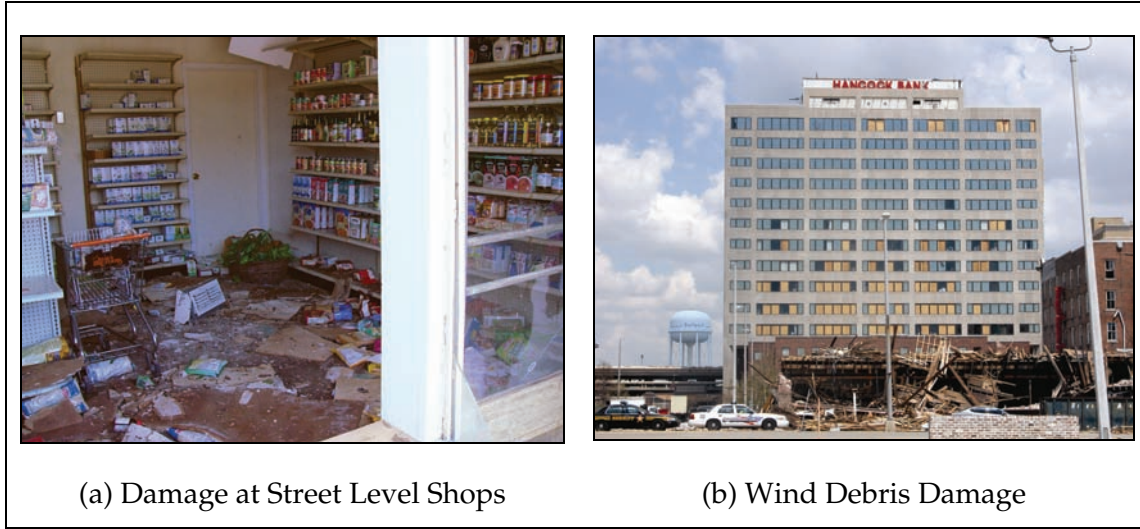
The downtown area of Gulfport, Mississippi, located about one-half mile north of the shoreline, generally appeared to have experienced 1-2 feet of storm surge. All of the buildings in the region had water damage at the ground level, as shown in Figure 3-14(a). Many other buildings had additional wind and wind-debris related damage at the upper stories. A few collapsed buildings were observed in the area as well. Figure 3-14(b) shows a collapsed unreinforced masonry structure at the forefront. The background shows the Hancock Bank building, which appeared to be the tallest building in the downtown area at 14 stories. About 30 percent of the windows were shattered on the south face above the third level. The windows that appear tinted black lost the exterior pane only. The concentration of damage at the lower levels suggests that the windows were shattered from debris picked up by the wind from the ground. At the time of investigation, restoration efforts were under way to clear debris and repair water damage to building interior from water that penetrated it through the damaged windows.

Figure 3-14. Flooding and wind damage in downtown Gulfport.

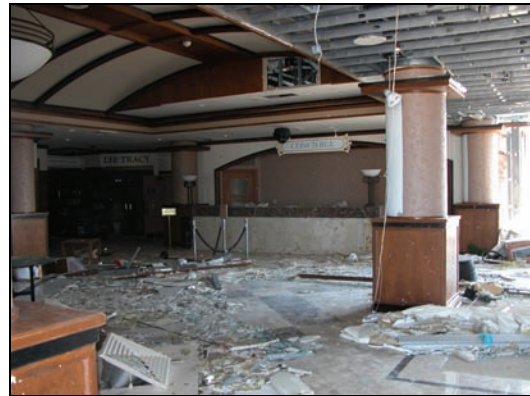
The extent of damage along the Mississippi coast is demonstrated by the beachfront 17-story Grand Casino Hotel constructed of reinforced concrete frame with shear walls. The approximately 20 ft. first story was partially enclosed, probably with break-away walls, to serve as a welcome lobby with access to stairs and elevators. Only the bare structural concrete columns and shear walls remained at this first level, with all else apparently swept away by the storm surge. The second and third stories, with heights of about 15 feet each, housed reception, shops and banquets rooms, among others. A light steel frame extended these two levels over the drive-thru valet parking. The exterior of these two stories suffered extensive damage to cladding. Figure 3-15(a) shows the front view (east facade) of the hotel building, and the exposed nonstructural framing. The building exterior was finished with layers of gypsum board, Styrofoam foam board that allowed for contouring the surface, and fabric lathe with a thin coat of colored plaster. These finishes were stripped from the nonstructural steel stud framing. As a result of exterior damage, high winds entered into the building and destroyed the interior space as shown in Figure 3-15(b). The exterior cladding was also stripped at several locations above the third-story level, exposing the steel stud framing. The casino barge associated with this hotel remained anchored

(a) Exterior Damage

(b) Interior Damage

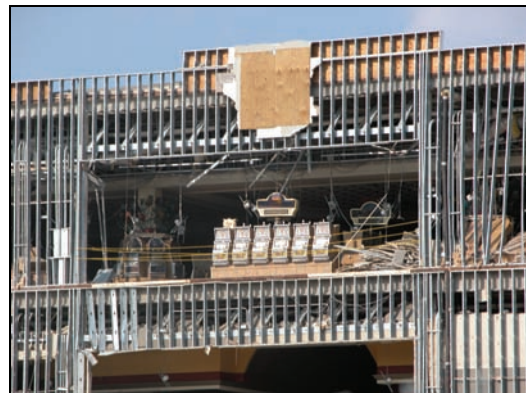
Many casinos, which were originally stationed along the Mississippi shoreline, were carried inland by the storm surge. A few of the casinos were deposited north of the coastal US 90 as shown in Figure 3-16(a). Impact between the barges and structures along the coast resulted in the partial collapse of at least one building and one parking structure. The casinos themselves were severely damaged on the exterior and interior. Figure 3-16(b) shows a close-up view through the third-level opening of another casino that crossed the US-90.

(a) Barge on Land

(b) Damage to Barge

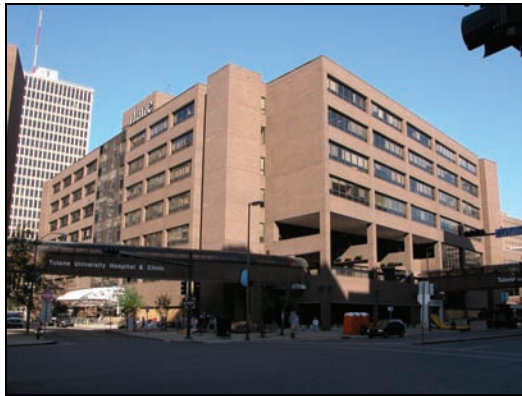
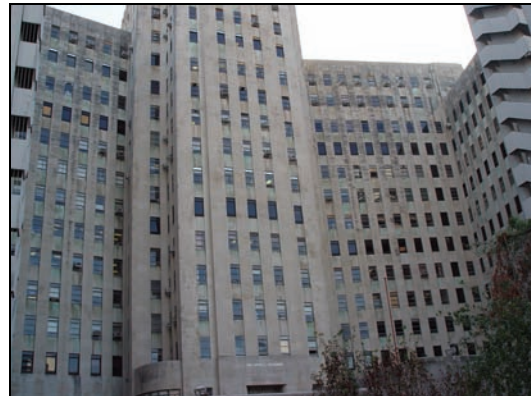
Tulane University Hospital Clinic is housed in a seven-story steel-frame building that flooded to a depth of approximately 1m for about two weeks. It has no basement, no major building service equipment at first-floor level, and few broken windows, so damage was limited primarily to architectural finishes at the ground floor. At the time of the MCEER reconnaissance, a contractor was demolishing ground floor drywall and drying the building as evident in Figure 3-18(a). Subsequently, Tulane University Hospital & Clinic

(a) Tulane Hospital

(b) Charity Hospital

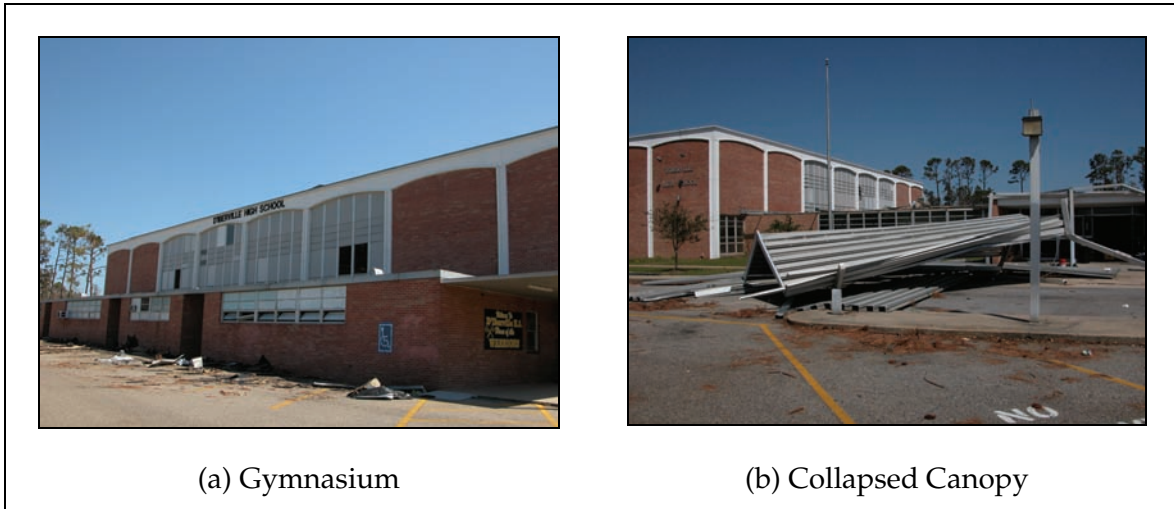
rooftop air conditioning units were damaged, and a 25-ft-by-50-ft light metal entrance canopy shown in Figure 3-20(b) was destroyed. The gymnasium structure, a concrete or steel-frame building, suffered damage to its masonry veneer. The school is located in a suburban neighborhood, in an area that was lightly wooded with pine trees; there was a debris field of pine boughs and pinecones. Approximately 10% of the windows were broken.

*Figure 3-20. D'Iberville high school in Biloxi Bay.*

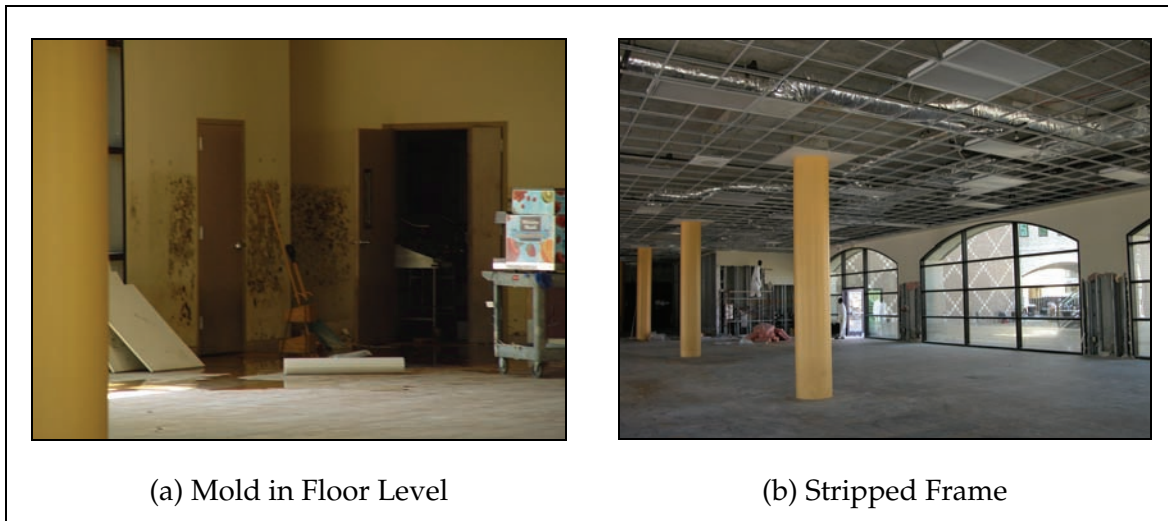
*Figure 3-21. Flood damage to new student center in university near New Orleans.*

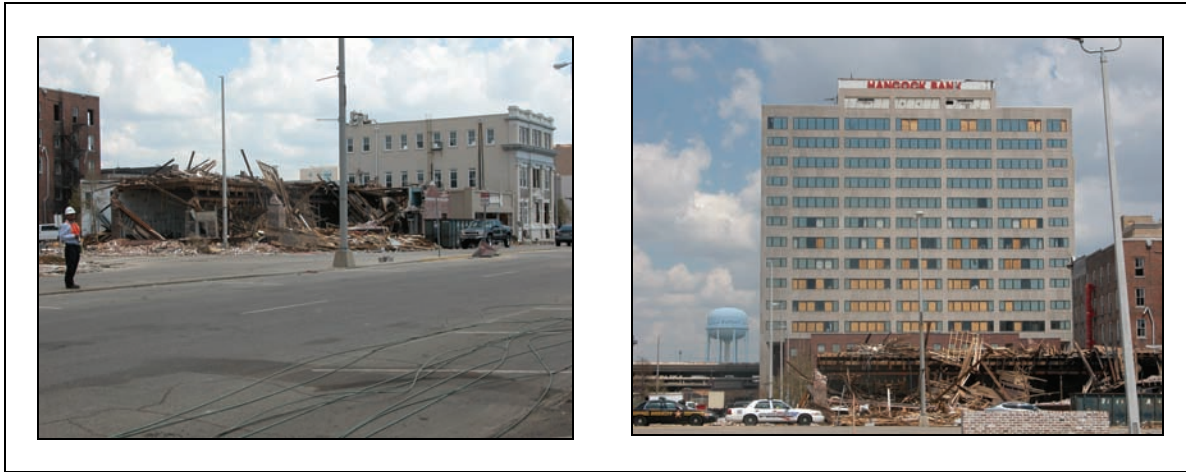
*Figure 4-1. Left: partial collapse of unreinforced masonry bearing-wall building, downtown Gulfport MS. Debris from this building may have impacted a high-rise building downwind, causing extensive wind damage (right).*

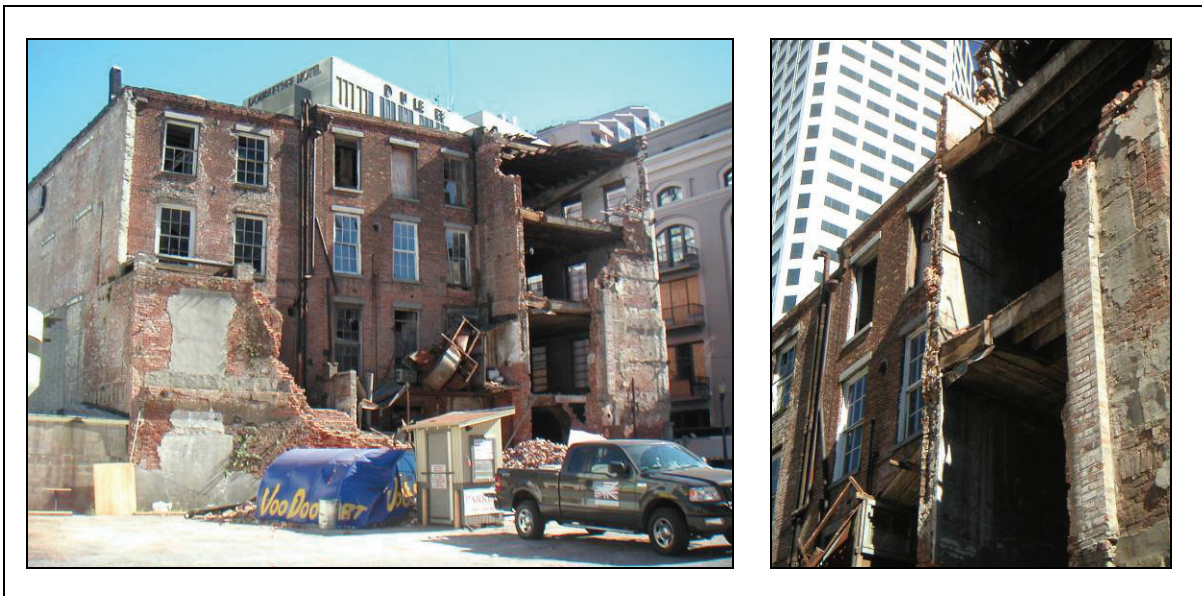
Similar damage was observed in an unreinforced masonry bearing-wall building in downtown New Orleans (Figure 4-2), where according to Vickery (2005), 10-meter peak gusts in exposure C were approximately 90 mph.

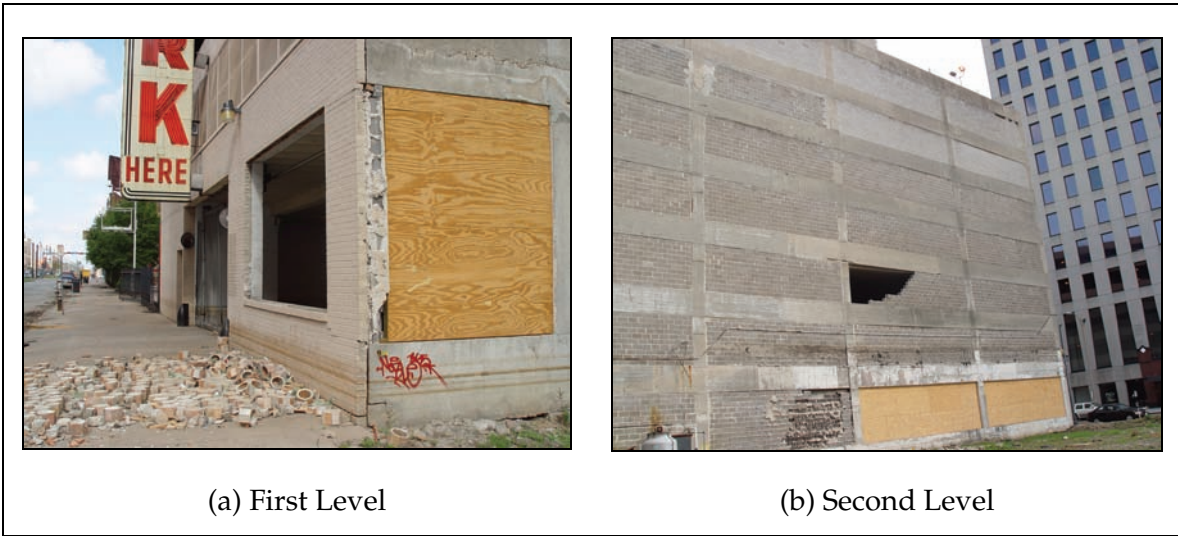
*Figure 4-4. Masonry infill damage.*

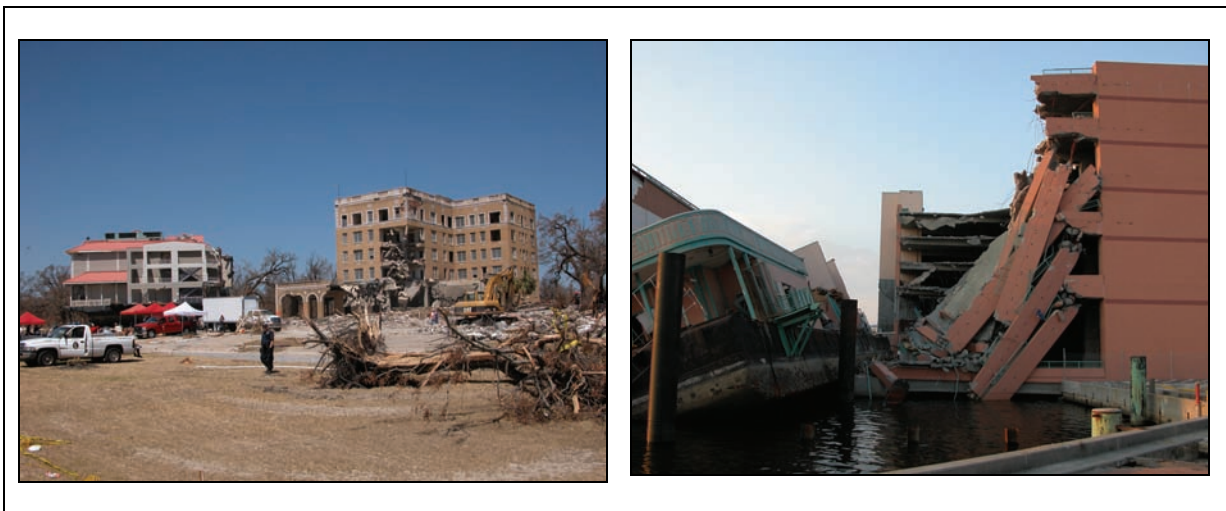
In a similar situation, a five-story (six-level) parking structure constructed of cast-in-place reinforced concrete partially collapsed. The parking structure formed part of a hotel and casino complex in Biloxi, with adjacent barges housing the gambling halls. Four bays on the west facade collapsed, apparently because of impact from the adjacent casino barge that impacted four columns as it was raised by the storm surge (Figure 4-5 right).

*Figure 4-5. Structural damage resulting from surge-borne debris.*

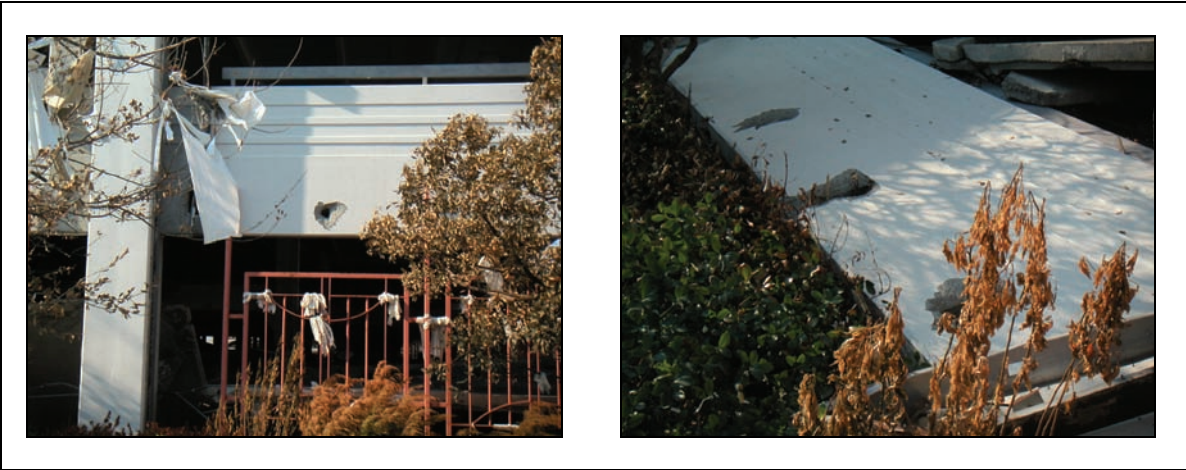
*Figure 4-6. Evidence of horizontal pounding by waves. Deck-beam shear key appears to have punched holes in the spandrel beam.*

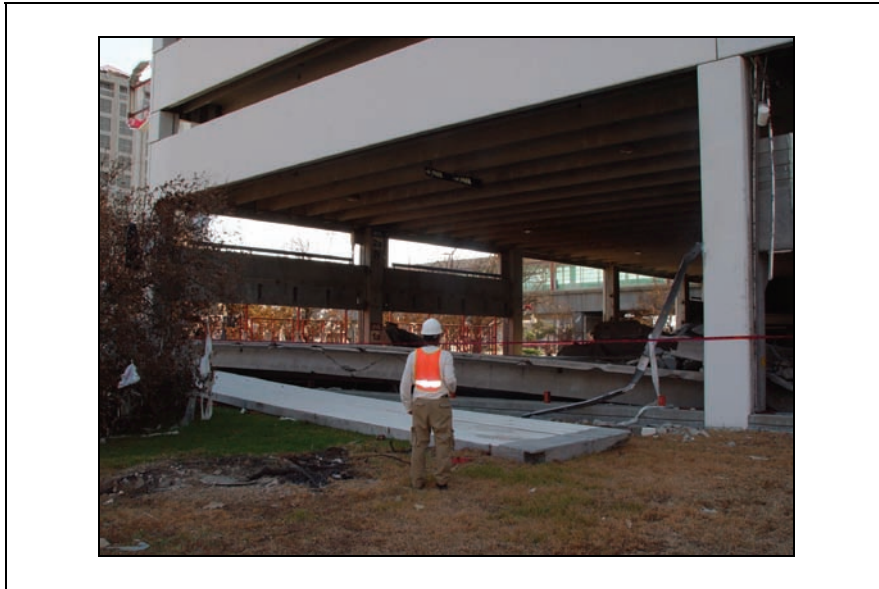
*Figure 4-8. Collapsed deck beams oriented perpendicular to the seashore.*

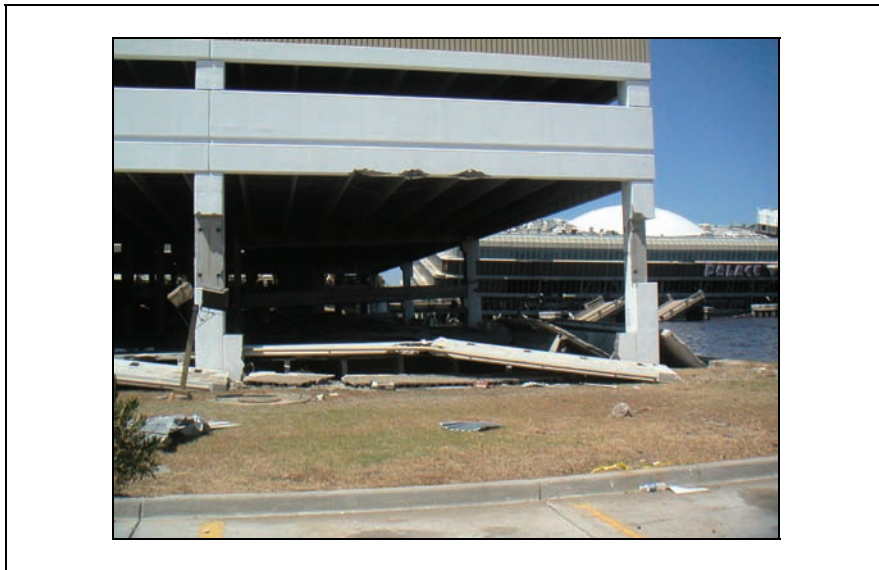
*Figure 4-9. Support of spandrel beam on the outside of the column.*

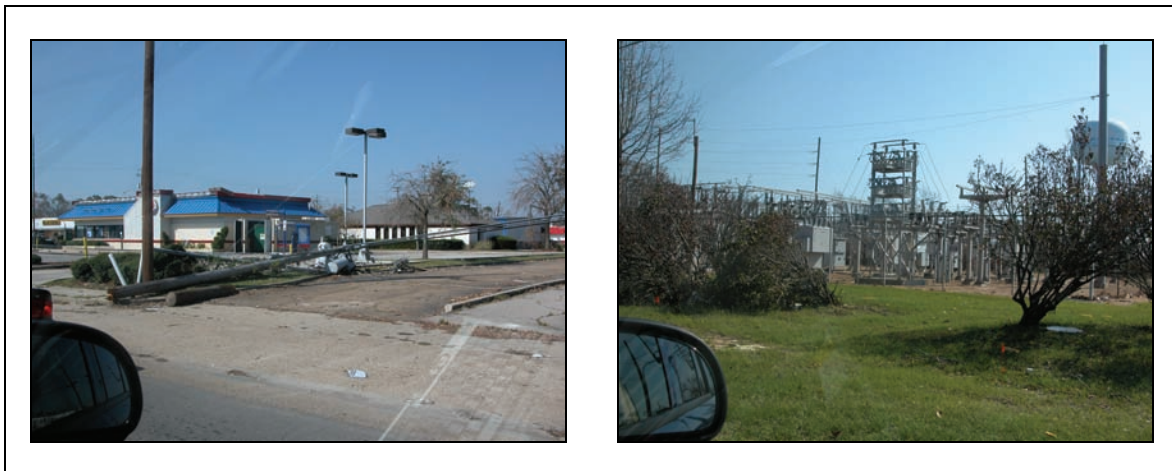
Electric power was lost to much of coastal Mississippi and the New Orleans areas. Damage to electric power distribution lines was observed throughout the affected area, with poles apparently downed both because of tree limbs or other debris (Figure 5-1), and because of wind or water pressure causing overturning of poles whose foundation soils or embedment depth were apparently inadequate. According to electric-utility workers in Biloxi MS and employees of the US government General Services Administration in Gulfport MS, flooding at electric substations caused damage to equipment requiring the replacement of the equipment. According to the electric-utility workers in Biloxi MS, flooded substation equipment was rapidly replaced because mutual-aid agreements and other emergency plans allowed the local electric power utility to have replacement equipment staged a day's drive north of the coast, the day before the hurricane struck, and trucked in as soon as it the storm had passed. As a consequence, electric power was available to 95% of Biloxi customers able to receive it within 10 days of the hurricane.

*Figure 5-1. Downed power pole with poletop transformer; exposed substation equipment in Biloxi, MS, replaced by October 7.*
