THE L'AQUILA, ITALY EARTHQUAKE OF 6 APRIL 2009

A PRELIMINARY FIELD REPORT BY EEFIT

The L'Aquila (Italy) Earthquake of 6th April 2009

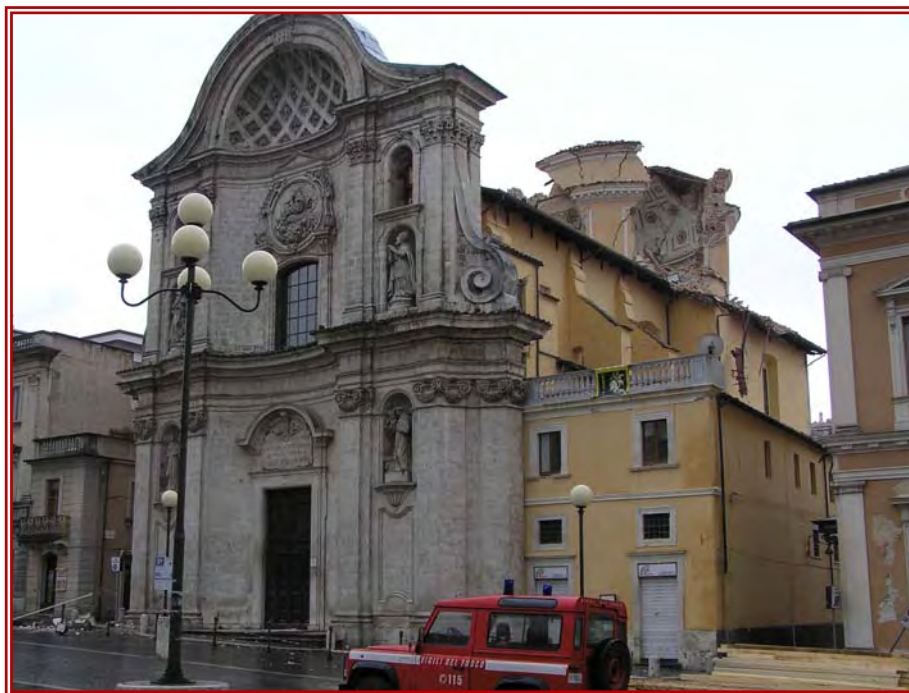
Aquila experienced a destructive earthquake in 1703. As a result, the majority of residential buildings in the walled city post-date 1703. The inner part of the city has a medieval layout with low rise masonry buildings and many historical monuments which include the important Church of Santa Maria del Suffragio (called Church of Anime Sante by locals) in the main square Piazza del Duomo. The Church of Anime Sante was built in 1713 by the fraternal order wedded to Santa Maria del Suffragio. The order chose Piazza Duomo for the construction of a new chapel after the 1703 earthquake which caused heavy damage to the prior chapel, situated to the rear of Saint Maxim Cathedral. The construction, designed by the architect Carlo Buratti, required many years and was completed in 1775. The central chapel of rectangular shape with barrel vault presents two smaller chapels on each side and a neoclassical dome designed to widen the area reserved to the presbytery. This dome collapsed in the April 6, 2009 earthquake (Figure 8).

Figure 8: Church of Santa Maria del Suffragio, which dome was damaged during the April 6, 2009 event.

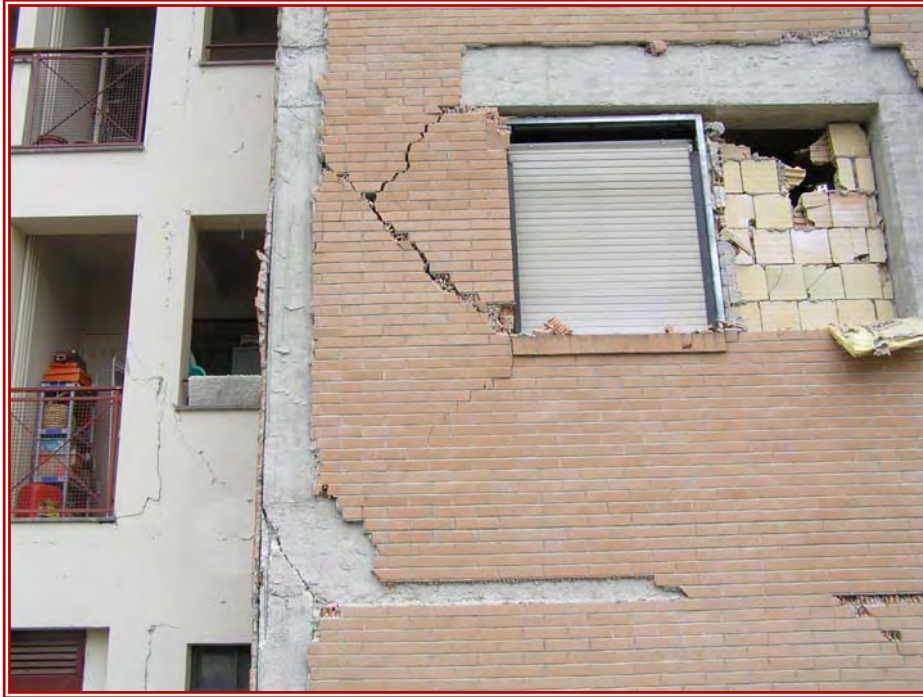
At the top of the hill a 5-storey RC Frame with approximately 80m x 20m plan and built in 1990 suffered extensive damage to non-structural elements and moderate damage in structural elements. Shear cracks in connections were observed. Poor reinforcement anchorage and lack of ties were evident. New two storey RC villas had recently been completed in the vicinity and were undamaged.

Figure 12: Detail of the 5 storey residential block at the top of the hill at Pettino, showing shear cracks in beam-column connection and infill panel failure.

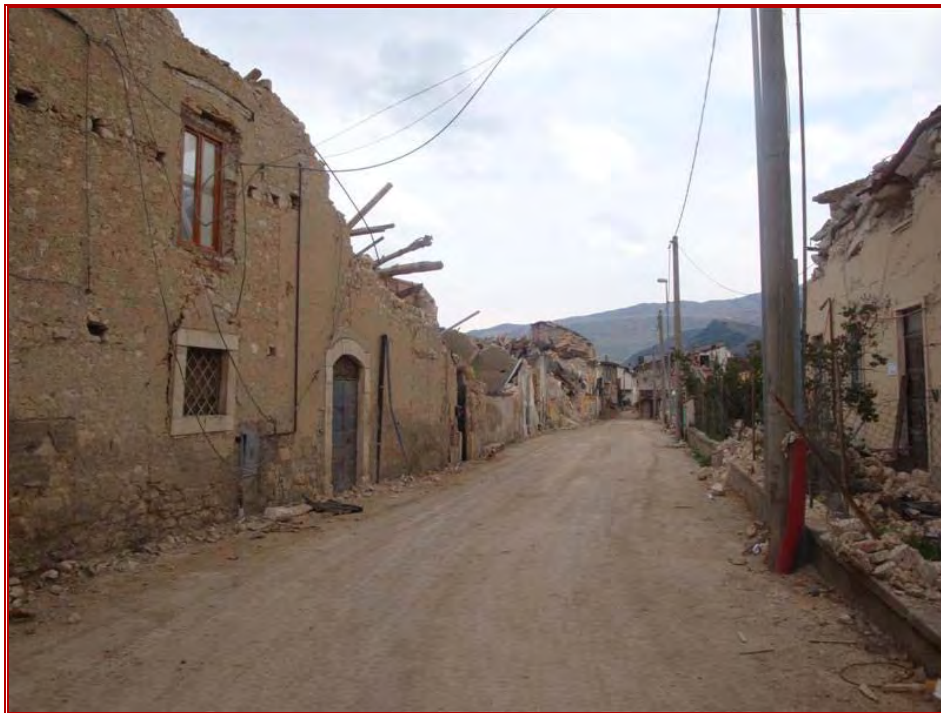
Figure 13: View to south down Onna main road showing very heavy damage (Grade 4) and destruction (Grade 5) of typical masonry buildings.

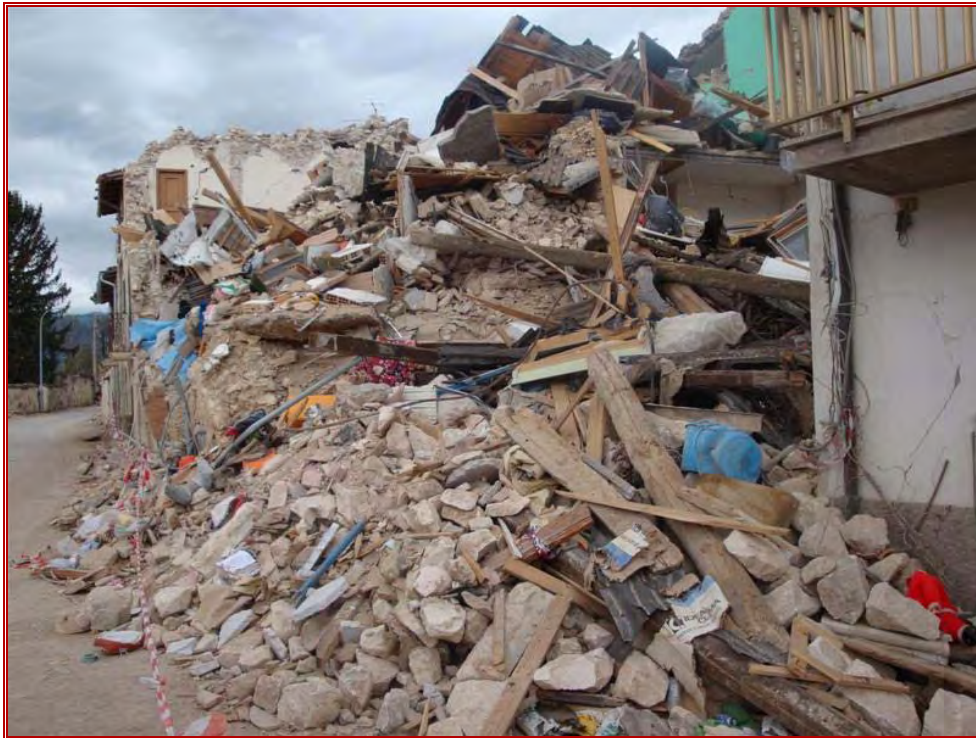
Figure 14: View of total collapse (Grade 5) of masonry building showing composite nature of building materials.

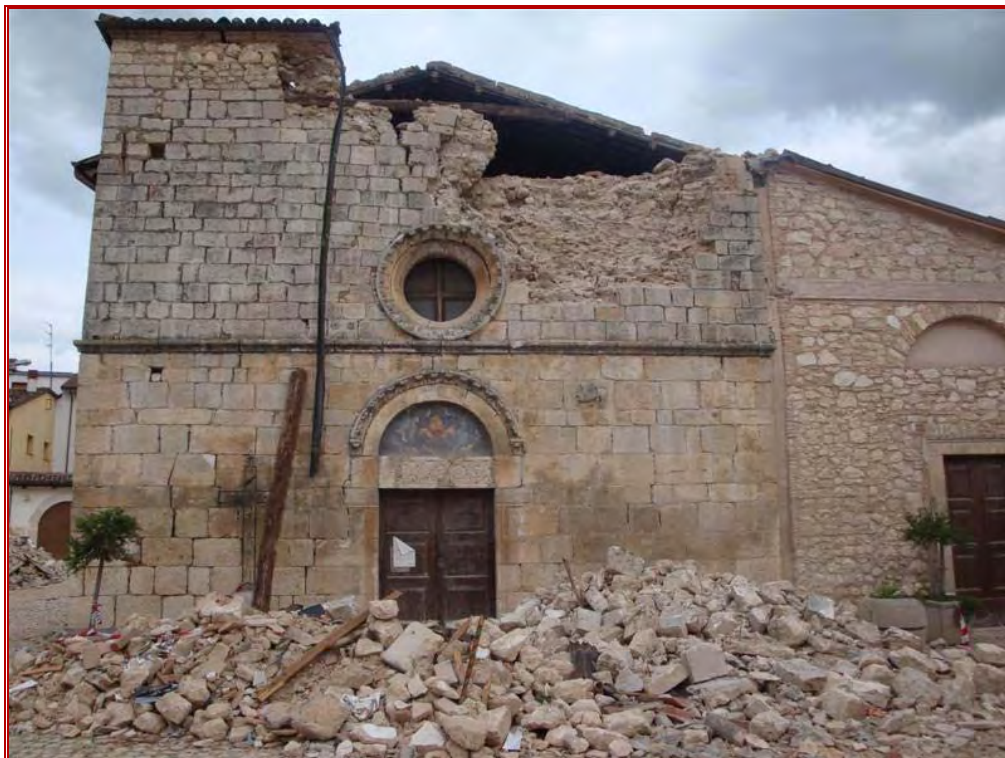
The building stock in the town is dominated by old, two to three storeys, stone masonry buildings with wood frame roofs covered with clay tiles. Many of these buildings have undergone alterations and the alterations have been constructed using clay brick, concrete block, wood board, or reinforced concrete. Steel beams were seen to have been used in a few of the altered buildings. In many cases these led to the buildings being a composite masonry construction (see Figure 14). These masonry and composite masonry buildings experienced a broad range of damage from moderate damage (Grade 2) with cracks in many walls to many cases of partial or total collapse (Grade 5). An old, stone masonry church located in the centre of the town experienced very heavy damage with failure of some walls and partial collapse of the roof (see Figure 15).

Figure 15: View of very heavy damage to church with wall failure and partial collapse of roof.

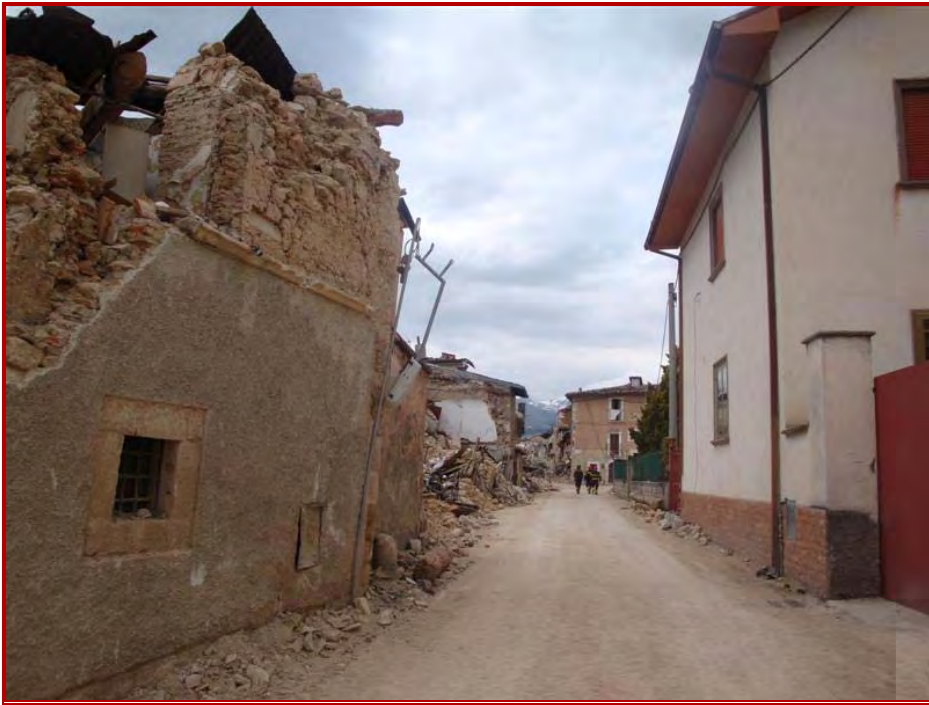
Two to three storeys, reinforced concrete frame buildings with clay brick infill walls are less common in the town. These buildings generally experienced lower levels of damage compared to the masonry structures (Figure 16). A school building comprising a single storey, reinforced concrete frame with clay brick infill walls structure experienced negligible to slight damage (Figure 17).

Figure 16: View of partially collapsed masonry building (left) and negligibly damaged reinforced concrete building (right).

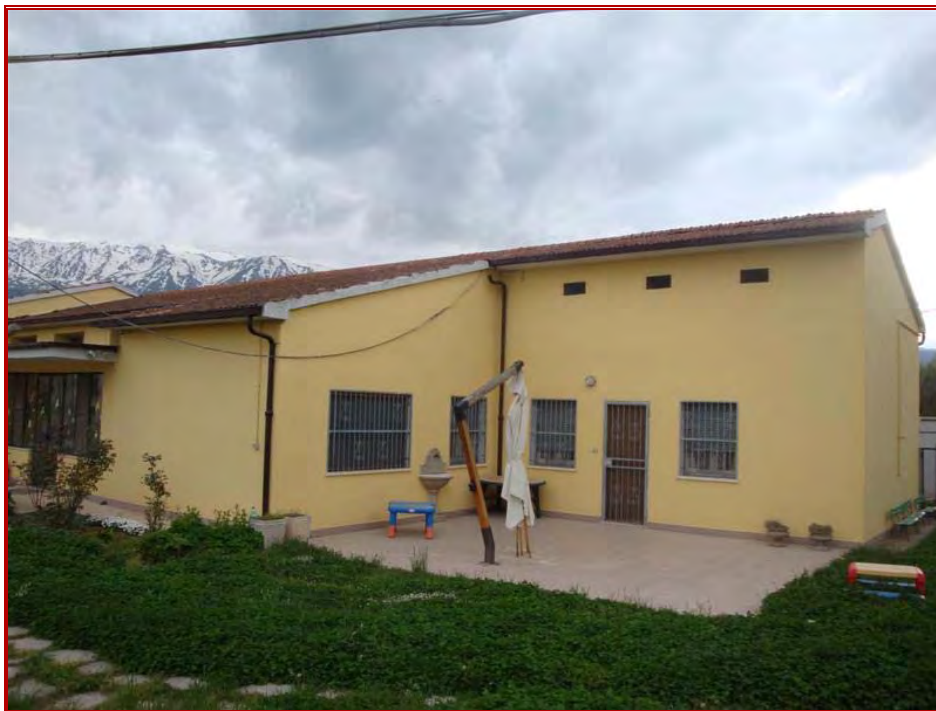
Figure 17: View of reinforced concrete frame with infill brick wall school building showing negligible damage.

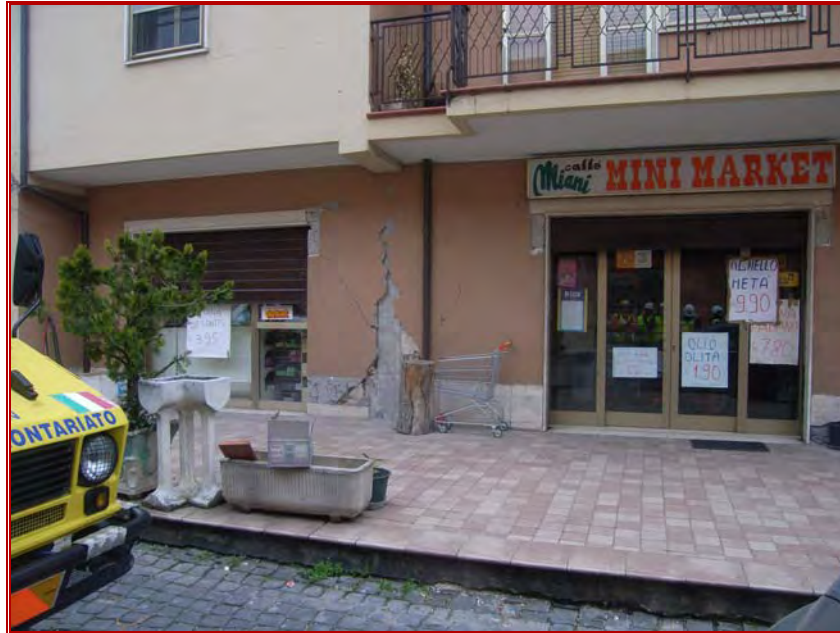
Figure 19: Reinforced Concrete frame structure with damage to infill panel

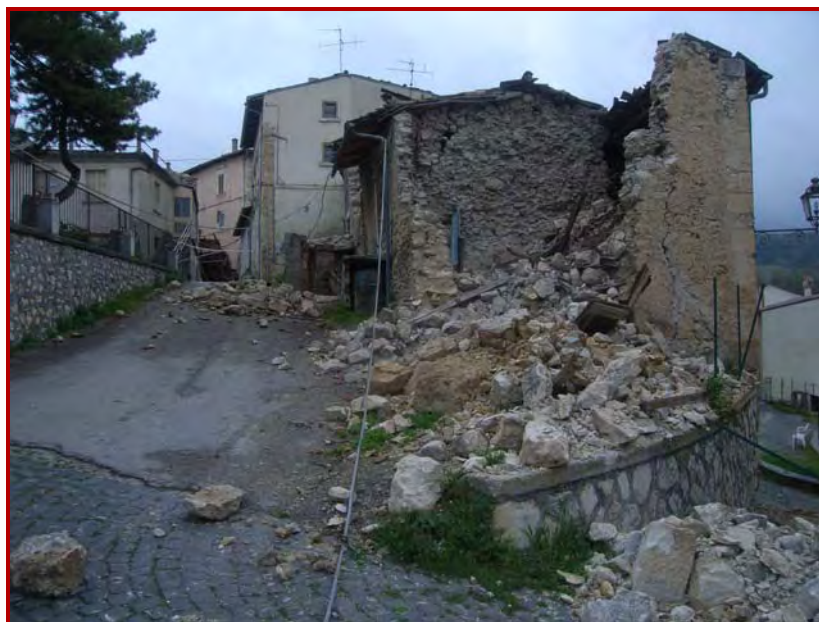
Figure 20: Collapsed masonry structure

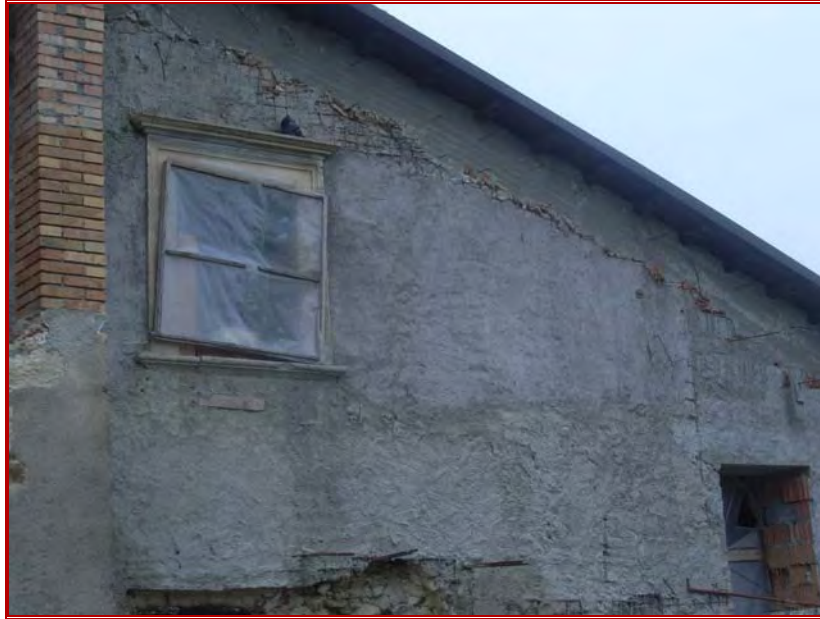
renovation with the addition of strengthening such as concrete ring beam at roof level, cross ties and mesh reinforcement in the render (Figure 21). It was observed that masonry structures that had been retrofit sustained substantially less damage than those that had not been retrofit. Approximately 5% of reinforced concrete frame structures suffered damage but this was non-structural damage to infill block-work panels and was generally rated as slight. The population of the town is 1100 and there were 7 fatalities

Figure 21: Masonry Structure in Process of Strengthening.

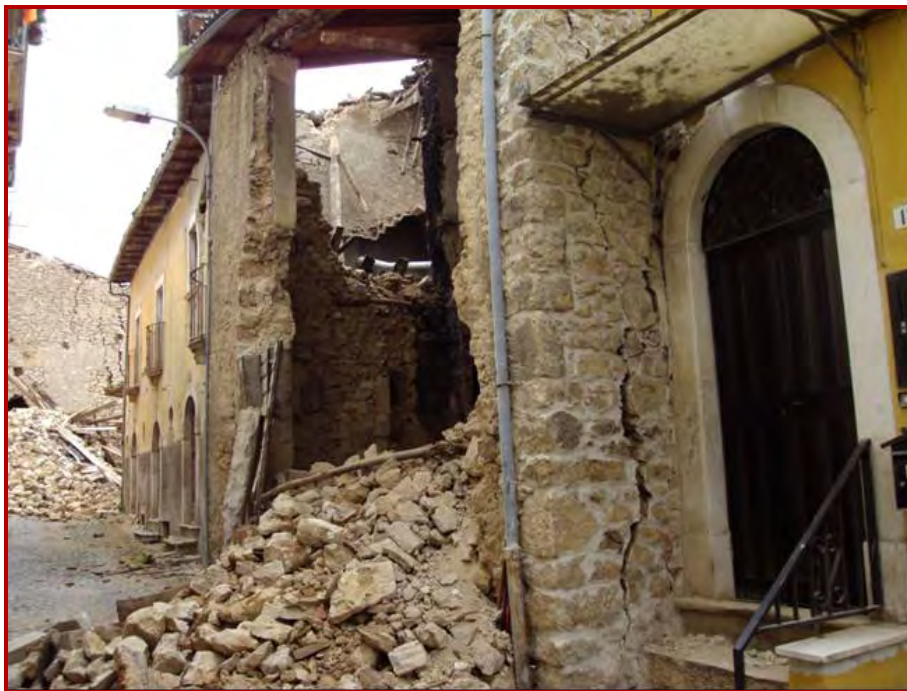
Figure 22. Example of masonry building damage in San Gregorio.

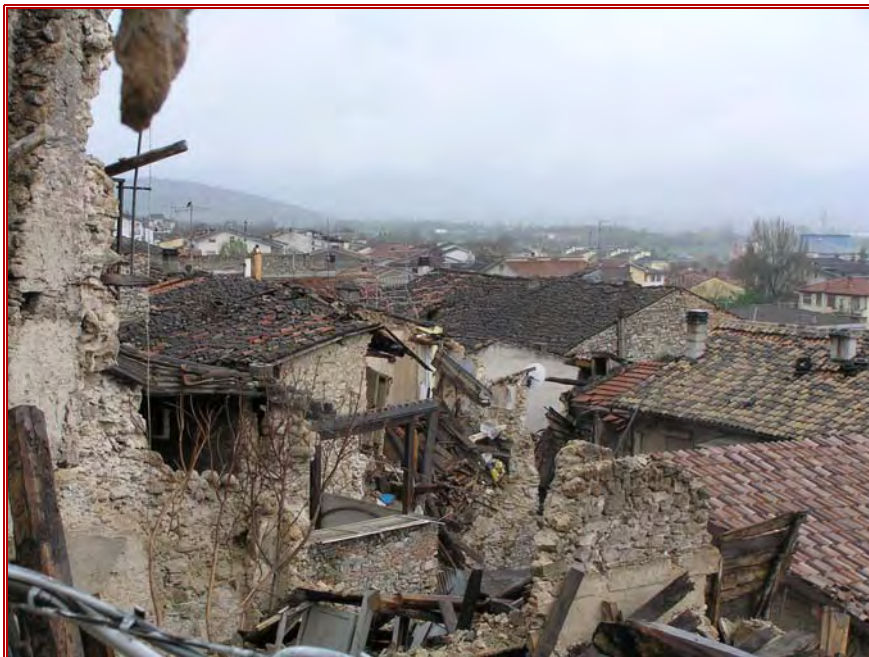
Figure 23: Panoramic view of damaged masonry houses in Paganica

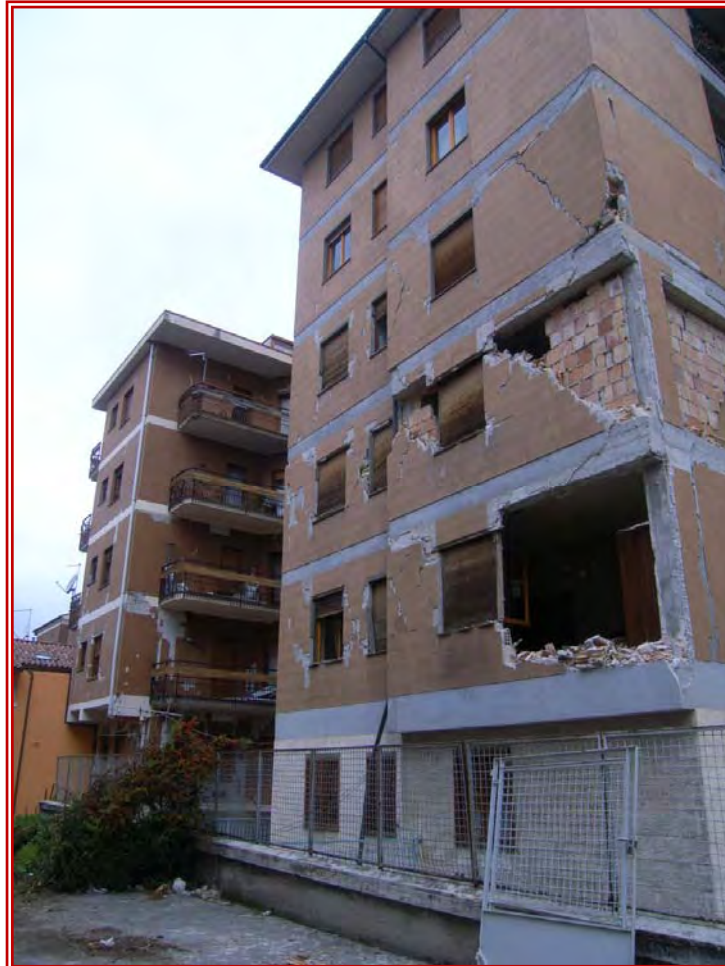
In the majority of towns surrounding Aquila the reinforced concrete frames were undamaged with varying levels of damage to the infill panelling (e.g. Figure 25). This makes them easily repairable, but the extent of infill damage sometimes precluded immediate occupancy. At this stage we cannot comment on the appropriateness of this performance, as we cannot yet correlate observed damage to the ground motion experienced in the surveyed areas.

Figure 25: RC frame in Aquila Centre with severe damage to infill but intact structural frame.

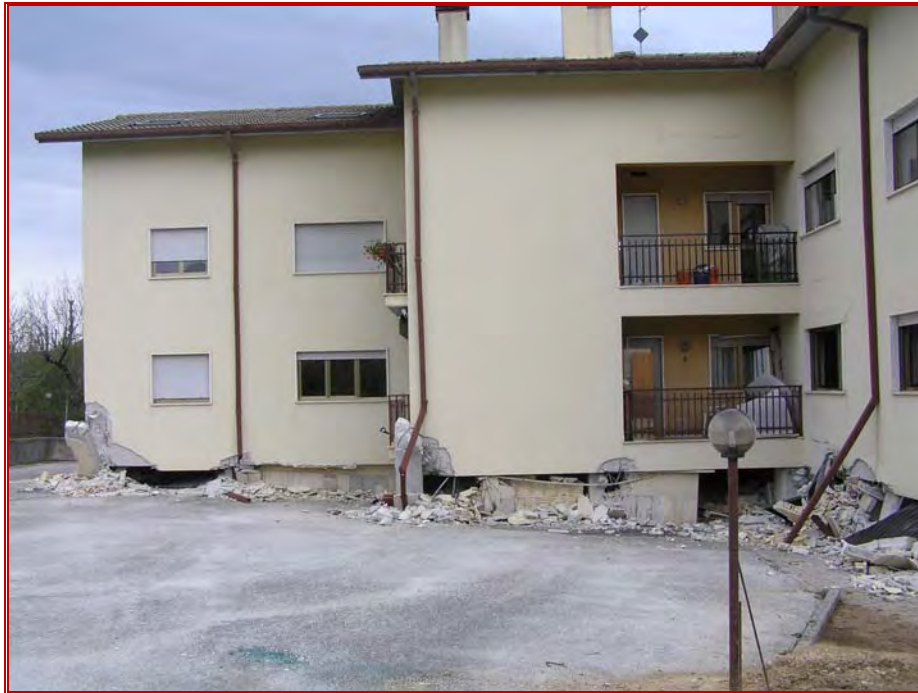
Exceptions to this were three observed soft-storey failures in Pettino (2) and San Gregorio (1). In all these cases failure was precipitated by irregular stiffness in elevation. Poor detailing of reinforcement in connections was evident as well as lack of confinement in columns (see Figures 26 to 28). These structures date from the mid 1980s and should have contained a degree of seismic design.

Figure 26: Three storey RC frame with soft-storey failure in Pettino.

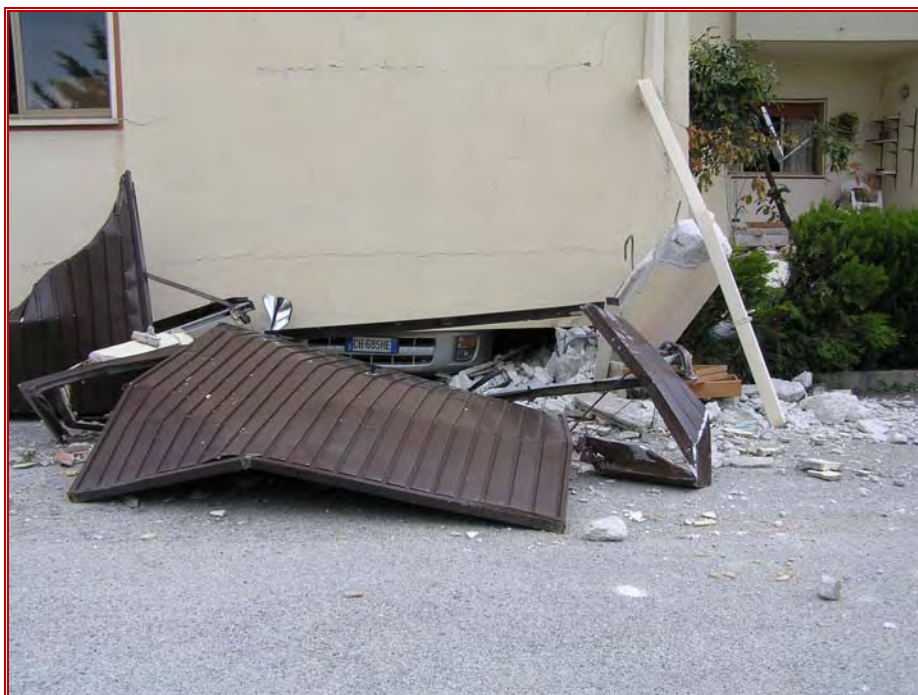
Figure 27: Detail of second soft-storey collapsed RC frame in Pettino

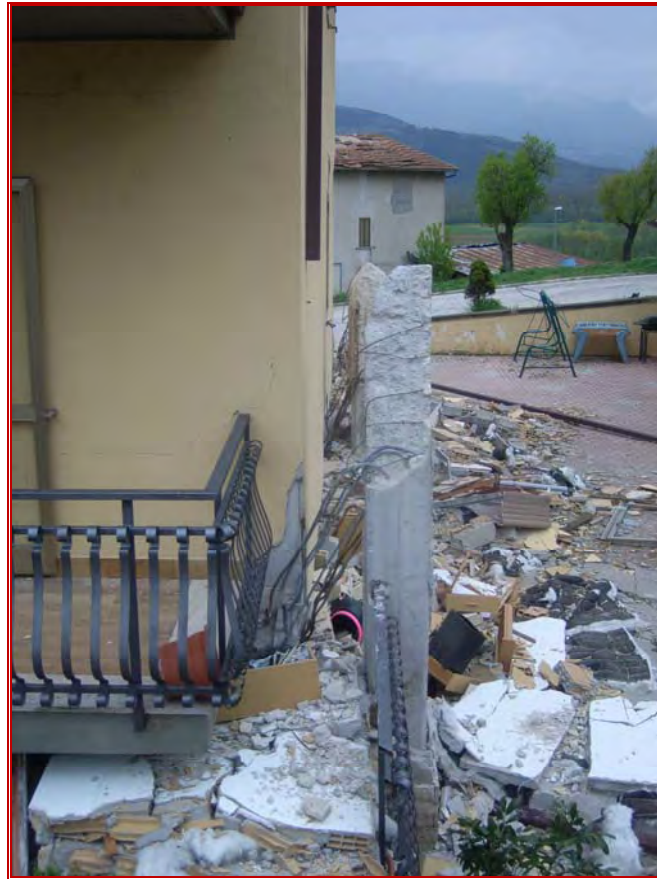
Figure 28: Detail of soft-storey collapse of RC frame in San Gregorio

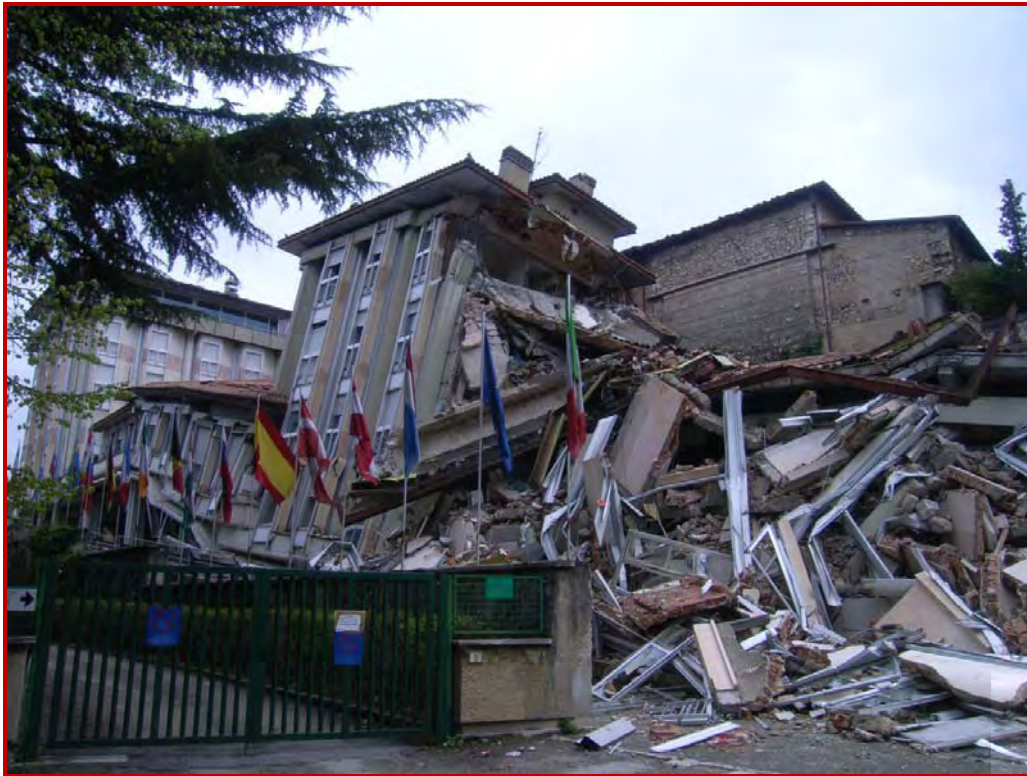
Three major failures to RC frames were also observed by the EEFIT Team in Aquila Centre: the Aquila University halls of residence, a 5 storey (with basement) residential building (Figure 31) and the Hotel Duca degli Abruzzi (Figure 29). In all cases the buildings were constructed in the late 1970's, just after the introduction of the first seismic code for RC buildings was introduced in Italy. In each case a section of the building underwent total collapse indicating a lack of robustness and redundancy of members. The Hotel degli Abruzzi seems to have failed through a combination of soft-storey mechanism formation exacerbated by sloping topology. Poor detailing of column reinforcement was observed with smooth reinforcing bars and inadequate confinement steel (Figure 30) that seems incongruent with the requirements of the 1974 code. In the case of the halls of residence, it was not possible to identify the failure mechanism due to site clearance for rescue. However, from exposed connections and rubble, smooth reinforcement was again present. In the residential building one of the main problems is seen to be the lack of transverse reinforcement in columns and connections. Columns seem to have failed in compression before beam yielding. Despite these collapses, the majority of RC frame buildings in Aquila town centre were not structurally damaged but sustained extensive non-structural damage.

Figure 29: Hotel Degli Abruzzi in Aquila. Soft-storey failure of RC frame.

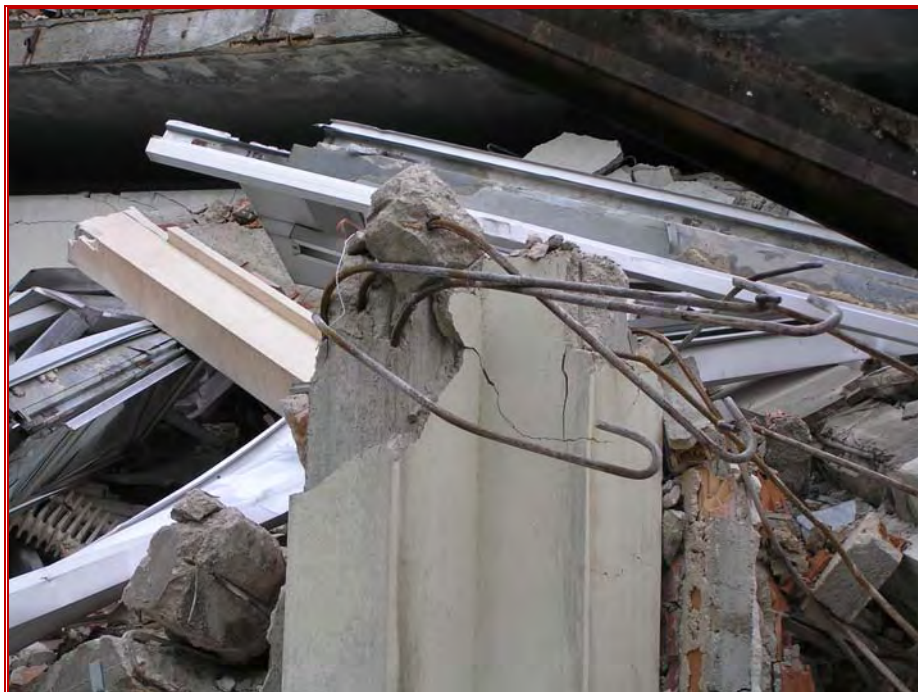
Figure 30: Detail of failed column from Hotel degli Abruzzi in Aquila

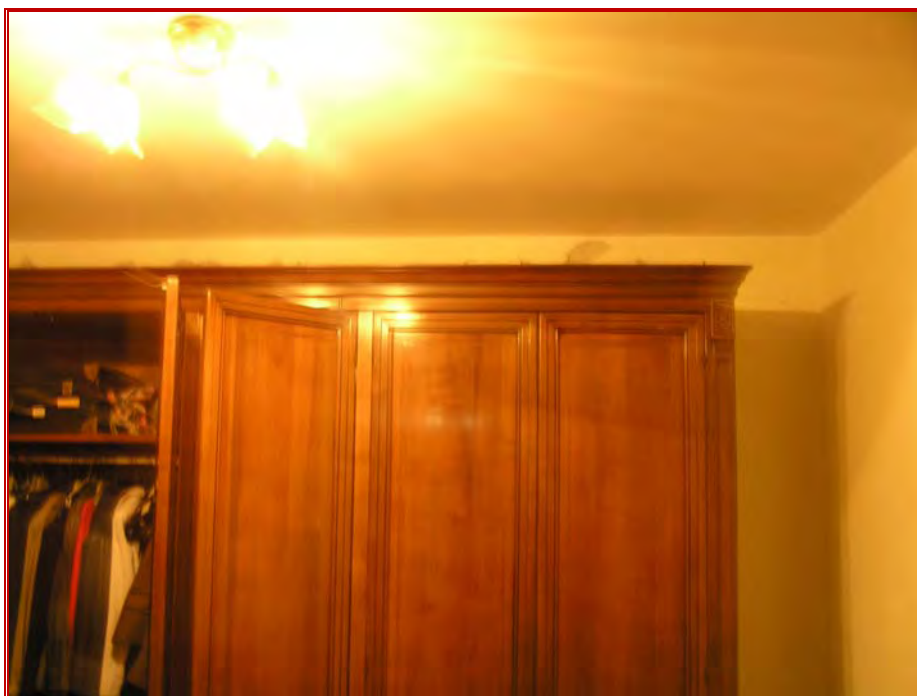
Figure 33: Inside of residential building in Figure 32. Evidence of strong ground shaking shown by wardrobe having damaged plaster through pounding.

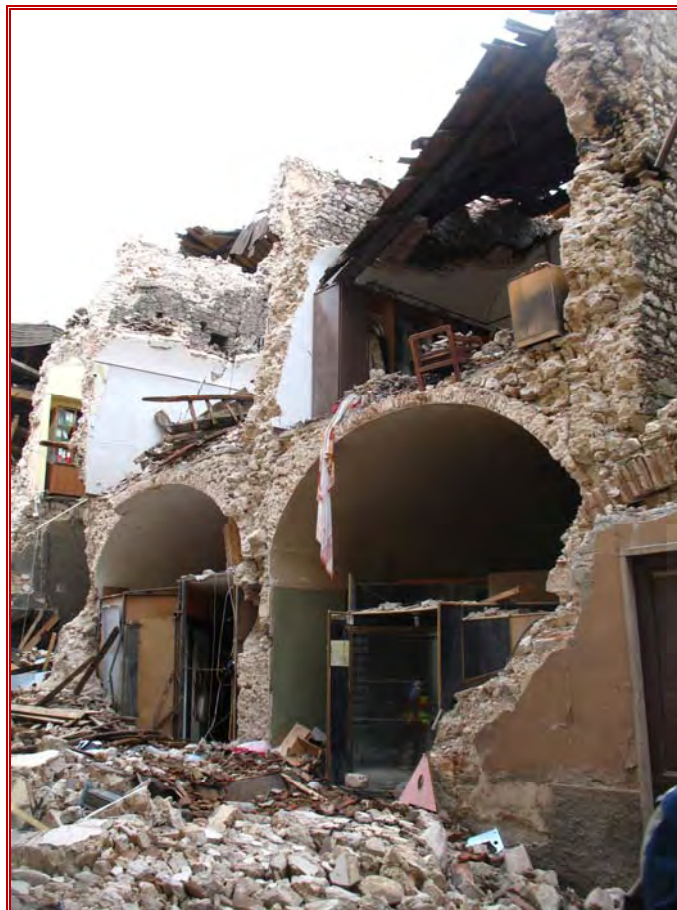
Figure 34: Building typologies - a major collapse opposite University Building in L'Aquila showing the typical masonry wall construction and vaulted floor construction.

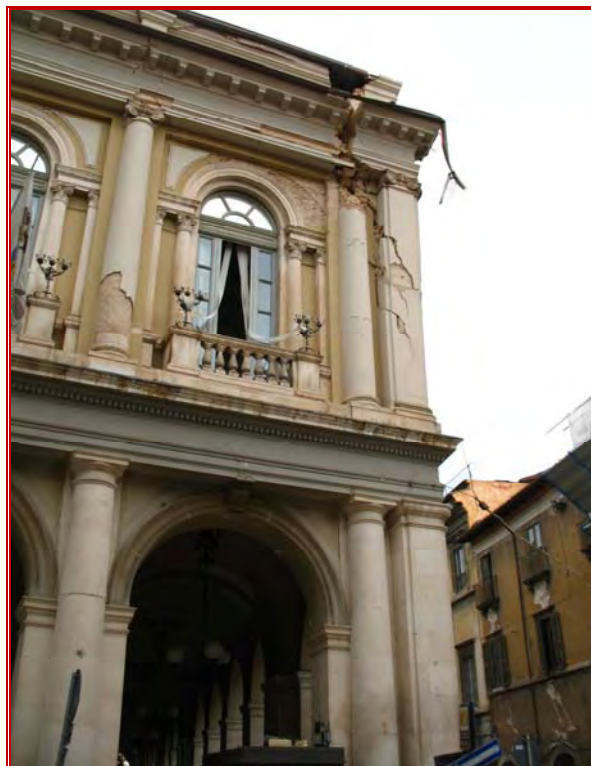
In massive buildings and monuments of L'Aquila, the tension forces that initiate collapse of masonry could only form in the upper storeys of the buildings, so parapets, top corners, and church timpani were the most severely damaged

Figure 37: Damage to corner of government building in L'Aquila

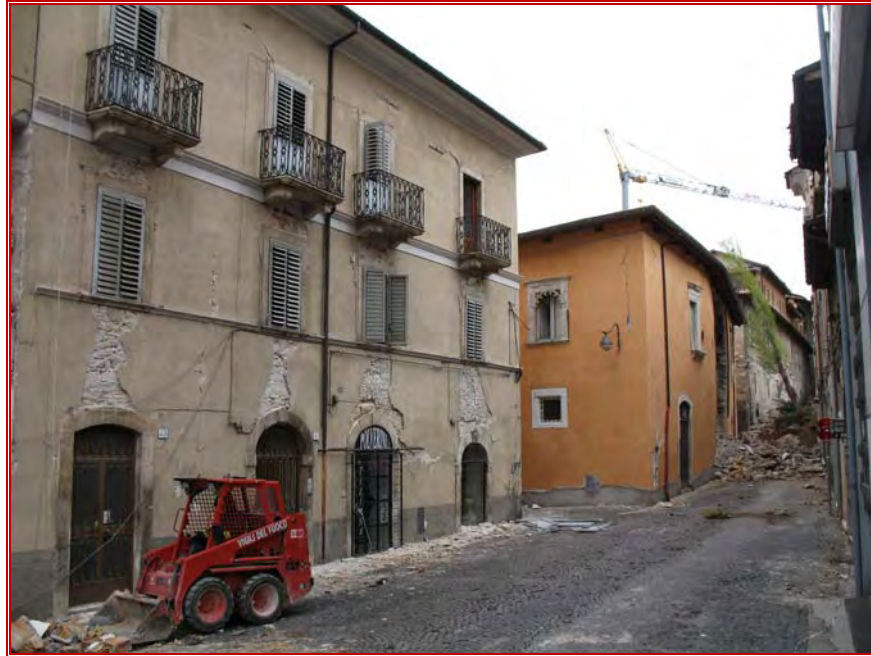
The largest concentration of masonry buildings is in the Centro Storico (old town) of L'Aquila. As well as the forms of severe damage and partial collapse described above, a large proportion of buildings suffered wide spread cracking, in the form of X-cracks due to in plane shear forces or cracking in the corners.

Figure 38: Typical minor to moderate damage to masonry buildings in L'Aquila

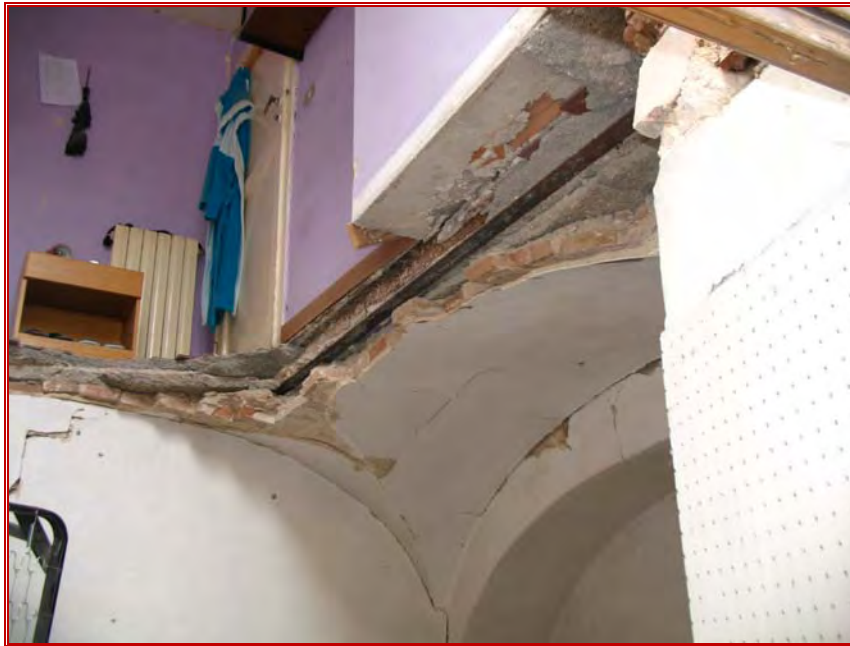
Figure 39: Example of collapse of vaulted floor in L'Aquila

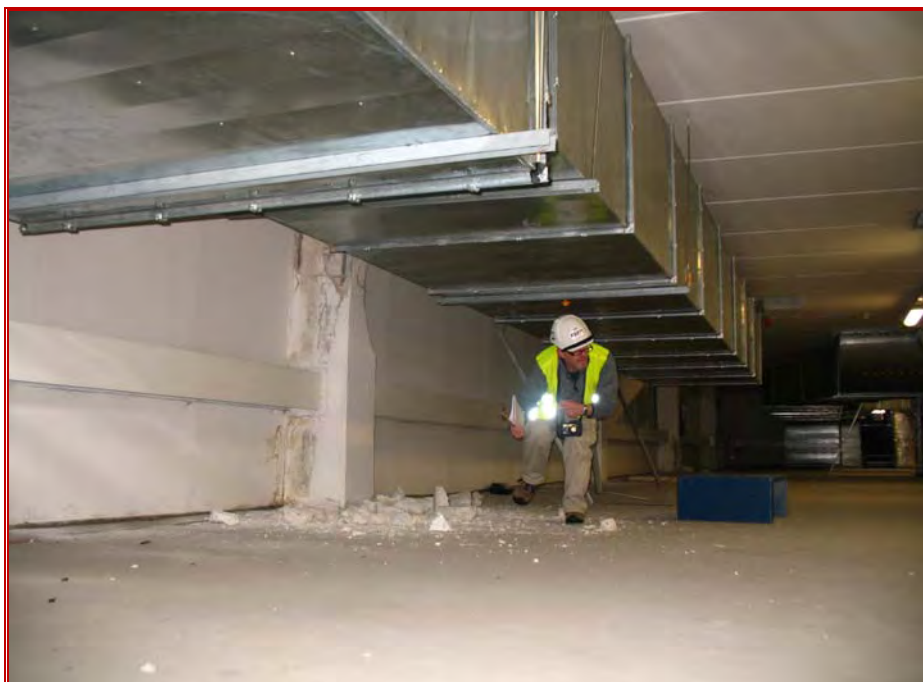
Figure 41: Short-column failure in Dompe' Pharmaceutical Plant

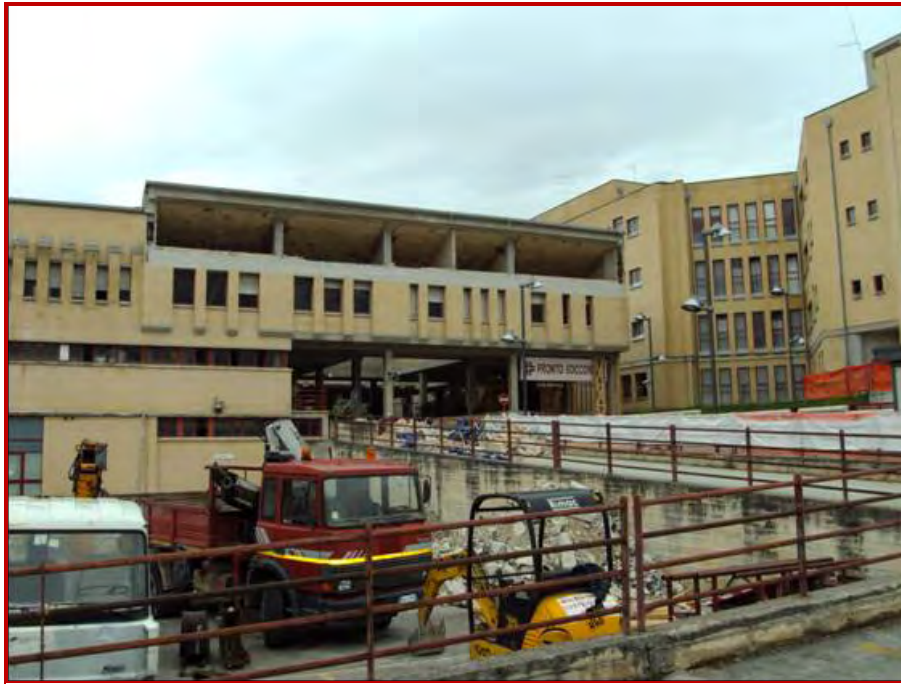
Figure 43: Northern blocks of L'Aquila hospital. Note that the infill walls on the top floor of the entrance collapsed.

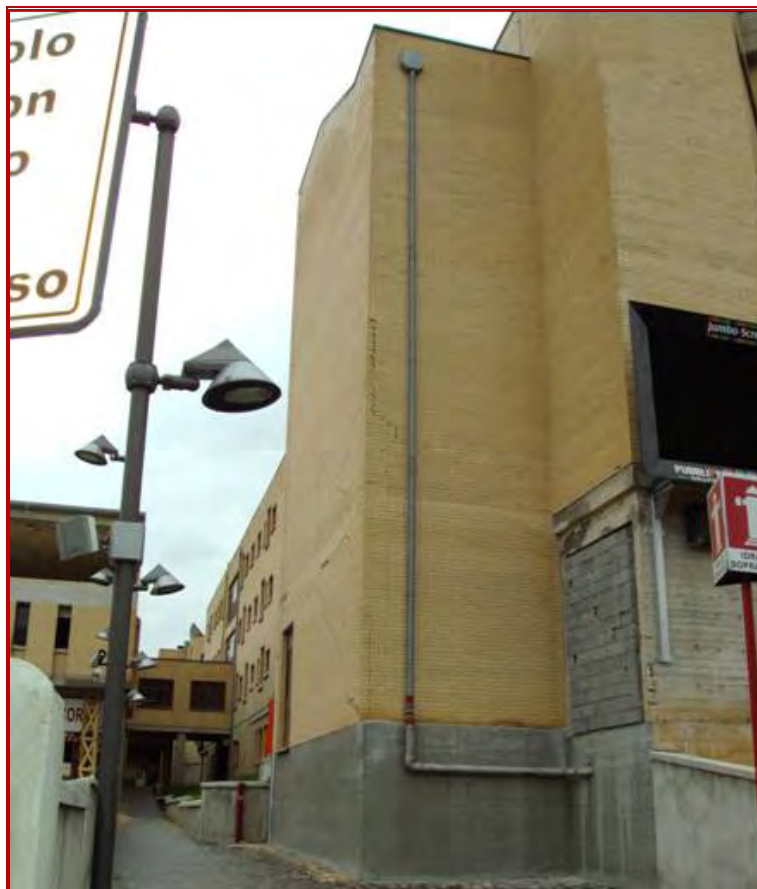
Figure 44. Shear cracks on the ground and first floors on one of the Northern hospital buildings. The concrete block infill wall on the right-hand-side of the photo was displaced from its axis about 3-5 cm.

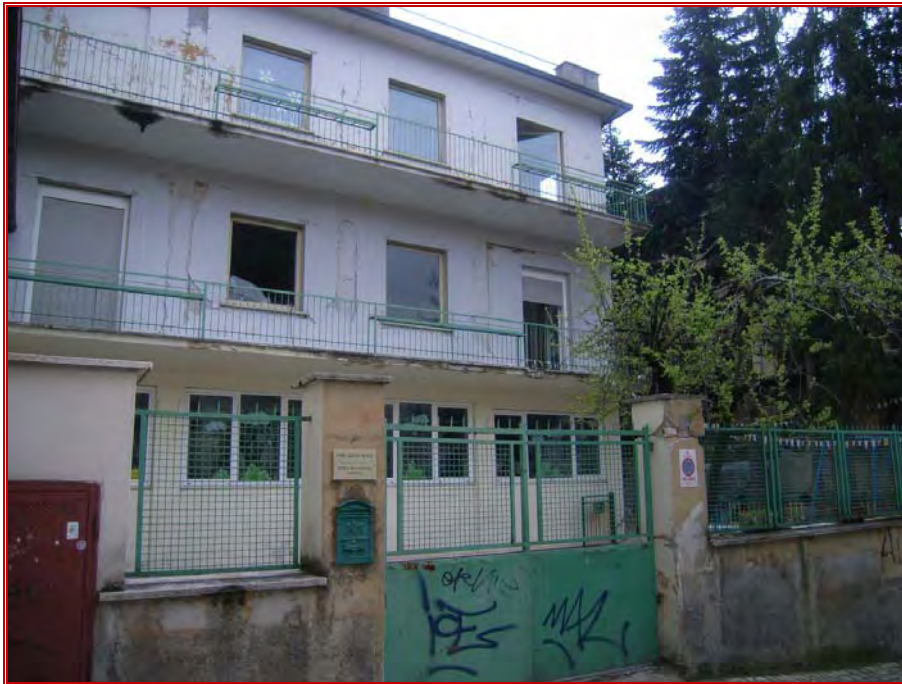
Figure 47: Elementary school in Aquila. RC frame building with infill, which sustained slight damage.

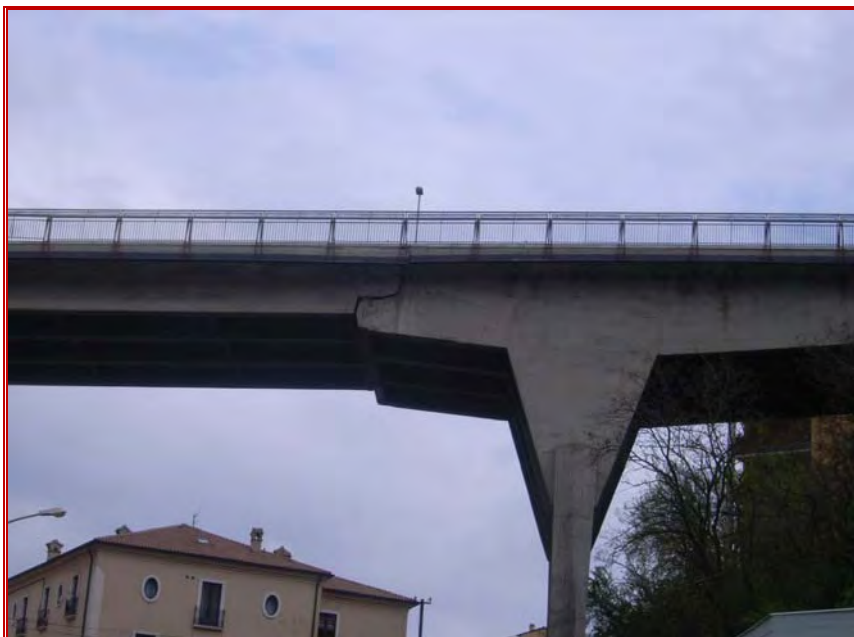
Figure 50:View of propped cantilever bridge with displacement at connection.

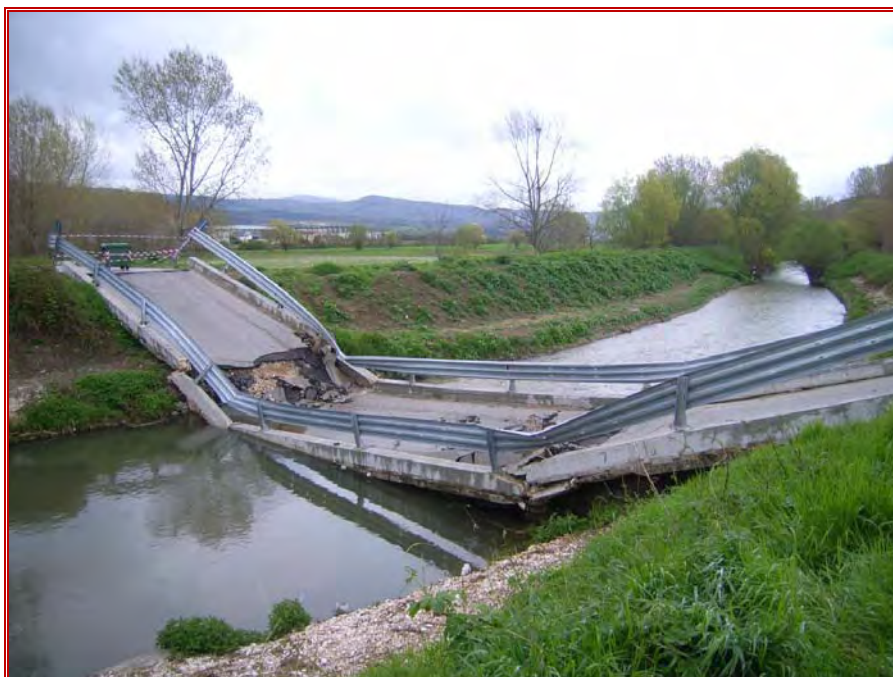
Figure 51: Failed minor road bridge at Fossa

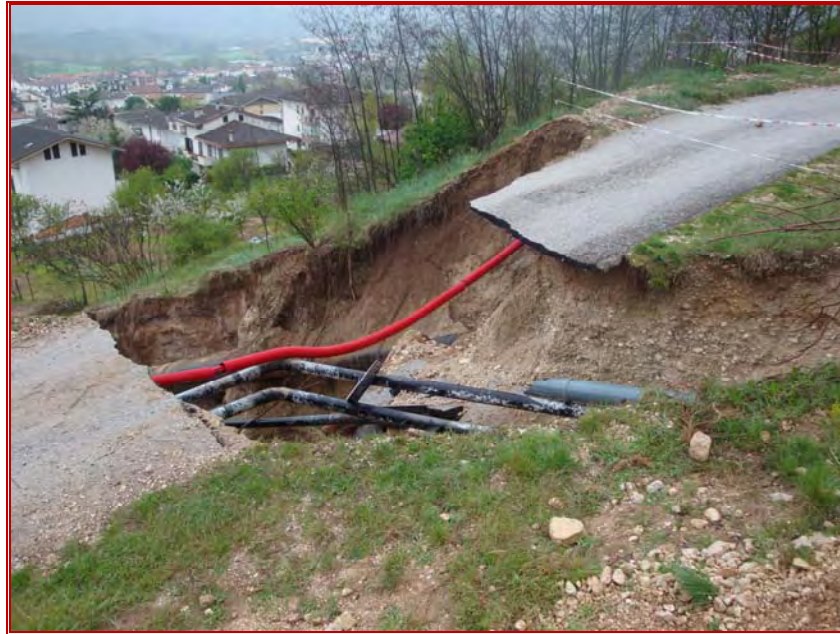
Figure 52: Failed water main at Paganica

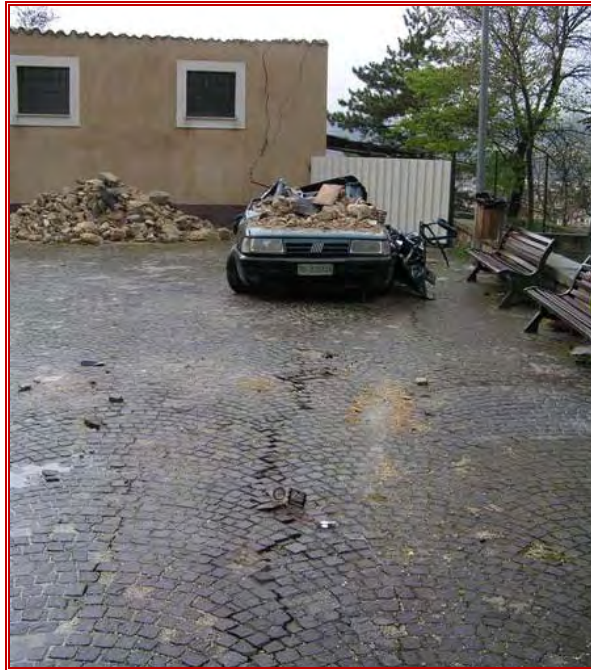
Figure 53: Tension cracks passing through stone paving and single storey building at Paganica

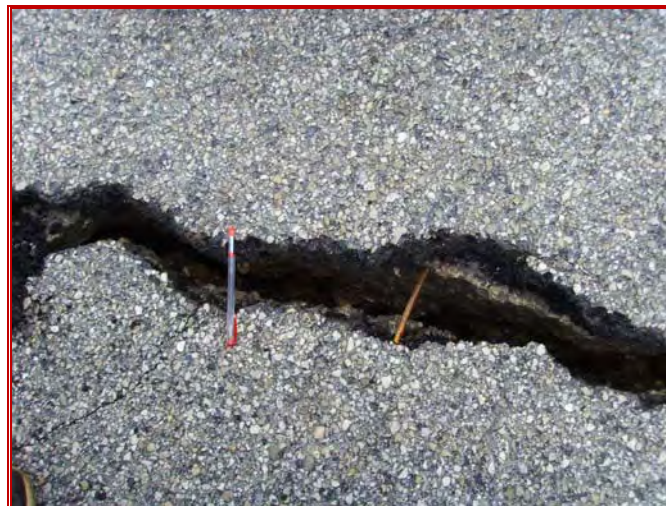
Figure 54: Tension crack at Paganica

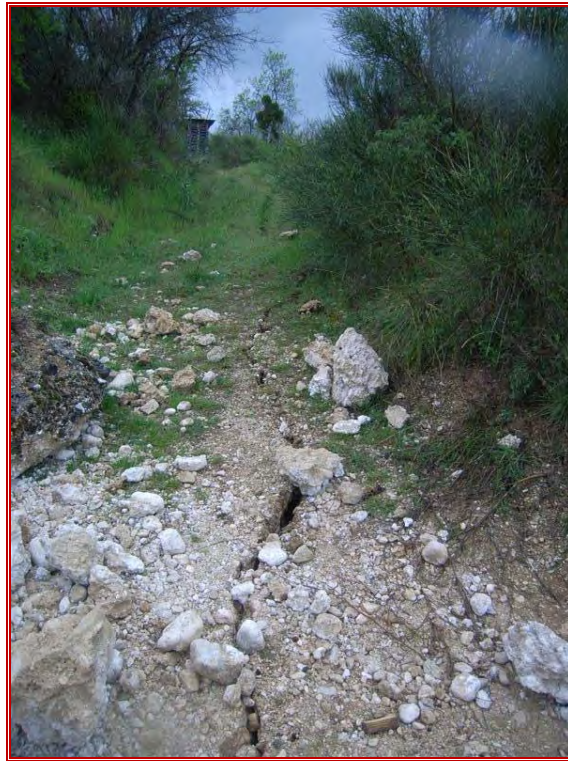
Figure 55: Tension crack in the hillside above Paganica Town

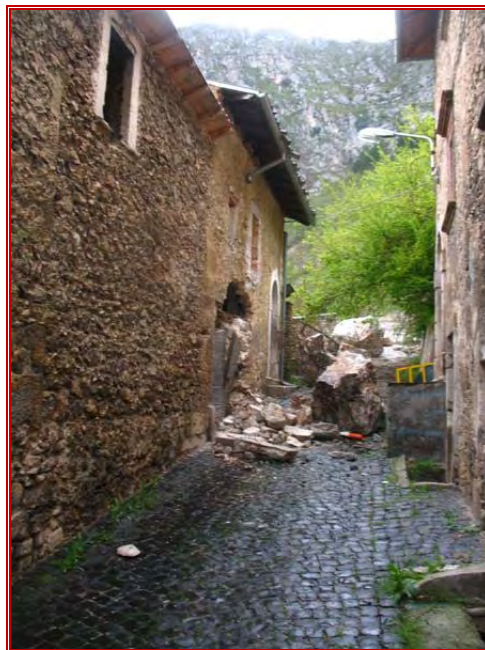
Figure 57: Rock fall in Fossa Town

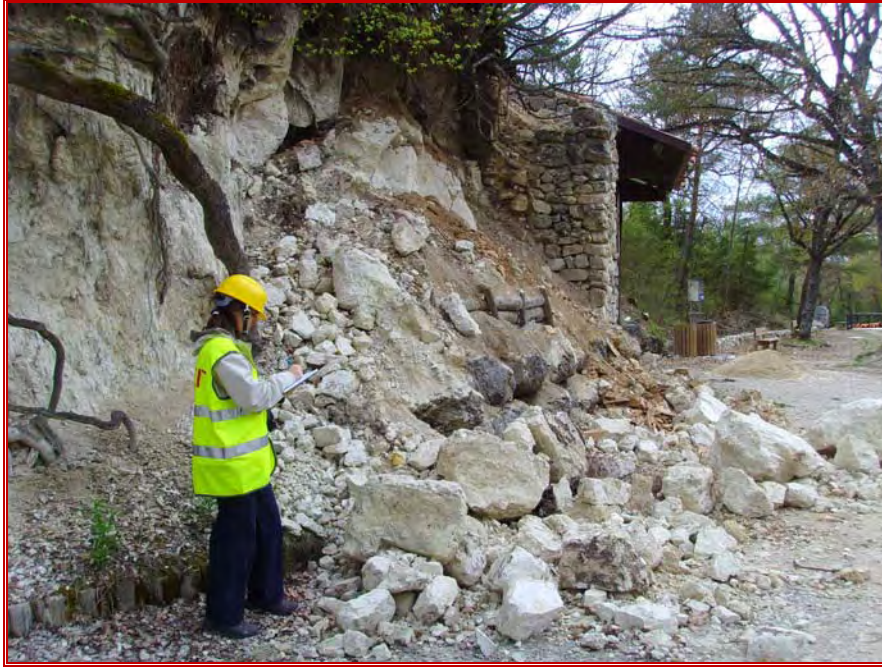
Figure 58: Rock fall at Lago Sinizzo
