THE L'AQUILA, ITALY EARTHQUAKE OF 6 APRIL 2009

A PRELIMINARY FIELD REPORT BY EEFIT

The L'Aquila (Italy) Earthquake of 6th April 2009

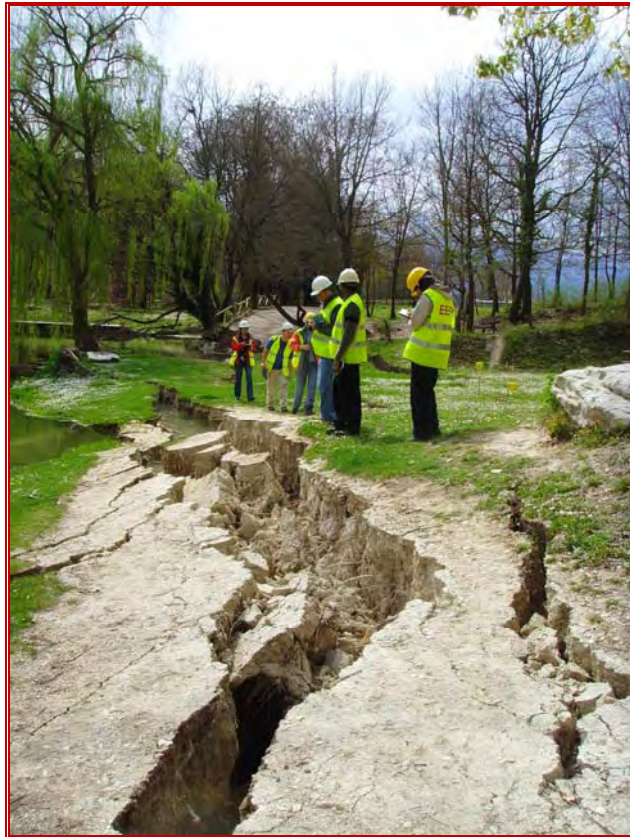
Figure 59: Slumping in fill around the edges of Lago Sinizzo.

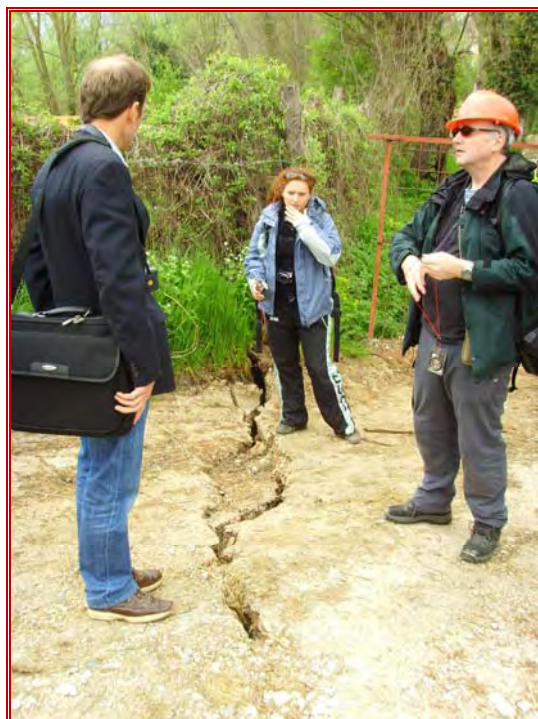
Figure 60: Tension cracks on the abutment adjacent to the bridge at Madonna Del Ponte
