# DAMAGE ASSESSMENT USING HIGH RESOLUTION SATELLITE IMAGERY: APPLICATION TO 2001 BHUJ, INDIA, EARTHQUAKE

L. Chiroiu<sup>1,2</sup>, G. André<sup>1,2</sup>

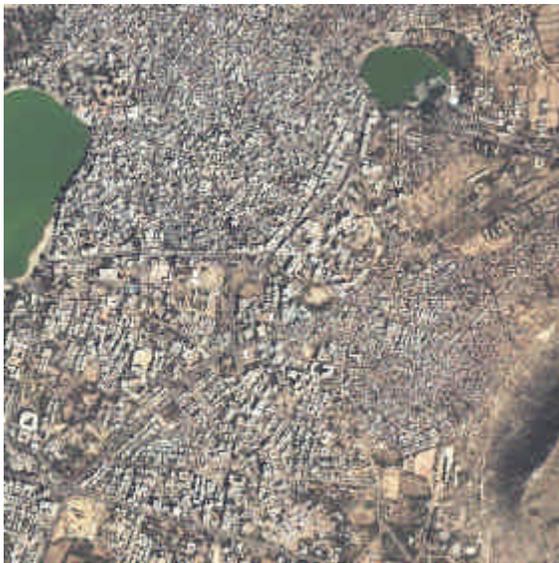
FIGURE 1. Bhuj, January 28, 2001, 1 meter IKONOS image (credit: www.spaceimaging.com)

The data used in this work is a 1 meter IKONOS multispectral simulation (a combination of 1 meter panchromatic and 4 meters multispectral) taken two days after the earthquake (Fig. 1), and a 2 meters panchromatic image acquired in 1998 by KVR-1000 satellite (Fig. 2). The IKONOS image covers 90 percent of the urban area of Bhuj city, while the KVR image covers the entire city, including the rural zones. Sharpen and texture filters were applied to both images in order to improve the quality of the data.

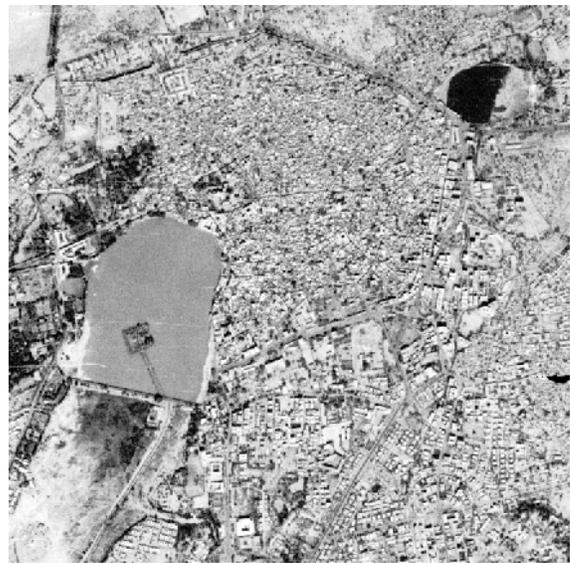
FIGURE 2. Bhuj, 1998, 2 meters KVR 1000 image (credit: www.cartographic.com)

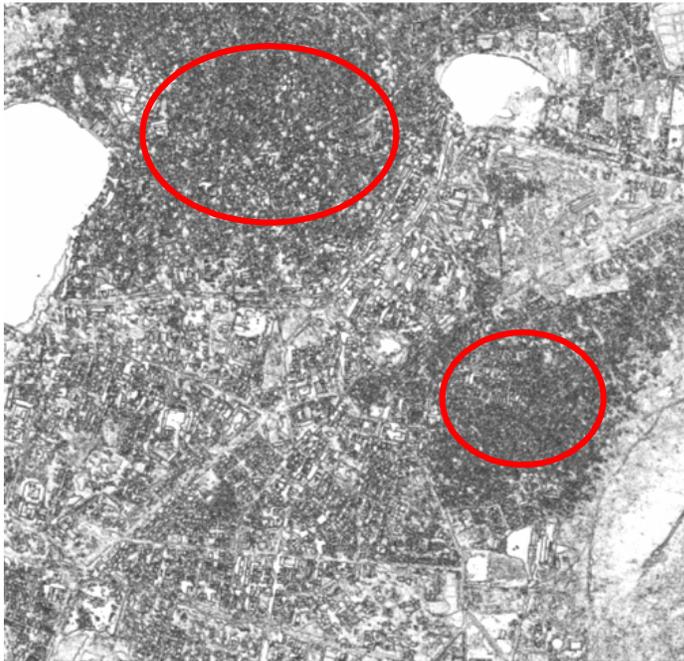
FIGURE 3. The red circles correspond to the typical ancient building types, with the old town at the north side.

The KVR image, acquired before the earthquake, shows clearly the different building types of the city. If the south part of the town has a regular distribution of buildings, the north and the east sides present a typical ancient architecture, supposed to be the “old town” and respectively a “shantytown”. The contrast of the two major building types is amplified by a typical filter which performs an automatic extraction of the contours (Fig. 3). In the “old town”, the small size of buildings, which is around 5 – 6 pixels (10 - 12 meters), like its irregular spatial distribution could represent a traditional masonry buildings, with a poor quality of materials and a reduced seismic design. The same characteristics were observed in the east part of the city, with an even smaller size of the buildings, area which is difficult to be assimilated with an urban structure, and which we supposed to be a “shantytown” (Fig. 4). The south side of the city presents a regular distribution of features. The streets are well defined and the buildings are bigger, probably in reinforced concrete or steel frames (Fig. 5).

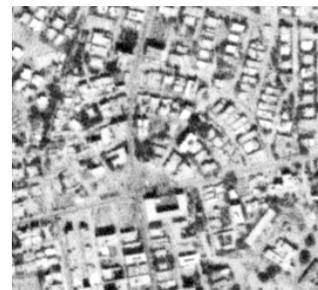
FIGURE 5. The “modern” side of the town, with a regular distribution of buildings

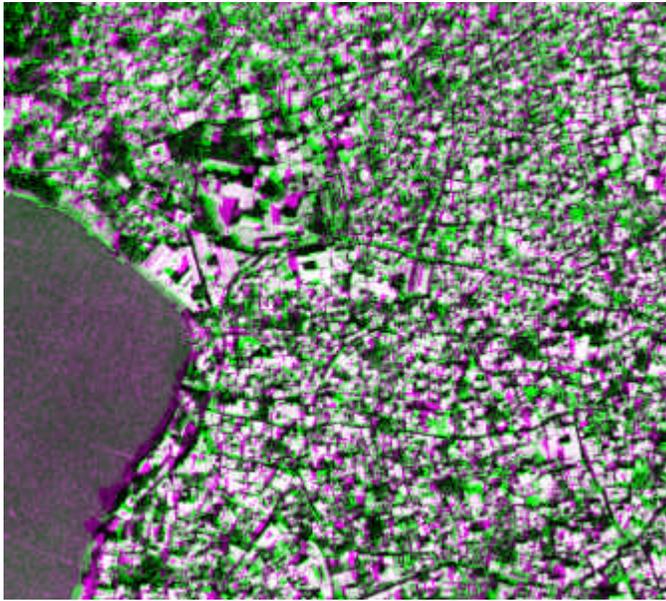
A false color composition was made in order to illustrate the variation of reflectance between the two scenes (Fig. 6). The green color corresponds to an increase of the reflectance, which may be assimilate to damaged elements. The magenta corresponds to a decrease of the reflectance, which may reflect the new elements appeared on the image acquired after the earthquake (e.g. new buildings erected during the period of time passed between the acquisition of the two images). In this case we could not separate changes due to collapse to changes due to shadows, and damages zones could not be detected.

FIGURE 6. False colour composition of one image before the earthquake (channels Red and Blue) and one image after the earthquake (Green channel).

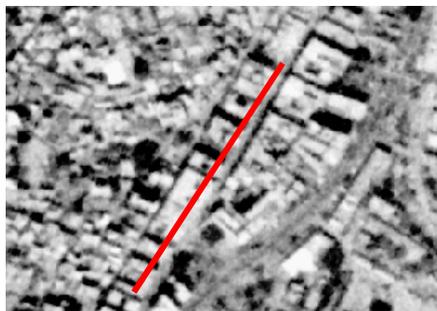
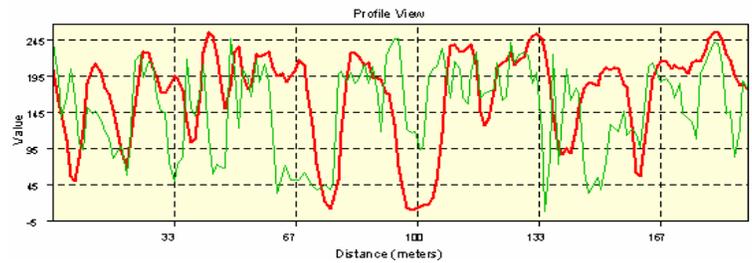
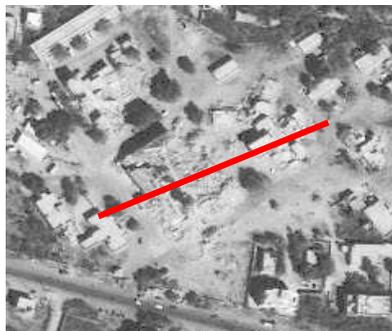
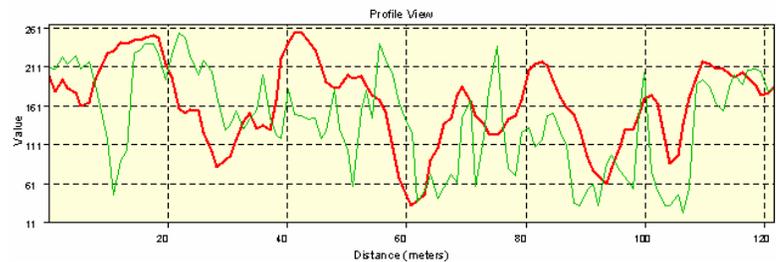
Using a radiometric profile, we tried to compare the reflectance (Fig. 7, a & b) of the two images, for a total collapsed area and for an unaffected one. We observed that the unaffected area presents important differences between the radiometric values of the two images, so we could not interpret the absence of correlation between the two curves regarding the collapsed area like a direct consequence of damages.

FIGURE 7. Reflectance profiles for an unaffected zone (a) and for a total collapsed zone (b) The Red curve correspond to the values of the image before, while the Green curve correspond to the image after.

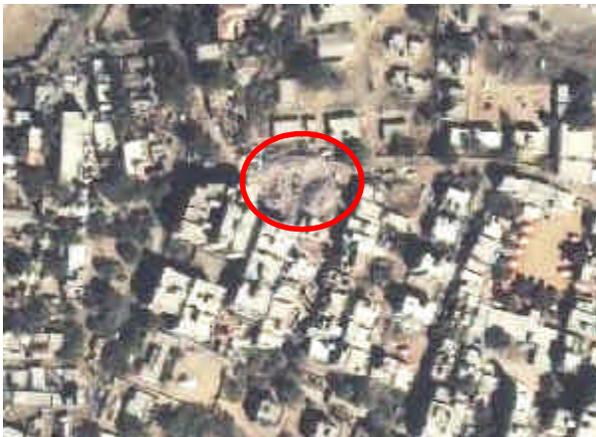
FIGURE 8. A total collapse of a building, in the red circle, is detected by a mono temporal photo interpretation (scale 1/3000)

In the south part of the town, the recognition of destruction was facilitated by the regular distribution of buildings (Figs 8 and 9).

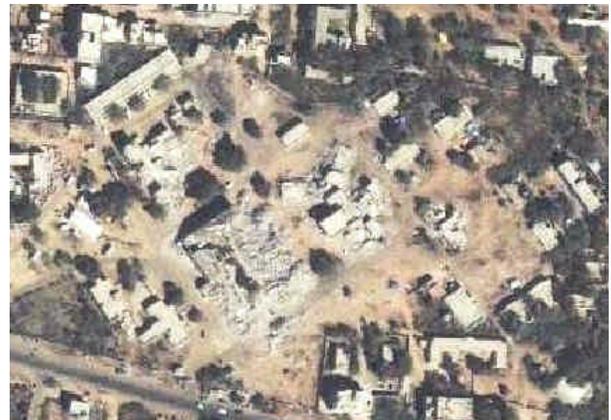
FIGURE 9. Collapse of a few buildings, in the modern side of the city (scale 1/3000)

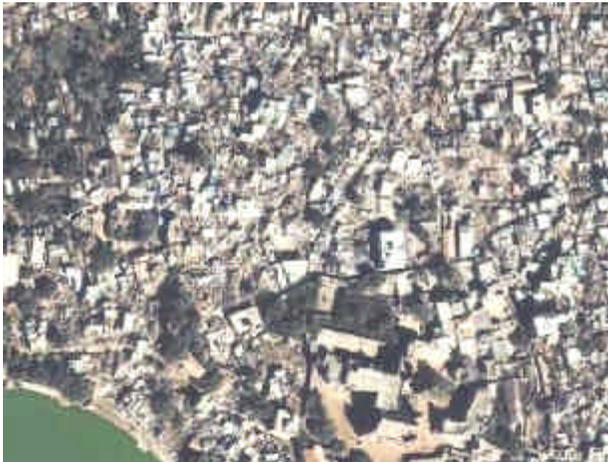
In the north side of the city, like in the “shantytown”, the damage is difficult to estimate, given that the urban structure is very irregular and the dimensions of the elements are very small. The completely destroyed zones are visible but where the damages are not extended over a large area the interpretation is more difficult. If the old city seems to be heavily touched (Fig.10), damages were impossible to detect in the “shantytown” (Fig.11), even applying a multitemporal approach.

FIGURE 10. The north side of the old town suffered widespread destructions (scale 1/3000)

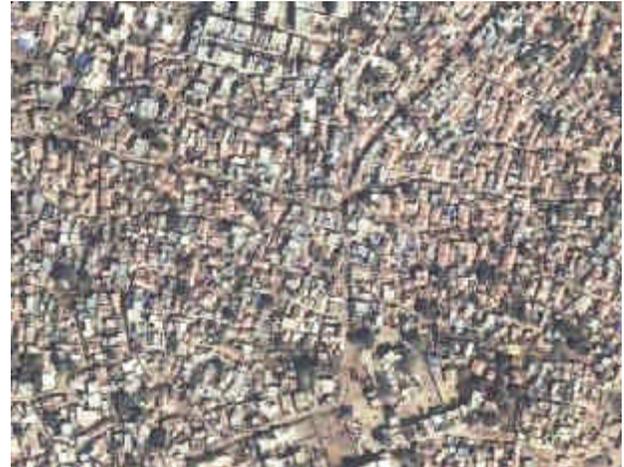
FIGURE 11. The damages in the “shantytown” are difficult to detect (scale 1/3000)

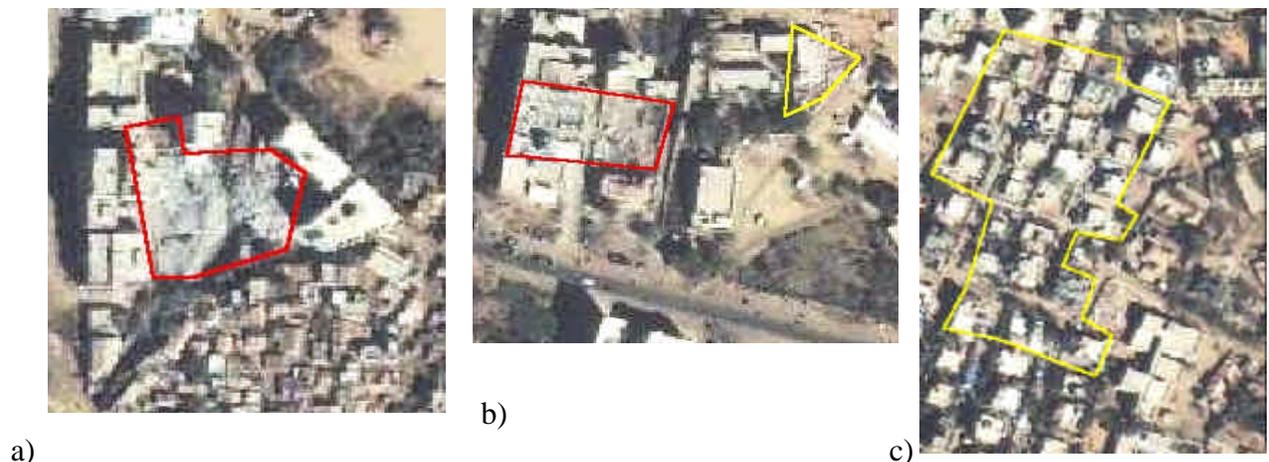
Damage states are generally not recognizable by remote sensing, only buildings completely destroyed being detected. However, a distinction was made between two levels of destructions: extensive damage and complete damage (Fig. 12 a, b and c). The extensive damage is considered when a building or an entire zone is damaged, but the building(s) is not totally collapsed (partial failure of the structure). The complete damage corresponds to a totally collapsed building (total failure of the structure).

FIGURE 12. a) A collapsed building classified completely damaged; b) An example of complete damage (in red) vs. extensive damage (in yellow); c) An entire zone considered with severe damage

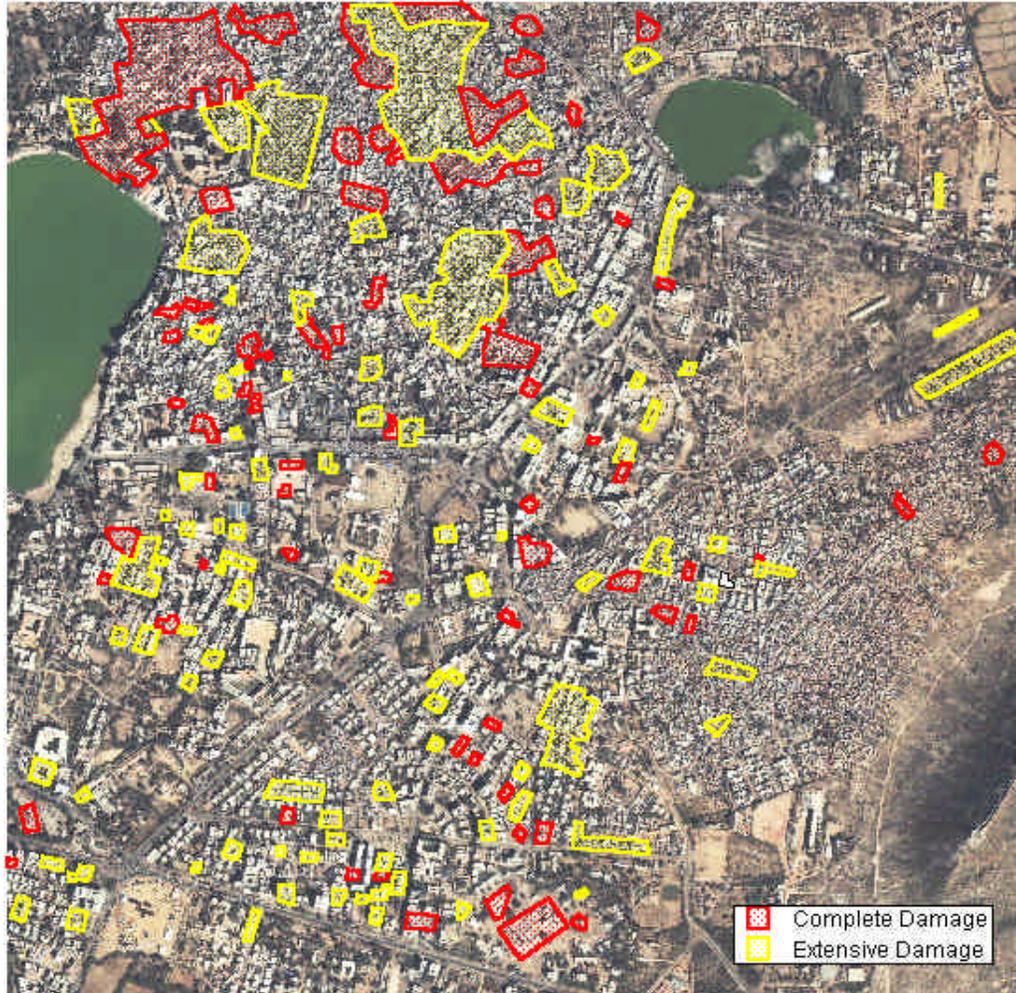
A GIS was used in order to display the spatial distribution of damages (Fig. 13). An important concentration of destructions can be observed in the north side of the city, where the high vulnerability of the old town had amplified the losses.

FIGURE 13. The spatial distribution of losses for the urban area of Bhuj city.

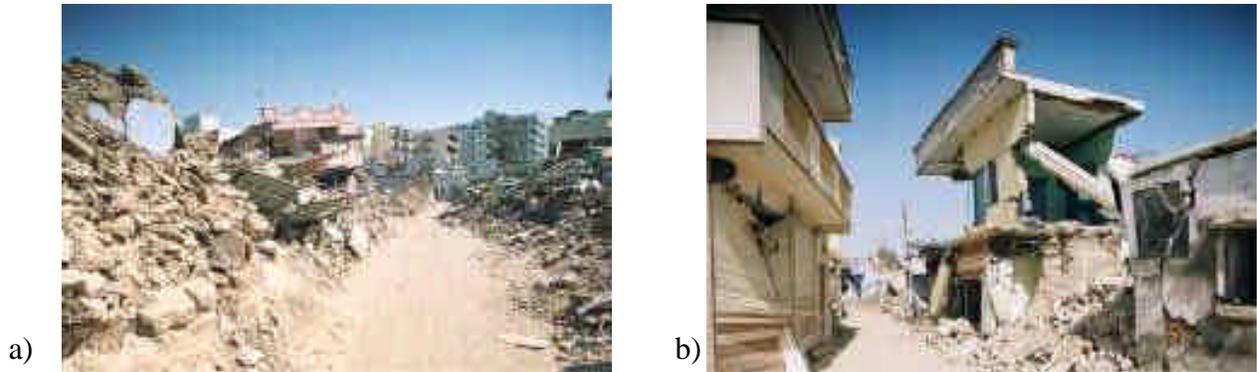
this study shows a high concentration of losses in the north side of the city, in the “old town”. The dimensions of damages in this part of the city are expressed clearly by some pictures taken after the earthquake (Fig. 14, a and b).

FIGURE 14. a) & b) . The old town of Bhuj – UNESCO India Earthquake Report ([www.conservationtech.com/india-UNESCO/INDIA-home.htm](http://www.conservationtech.com/india-UNESCO/INDIA-home.htm))
