FLOOD VULNERABILITY and CONTINGENCY PLAN

Warrap State, South Sudan

Mapping and Assessment Report

December 2013

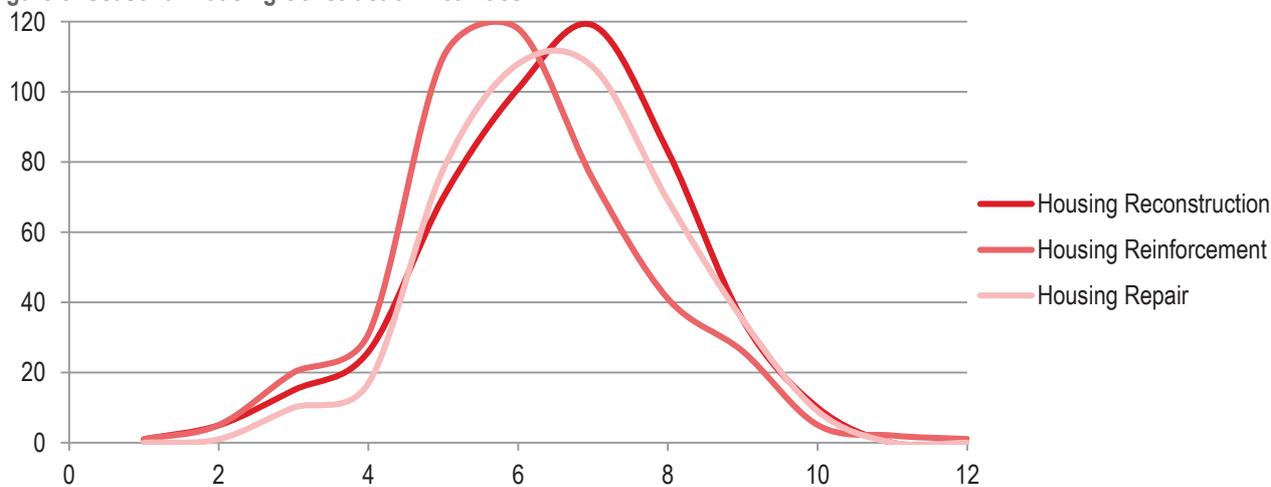
Interestingly, communities report different housing repair, reinforcement and reconstruction activities during different seasons of the year. Figure 5 illustrates the seasonal differences in housing construction activities starting in September and running until August. Housing reinforcement activities commonly run from December to March; the majority of communities conducting these activities in January. Repair activities run a little later in the dry season – from January to April – with the majority of communities conducting these activities in February. Reconstruction activities run longer throughout the dry season from December to April, but the majority of communities report that they undertake these activities later in the dry season; most commonly in March. These activity times are important for aid actors to understand in order to provide appropriate mitigation and preparedness responses at appropriate times throughout the calendar year.

Figure 5: Seasonal Housing Construction Activities

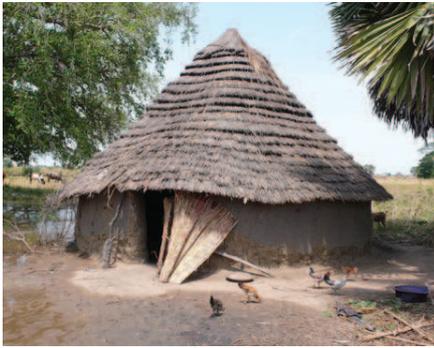
Image 1

The majority of households that have been affected by flooding are agropastoralists who also engage in farming activities, their existing main residence is made up of very basic sleeping shelters of minimal size. The main shelter, called a 'tukul', consists of a single room with a single entrance and rarely any windows. The predominant construction method is wattle and daub walls with a mud floor and thatch roof, although they may also be made of burnt and mud bricks as well as bamboo depending on availability. The tukul is either round or square in plan with the thatched grass roof supported by long poles from either bamboo or straight trees that rest on the walls or a series of wood columns (from large tree branches with a Y shape at the top).

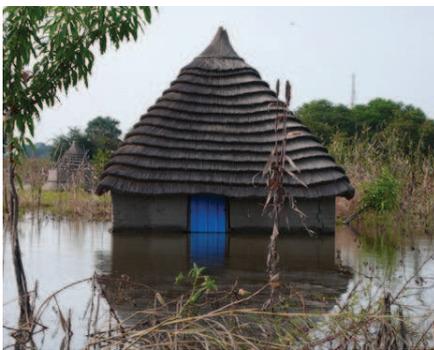
Image 2

A household may have more than one tukul for sleeping and may also have tukuls or similar structures with one used for cooking and another for food storage. The size of tukuls varies by household ranging from approximately 3 metres to 6 meters in diameter, with much larger ones mainly used for keeping livestock safe at night.

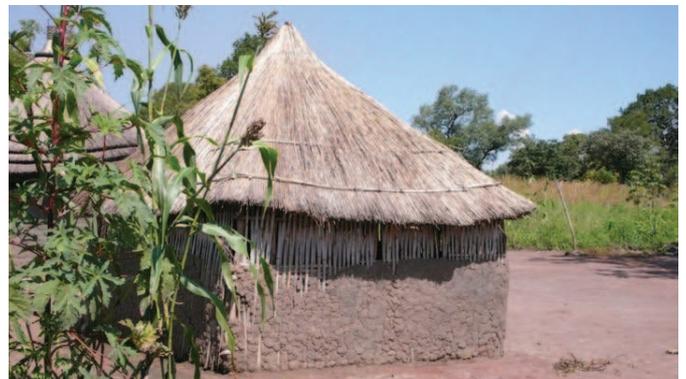
The supporting structure of this tukul uses tree branches arranged in a circular plan before applying the mud walls to both the inside and outside. A more complex multi-layered bundled thatched roof provides better water resistance.

Note the water damage at the base of the mud walls. This was the most common tukul design in the villages visited.

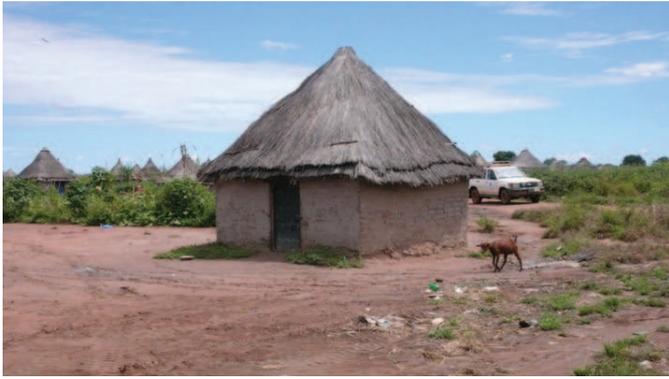
Burnt bricks are made in kilns that require large amounts of fire wood as fuel. The bricks are laid using a cement mortar or one made from a local soil with hardening properties. The walls are also parged with the same material.

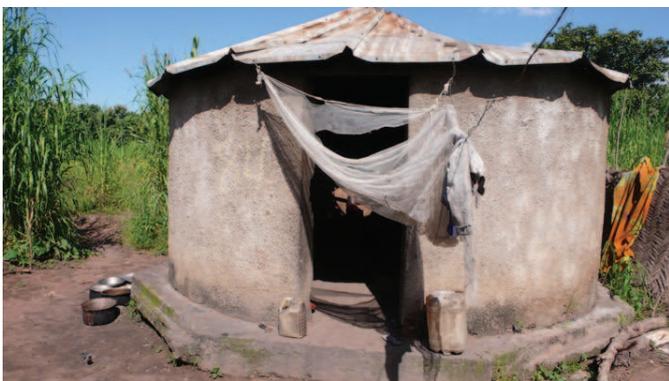
This concrete tukul was an anomaly in that it was built to house workers in a government factory. Although this tukul was found in an area that did have any flooding, the concrete floor is substantially raised to reduce any impacts should flooding occur. A metal roof was installed at a low slope since the chance of leakage is reduced.

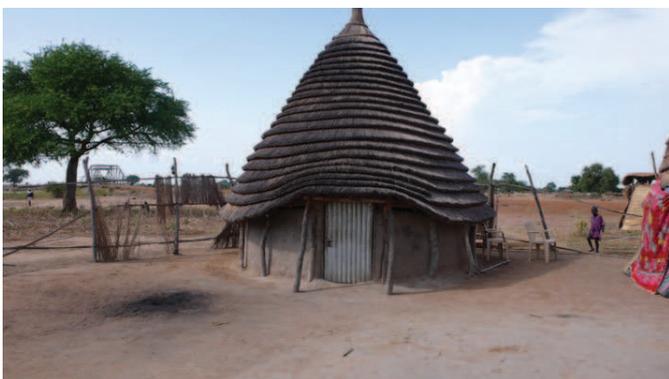
The large high pitched roof of this tukul is supported on external wood posts external to the mud wall. The larger/higher roof potentially requires larger supports than just the wall. The external supports also have the potential to withstand water damage leaving the roof in place with only the walls requiring repair after a flood.

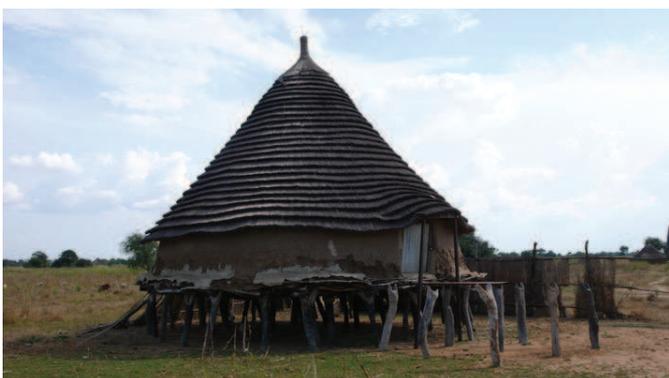
Found in only a few villages which were not affected by flooding is a tukul raised on large wood posts. The tukul construction is standard with the exception of the posts and floor supports that raise the tukul about 1 to 1.5 metres above the ground. Note the size and number of wood supports

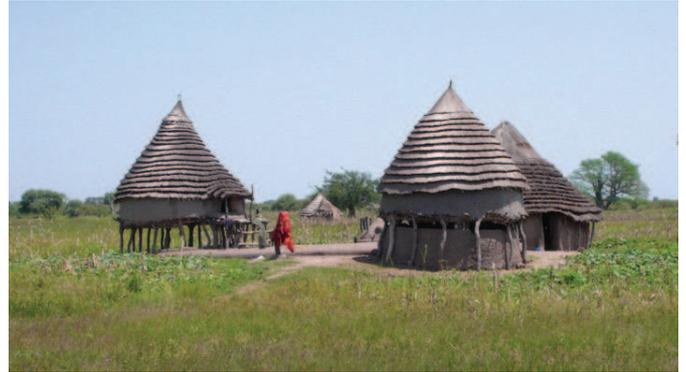
Raising a portion of land on which to build the tukul was common practice, in a number of areas that did not report major flooding. The tukuls are arranged around the perimeter of the raised portion, this leaves the outer edge of the walls vulnerable to erosion from water.

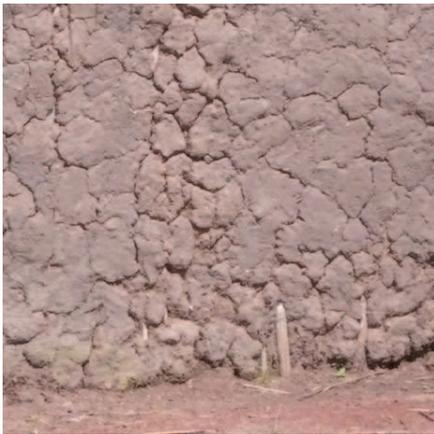
Local mud - wall plaster

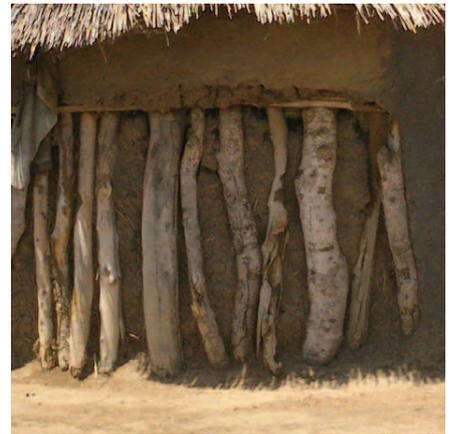
Large Branches - support roof structure

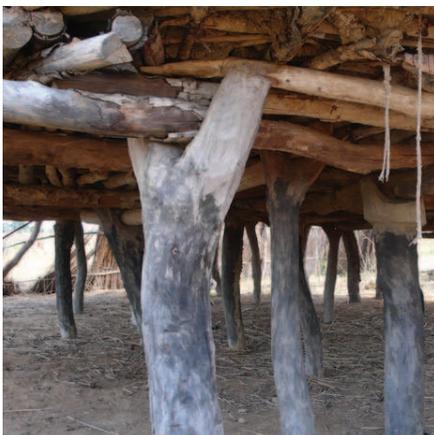
Support branches - support raised floor

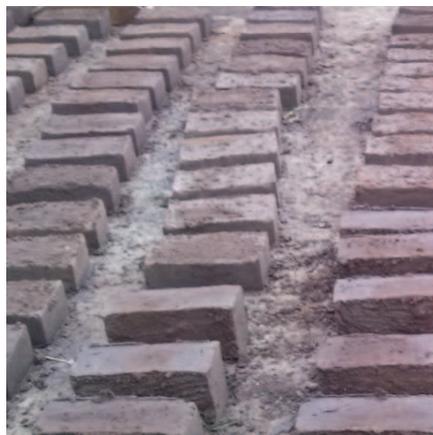
Mud blocks - construction of walls

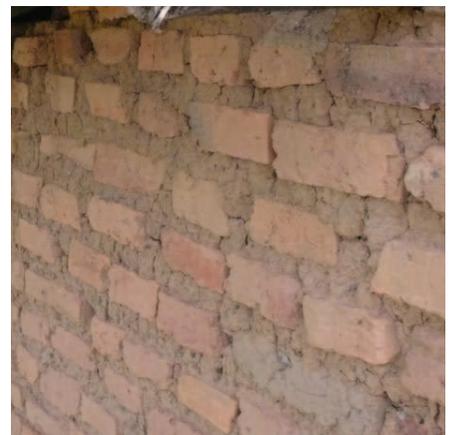
Burnt bricks - construction of walls

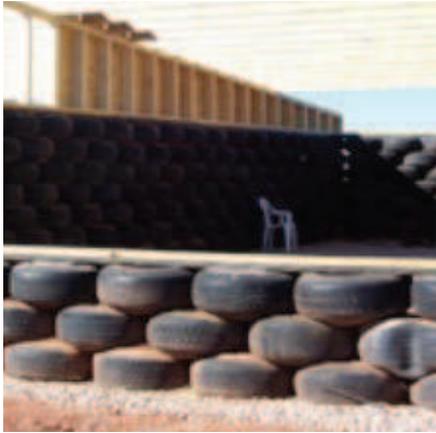
Tires - alternative foundation material similar to a retaining wall

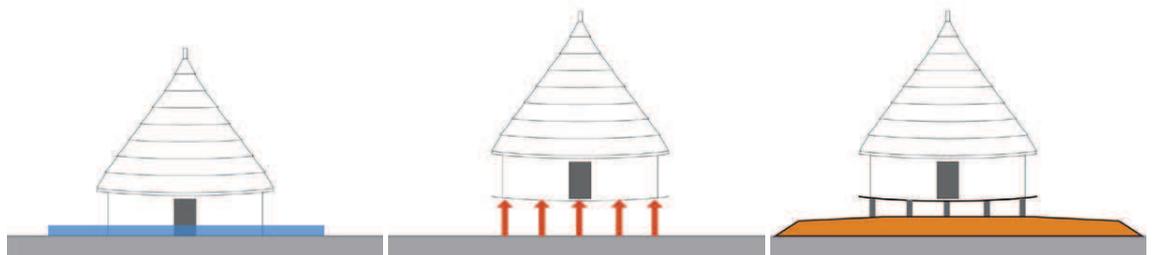
Figure 5
Shelter concept
to protect against
flooding

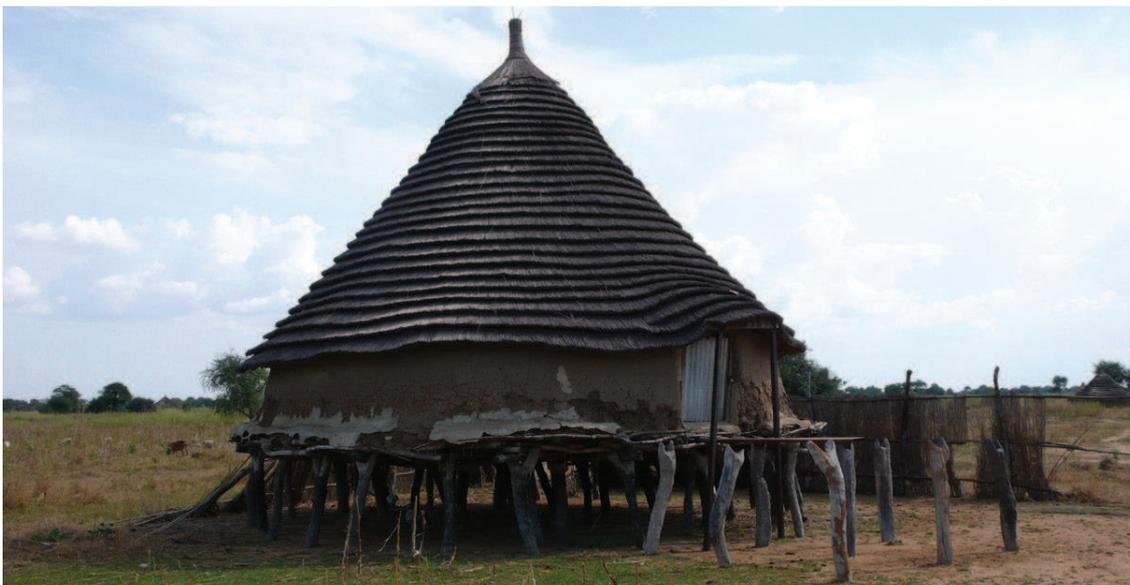
Raising the floor level on a stilts can be achieved using the more traditional approach of ‘found’ wood or achieve more economically with dimensional ‘milled’ lumber. Although wood is available depending on village, it may still need to be purchased or proper permits obtained if taken from a forest. The variability in what can be found or purchased locally makes it difficult to engineer a solution and therefore each construction must be considered separately depending on the materials at hand as the methods currently used, one method is shown in Figure __. By using dimensional lumber the solution can be engineered to ensure a more economical use of materials. The use of wood still lends itself to a few problems beyond just procurement, mainly termites and wrought from sitting in water for prolonged periods and therefore very high quality timber would be required such as teak. It was noted that although many tukuls employed this technique, none were seen to be sitting directly in water or areas that experienced prolonged flooding. Due to the potential amount and quality of wood required to implement such a project on a large scale the environmental impacts on deforestation could be significant. If lesser quality wood is used the longevity of the solution is compromised and may not be easily repaired in the future. For these reasons this method is not recommended unless a particular village can prove it to be a sustainable solution.

Figure 6
Tukul raised
on large wood
members

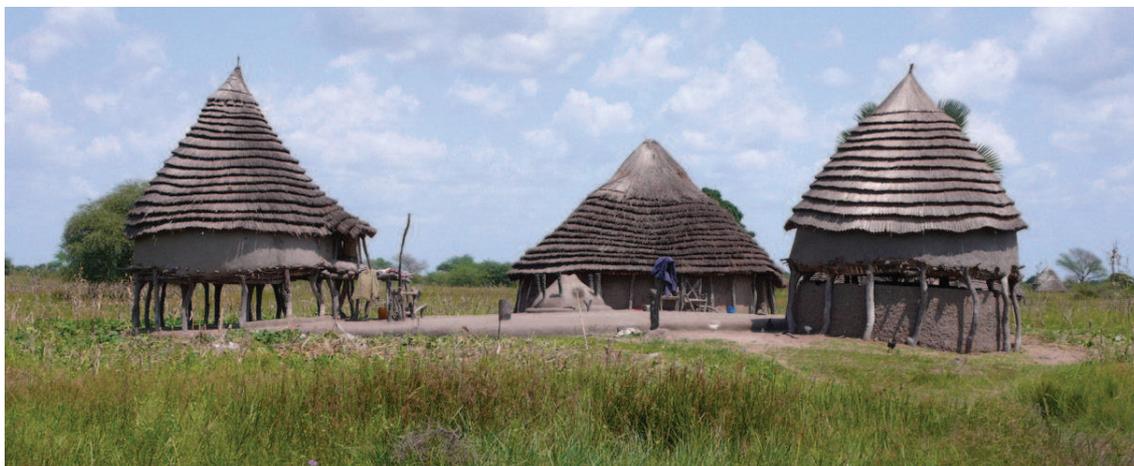
Figure 7
Tukuls located on ground that has been raised

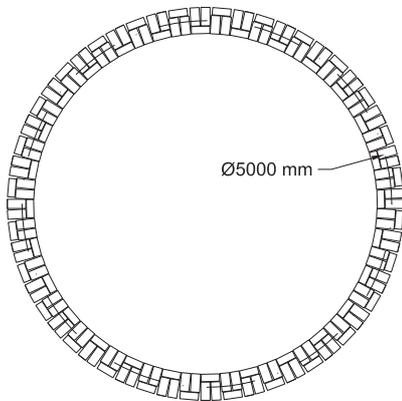
FOUNDATION WALL PLAN

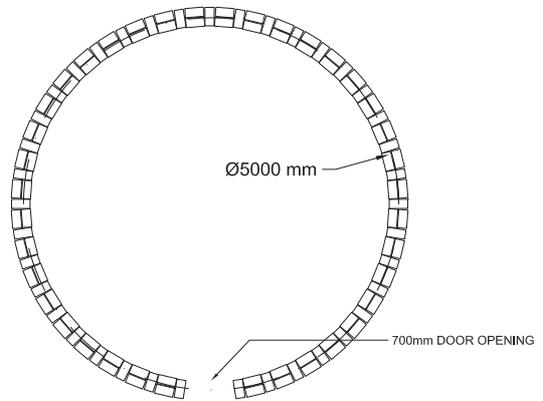
TYPICAL WALL PLAN

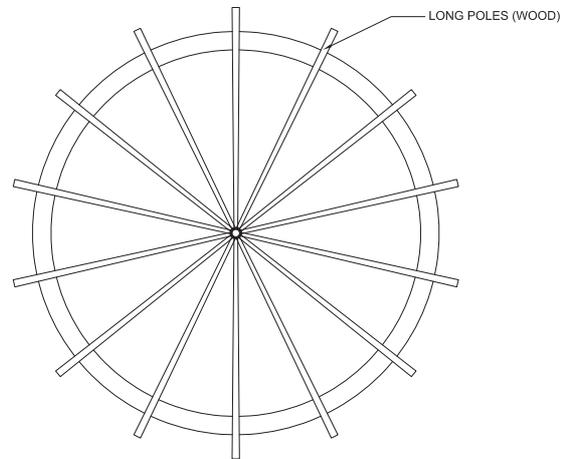
ROOF PLAN
