# SHELTER PROJECTS 2008

IASC Emergency Shelter Cluster

### Shelter Options 2008

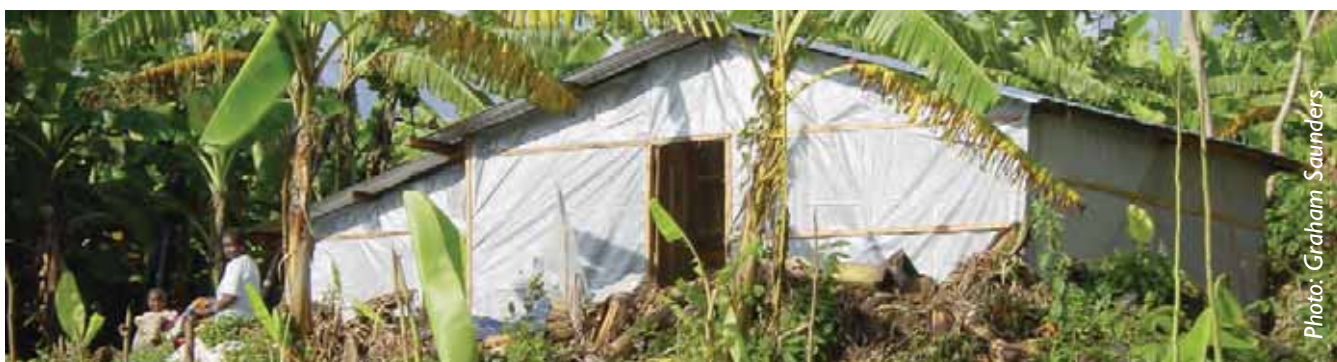
*Sample of a temporary house*

The unit was designed for robustness, without the need for cast foundations, so it could be dismantled and moved if necessary. Beneficiaries were instead encouraged to build up foundations with rocks and earth in order to reduce surface water inside the houses.

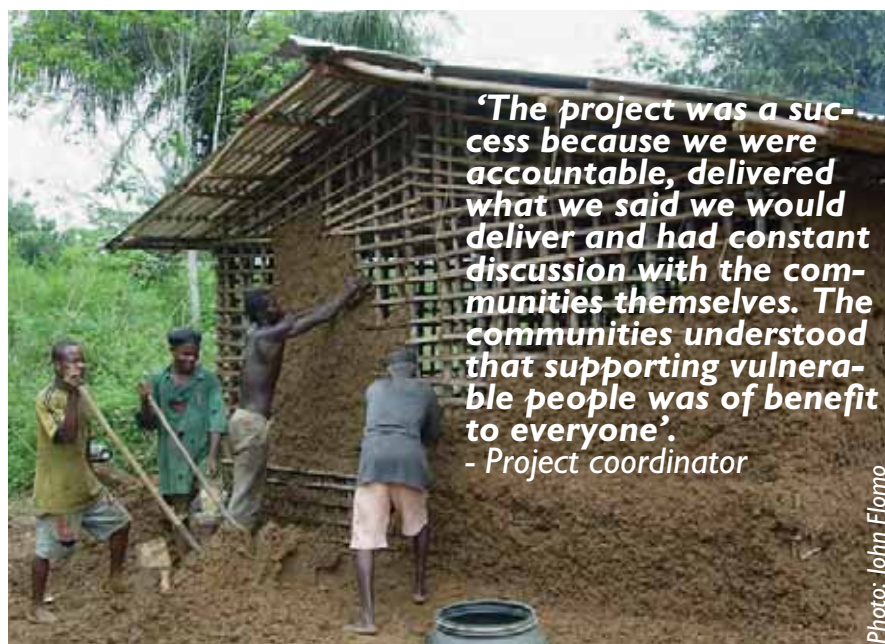
Traditional shelters under construction

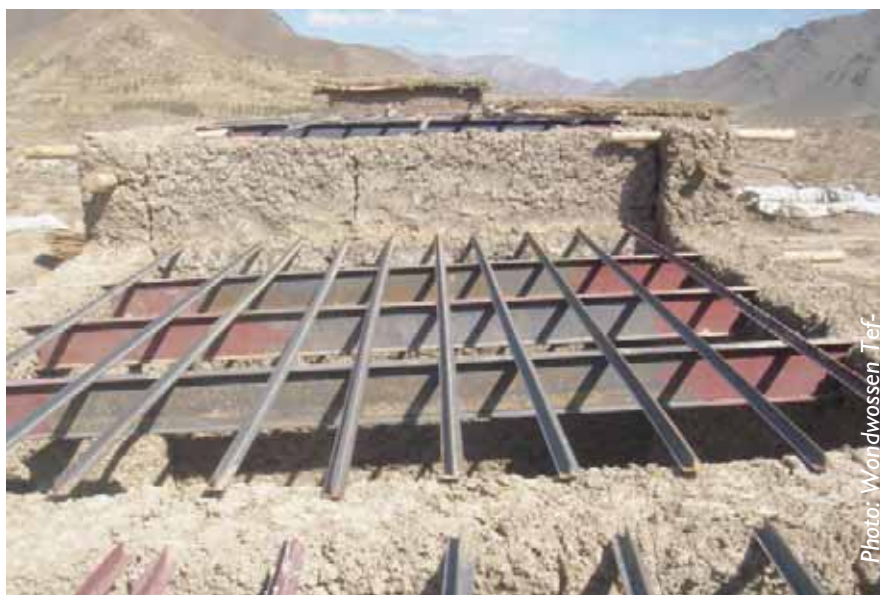
Steel trusses

During 2007 and 2008, rising costs of steel led to cost escalations from US\$ 900 per shelter to in excess of US\$ 1500 per shelter. This caused serious budget shortages and the materials used consequently needed to be reassessed.

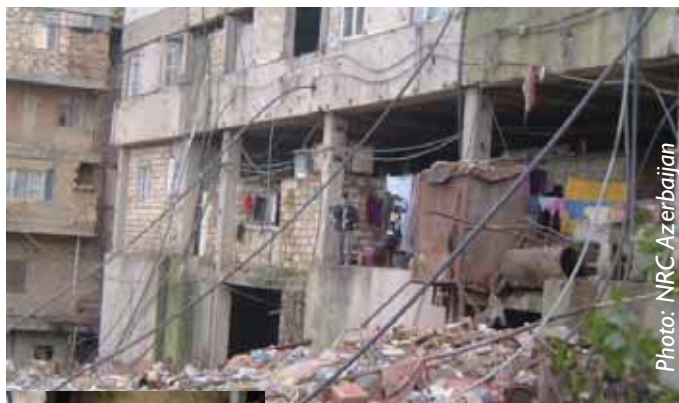
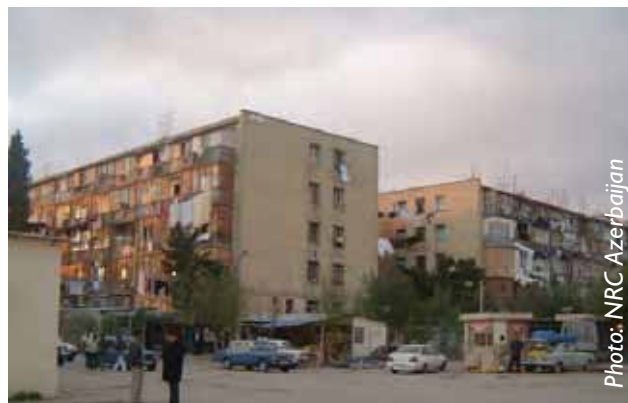
*Bathrooms before and after upgrade*

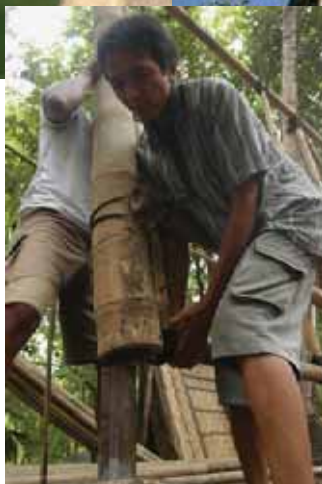
*Connecting a vertical post to the foundation*

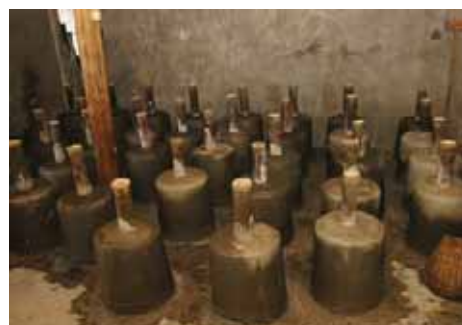
*Foundation pads cast with bamboo to connect them to the frame*

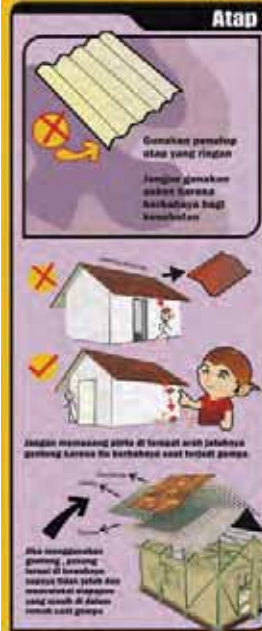
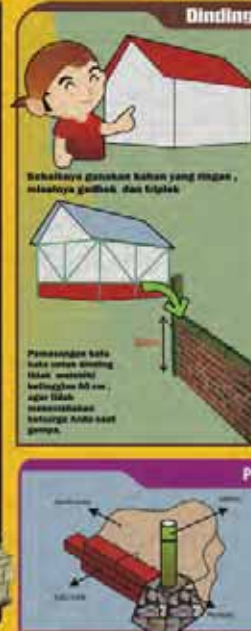
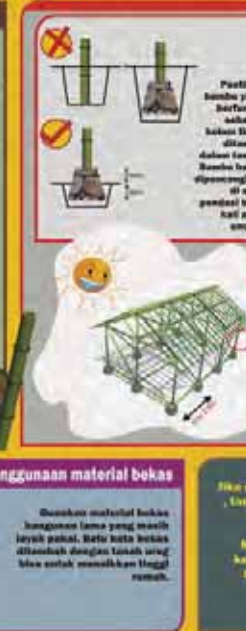
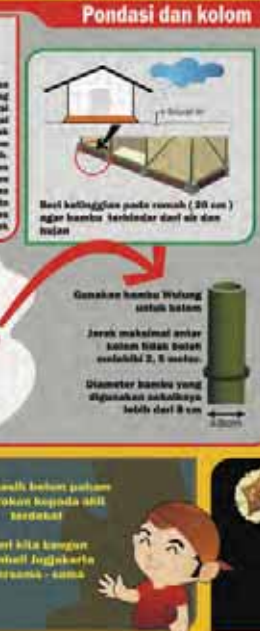
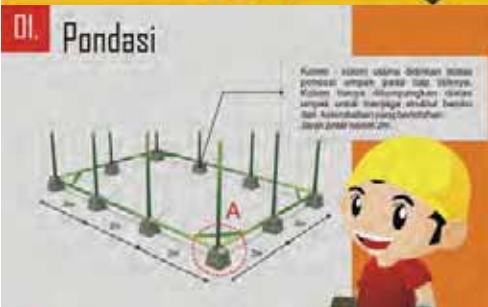
## PETUNJUK TEKNIS Rumah Cikal dari Bambu

# MARI MEMBANGUN RUMAH CIKAL DARI BAMBU

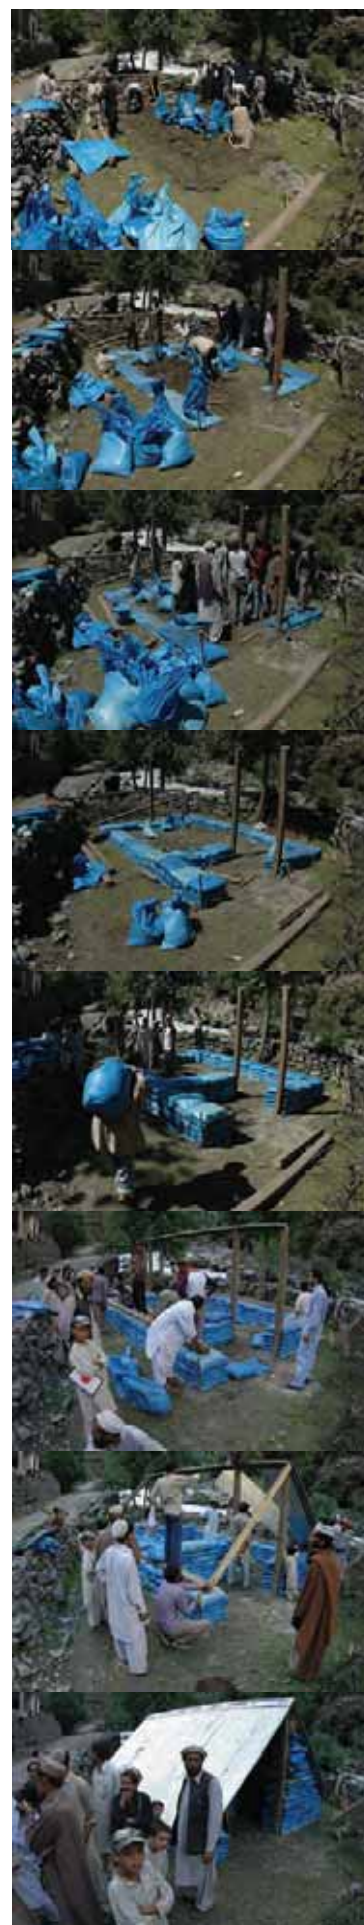
Building one of the transitional shelters

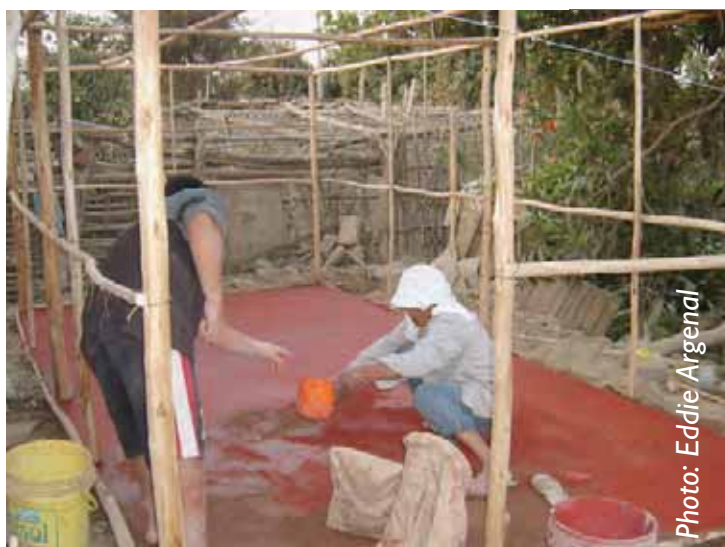
Making the concrete floor slab

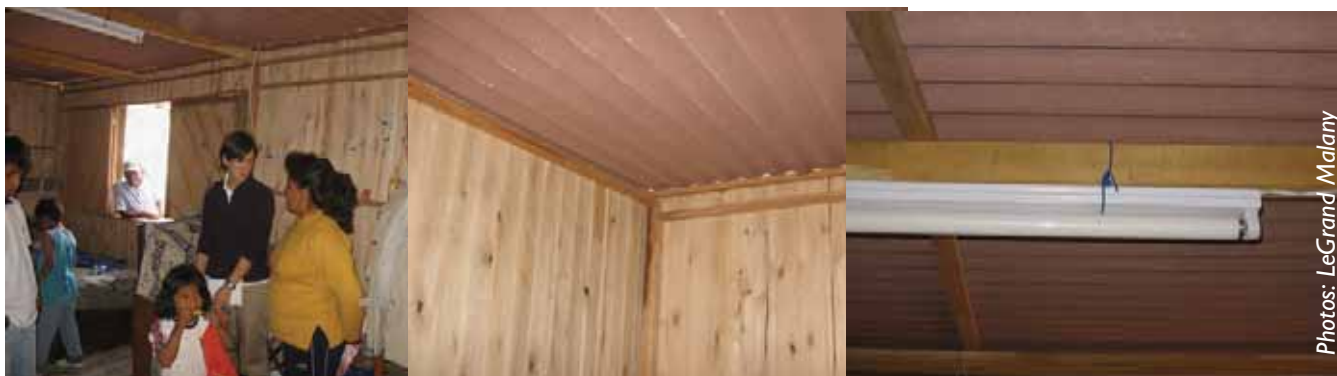
*Completed shelter built on the roof of a damaged house*

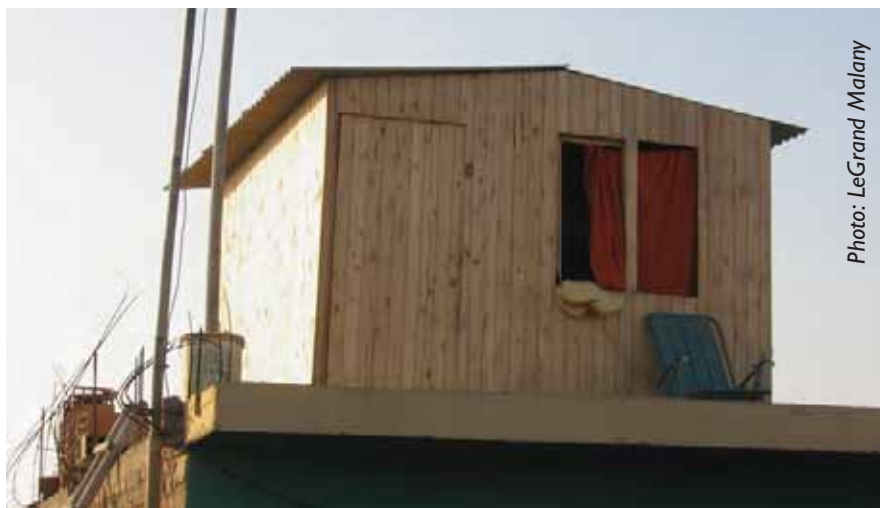
*Completed shelter built on the roof of a damaged house*
