# **EFFECTS OF THE 26 DECEMBER 2004 INDIAN OCEAN TSUNAMI IN THE REPUBLIC OF SEYCHELLES**

**Report of the Canada-UNESCO Indian Ocean Tsunami Expedition  
19 January – 5 February 2005**

**Open File 4539**

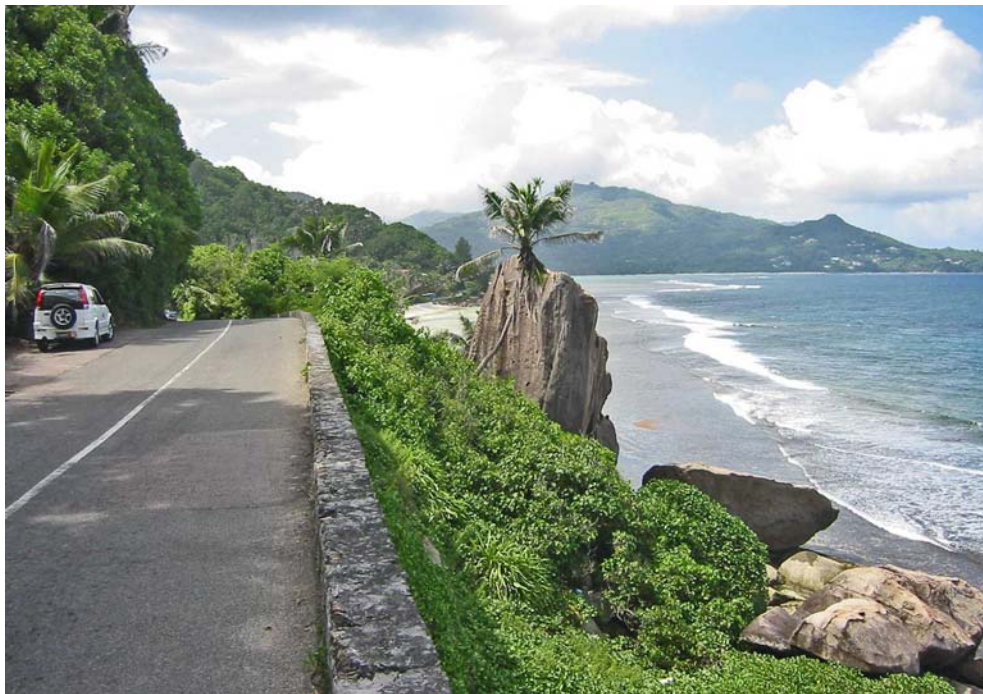
**Frontispiece:** East-coast road looking north toward Anse Royale, Mahé, showing high-relief coast in granitic rocks, with massive granite blocks in foreground and sandy beach with wide fringing reef platform beyond. Photo: DLF (GSC), 2 Feb 2005.

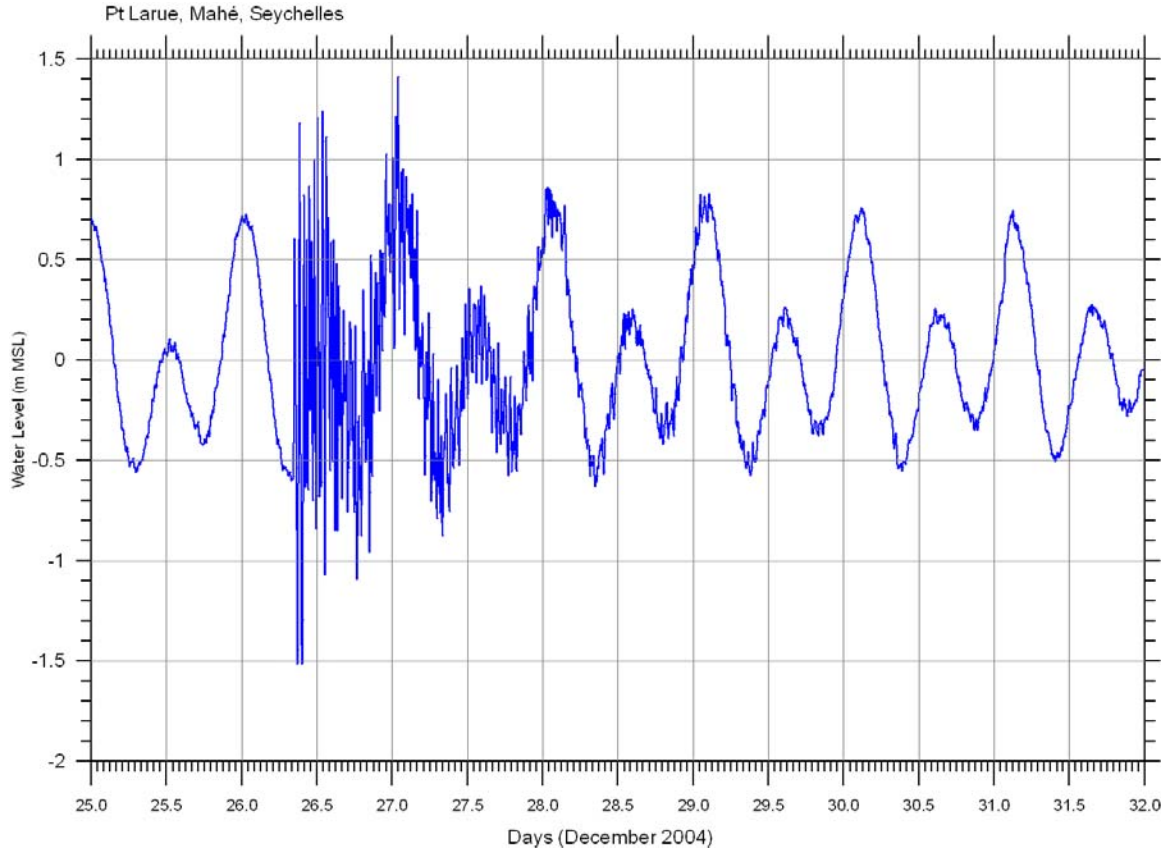
Fig. 1: The 4-minute water-level record from the tide gauge at Mahé (Seychelles), showing the arrival of the tsunami wave train and ongoing oscillations over several days (data courtesy of SOEST, University of Hawaii).

- ❑ The first indication of the tsunami on the Mahé tide gauge (sampling interval 4 minutes) was a rise in water level to lower than higher high water at large tides between 08:08 and 08:12 UTC (between 12:08 and 12:12 local time). This initial rise in water level was corroborated by some observers on Mahé and Praslin. They stated that the first effect was in fact an increase in water level from the low tide to the normal high tide level, or just above. This is in contrast to accounts of most observers who noticed an initial lowering of sea level far below the level of the lowest tides but missed the preceding rise of sea level.

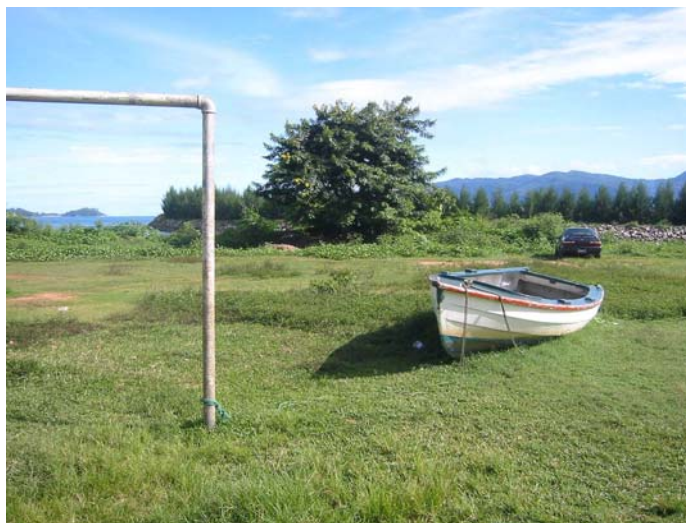
Fig. 6: Boat tied to goalpost on soccer field at Northeast Point. Grass in foreground is flattened and strewn with fine marine organic debris. Photo: DLF (GSC), 23 Jan 2005.

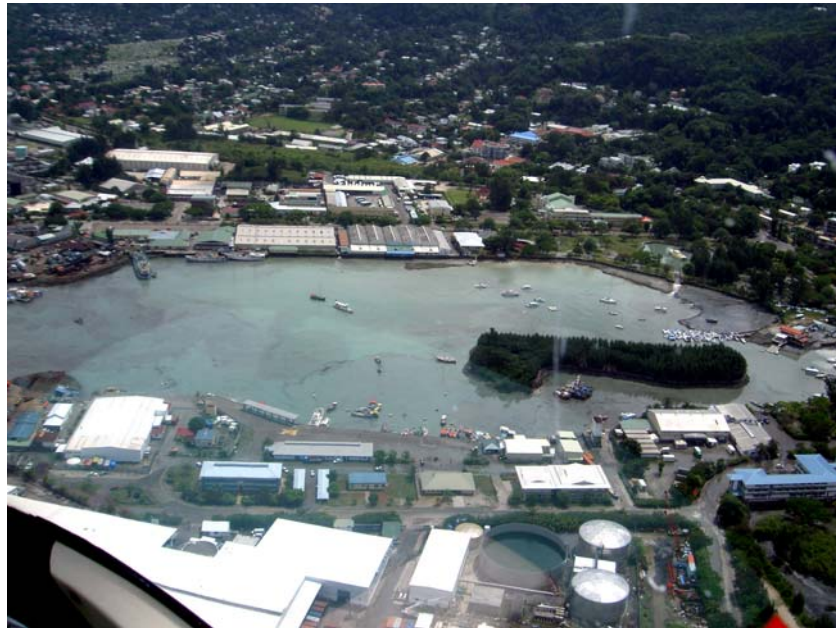
Fig. 9: Oblique aerial (looking south) view of the fishing harbour, from the north, 26 Dec 2004, during a low-water phase. The exact time of this photograph is not known, but the walls and paving on the fishing dock remain intact at this time. A fishing boat lies on its side to the left of the large white warehouse at lower left and some of the failure of the dock in that area may already have occurred. Photo courtesy of Dan Holtzhane.

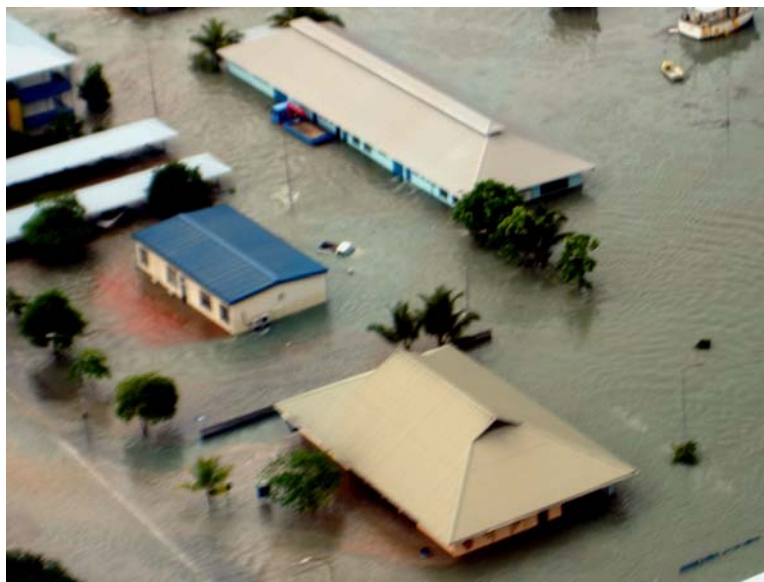
Fig. 10: Oblique aerial view of the fishing harbour on 26 Dec 2004 during a flooding phase. The buildings, including the Seychelles Fisheries Authority at left, are easily recognizable in the preceding figure. Photo courtesy of Dan Holtzhane.

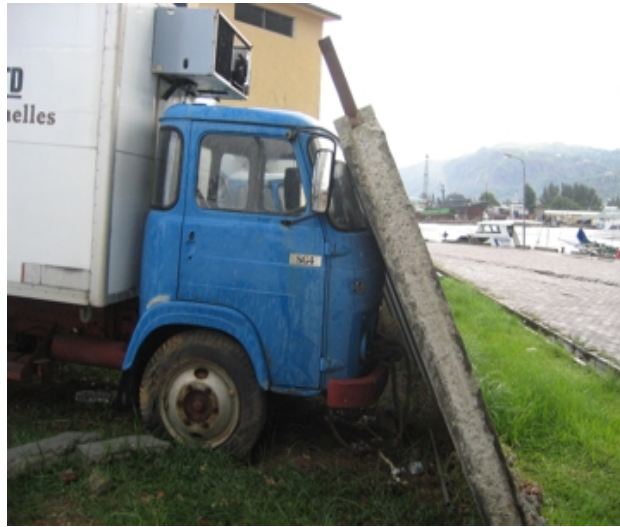
Fig. 11: Concrete wall toppled by the force of the tsunami, inner harbour, Victoria. Photo: LEJ (GSC), 25 Jan 2005.

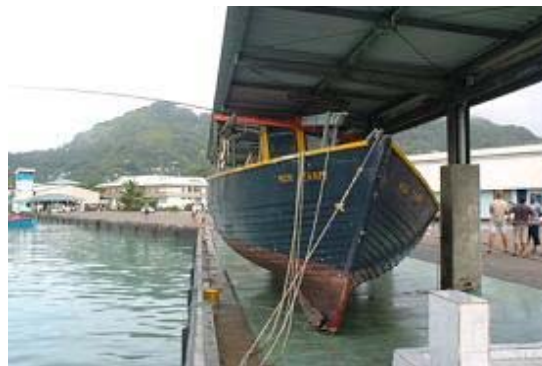
Fig. 12: Boat carried on to a dock by the tsunami, inner harbour, Victoria. Photo by Stephen and Liz Englert, 26 Dec 2004.

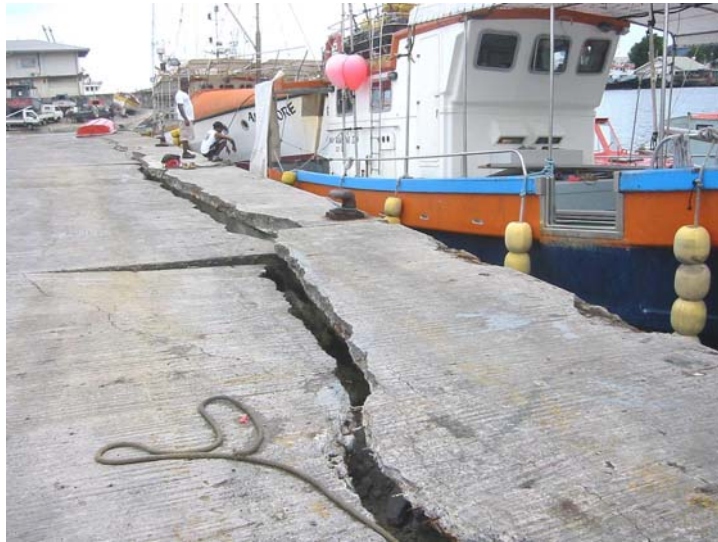
Figure 13: Tensional cracking due to movement of sheet piles toward the harbour. Repeated recession of floodwaters eroded a chasm beneath the offset concrete slab. Photo: DLF (GSC), 25 Jan 2005.

water levels in the harbour turned the sheet pile wall into a dam. The loss of shear strength within the fill permitted the displacement and failure of the anchor structures and movement of the sheet pile wall seaward. Surface fissuring marks the displacement of the anchor wall or piles. It is not known when the initial failure of the fill structure occurred. It may have happened as a result of the initial inundation and rapid drawdown with each additional cycle compounding the damage. These failures are among the costliest and perhaps least expected impacts to infrastructure resulting from the tsunami in Seychelles.

**Remarks:** Engineers have recommended extensive excavation of the fill and construction of a new sheet pile wall in the area of damage. A similar failure in an older fill to the west has cut across an office building and adjacent paved parking lot and extended approximately 50 m west into the waterfront park, parallel to a stone seawall that showed no evidence of structural damage.

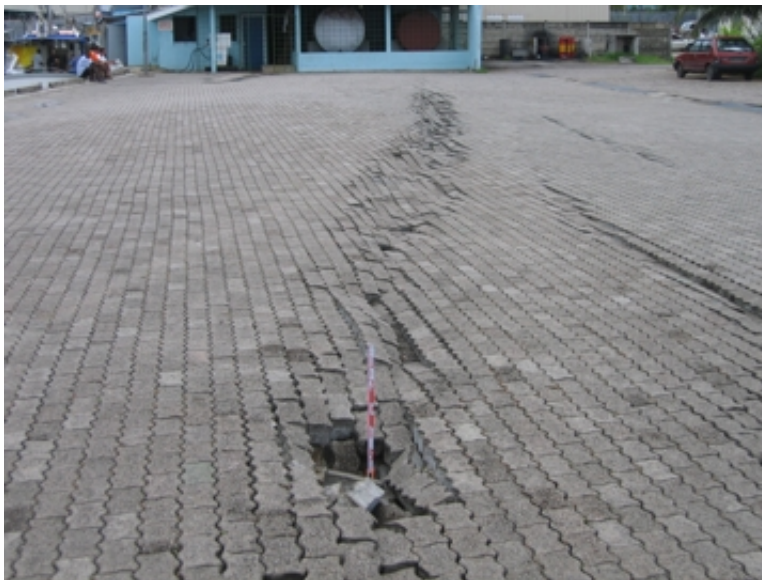
Fig. 14: Fissures created by dragging of anchor wall seaward. Adjacent sub-parallel cracks were caused by additional spreading of fill inboard of anchor wall (colour divisions on scale 10 cm). Photo: LEJ (GSC), 25 Jan 2005.

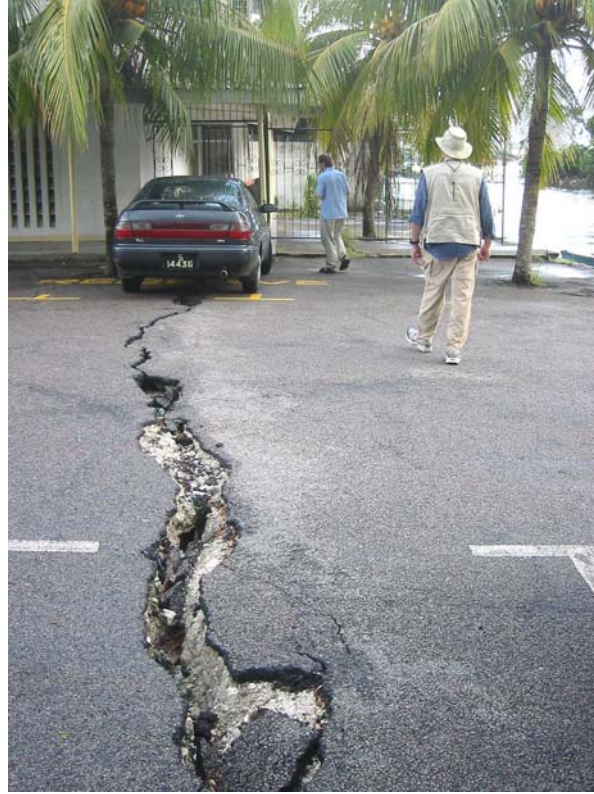
Fig. 15: Lateral spread failure intersecting building. Photo: DLF (GSC), 25 Jan 2005.

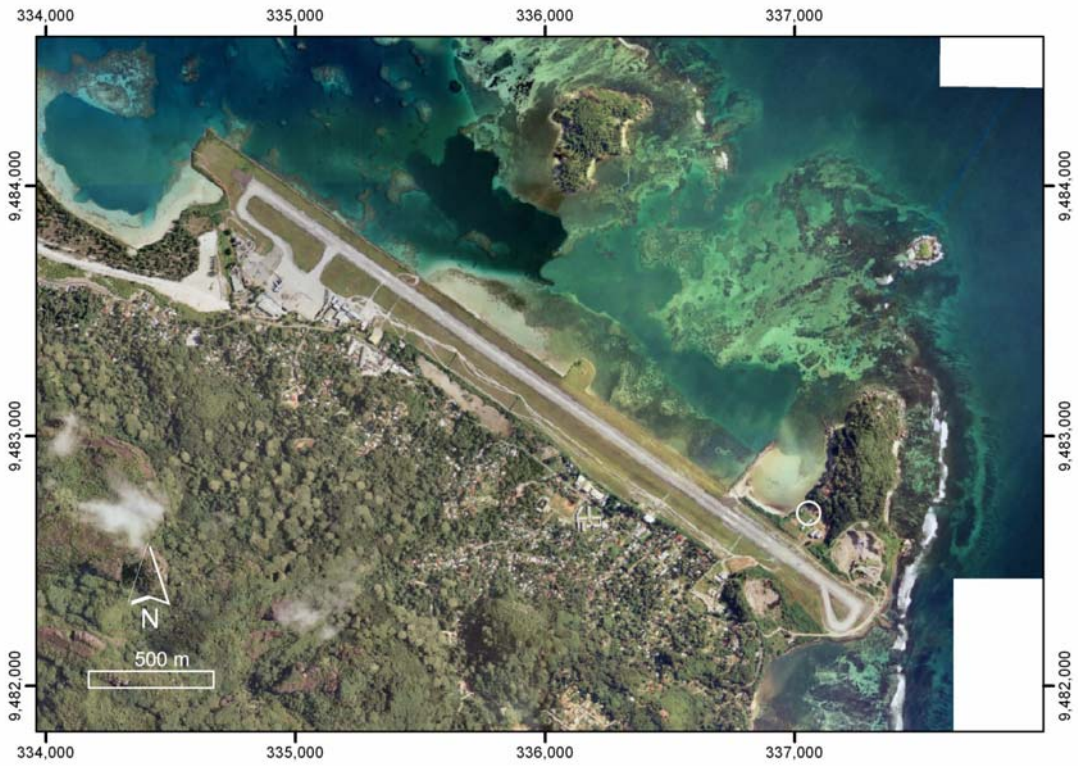
Fig. 16: Location of the international airport. GPS sites are circled.

**Environment:** The airport is located on reclaimed land, and is composed of coralline rubble fill emplaced on a fringing reef, with a rubble mound revetment. The tide gauge is situated on the north side of a jetty that extends eastward onto the reef flat north near the southern end of the airport runway (Figs. 16 and 17).

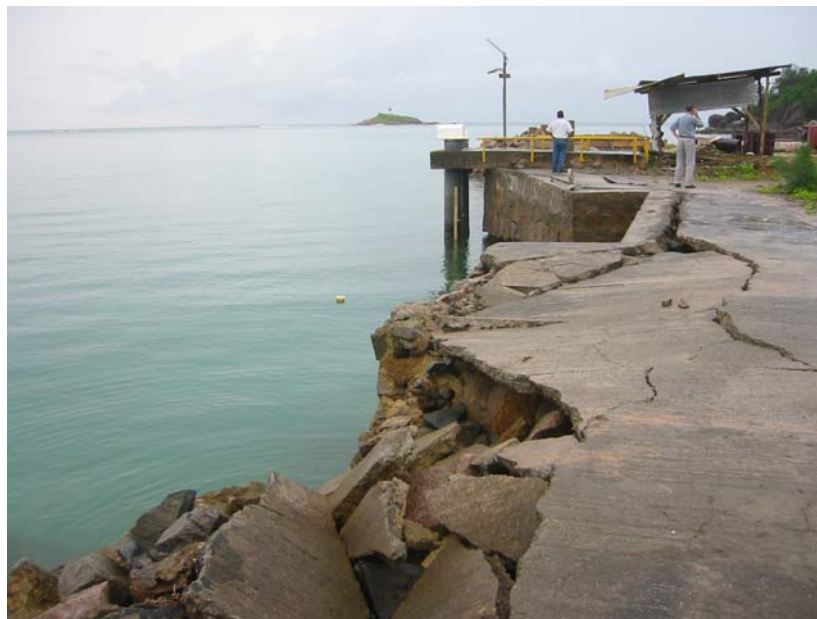
**Damage:** According to reports from officials in the Seychelles Weather Office, fish and coral debris were deposited over the first 200 m of the runway at the south end (Runway 31). Flooding covered half the width of the runway near the road crossing to the Met Service radiosonde facility and further along the side of runway in vicinity of the tide gauge jetty. Additional structural damage was sustained at the tide-gauge jetty as a result of a lateral spread failure (Fig. 17).

Fig. 17: Tide-gauge stilling wells and staff, showing structural damage to the wharf at the outer end of the jetty. Photo: LEJ (GSC) [DLF camera], 25 Jan 2005.

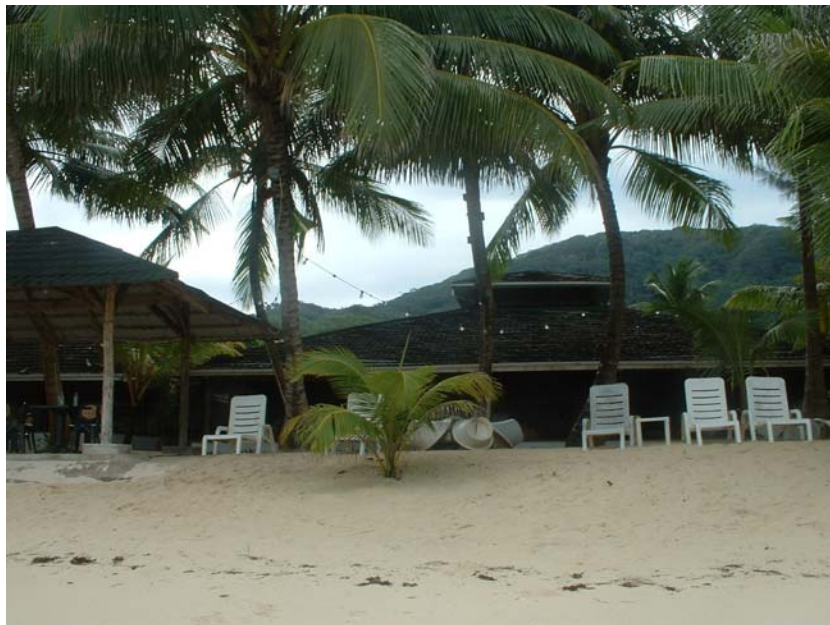
Fig. 18: Casuarina Hotel from the sea, showing chairs on the berm, with hotel beyond. A very exposed location. Photo: JS (GSC), 25 Jan 2005.

**Environment:** This hotel is located on the beach front in Anse aux Pins (Fig. 19). Entering the hotel, one walks through the lobby, into the bar, and out to an area of tables set on the sand of the berm. All this is on the same level (Figs. 18 and 19).

**Remarks:** This is one of several sites where, unfortunately, the natural coast has been modified (Figs. 18 and 19). The coastline is fixed and the hotel floor is at the same level as a rather low berm.

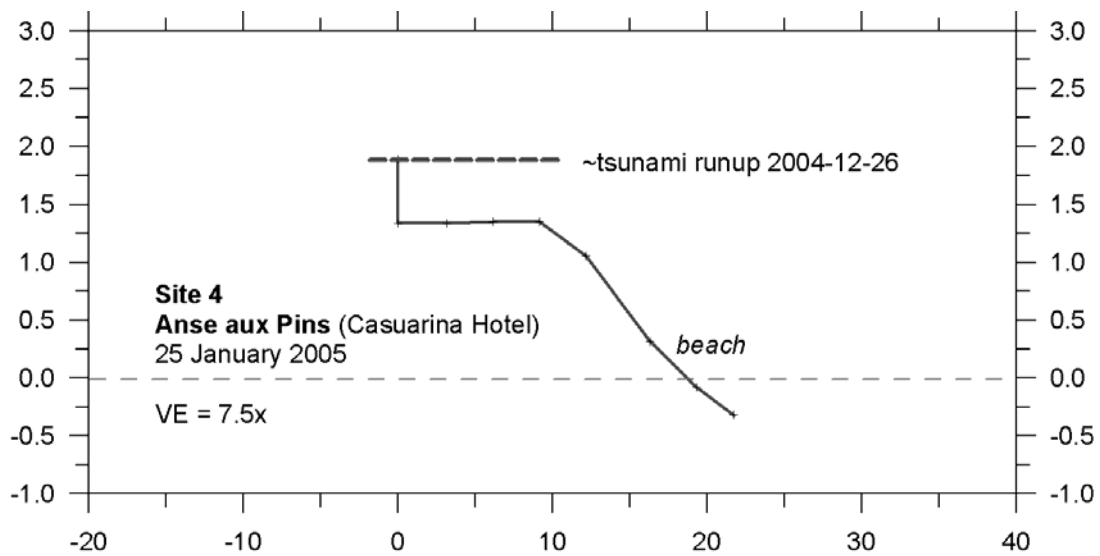
Fig. 20: Profile at Casuarina Hotel, 25 January 2005. Water level at 15:55 is the lowest value on the profile. The floor of the hotel is more or less at the same level as the flat sandy berm.

**Damage:** Minimal, mainly flood damage to computers and related equipment.

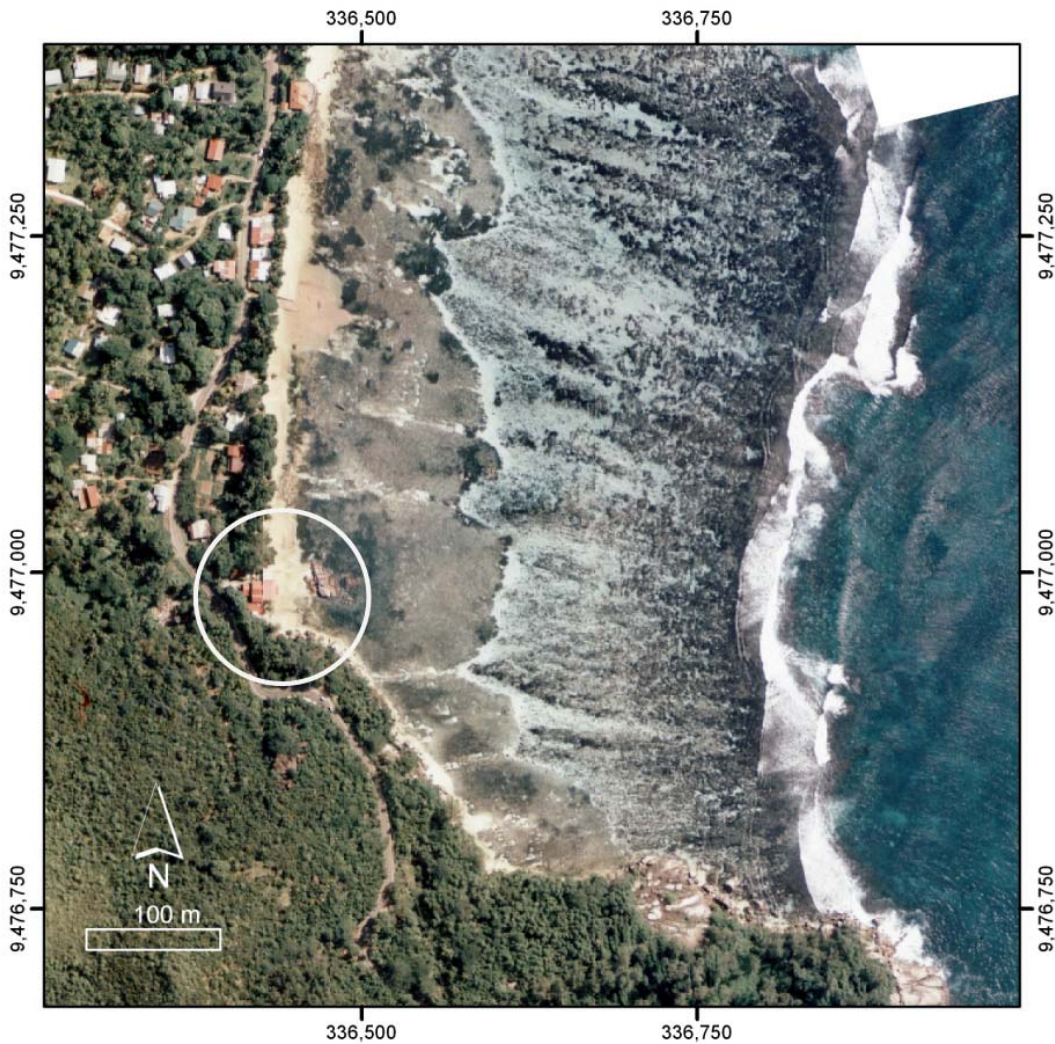
Fig. 22: Enlarged view of the site of the Fairyland Hotel.

**Environment:** The Fairyland Hotel site is located at the southern limit of a sandy beach abutting the granitic headline of Pointe au Sel, which rises abruptly to tens of metres above sea level immediately to the south (Figs. 19, 21, 22). The hotel and adjacent beach are sheltered by a coral reef about 250 m offshore, and by an outcrop of granite which is totally emergent at low tide directly seaward of the hotel. The beach has been modified to accommodate the hotel. A low beach berm was removed to facilitate construction and beach access (Figs. 23-26).

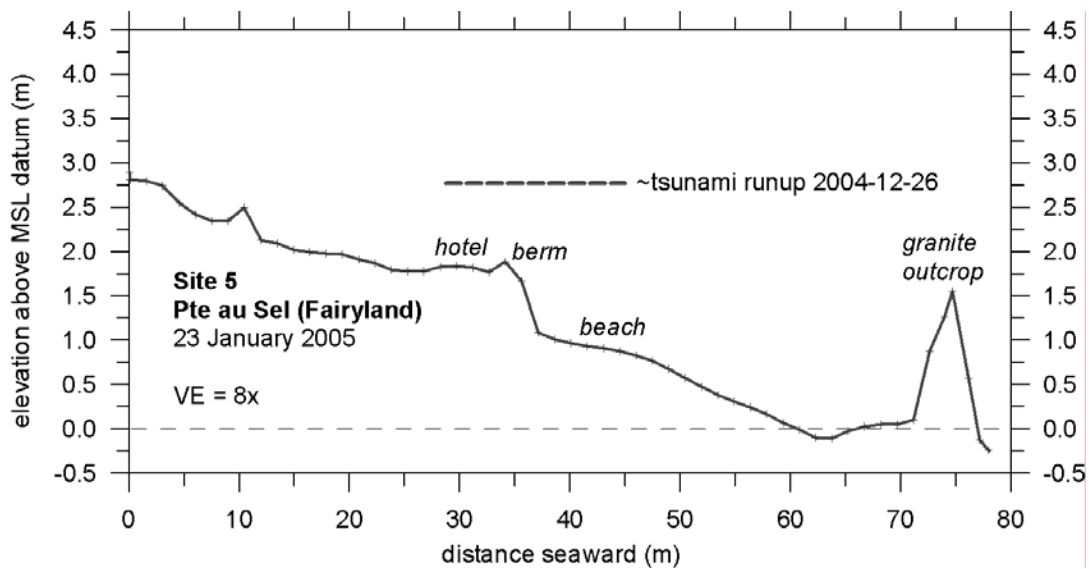
Fig. 23: Profile at Fairlyland, from near top of driveway parallel to hotel on north side, out across beach, flats, and granite outcrop on reef flat.

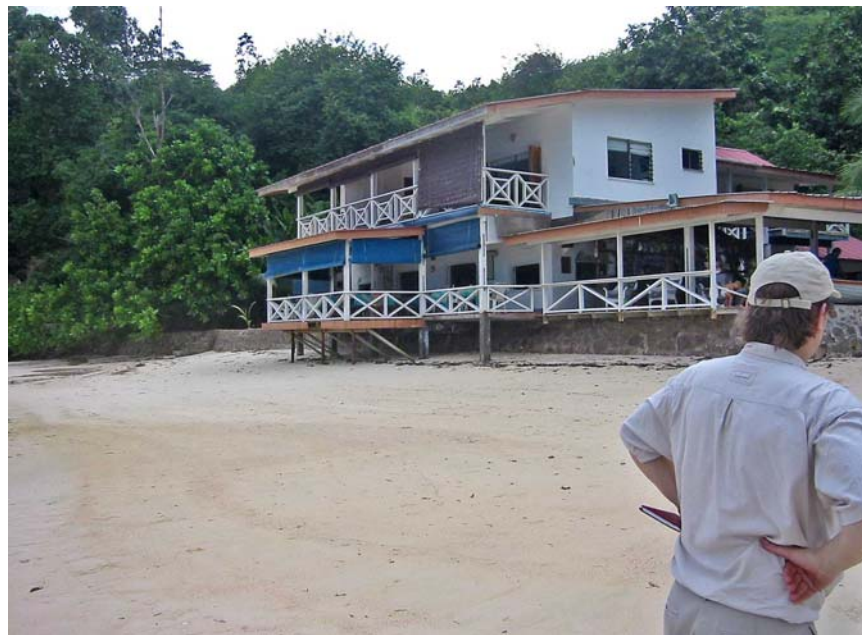
**Damage:** Flood damage to hotel interior, electrical appliances, impact of wave detached wooden planks from exterior sun deck.

Fig. 24: Fairlyland Hotel. Highest tsunami water level reached to approximately the top of the railing along the first floor. Note the location of the building on the beach. A former beach berm has been removed and replaced by a low seawall. Photo: DLF (GSC), 24 Jan 2005. See also cover photo.

**Remarks:** Adjacent properties immediately to the north suffered far less inundation and damage. It should

be noted that these properties had unaltered beach berms that stood about 70 cm above the level of the highest beach deposits at Fairyland. This made a significant difference in the depth and extent of flooding of these areas.

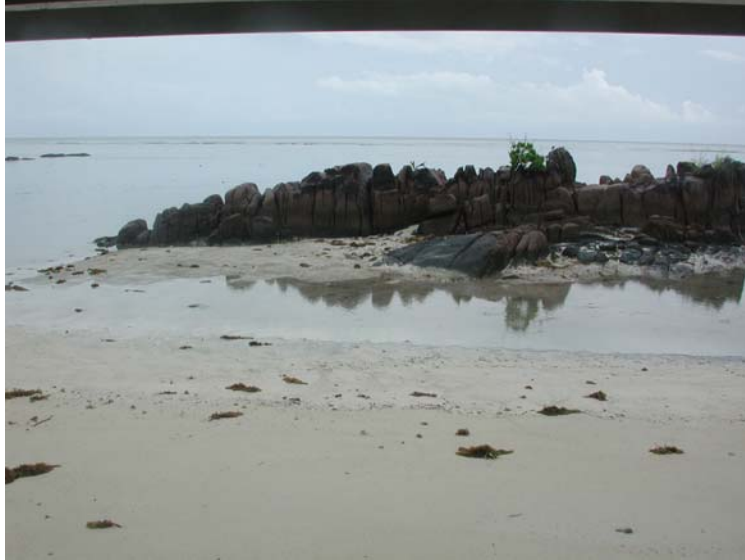
Fig. 25: View of approximately 3 m high bedrock outcrop from first level of Fairyland Hotel, showing drawdown between waves, 12:00-13:00, 26 Dec 2004. Photo by Giles Platt.

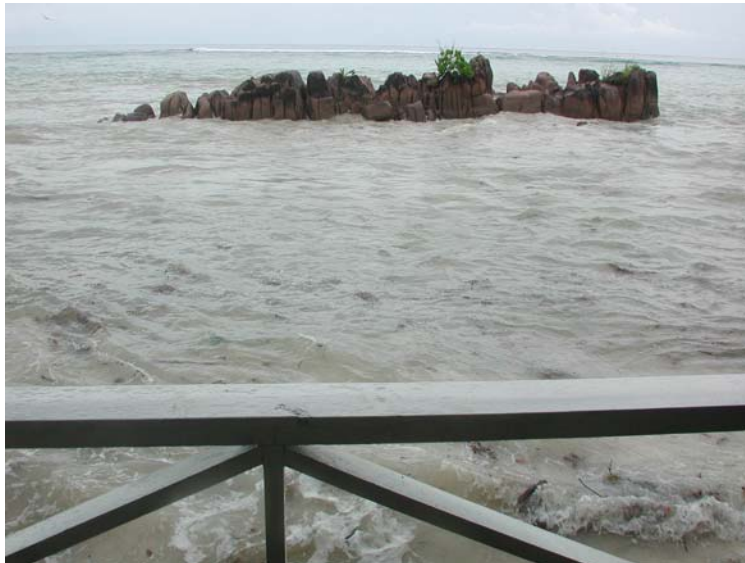
Fig. 26: Water rushing in within a few minutes of photograph above. Note turbidity in the usually crystal clear and azure waters of Seychelles. Highest water level at this site was level with the rail in foreground. Photo by Giles Platt.

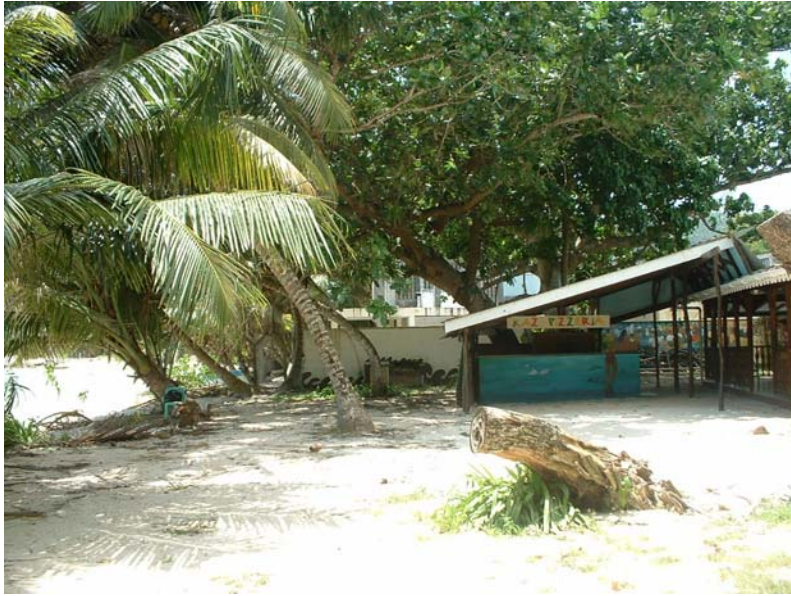
Fig. 28: The exposed location of Kaz Kreole restaurant is shown here. Note collapsed roof. Photo: JS (GSC), 1 Feb 2005.

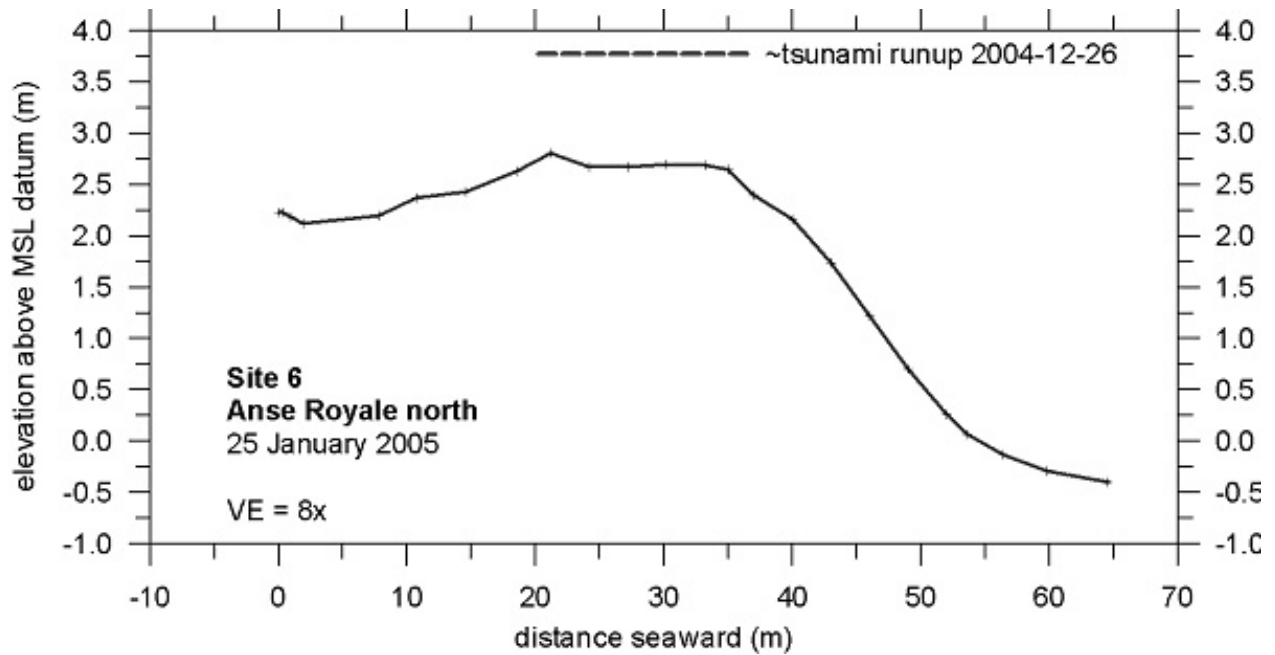
Fig. 29: Profile at Anse Royale north, immediately north of the Kaz Kreole restaurant (Fig. 28), which is located on the crest of the berm.

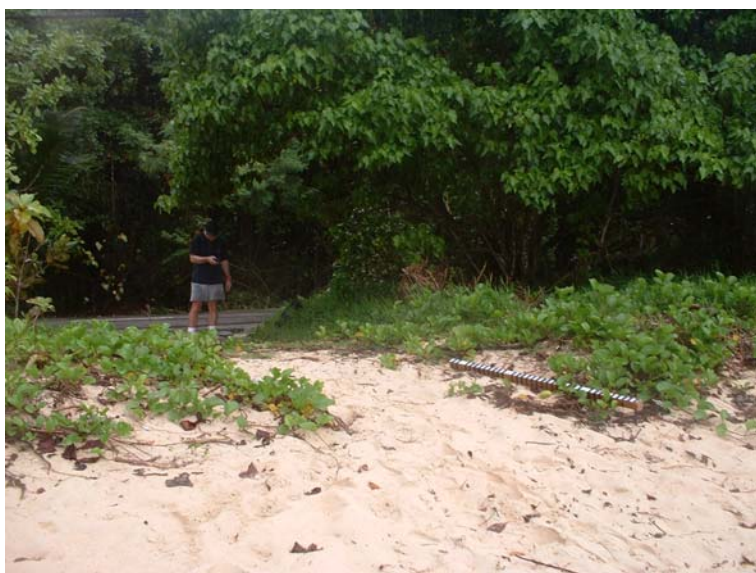
Fig 30: Track crossing low berm at the Anse Royale South profile site (note man for scale). Photo: JS (GSC), 25 Jan 2005.

**Description:** There was no one to interview here. We based our interpretation on physical evidence alone (Figs. 30-32). Water crossed the road, spreading sand and vegetative debris into the low-lying area on the far side. On a later visit to survey the site with GPS, we noticed vegetation above our heads in the trees and against a telephone pole support wire, and also a piece of corrugated iron wrapped around a pole.

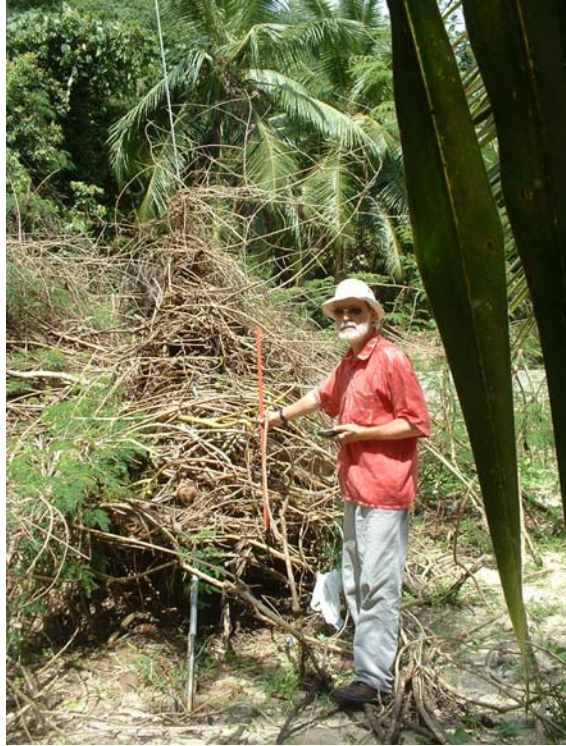
Fig. 31: Plant debris wrapped around a steel guy wire to a height of 2 m above the berm at Anse Royal south. Photo: JS (GSC), 1 Feb 2005.

Fig. 33: Profile at Anse Royale south. The berm crest at 2.89 m above MSLD was overtopped in the tsunami. However, immediately south of this site we observed debris that was approximately 1.6 and 2.0 m higher than the berm elevation (Fig.31). There was evidence of strong currents flowing at 320° (berm alignment 355°), suggesting control of flow by the steep rock slope immediately behind the road. We estimate the maximum run-up level therefore to have been about  $4.36 \pm 0.2$  m MSLD.

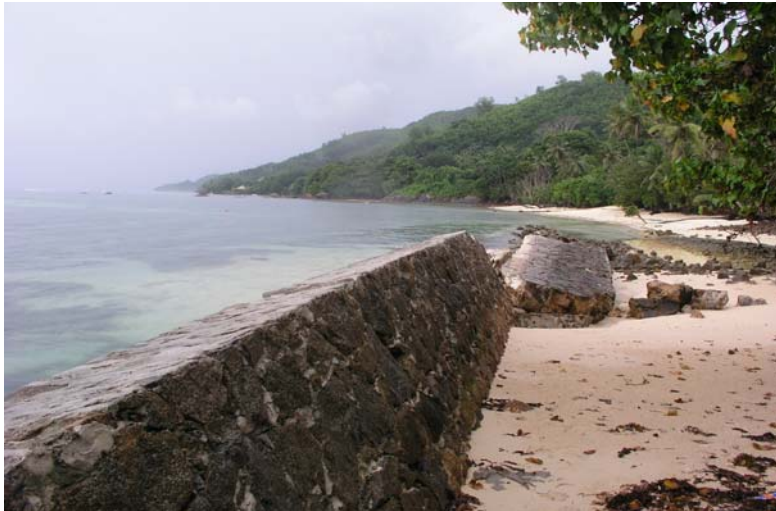
Fig. 32: Seawall that was damaged during the tsunami event just to the north of the profile. Photo: JVB (GSC), 25 Jan 2005.

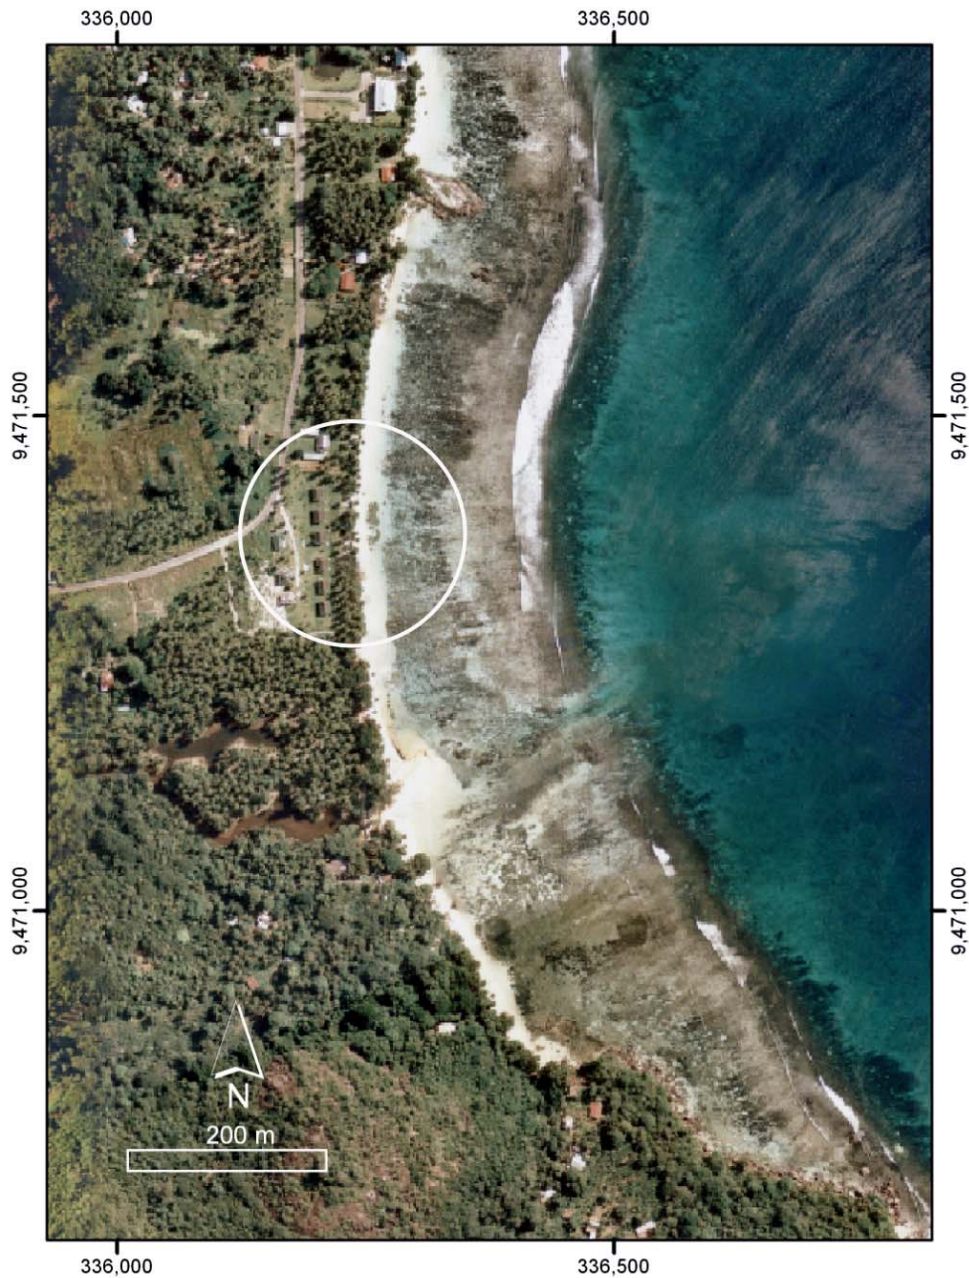
Fig. 34: Anse Forbans. The chalets (where the field party stayed) are in the white circle. The tsunami waves did not breach the sandy coastal berm behind the upper beach.

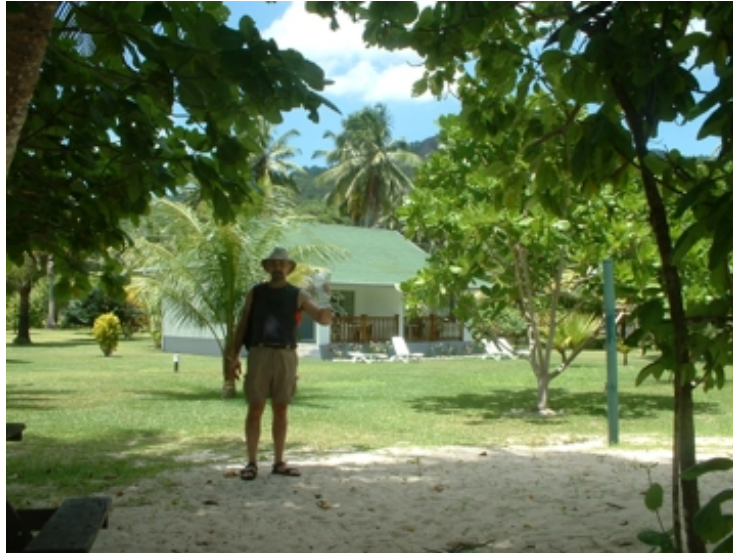
Fig. 35: Anse Forbans resort, photo taken from crest of beach berm looking toward bungalows. The sand marks the limit of the spill-over of tsunami beyond the crest of the berm. Photo: JS (GSC), 25 Jan 2005.

At 13:10 PM, the largest wave struck, reaching the top of the beach berm, spilling over it, depositing sand (Fig. 35), and causing minor flooding with no damage to buildings. It looked like a wave that had already broken and it was about 1.0 to 1.3 m in height. Within about 3 minutes, the water receded and the reef was dry again. For the rest of the afternoon, waves arrived, first with an interval of about 45 minutes and progressively lengthening in time between waves to about 1 hour and 15 minutes. There was a notable

**Maximum run-up distance:** A small amount of water spilled over the beach crest Fig. 35).

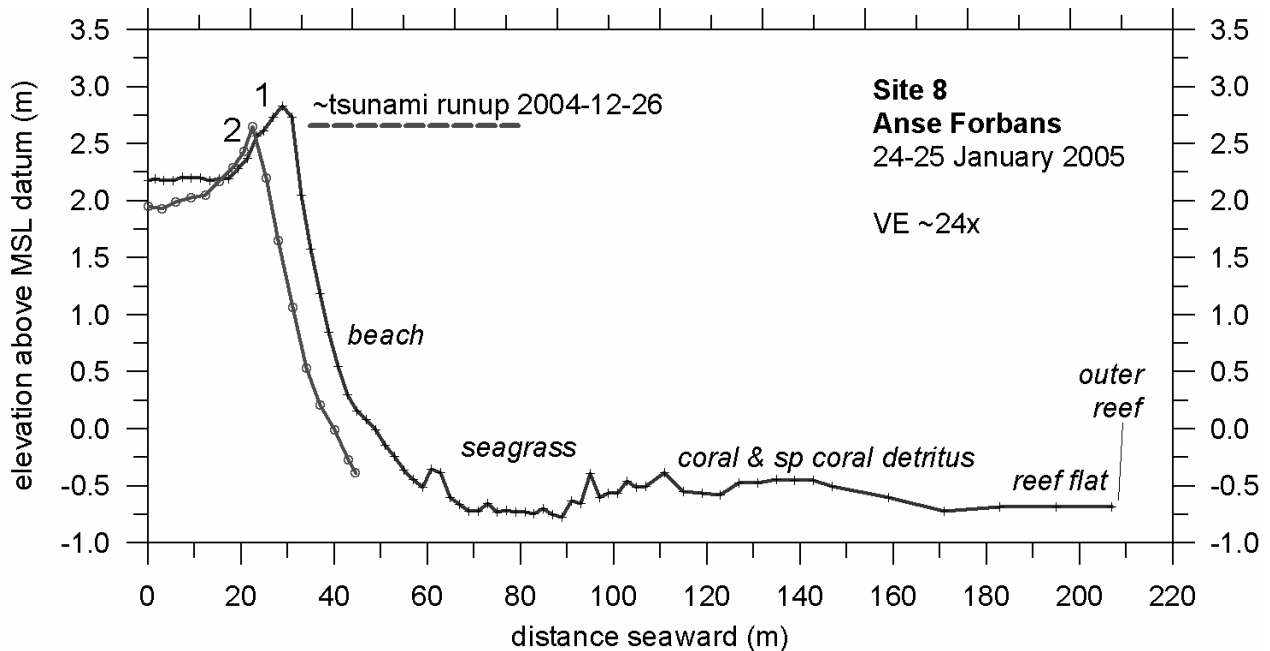
Fig. 36: Anse Forbans profile. The highest waves associated with the tsunami barely spilled over the level of the natural berm, which is 0.65 m above the level of the flat area (extreme left of the profile) on which the chalets are sited. This illustrates the vital importance of retaining natural coastal berms.

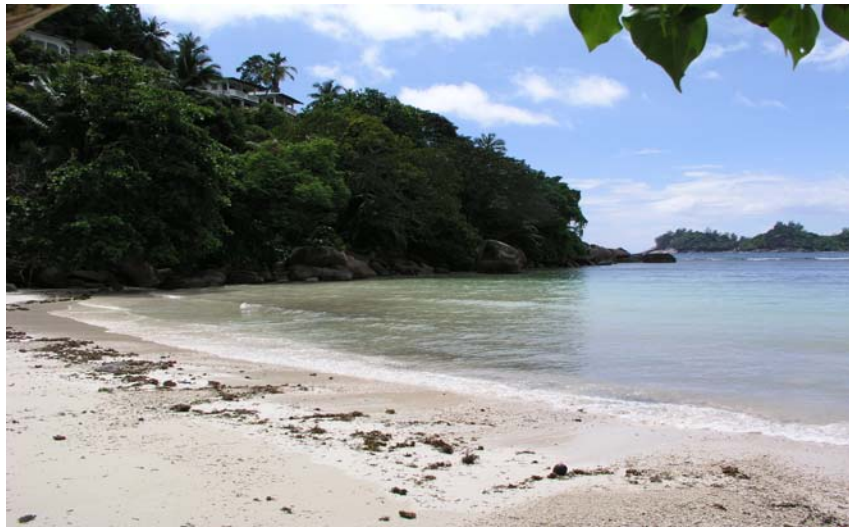
Fig. 37: Baie Lazare looking south. Photo JVB (GSC), 20 Jan. 2005.

**Environment:** Baie Lazare is a south-facing, semi-circular cove protected to the west and east by the granite headlands of Pointe Lazare and Pointe Maravi, respectively. A fringing reef lies immediately offshore (Figs. 37 and 38).

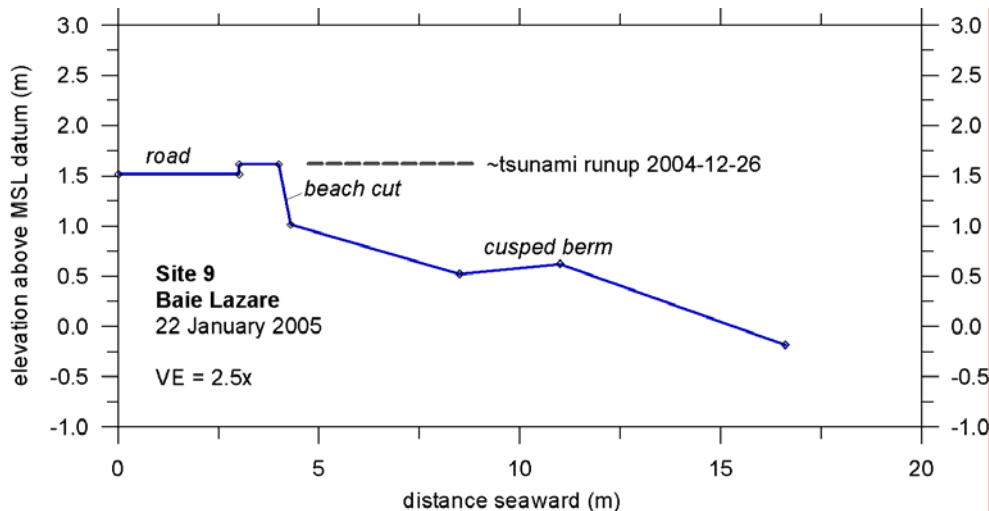
Fig. 39: Profile across beach with cusped berm at Baie Lazare, showing beach cut in upper berm in front of the road.

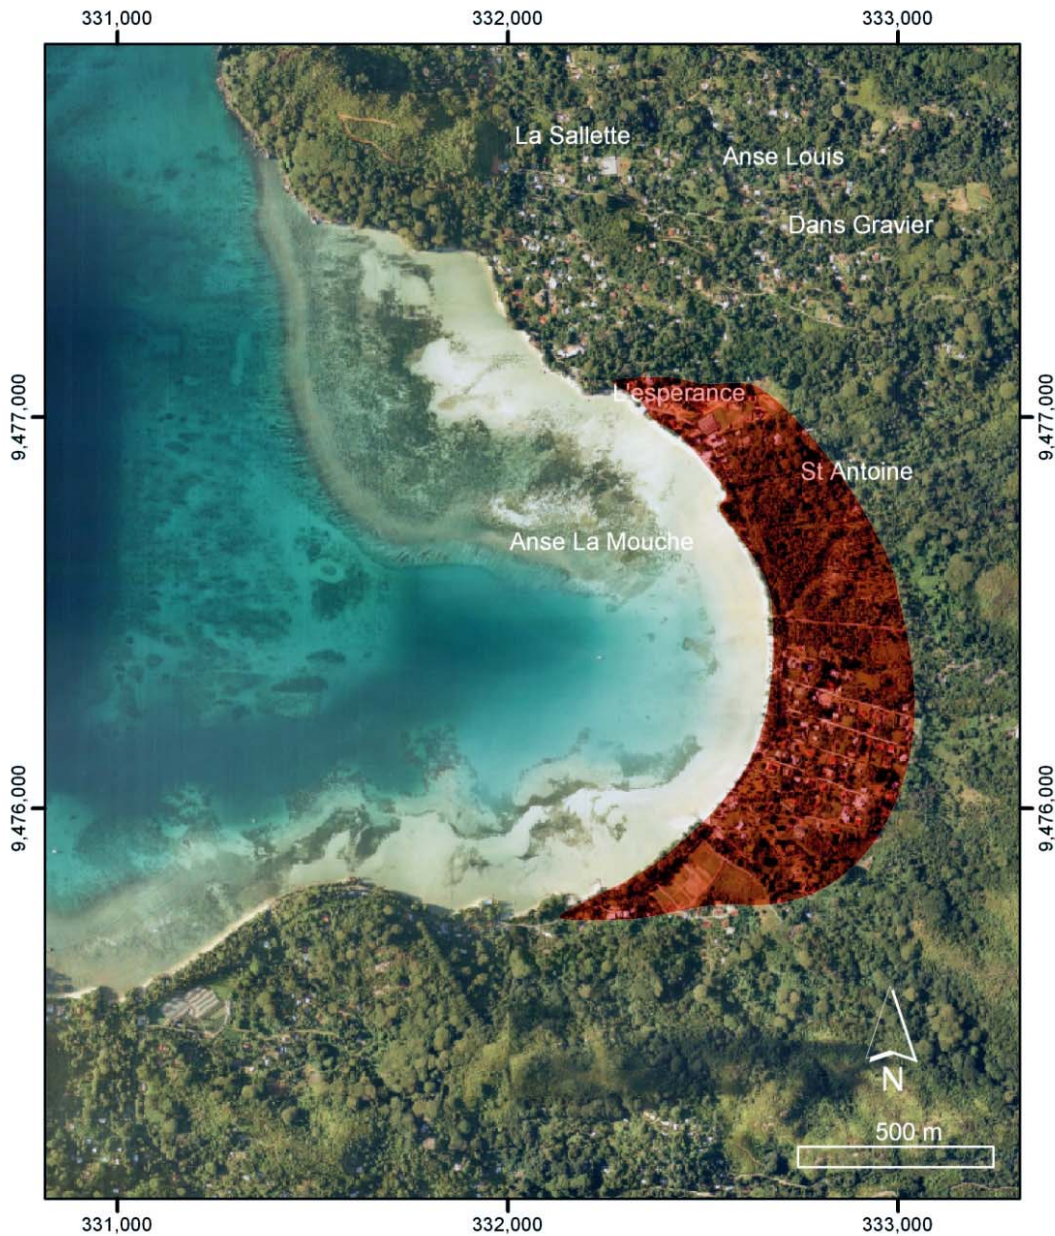
Fig. 40: Anse à la Mouche showing approximate area inundated (red) by the most destructive (17:30) tsunami.

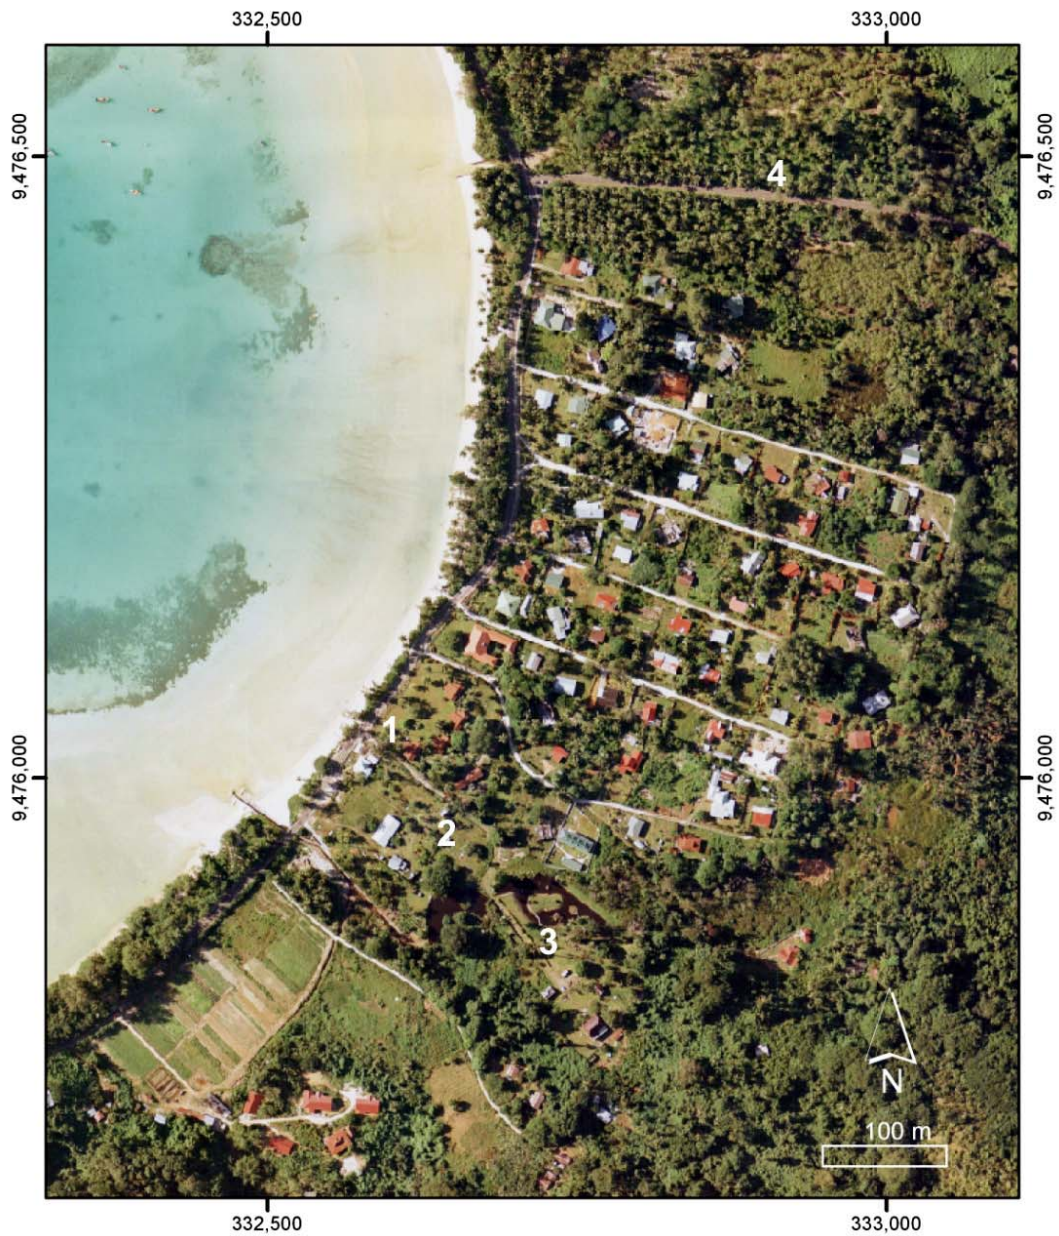
Fig. 41: Anse à la Mouche area showing the Anchor Café (1), the approximate location of the tortoise pens (2) and the freshwater ponds (3) that contained marine fish after the 17:30 flooding event. The limit of flooding lay landward of the ponds. One of the most reliable measurements of flood limits was a GPS measurement taken on the Chemin les Canelles (4). This location was identified using a photograph of flood debris on the road.

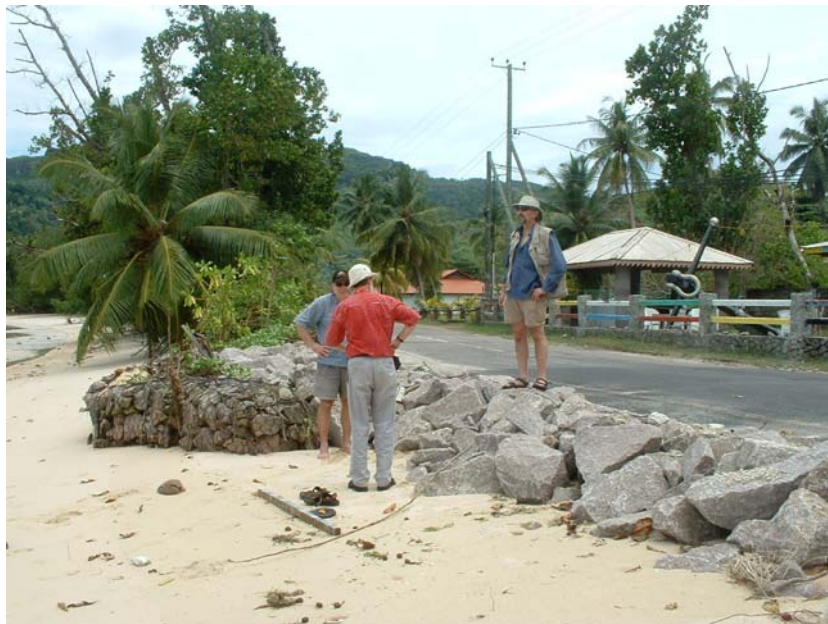
Fig. 43: The seafront at Anchor Café. Note the low boulder rip rap, the road, and the café beyond. Prior to the tsunami, there was enough land on the seaward side of the road for a kayak shed. Photo: JS (GSC), 26 Jan 2005.
