# **EFFECTS OF THE 26 DECEMBER 2004 INDIAN OCEAN TSUNAMI IN THE REPUBLIC OF SEYCHELLES**

**Report of the Canada-UNESCO Indian Ocean Tsunami Expedition  
19 January – 5 February 2005**

**Open File 4539**

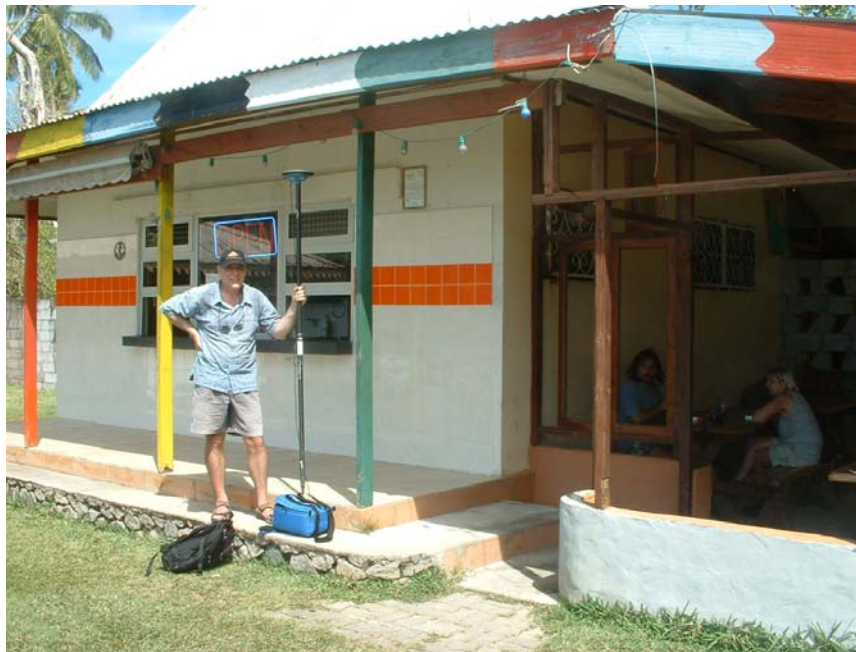
Fig. 44: Anchor Café. The high water level was level with the counter top behind V. Barrie. Photo: JS (GSC), 26 Jan 2005.

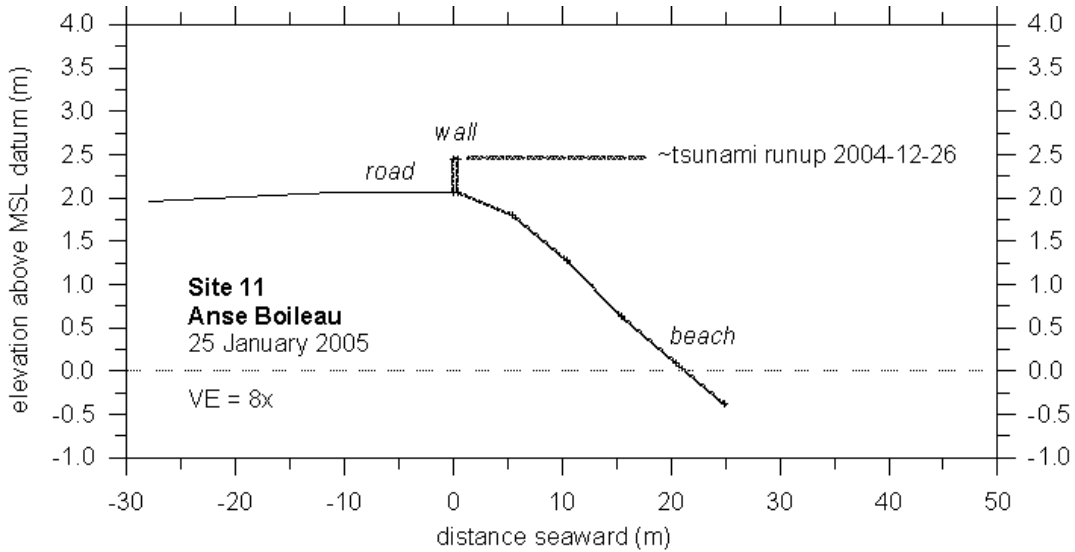
Fig. 46: Profile at Anse Boileau. Water barely covered the wall, and drained to the road behind, causing minor flooding.

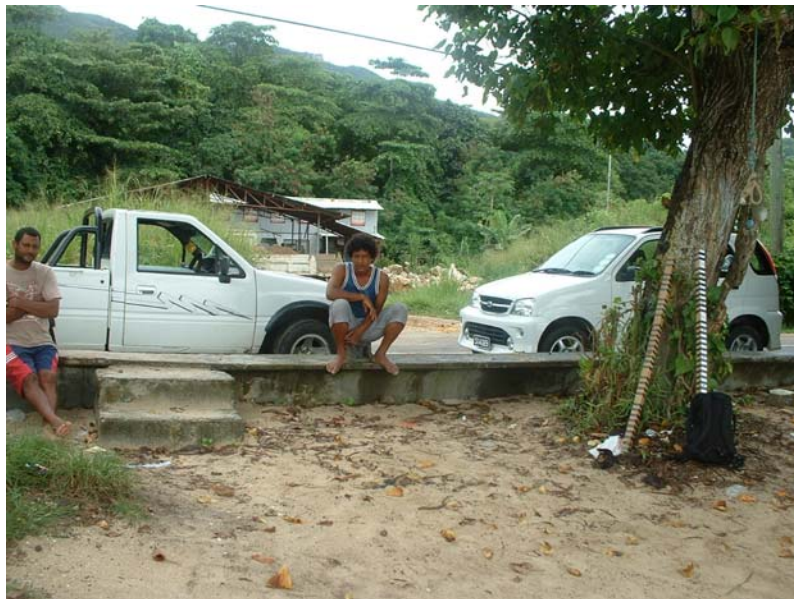
Fig. 47: At rear of beach at Anse Boileau. The tsunami waves spilled over the wall, and water ran across the road as far as the store at the other side. Top of wall is GPS site BOWL. Photo: JS (GSC), 25 Jan 2005.

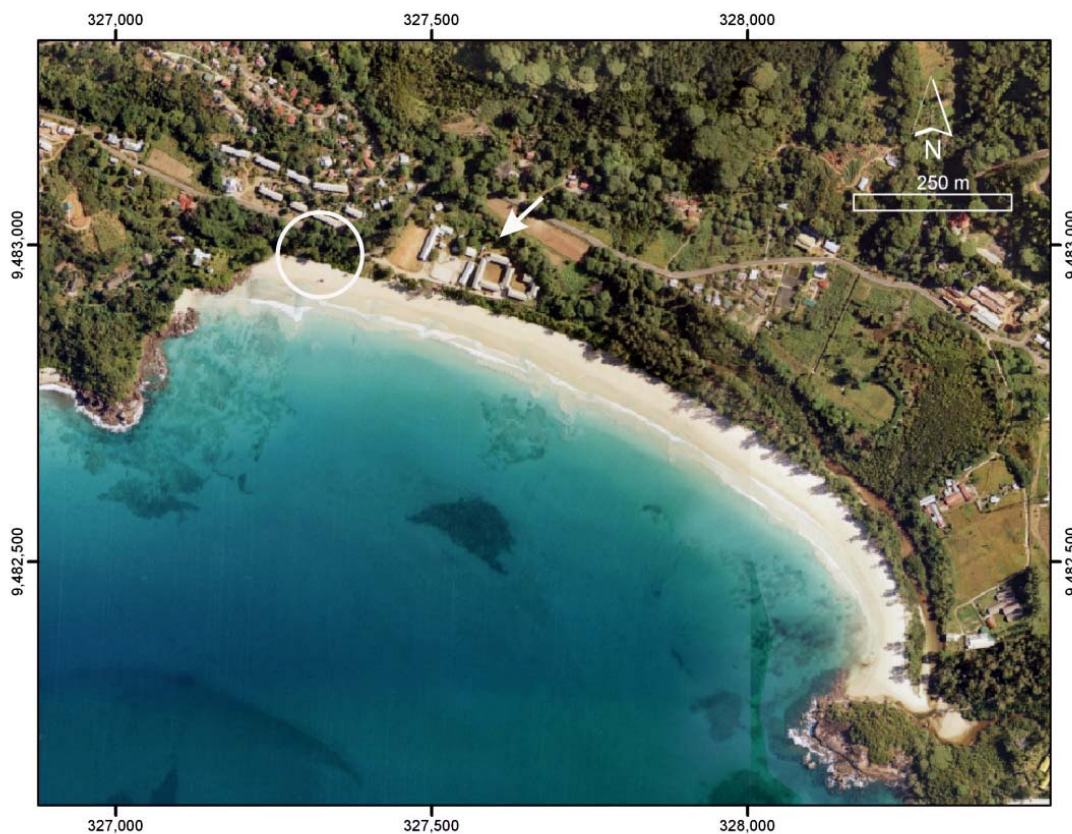
Fig. 48: Grande Anse, a wide sandy beach without a reef, fully exposed to Indian Ocean wave energy. The tsunami waves merely reached as high as normal storm waves or a high tide level. The profile location is circled and the school located by the arrow.

**Environment:** This site lies at the west side of the island, and consists of a long wide sandy beach exposed to the south-southwest (approximately 210°) in an open reef-gap setting (Figs. 48 and 49). There is a low wave-cut scarp at the top of the beach, cut into a heavily vegetated upper berm (Figs. 50, 51). The beach has protected status, and there are no major roads running parallel to the high water line. There is a school part way along the beach, about 30 m landward of the beach crest. Access to the beach is via wooden steps. A river enters at the north end, where it has carved a steep-sided channel into the beach

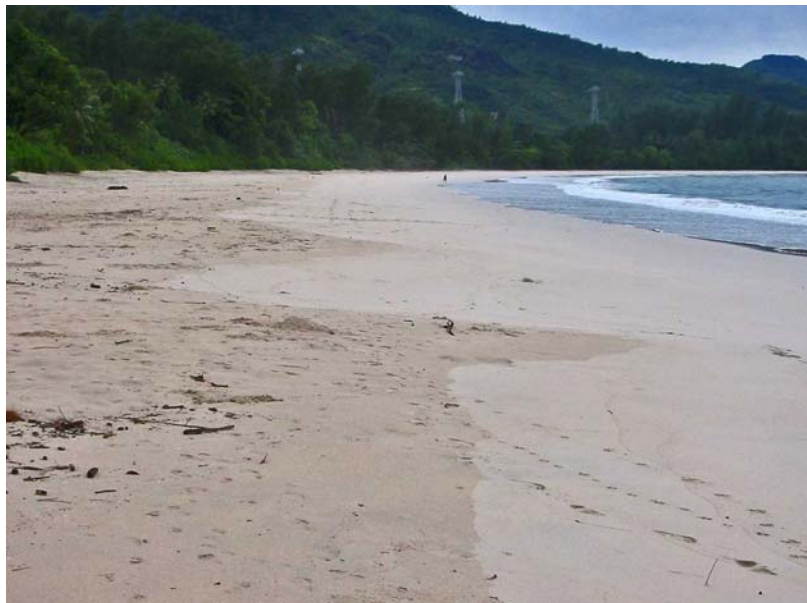
Fig. 49: Cusps on the high-energy, reef-gap, sandy beach at Grande Anse. Photo: DLF (GSC), 26 Jan 2005.

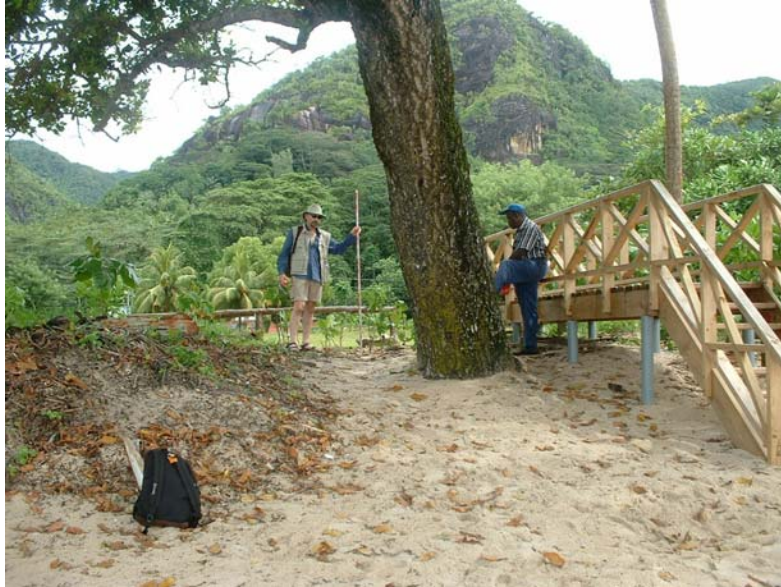
Fig. 50: Team member L. Jackson holding a rod at the position of maximum run-up (according to the informant leaning on the steps). This is GPS site G2AX. Photo: JS (GSC), 26 Jan 2005.

**Maximum run-up level:** About 4.3 m MSLD (high but not high enough to overtop the beach berm in this area; Fig.50).

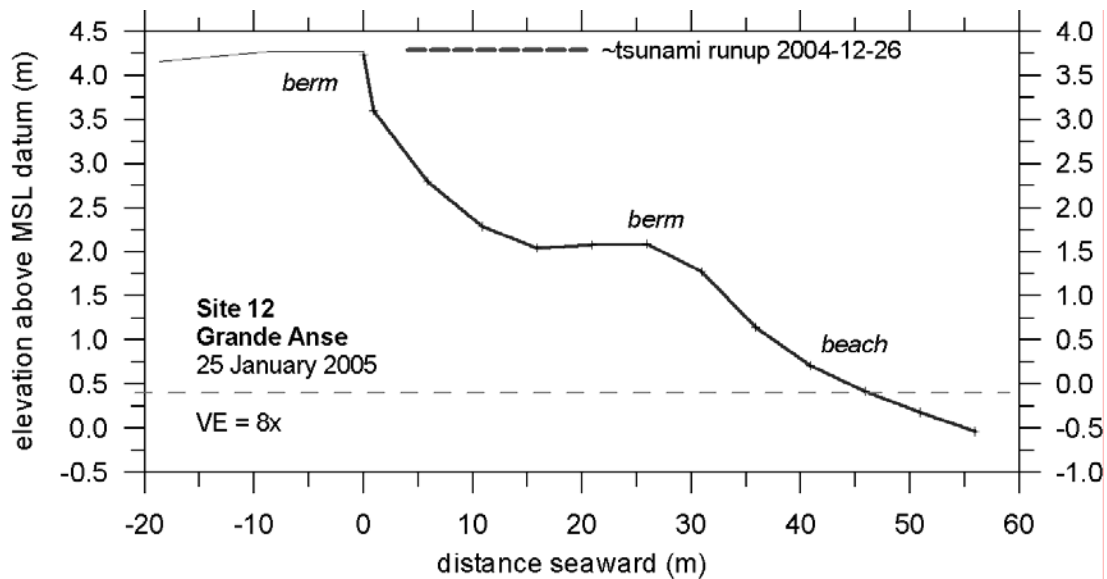
Fig. 51: Profile at Grand Anse. The ocean is to the right. Note prominent cusped berm at 25-30 m on the profile.

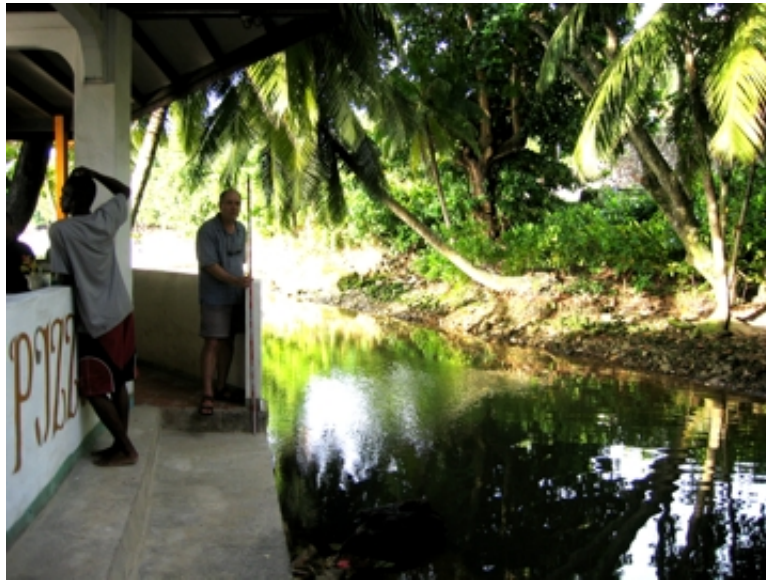
Fig. 53: Tsunami waters just reached the step upon which the two men are standing at Baobab Pizzeria, Beau Vallon. This is about 1.6 m above sea level shown in picture, or approximately at higher high tide level. Photo: LEJ (GSC), 23 Jan 2005.

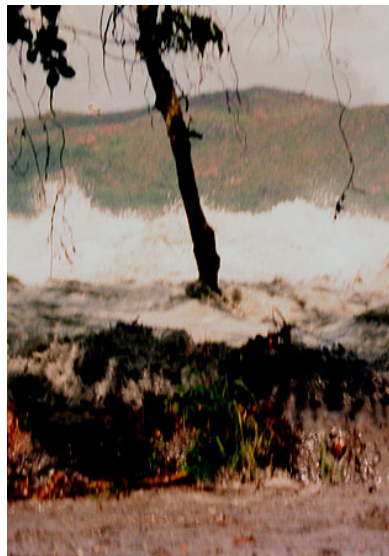
Fig. 56: Photo supplied by Paul Turcotte showing tsunami waves crashing on the beach scarp across the road from his house, 26 December 2004.

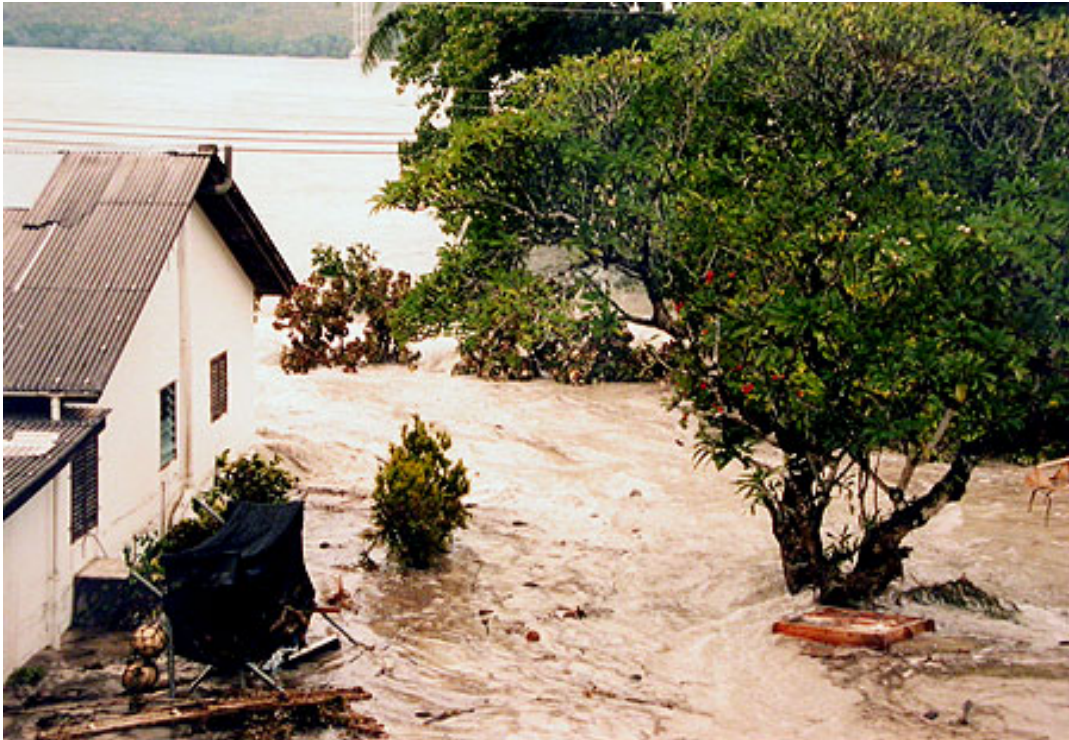
Fig. 57: Tsunami floodwaters surround the Turcotte house. Photo by Paul Turcotte, 26 December 2004.

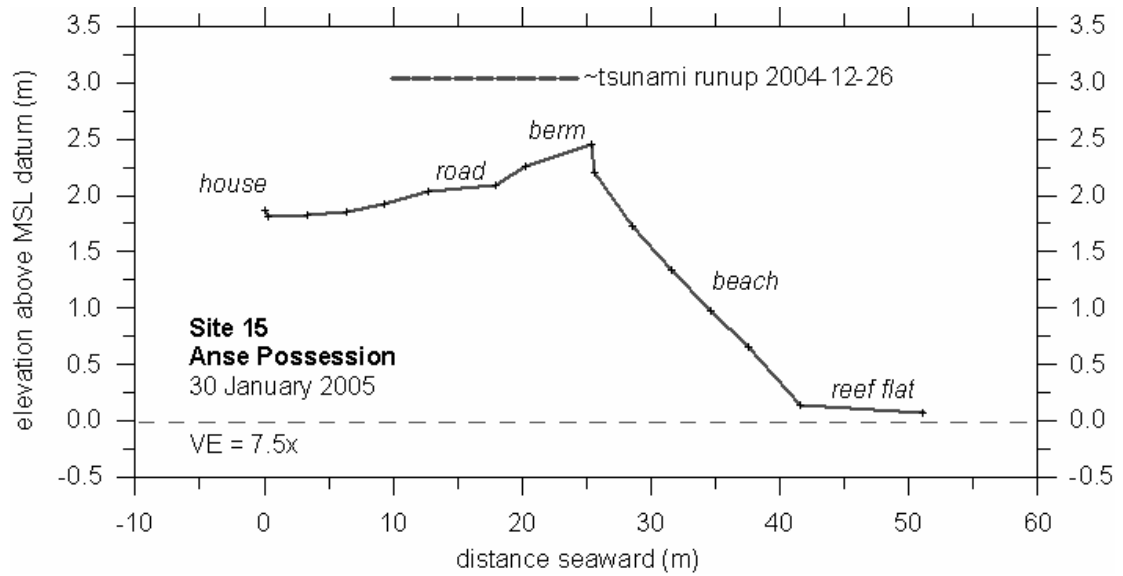
Fig. 58: Profile at Anse Possession. The line extends from the corner of the Turcotte residence across the road, berm, and a low scarp to the beach and intertidal flats (at right). The ground at the corner of the house is 1.87 m MSLD and the highest water mark on the outside of the house was 1.14 m above ground level. Thus the maximum flood level was 3.01 m MSLD. Inundation was facilitated by the landward slope of the ground surface.

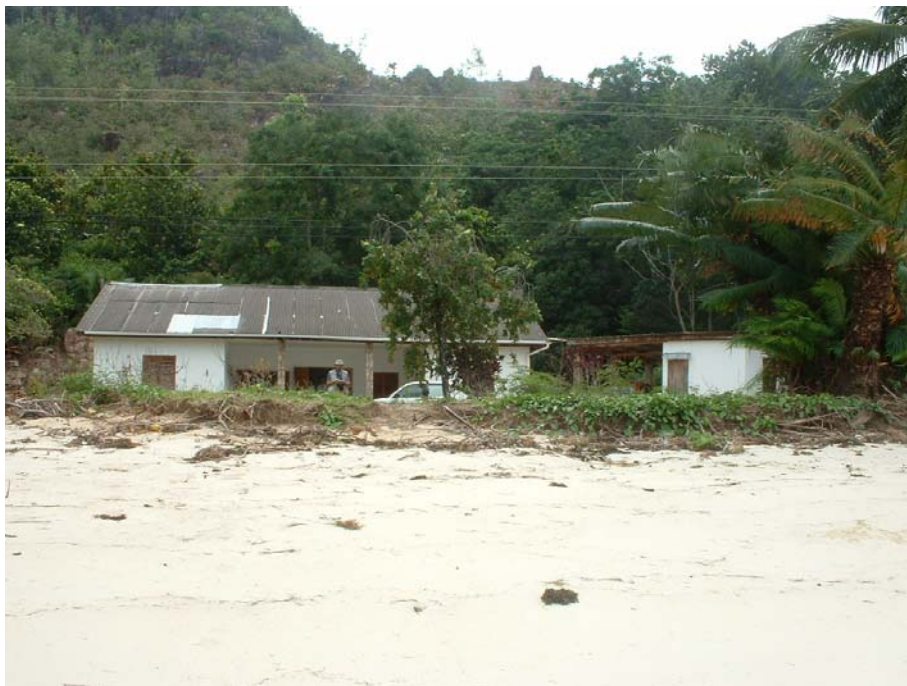
Fig. 59: View of Turcotte residence at Anse Possession from the adjacent intertidal flats. Photo: JS (GSC), 30 Jan 2005.

tend to trap flood water (Figs 58 and 59). Boulders placed along the road in front of the house were rolled toward the house by the surging tsunami waters. The largest of these had an intermediate diameter of 57 cm. The minimum flow velocity ( $U$ ) required to initiate movement of this boulder can be estimated from empirical equations used in civil engineering. Estimates for flow velocity based on an intermediate diameter of 57 cm and specific gravity of 2.5 are given below:

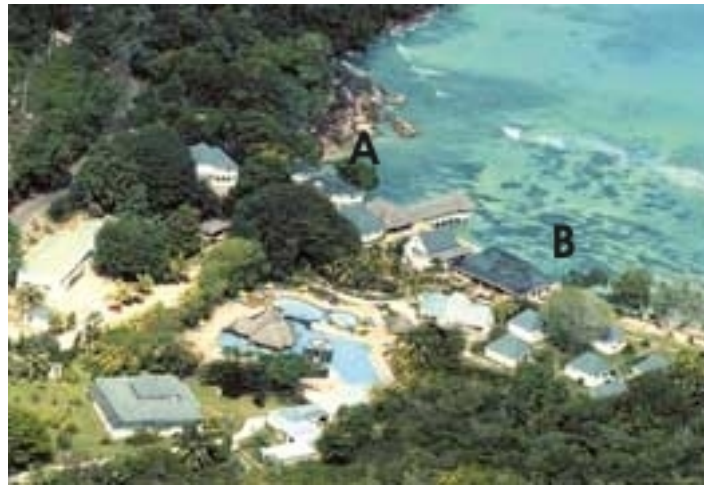
Fig. 61: A- La Reserve Hotel. All of the buildings between points A and B will have to be demolished because of structural failure due to undermining of their foundations by the draining tsunami flood. The pier restaurant is midway between the two letters. North is toward the right. Virtually the entire property was inundated by the tsunami. Photo from <http://www.mauritius-seychelles.com/la-reserve-hotel-seychelles.html>.

- ❑ Major structural damage occurred to private property at one hotel (La Reserve) on Praslin. At this site, the damage was caused primarily by the draining of tsunami waters, which eroded and undermined foundations, causing distortion of the structures to the extent that they will have to be demolished. Direct wave impacts were also sustained, resulting in broken windows and interior damage.

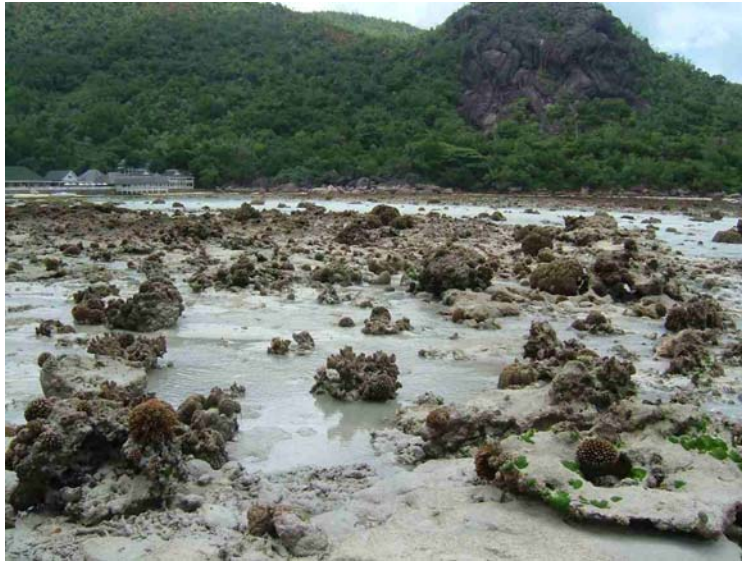
Fig. 62: Brain corals exposed on the floor of the completely drained Anse Petit Cour ca. 08:00 UTC, 26 December 2004. La Reserve Hotel is seen in the background. View to the southwest. Photo courtesy Peter Pomeroy, La Reserve Hotel.

**Description:** La Reserve Hotel was one of the most impacted sites on Praslin Island. The first indication of the impending tsunami was the draining of Anse Petite Cour between 11:00 and 12:00 local time on December 26. Coral heads at the bottom of the bay were completely exposed. A photograph taken by a guest documents the draining of the bay (Fig. 62).

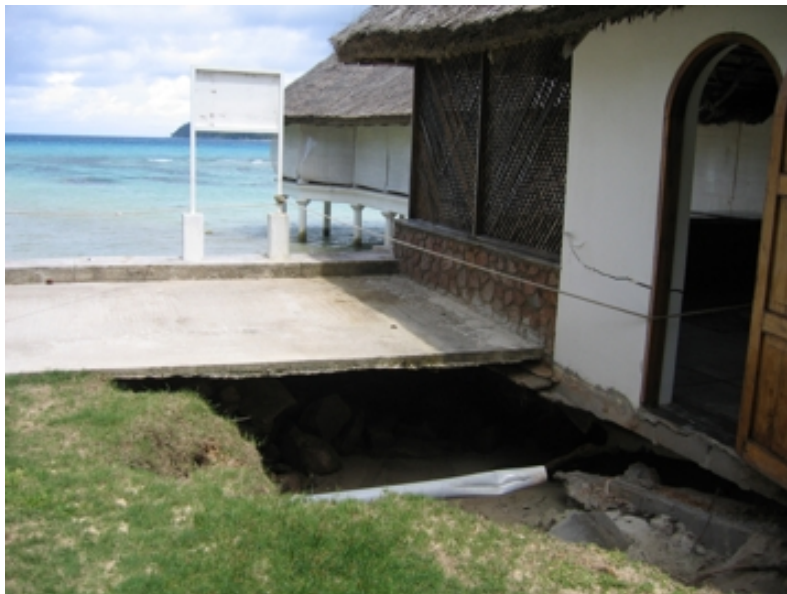
Fig. 63: Southwest side of pier restaurant showing erosion of foundation and partial collapse. Several of the piers of the structure in the background have rotated out of plumb. Photo: LEJ (GSC), 29 Jan 2005.

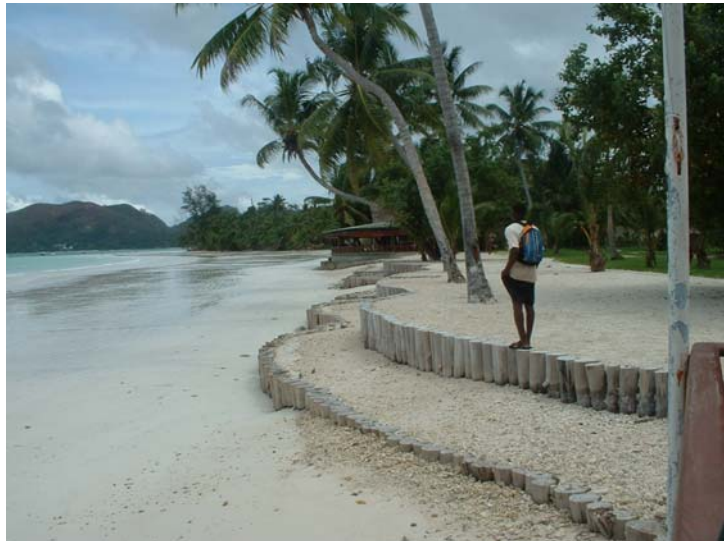
Fig. 65: The waterfront of the Paradise Sun hotel, showing the erosion of the beach has been an ongoing concern. The beach beyond looks undeveloped, but in fact this is one of the most developed stretches of coast on the island: hotels lie just to right of the fringing palms. Photo: JS (GSC), 28 Jan 2005.

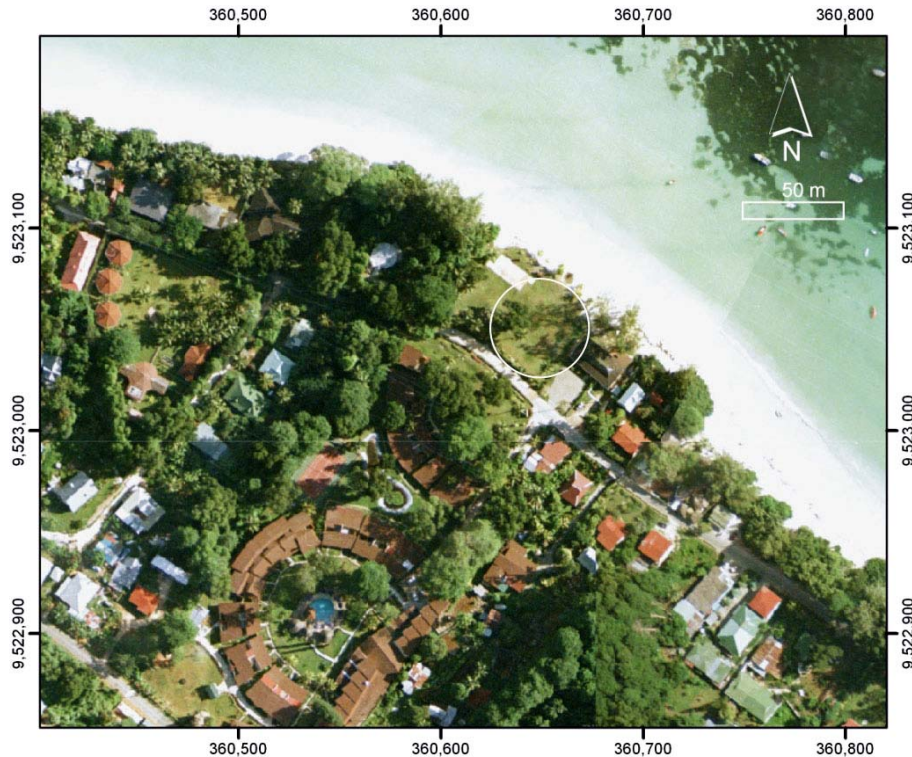
Fig 66: The Berjaya Praslin hotel complex. The grassy area immediately northwest of the pizzeria is circled. This area was flooded and received a tsunami deposit of well-sorted medium to fine sand (Figs. 67 - 69). The run-up in this area reached the seaward part of the semi-circular hotel complex. The limit is about 175 m from the top of the beach or about 200 m from the MSL shoreline.

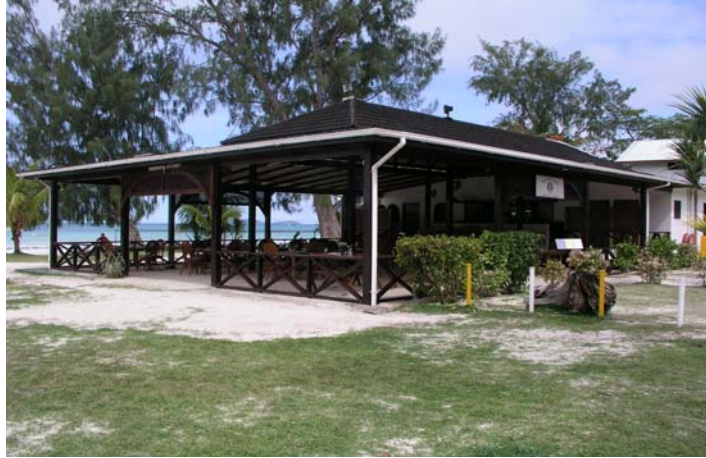
Fig. 67: Restaurant on the beach, Berjaya Praslin Hotel. Photo: JVB (GSC) 28 Jan 2005.

**Damage:** There was no structural damage. Some of the low berm at high tide level – near the fence – was eroded. However, a tsunami deposit of well-sorted fine to medium sand (maximum thickness of 7 cm) was deposited over the grassy area beside the pizzeria (Figs. 67 and 68) and up to approximately 175 m inland (Fig. 69).

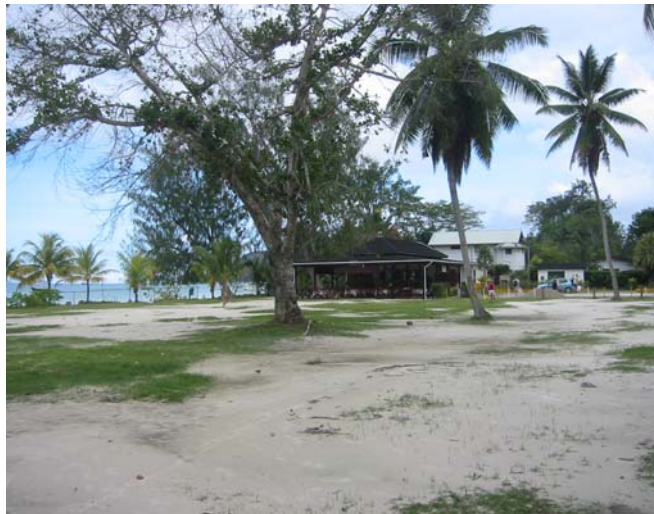
Fig. 68: Discontinuous sheet sand deposited by tsunami in park beside restaurant (in background). Photo: DLF (GSC), 28 Jan 2005.

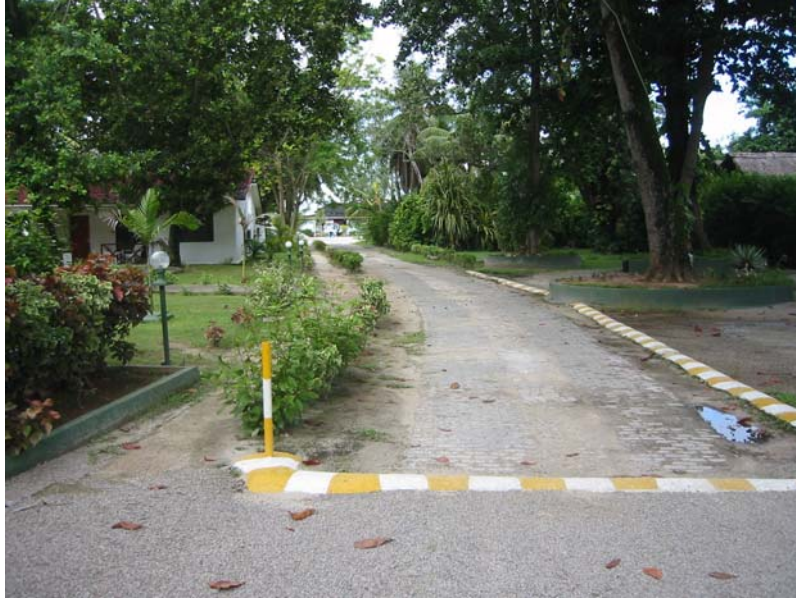
Fig. 69: Sand deposited beside speed bump 175 m inland (looking seaward to beach beyond buildings in far distance). Photo: DLF (GSC), 28 Jan 2005.

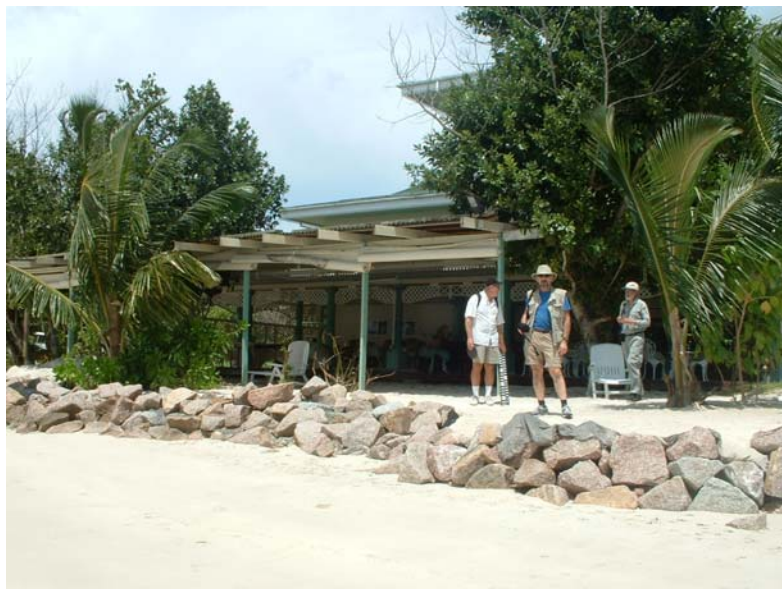
Fig. 73: Palm Beach Hotel, Grand Anse, Praslin. Note the low granite rip rap that supposedly provides defense against waves. The natural berm is gone and the coast is constrained. Photo: JS (GSC), 28 Jan 2005.

**Remarks:** Almost invariably damage occurred where hotel structures have been sited directly on beaches (Fig. 73), and where natural beach processes have been restrained by roads, structures, and in this instance, groynes. The rip rap is a clue to an existing problem. The manager was very forthcoming and provided photographs and also a dramatic video showing the floodwater rushing through the bar.
