**Activities in El Salvador  
In Support of the  
Hurricane Mitch  
Reconstruction Program**

**A Final Report Submitted to  
The U.S. Agency for International Development**

**U.S. Geological Survey**

**May 2002**

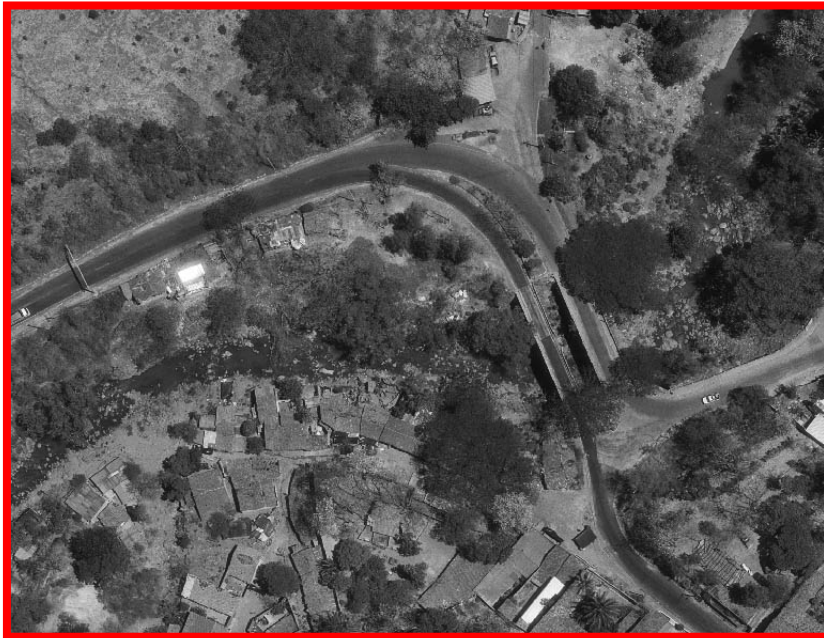
The figure to the left shows a bridge over the Rio Ticuisa in the town San Vicente. Most of the aerial photography flown over El Salvador was flown at a scale of 1:40,000, however high-resolution scanning of negatives produces images with resolutions of 2-3 feet, equivalent to much larger scale photography.

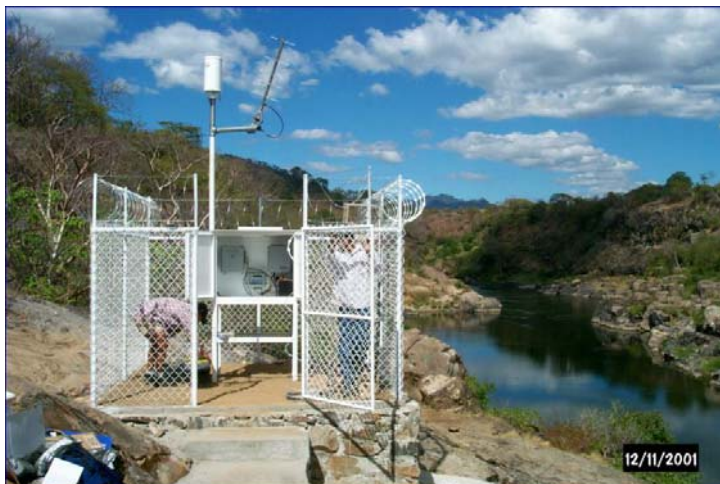
Figure 2. Streamflow monitoring station Río Lempa near San Gregorio.

Real-time transmission of data from hydrologic monitoring stations is new to El Salvador – the technology implemented in El Salvador is the same as that used by the USGS in the United States. Each station transmits hydrologic data via satellite, which is received in real-time by downlink stations in El Salvador and Puerto Rico. There are two modes of operation: 1) normal mode, in which hydrologic data collected every 15 minutes are transmitted via satellite at 3-hour intervals; and 2) emergency mode, in which hydrologic data are transmitted as frequently as every 5 minutes during periods of flooding or heavy rainfall. An example of the streamflow gaging stations installed as part of the USGS program in El Salvador is shown in Figure 2.

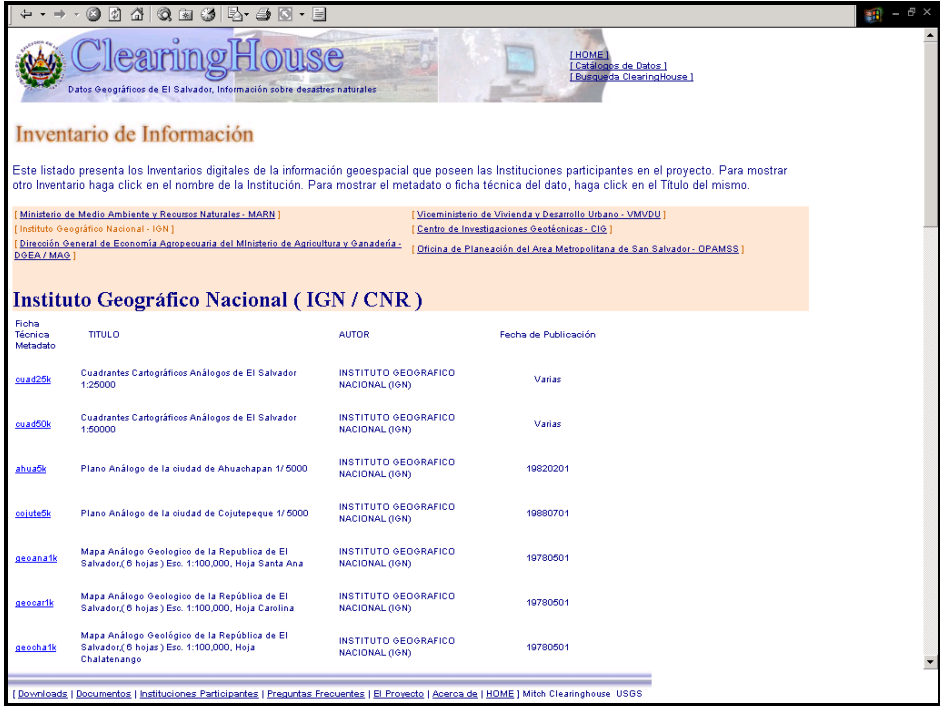
The screenshot shows the 'ClearingHouse' web application. At the top, there is a header with the logo and navigation links: [HOME], [Catálogos de Datos], and [Búsqueda ClearingHouse]. Below the header, the main section is titled 'Inventario de Información'. It contains a paragraph explaining the purpose of the inventory and instructions for users. A list of participating institutions is provided, including the Ministerio de Medio Ambiente y Recursos Naturales (MARN), Instituto Geográfico Nacional (IGN), Dirección General de Economía Agropecuaria del Ministerio de Agricultura y Ganadería (DOEA/MAG), Viceministerio de Vivienda y Desarrollo Urbano (VMVDU), Centro de Investigaciones Geotécnicas (CIG), and Oficina de Planeación del Área Metropolitana de San Salvador (OPAMSS). The main content area is titled 'Instituto Geográfico Nacional (IGN / CNR)' and displays a table of geospatial data inventories. The table has four columns: 'Ficha Técnica / Metadato', 'TÍTULO', 'AUTOR', and 'Fecha de Publicación'. The data rows include various maps and plans, such as 'Cuadrantes Cartográficos Análogos de El Salvador' and 'Plano Análogo de la ciudad de Ahuachapán'.

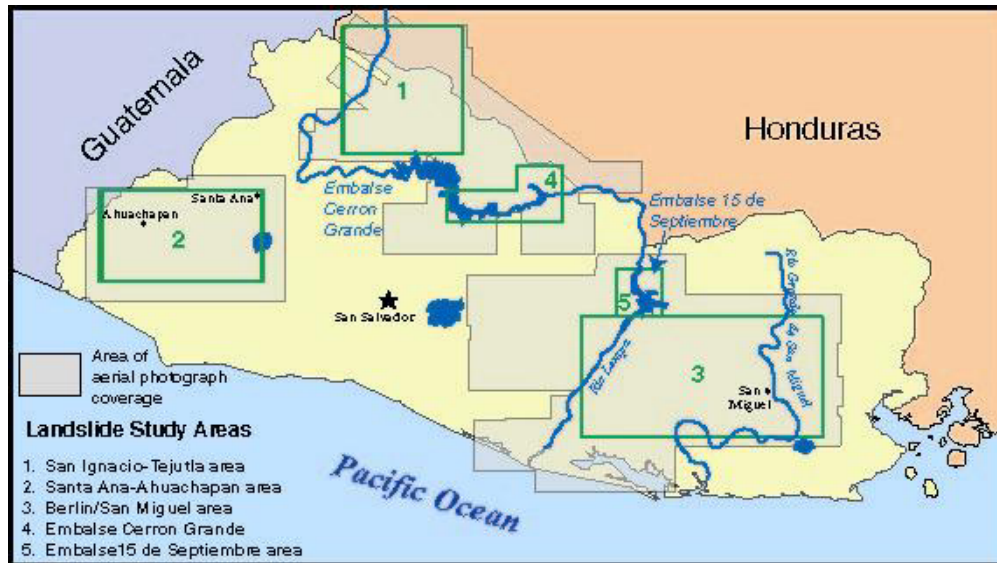
**Figure 1.** General location map of El Salvador and the landslide study areas. Areas 1, 2, and 3 were the initially defined study areas, areas 4 and 5 were added because of concerns about the possible effects of landslide on two large reservoirs. Shaded areas show the coverage of aerial photographs that were examined in this study.

**Accomplishments:** We completed detailed mapping of landslides and slope failures in five widely separated study areas throughout the country (Figure 1). These study areas were initially defined on the basis of recommendations from Salvadoran colleagues and officials, but they were further enlarged when we obtained aerial photographs that covered larger areas than those originally defined as study areas. In total, we thoroughly examined photography that covered an area of 11,490 km<sup>2</sup>, which is more than 50 percent of the country (Figure 1). Ultimately, we prepared a report and 11 plates at 1:50,000-scale showing maps of hurricane-induced landslides.

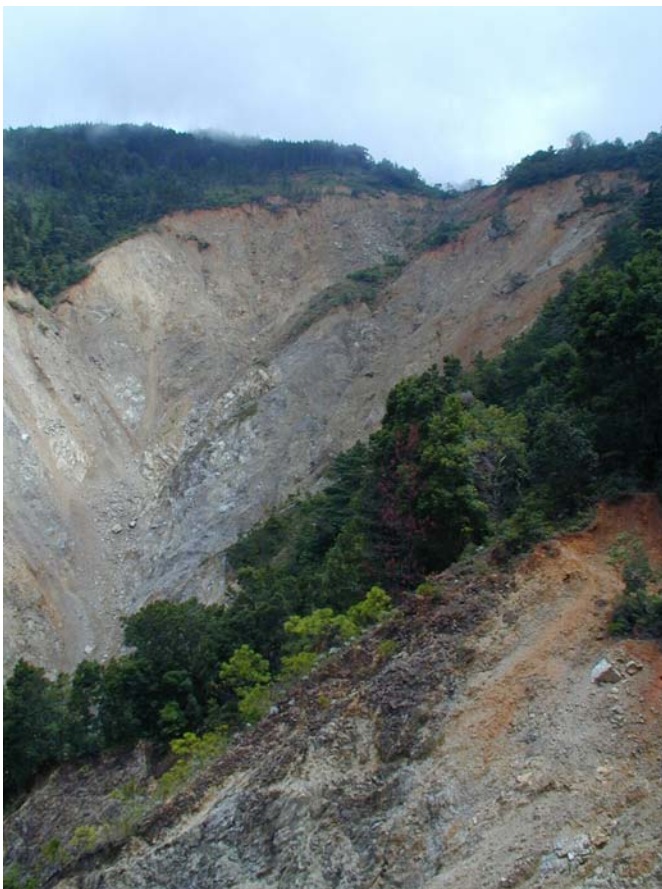
**Figure 2.** View to the northeast of the upper part of El Zompopera landslide. The collapse of unstable blocks in the upper part of the landslide destroyed a road at the crest of the ridge. Many unstable blocks remain in the upper part of the slide and a catastrophic collapse of those blocks could potentially dam the Río La Palma at the bottom of the valley. A catastrophic failure of a landslide dam could cause flooding and damage in the downstream town of La Palma.

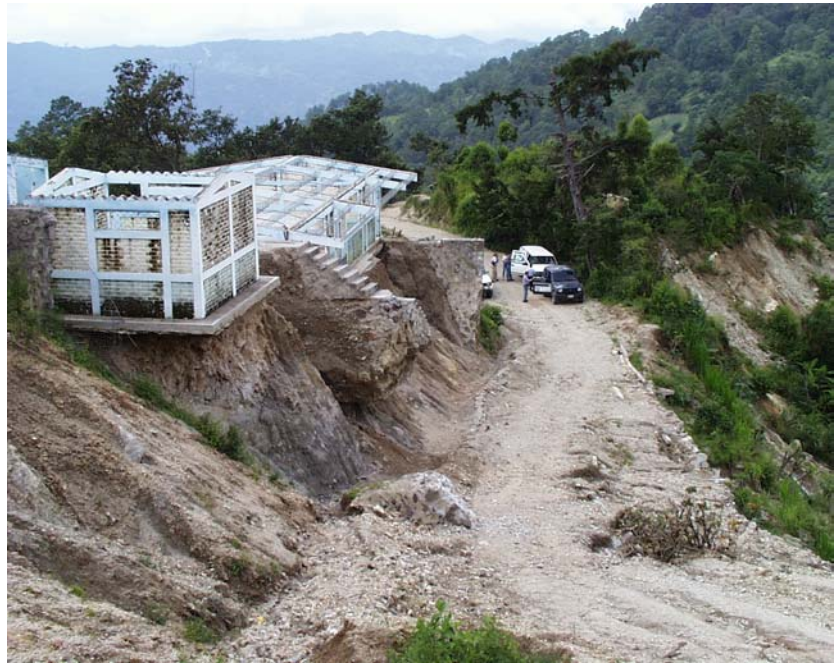
**Figure 3.** View of the El Pinar landslide and the abandoned school. A new road has been graded across the head of the landslide, which slid into the valley of the Río La Palma o Las Pozos on the right. Future movements on the landslide will likely disrupt the new road

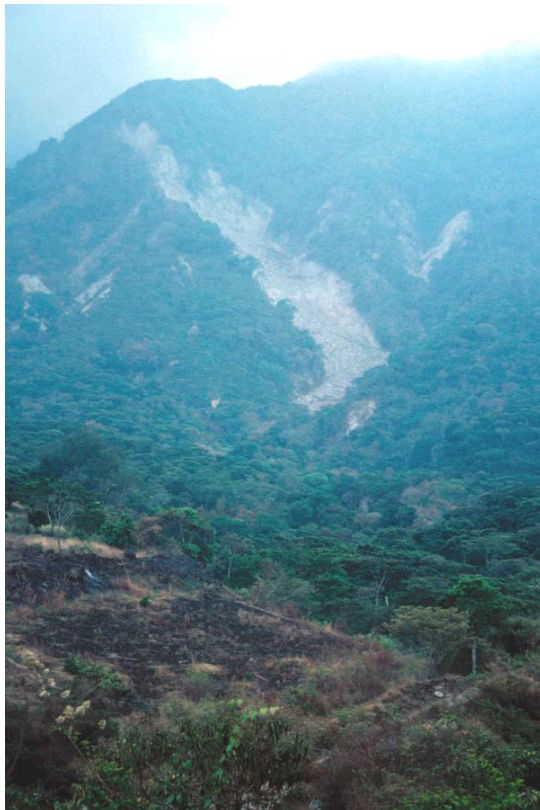
Figure 2 - photo of landslide at San Vicente volcano triggered by Feb 2001 earthquake

4. In response to landslides triggered at San Vicente volcano by the February 2001 earthquake, the local USAID mission as well as representatives from SNET requested that we expedite the lahar hazard analysis for San Vicente volcano. We sent them an advance map of the hazards analysis, and they used this map to discuss areas of potential hazard in the village of Guadalupe as residents rebuilt in the aftermath of the earthquake. Such discussions may have been partly responsible for minimizing the number of fatalities from a landslide/lahar triggered by rainfall in September 2001.

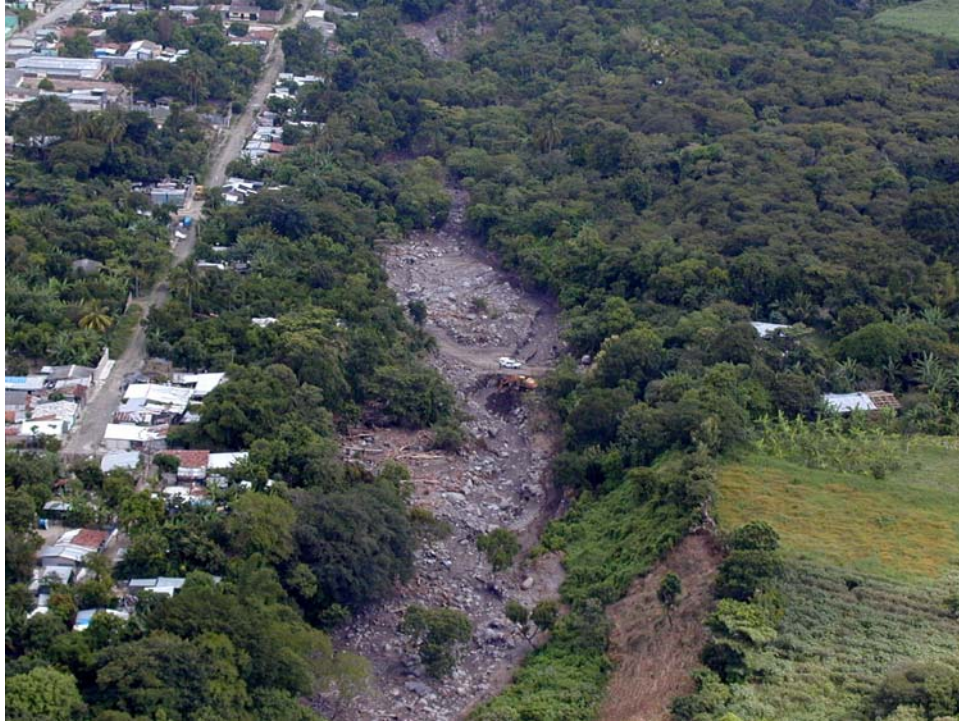
Figure 3 - Photo of September 2001 debris flow in Guadalupe

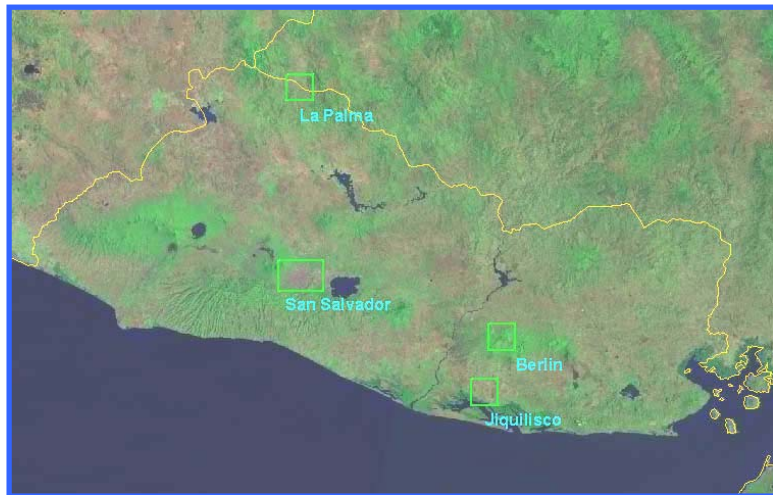
The main purpose of these Municipal GIS project was to provide municipal governments new maps, aerial photographs, natural hazard data, hardware, software and training for natural disaster preparedness, mitigation and urban development. The four sites chosen for this effort by the SICA and the GOES were San Salvador, La Palma, Jiquilisco, and Berlin (see figure to right).
