Interdisciplinary Observations on The January 2001 Bhuj, Gujarat Earthquake

April 2001

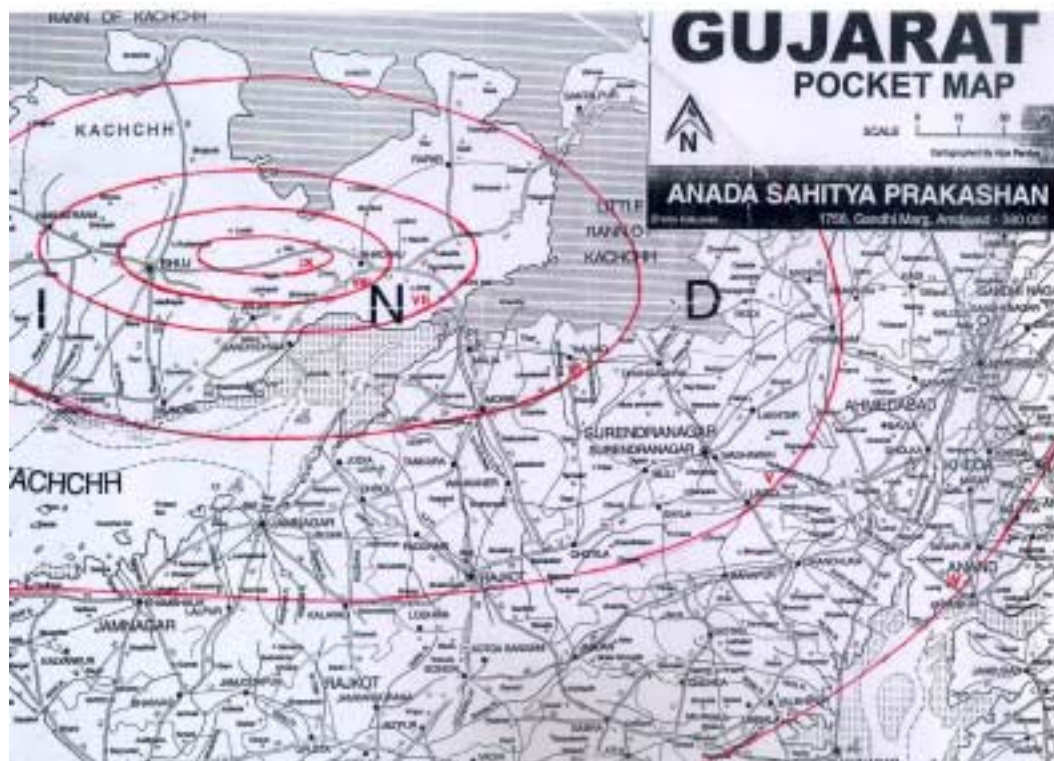
Figure 2.3. Preliminary map of the MSK intensity distribution in Gujarat due to the January 26, 2001 earthquake. Map courtesy of Ahmad Naderzadeh.

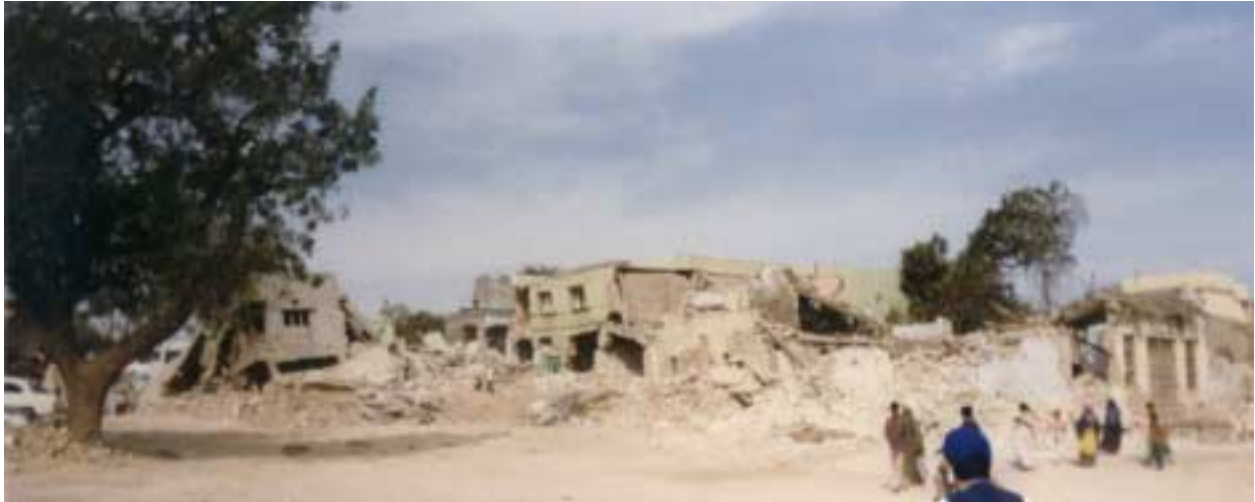
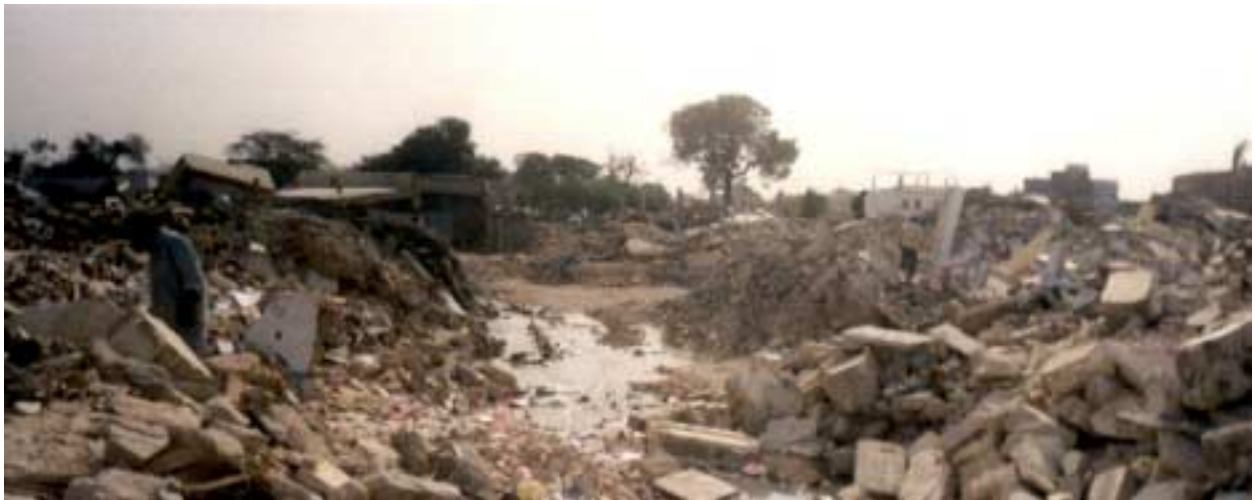
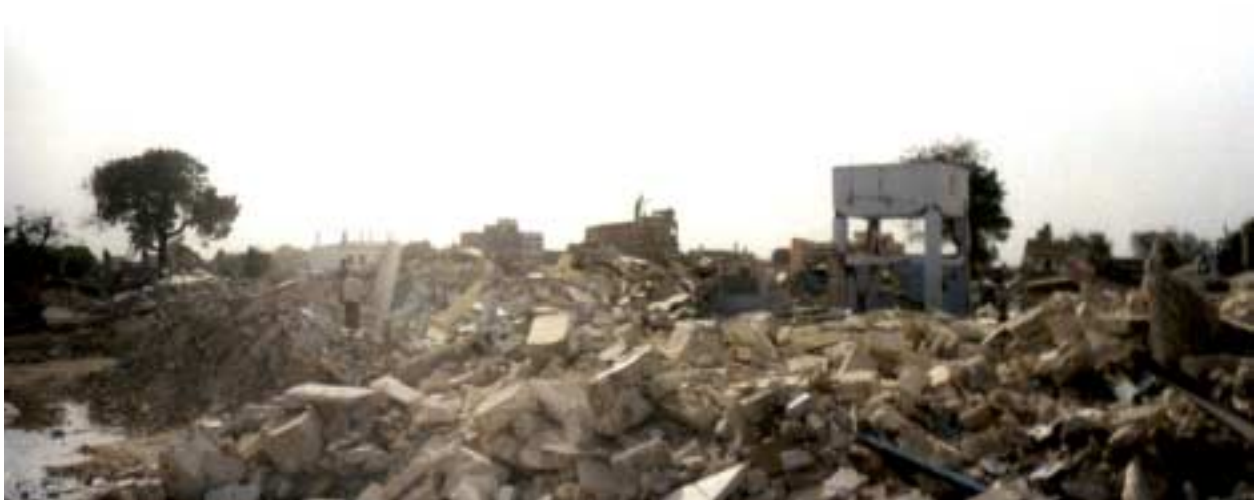
Figure 2.4. Destruction of masonry structures in the old section of Anjar. Photos courtesy of Charles Menun.

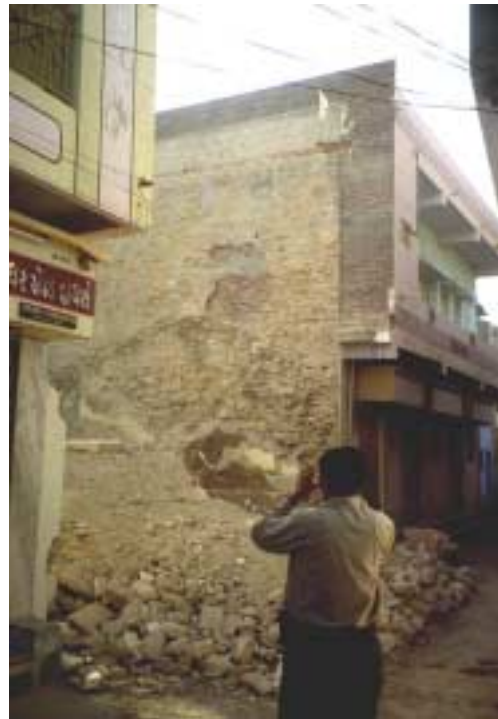
Figure 2.6. Damage in Morbi showing the variable performance of adjacent buildings. Photos (a) and (b) courtesy of Svetlana Uranova. Photo (c) courtesy of Charles Menun.

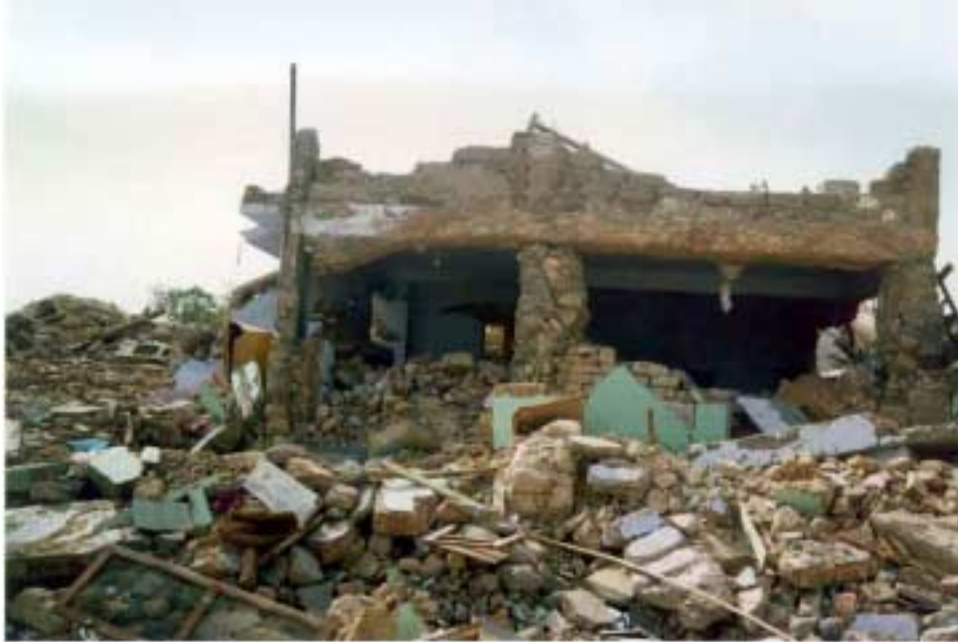
Figure 2.7. Damage to a stone masonry house in Anjar. Photo courtesy of Ahmad Naderzadeh.

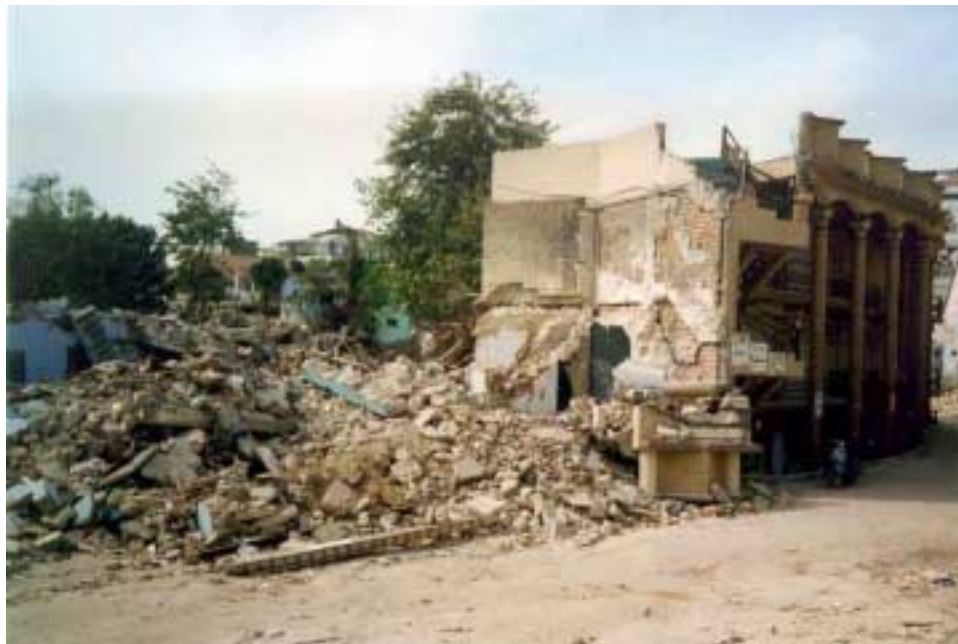
Figure 2.8. Collapse of a stone masonry house in Anjar. Photo courtesy of Ahmad Naderzadeh.

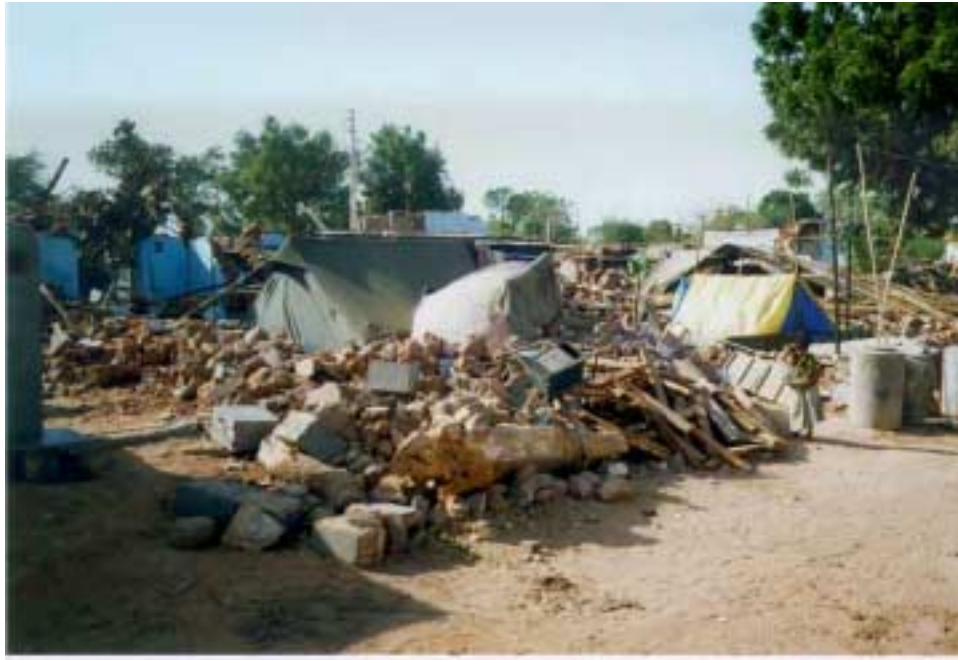
Figure 2.9. Destruction in Bhachau. Photo courtesy of Ahmad Naderzadeh.

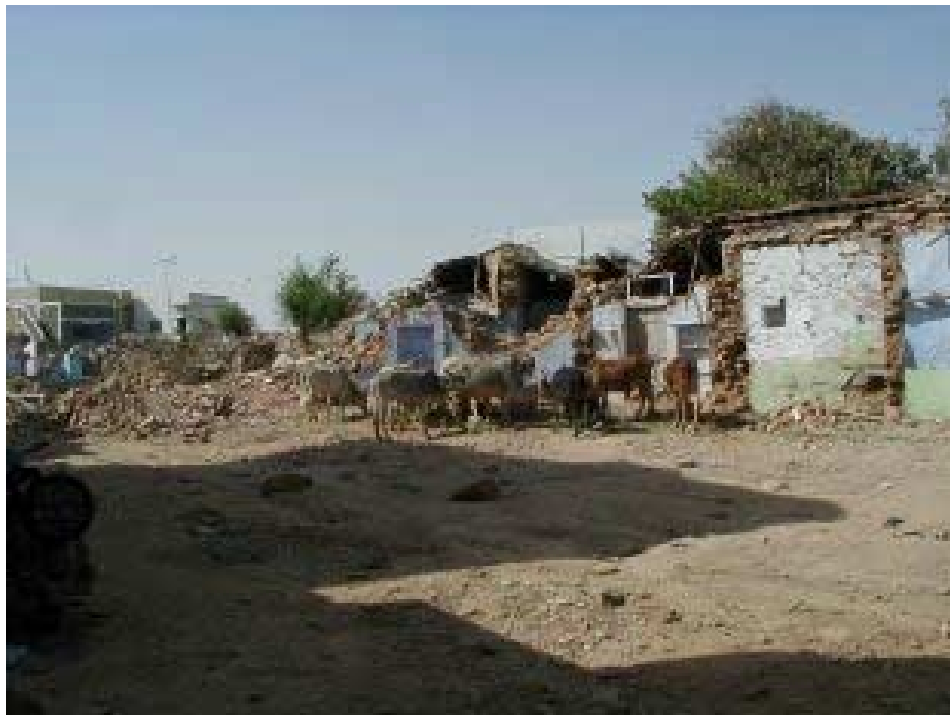
Figure 2.10. Most stone houses in the old town of Bhuj collapsed. Photo courtesy of Tetsu Masuda.

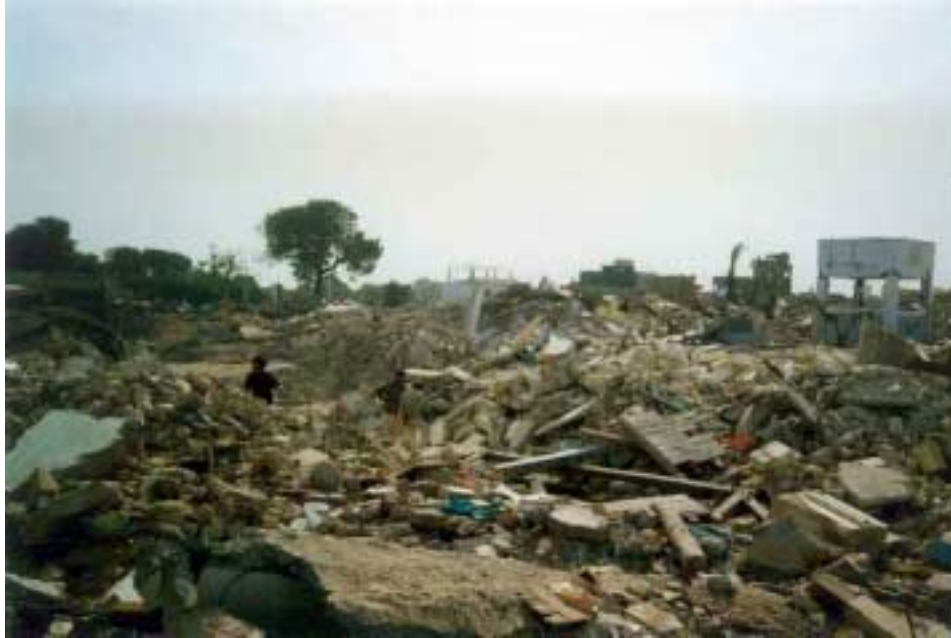
Figure 2.11. Destruction in Bhuj. Photo courtesy of Ahmad Naderzadeh.

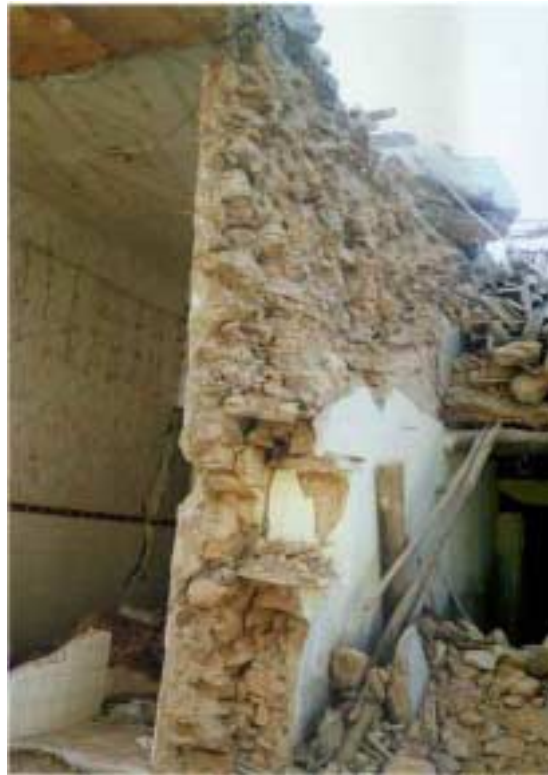
Figure 2.12. Damage to a rubble stone and mud mortar house in old Bhuj. Photo courtesy of Ahmad Naderzadeh.

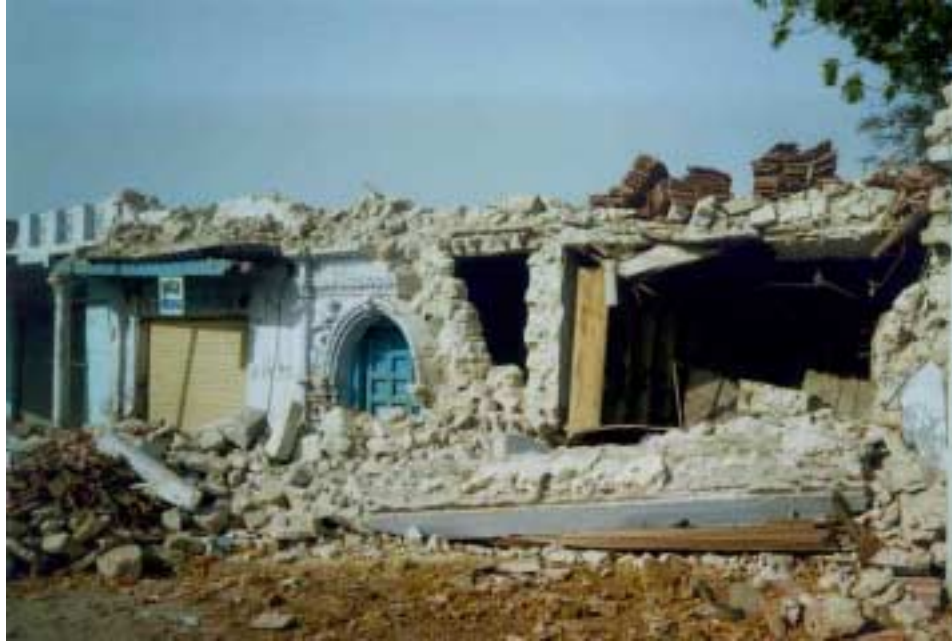
Figure 2.13. Damage to cutstone and lime mortar masonry building in old Bhuj. Photo courtesy of Ahmad Naderzadeh.

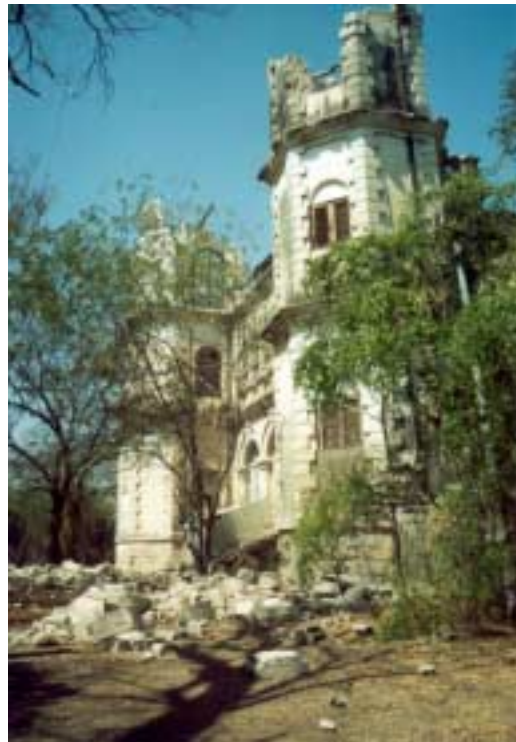
Figure 2.14. Damage to the tower and parapets of a palace in Limbdi. Photo courtesy of Svetlana Uranova.

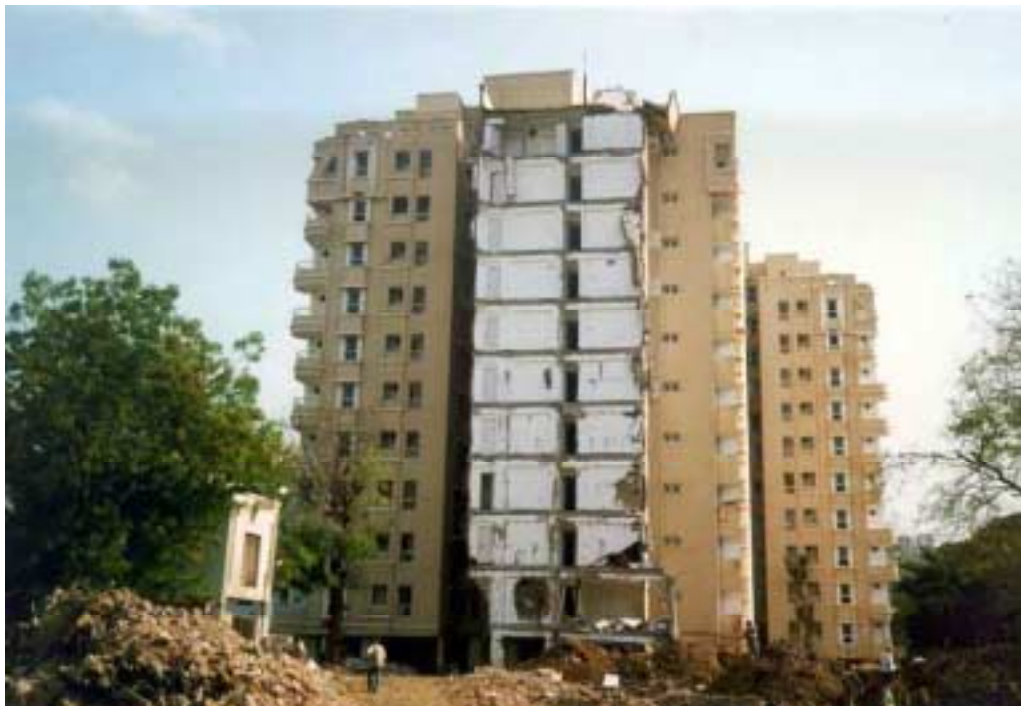
Figure 2.16. Shikhar Apartments, Ahmedabad. Building D (originally in foreground) collapsed due to soft story effects. Photo courtesy of Ahmad Naderzadeh.

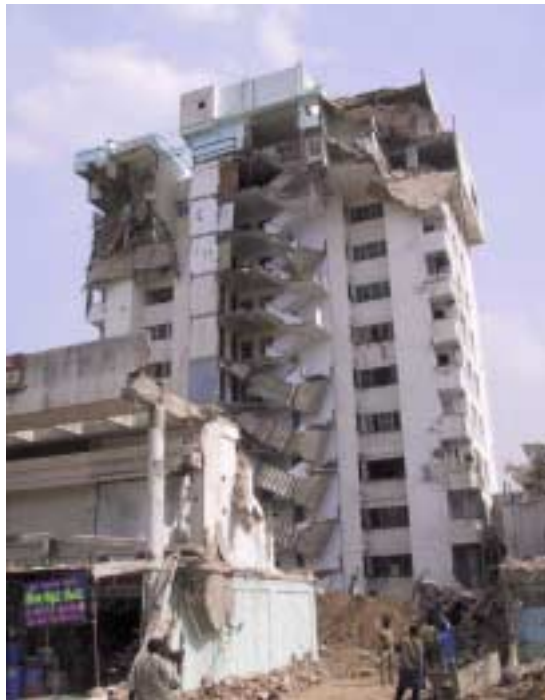
Figure 2.18. Manasi Apartments, Ahmedabad. 11-story building, in front of the building shown, collapsed due to soft story effects. Weight of swimming pool and reservoir at top of the collapsed building contributed to the severity of the damage. Photo courtesy of Weimin Dong.

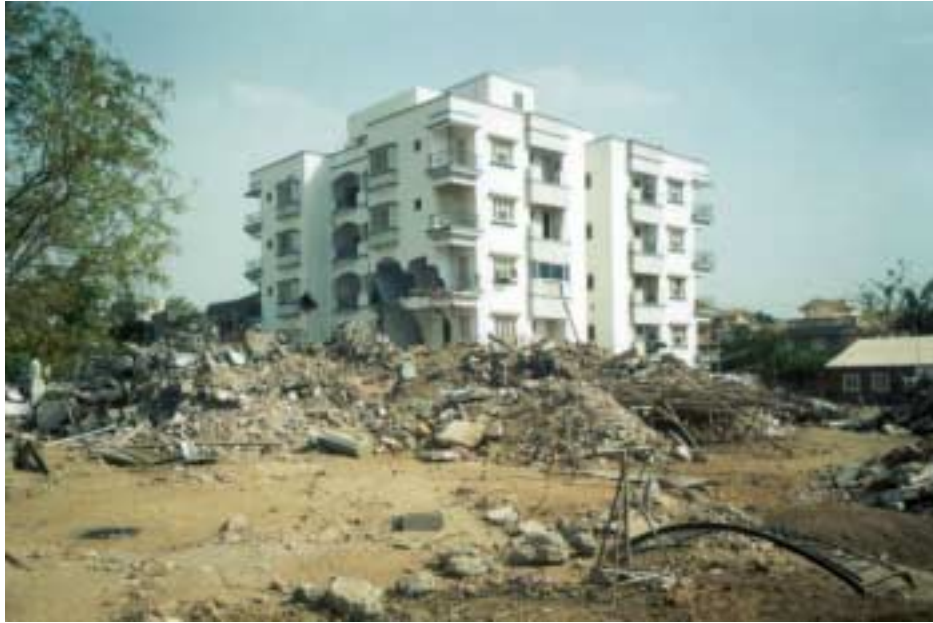
Figure 2.19. Ayodhya Apartments, Ahmedabad. Building identical to that shown collapsed as a result of soft story effects. Building in photo was significantly damaged by pounding during the collapse of the adjacent building. Photo courtesy of Svetlana Uranova.

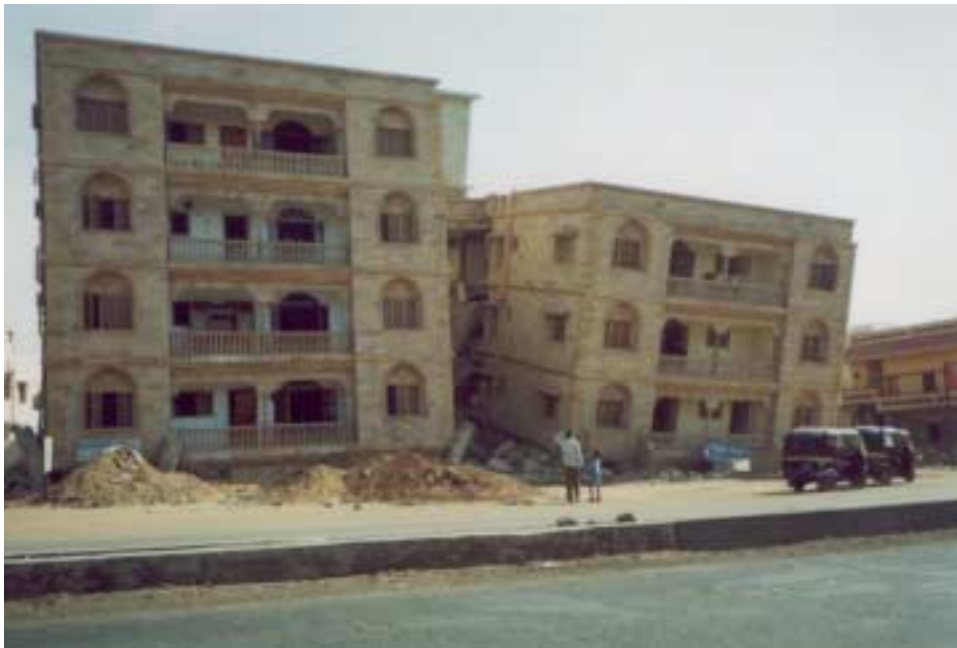
Figure 2.20. Taksila Apartments, Bhuj. Both 5-story buildings collapsed due to soft story effects. Photo courtesy of Svetlana Uranova.

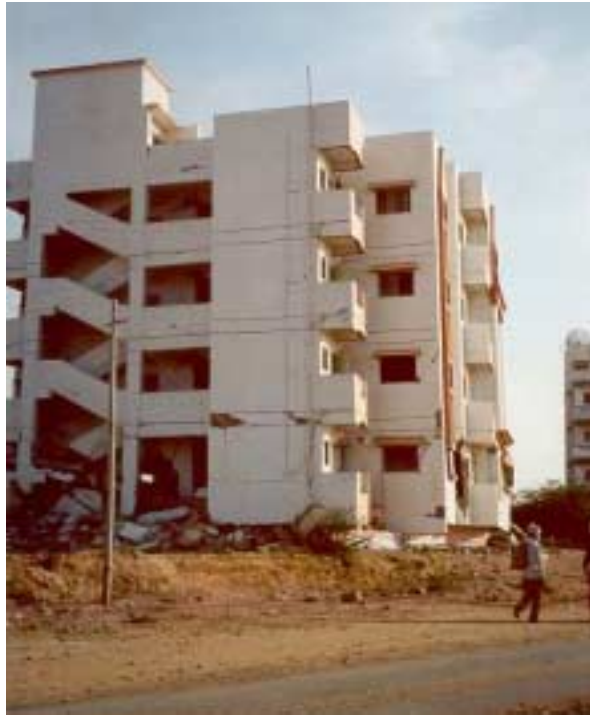
Figure 2.21. Soft story collapse of a five-story apartment building in Bhuj. Photo courtesy of Amod Dixit.

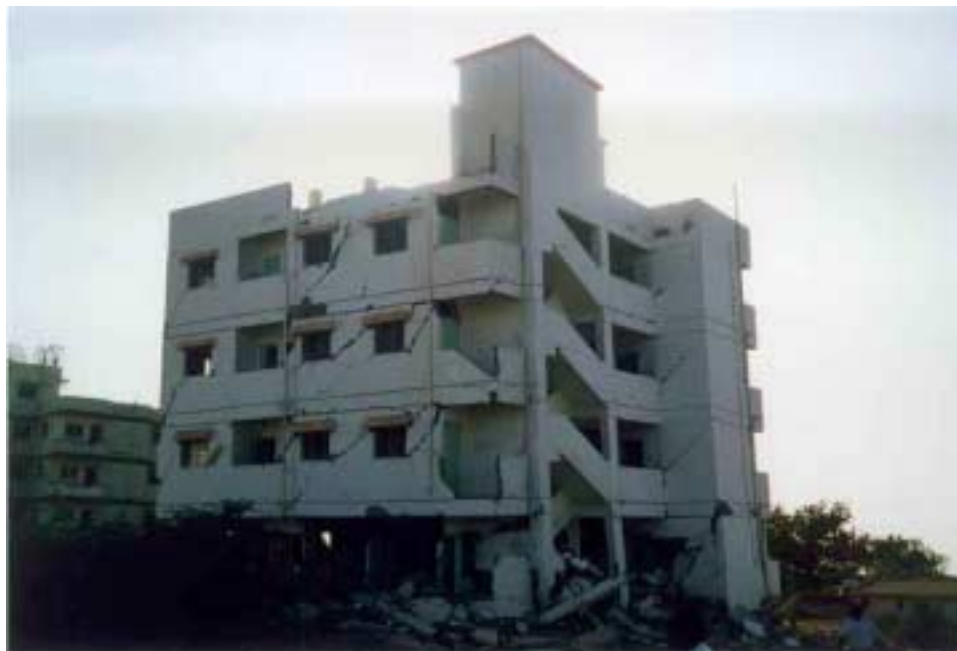
Figure 2.22. Different view of soft story collapse shown in Figure 21. Note the location of the water reservoir at the roof level relative to the floor plan. Photo courtesy of Ahmad Naderzadeh.

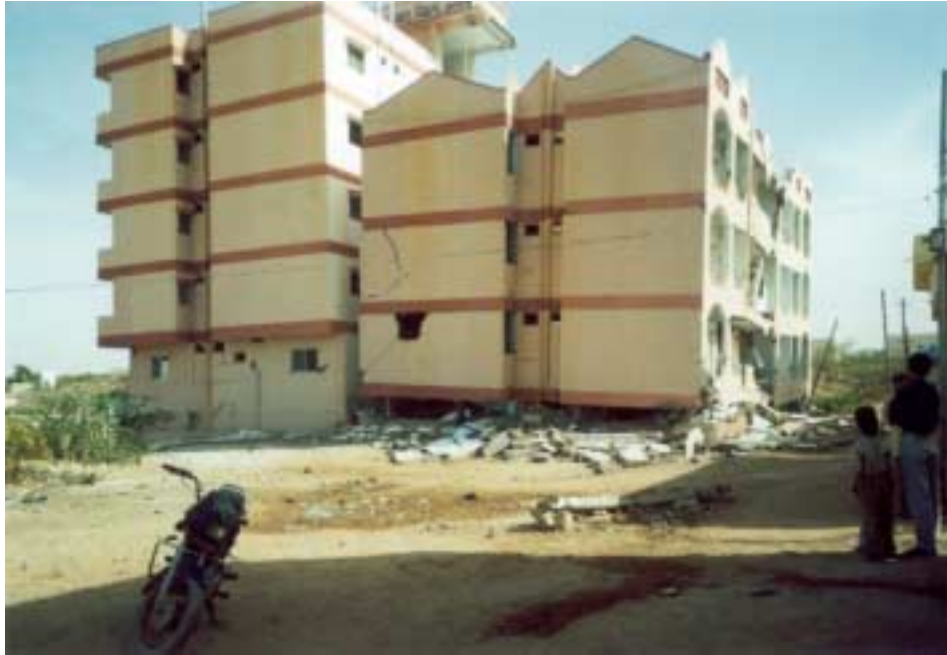
Figure 2.23. Komal Vihar Apartments, Bhuj. Collapsed building resulted from soft story effects. Photo courtesy of Svetlana Uranova.

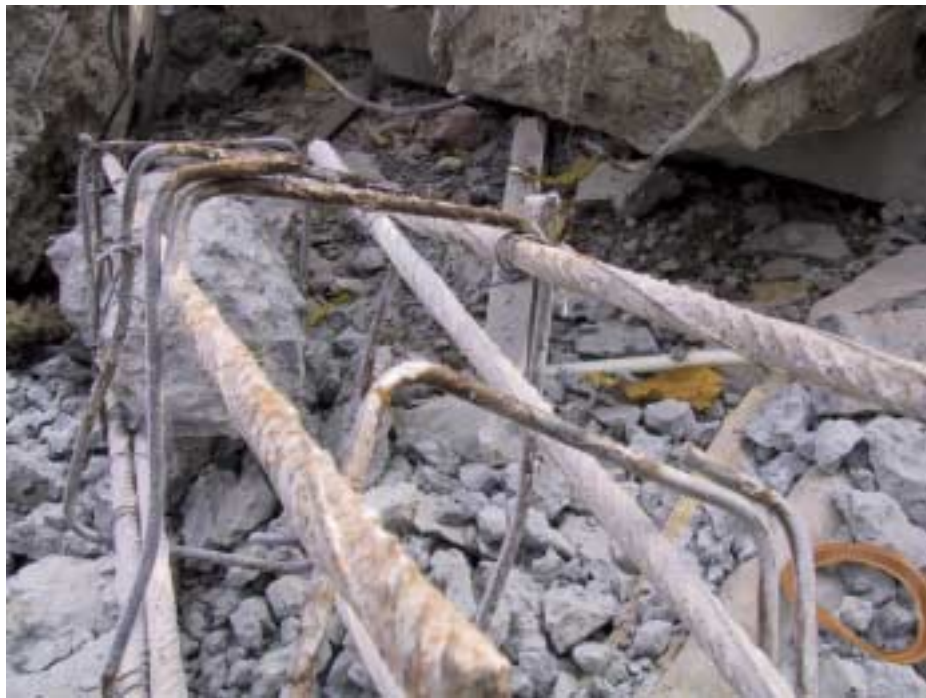
Figure 2.24. Damaged column from the Ayodhya apartment complex shown in Figure 2.19. Note the large column tie spacing and the use of 90° hooks. Photo courtesy of Weimin Dong.

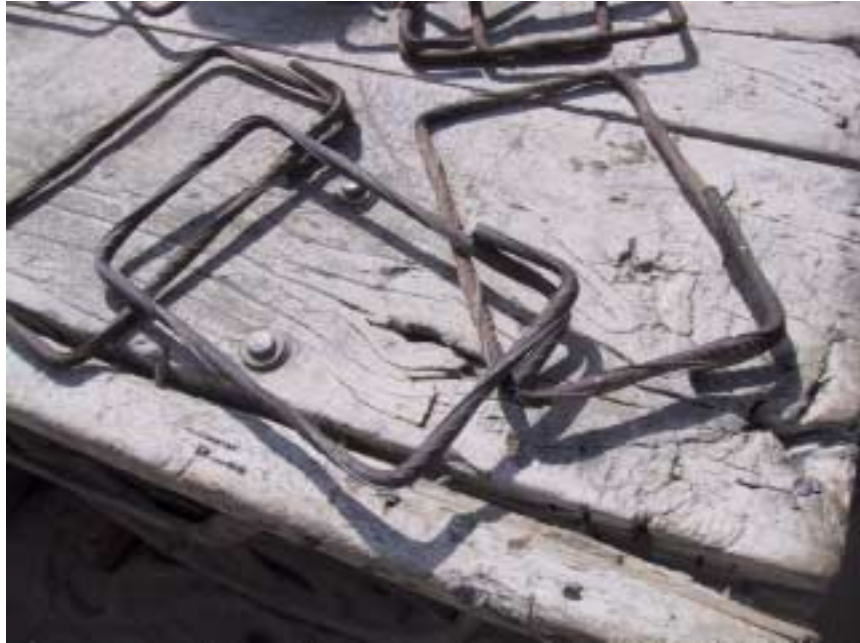
Figure 2.25. Evidence at a new construction site in Ahmedabad that 90° hooks instead of 135° hooks are still used for column ties. Photo courtesy of Weimin Dong.

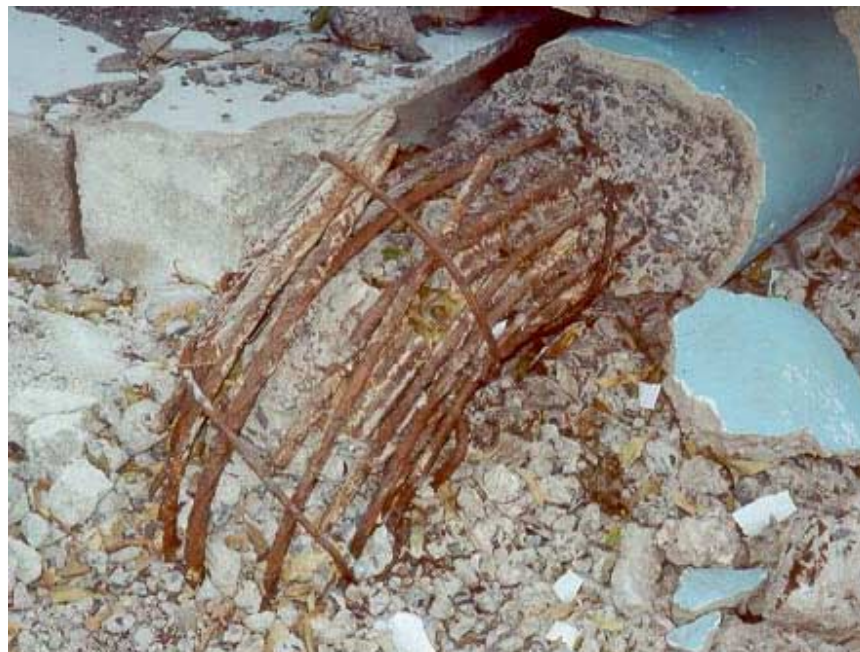
Figure 2.26. Reinforcement details of a column damaged in a soft story collapse. Note the congestion caused by lapping all of the longitudinal bars at one location. Also note the inadequate number of lateral ties over the splice length. Photo courtesy of Amod Dixit.

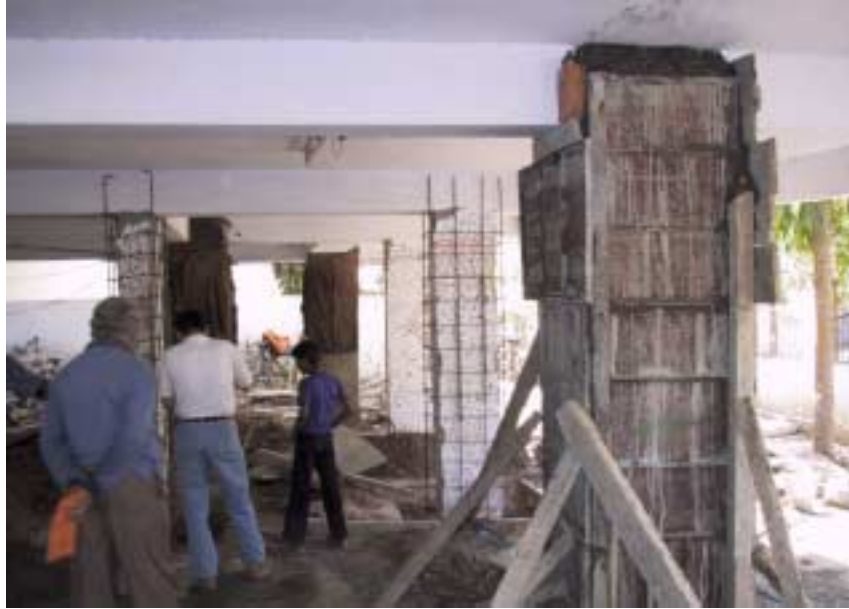
Figure 2.27. First floor of an apartment building in Ahmedabad being retrofitted without proper seismic design or details. Photo courtesy of Weimin Dong.

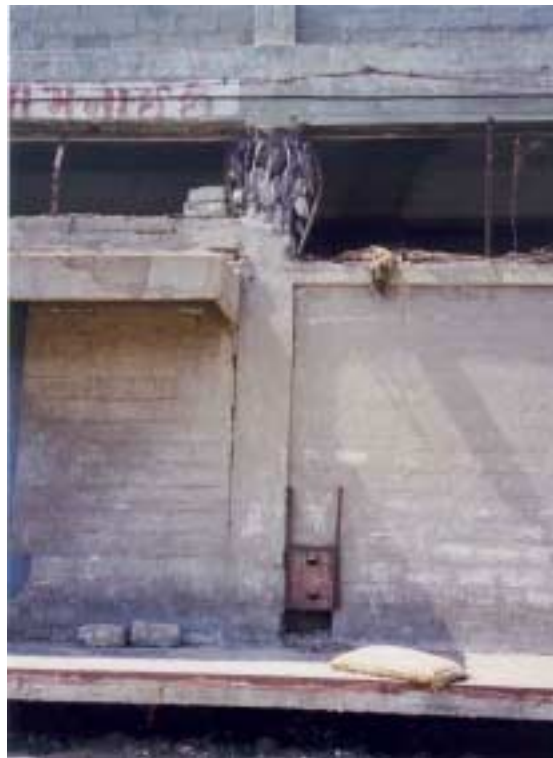
Figure 2.28. Damage due to short column effect in warehouse at the port of Kandla. Photo courtesy of Ahmad Naderzadeh.

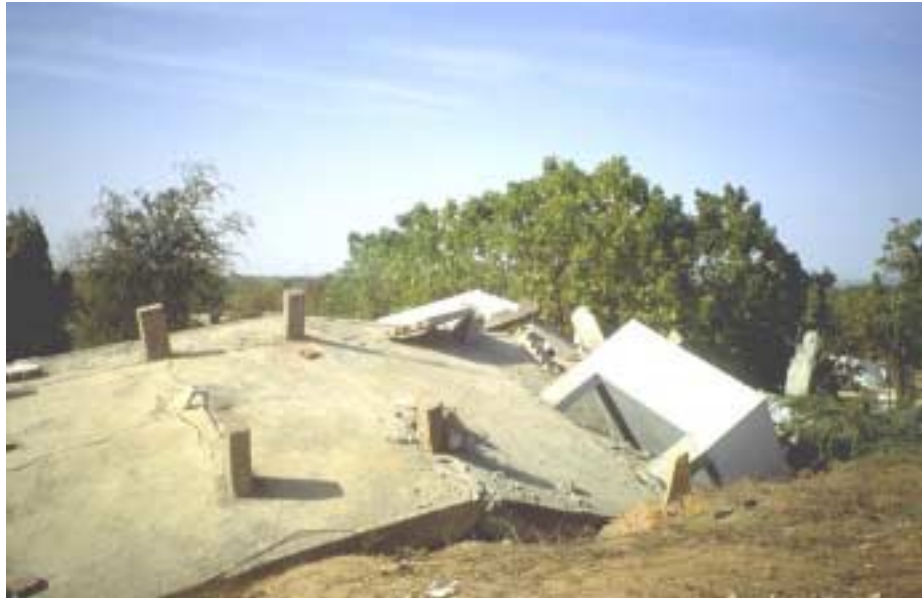
Figure 2.29. Roof level water reservoir perched on top of short columns. Location of the reservoir at a corner of the building amplified torsional motions and resulting loads. The photo shows the roof of a collapsed two-story RC building in Bhachau. Photo courtesy of Charles Menun.

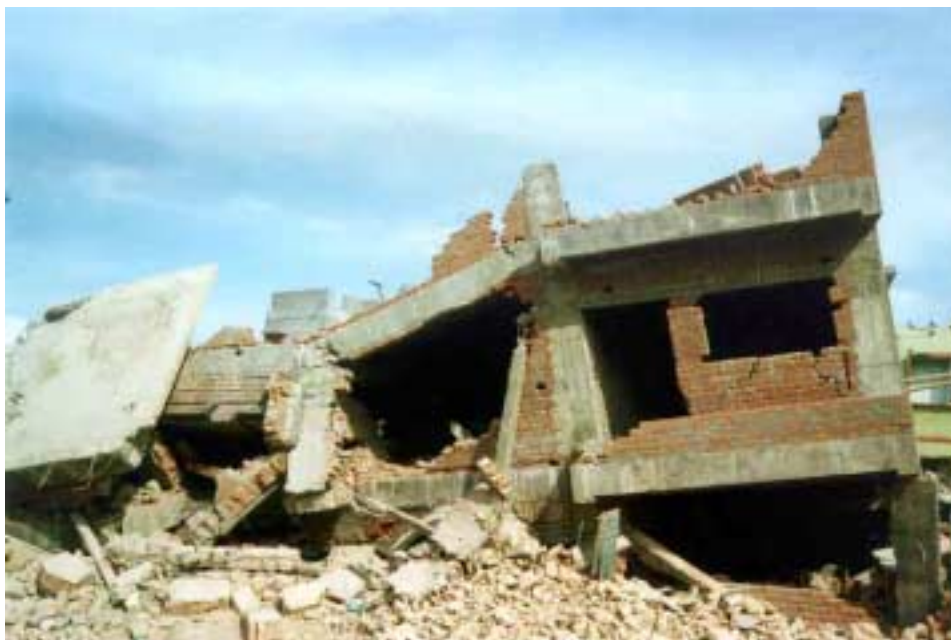
Figure 2.30. Damage caused by torsion due to unsymmetrical distribution of partition walls on the ground floor. Photo courtesy of Ahmad Naderzadeh.

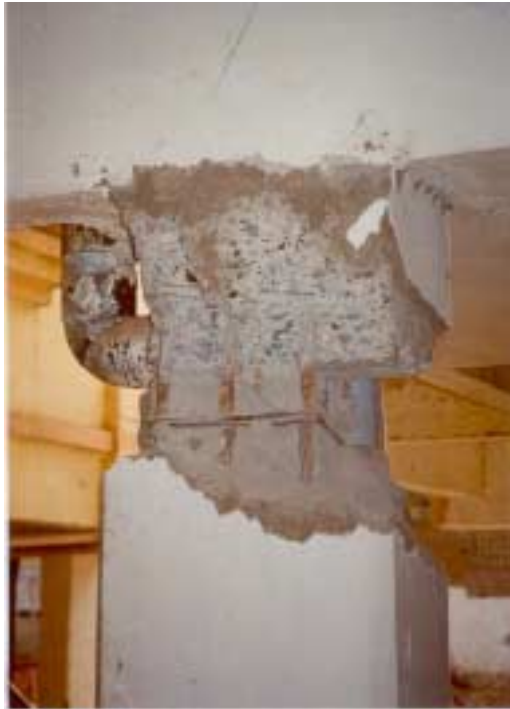
Figure 2.31. Ground floor column in Akshar Deep apartment complex, Ahmedabad. Photo courtesy of Amod Dixit.

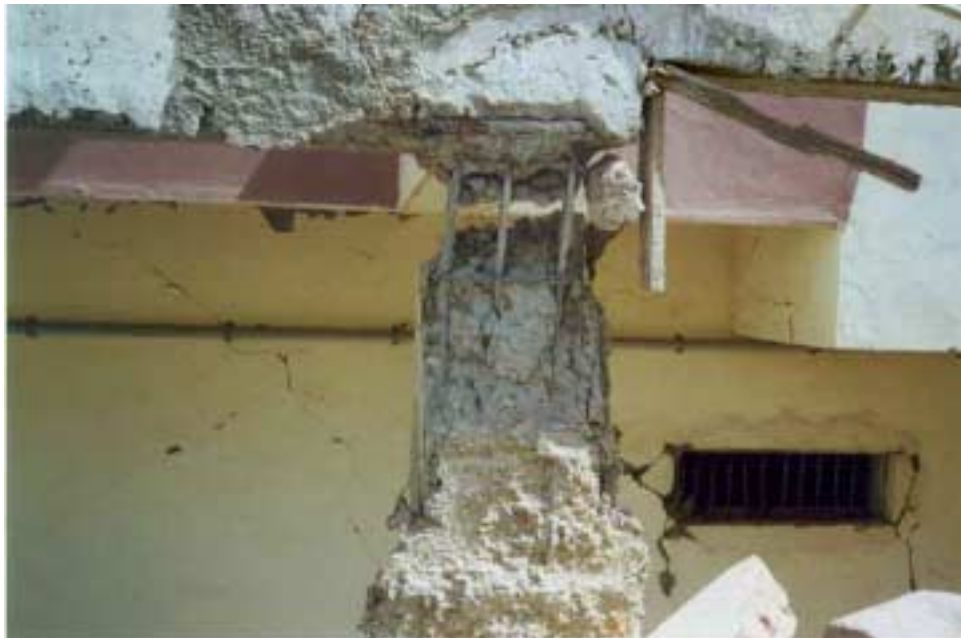
Figure 2.32. Poor quality concrete and lack of seismic detailing evident in beam column connection. Photo courtesy of Ahmad Naderzadeh.

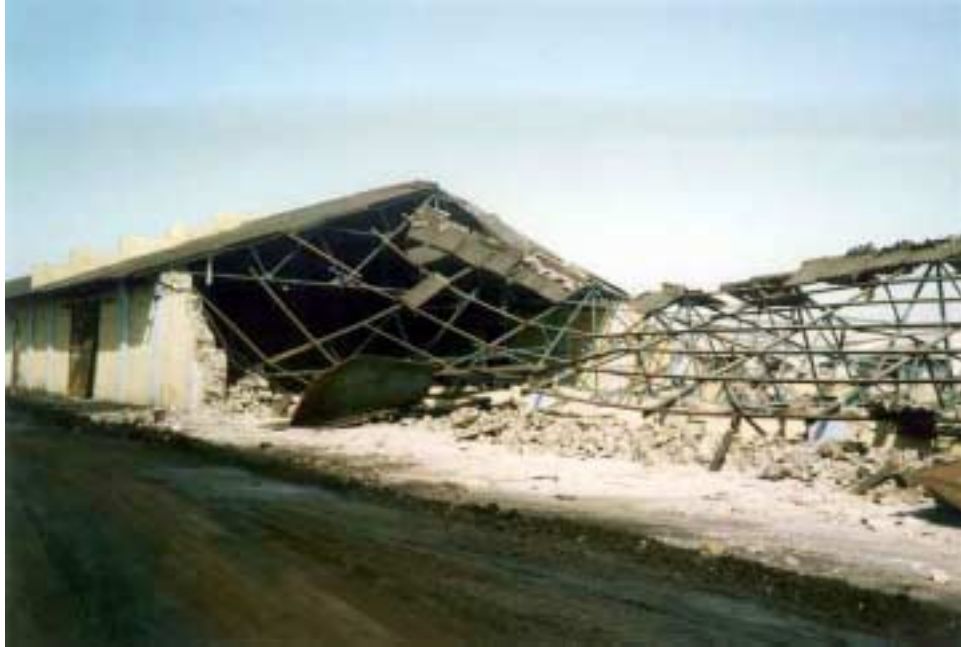
Figure 2.33. Collapse of a warehouse at the port of Navlakhi. Photo courtesy of Ahmad Naderzadeh.

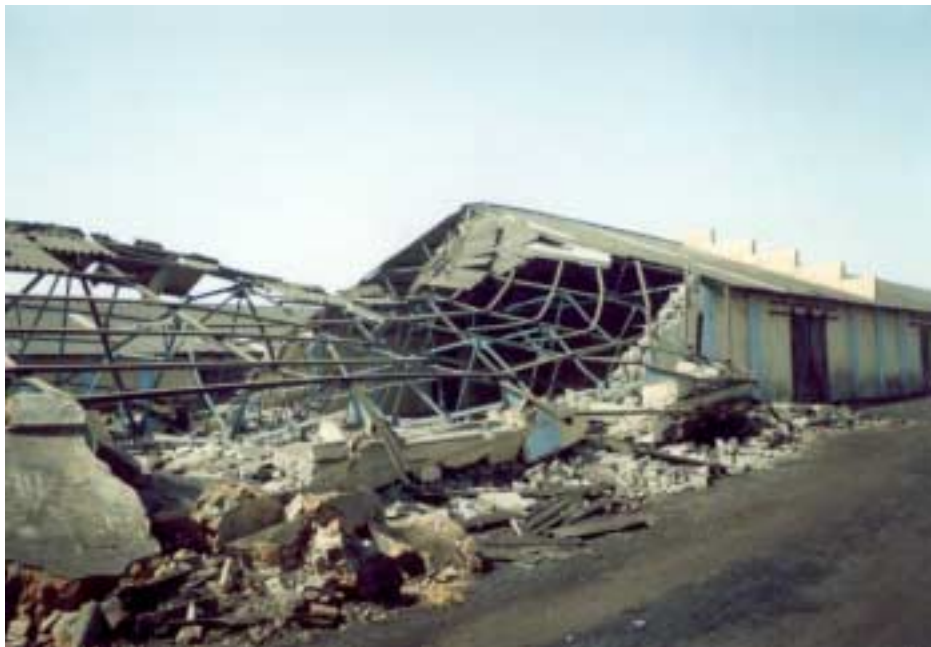
Figure 2.34. Collapse of a warehouse at the port of Navlakhi. Photo courtesy of Svetlana Uranova.

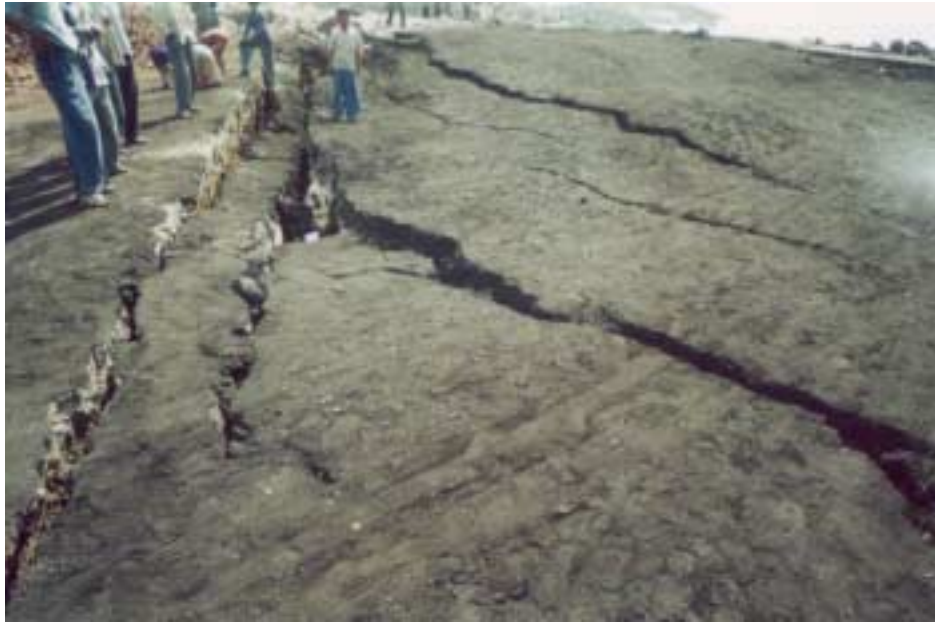
Figure 2.35. Lateral spreading due to liquefaction at the Port of Navlakhi. Photo courtesy of Svetlana Uranova.

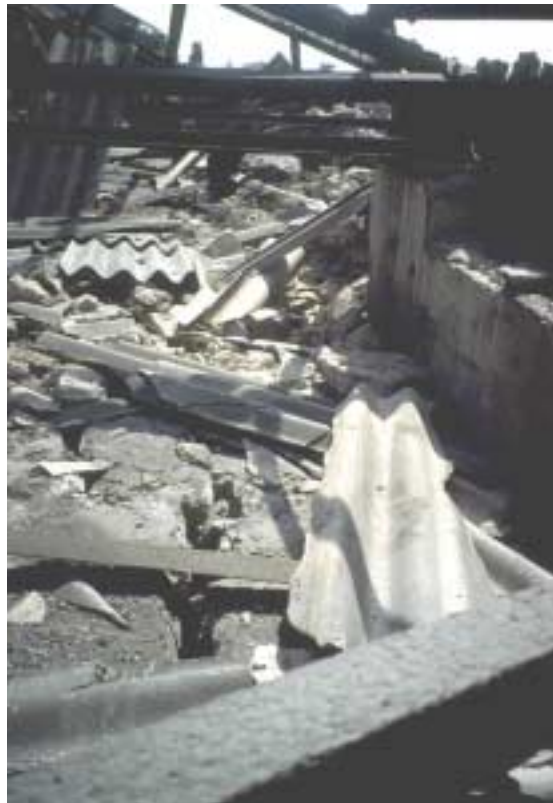
Figure 2.36. Lateral spreading due to liquefaction initiated collapse. Note the wide fissure inside the building footprint. Photo courtesy of Charles Menun.

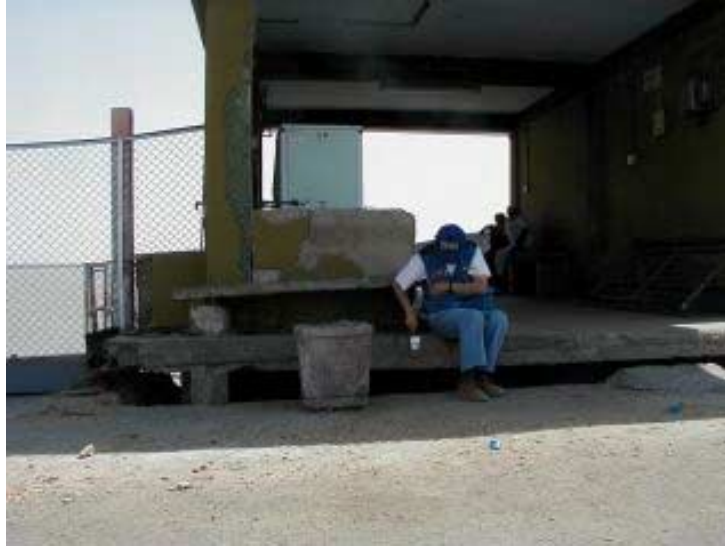
Figure 2.37. Subsidence of ground relative to pile-supported structure. Photo courtesy of Tetsu Masuda.

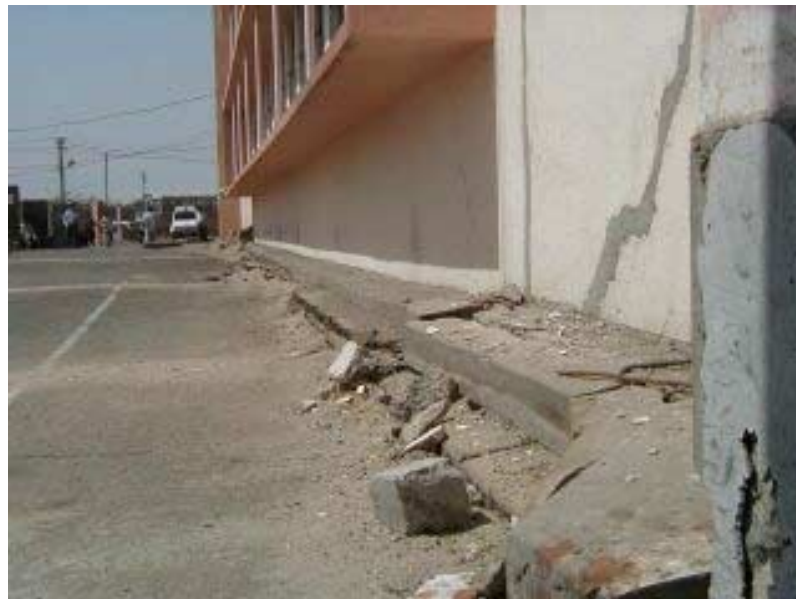
Figure 2.38. Subsidence of ground relative to pile-supported structure. Photo courtesy of Tetsu Masuda.

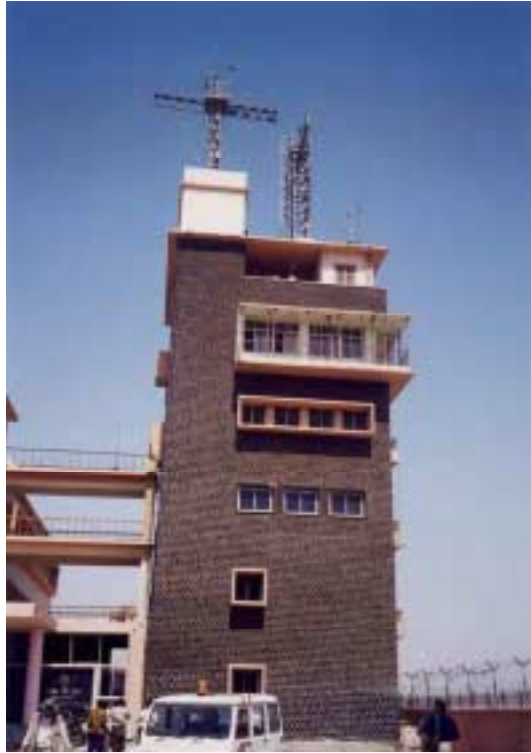
Figure 2.39. Port Authority Building, Kandla. Tilting of the control tower is due to settlement caused by liquefaction. Control tower is founded on piles. Photo courtesy of Ahmad Naderzadeh.

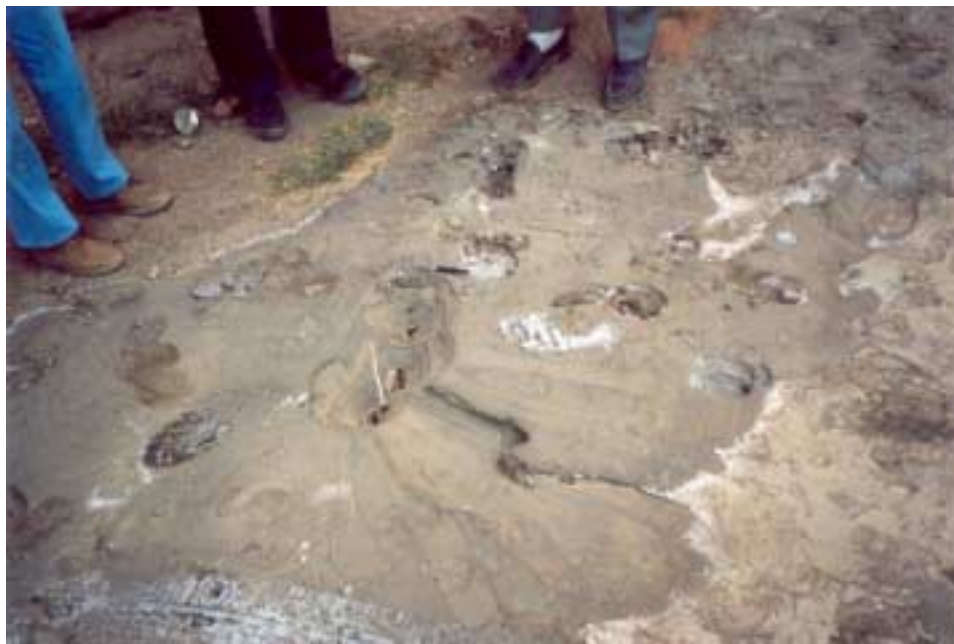
Figure 2.40. Sand boils due to liquefaction near the port of Kandla. Photo courtesy of Svetlana Uranova.

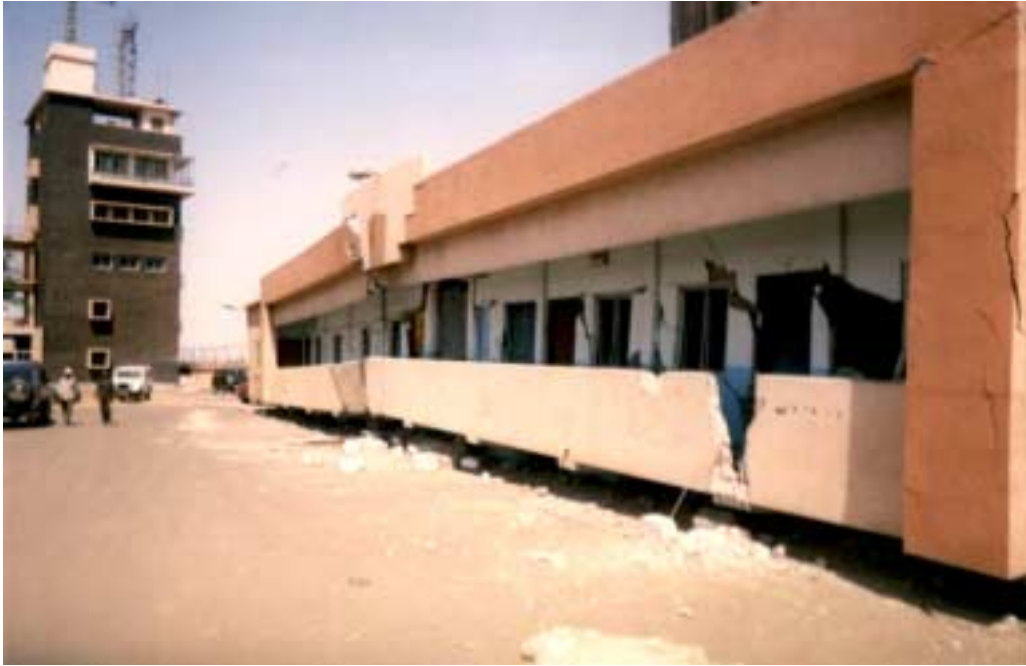
Figure 2.41. Soft story collapse of a two-story reinforced concrete building at the port of Kandla. Photo courtesy of Charles Menun.
