Interdisciplinary Observations on The January 2001 Bhuj, Gujarat Earthquake

April 2001

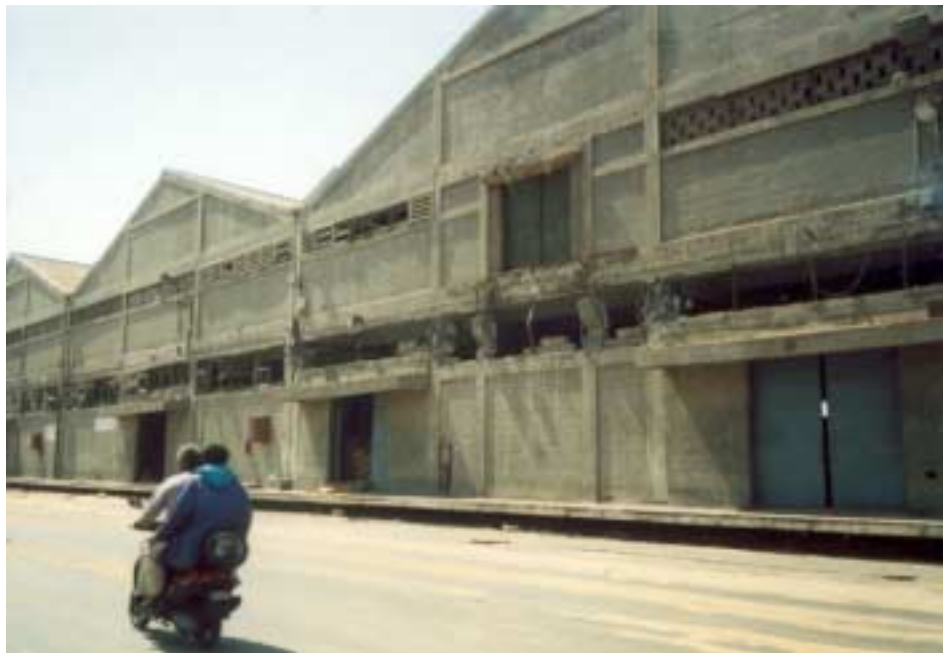
Figure 2.42. Damage to a warehouse at the port of Kandla due to short column effects. Photo courtesy of Svetlana Uranova.

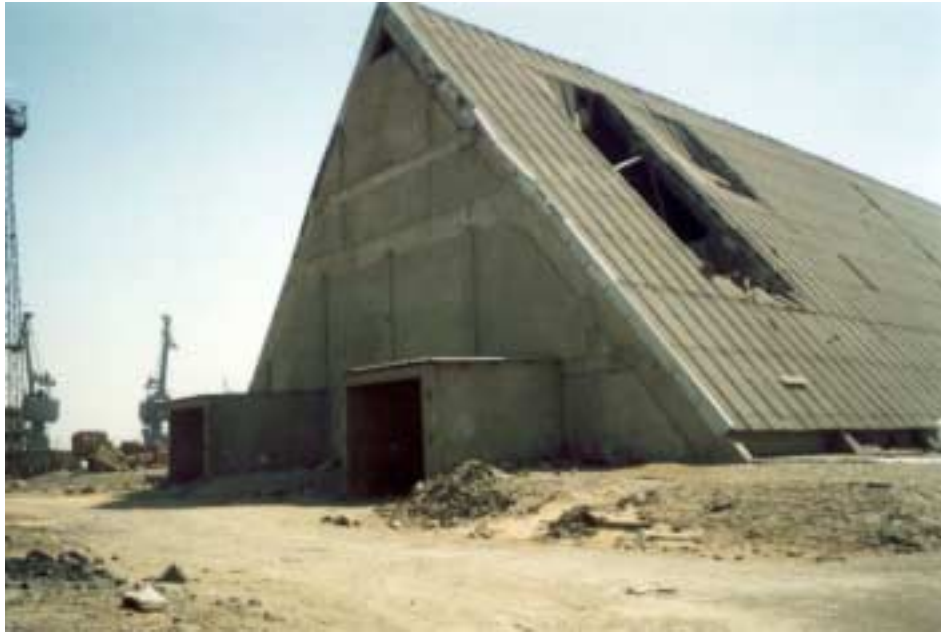
Figure 2.43. Partial collapse of roof of A-frame storage facility. Photo courtesy of Svetlana Uranova.

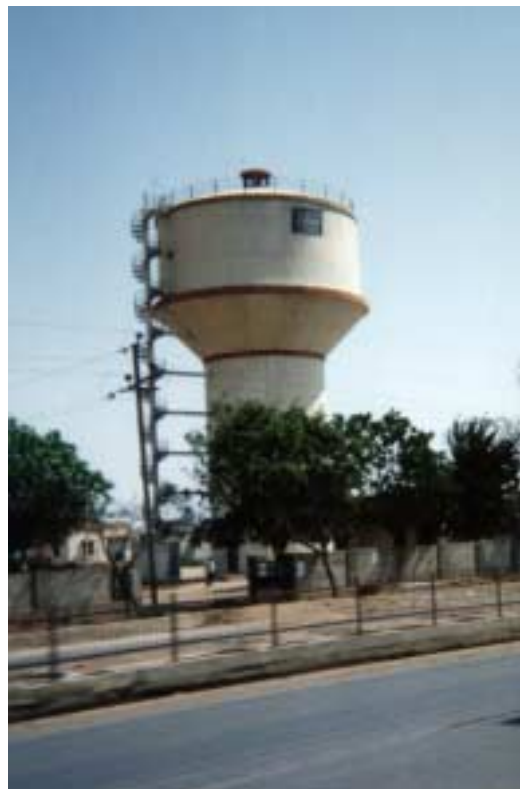
Figure 2.44. Government-designed elevated water tank near Gandhidham. No apparent damage. Photo courtesy of Charles Menun.

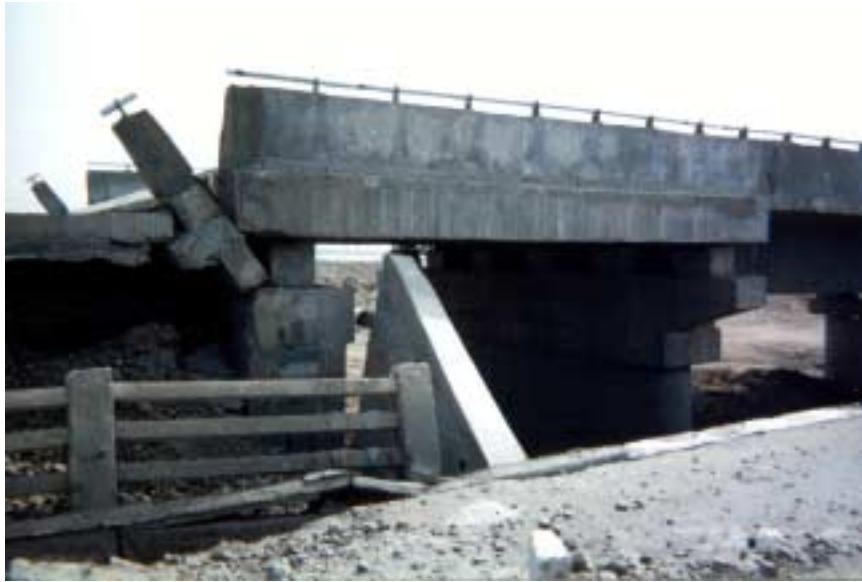
Figure 2.45. Damage to RC highway bridge under construction approximately 35 km east of the USGS epicenter. Photo courtesy of Charles Menun.

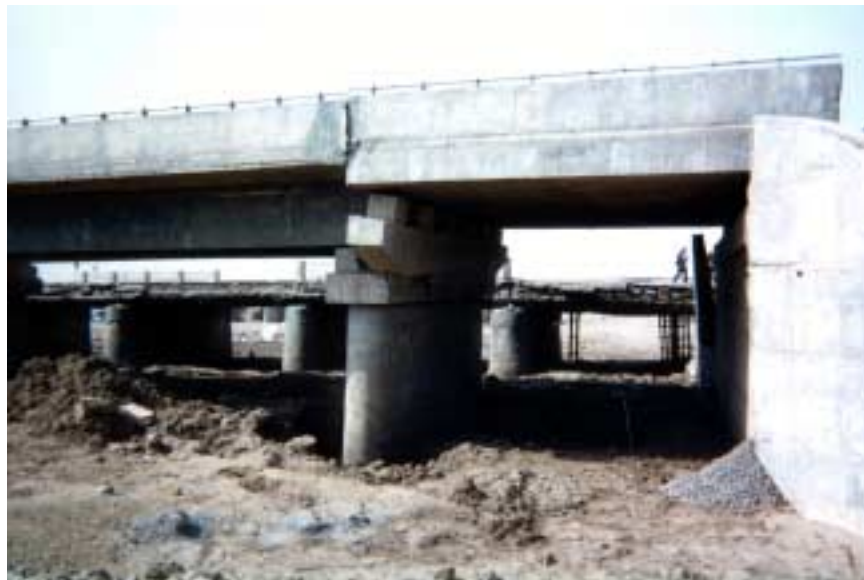
Figure 2.46. Damage to RC highway bridge under construction approximately 35 km east of the USGS epicenter. Photo courtesy of Charles Menun.

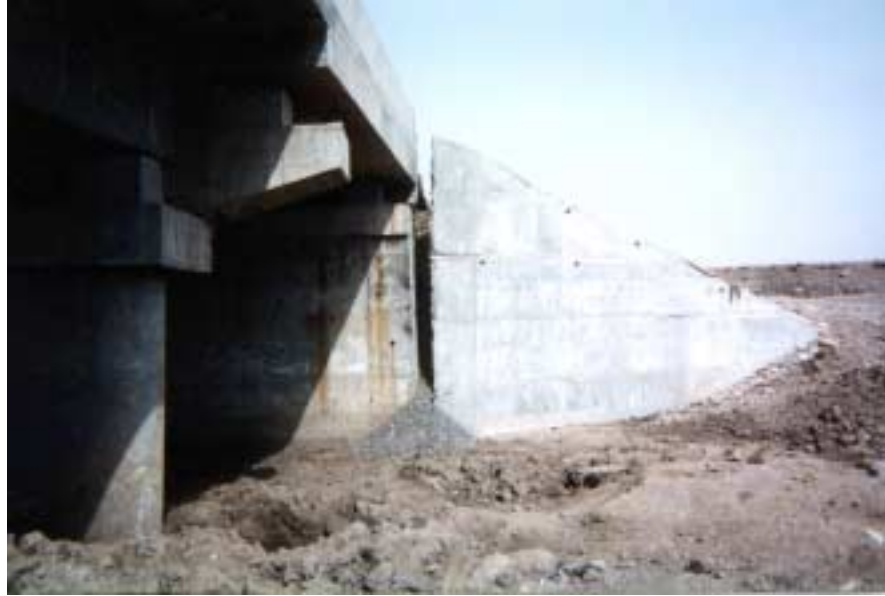
Figure 2.47. Damage to reinforced concrete highway bridge under construction approximately 35 km east of the USGS epicenter. Photo courtesy of Charles Menun.

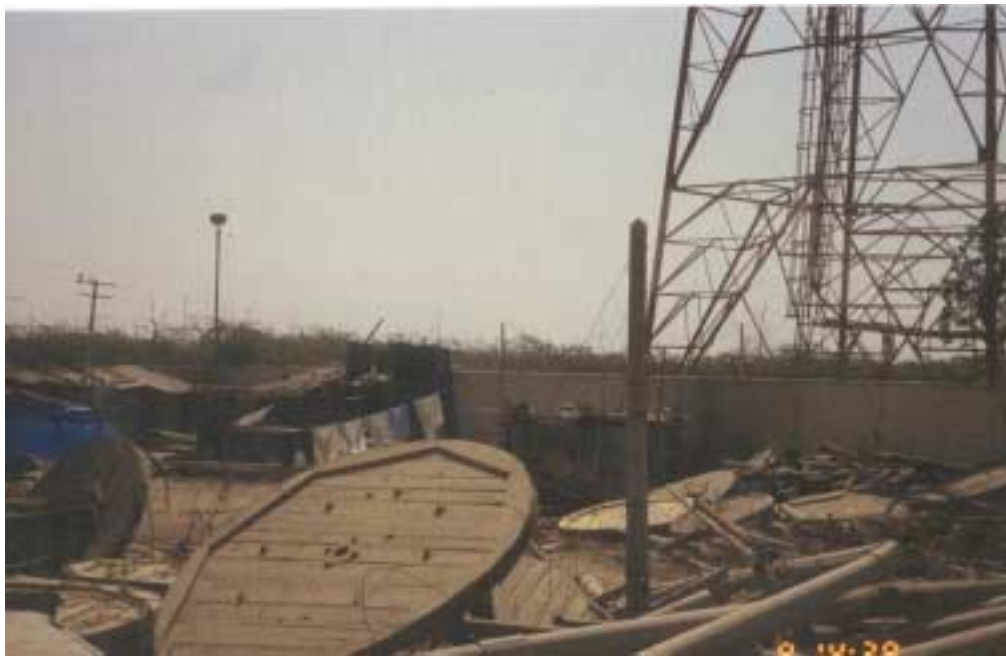
Figure 3.3. Destruction outside the Communications Center for Kachchh District, Gandhidham, March 2, 2001. Tower remained standing.

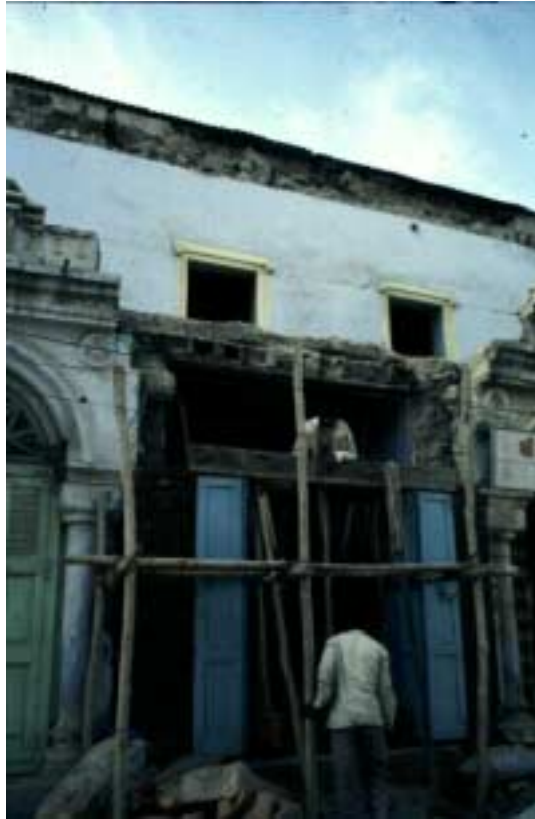
Figure 4.8. Temporary non-engineered shoring of a damaged residence, Morbi.

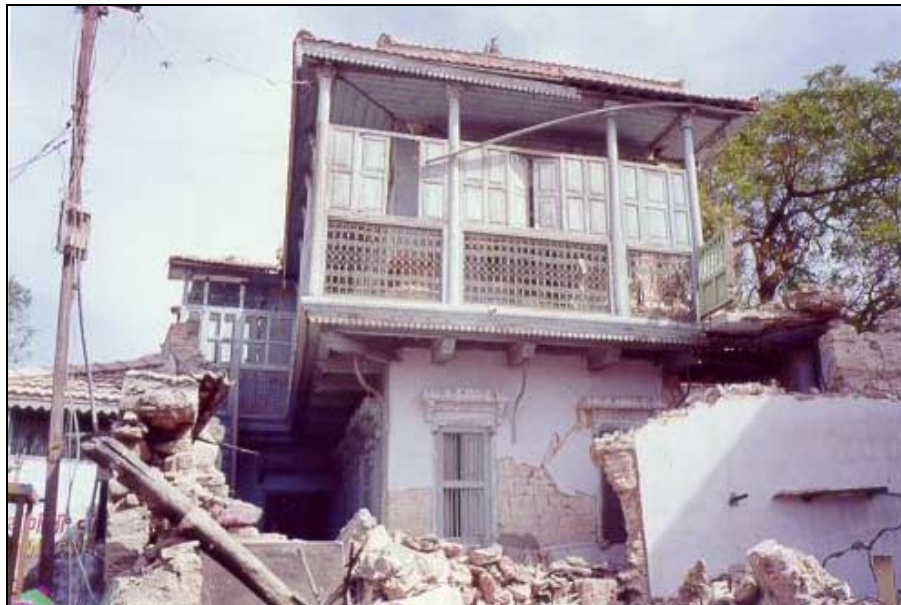
Figure 4.9. A damaged but still standing house of wooden construction, Anjar.
