Housing Recovery and  
Reconstruction Platform

# 18 Moderately Affected Districts

Updated Overview, July 2018

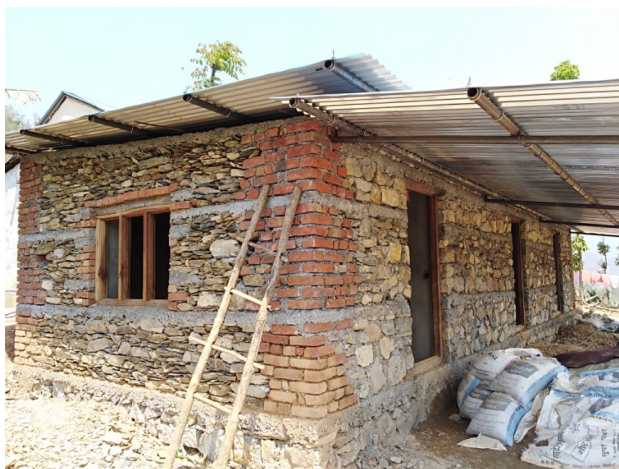
**Santoki Kumar, Sandhikhark 7, Markakhola, Arghakhanchi:** hybrid structure with stone and brick masonry and a mix of mud and cement mortar. The owner brick masonry in the corners to reduce labour requirements and constructed the rest of the house himself. The wall to roof connection is poor and the DLPIU engineer listed the house as non-compliant. However, the engineers are not able to support with implementing correction and exception techniques as they have not received any training on this.

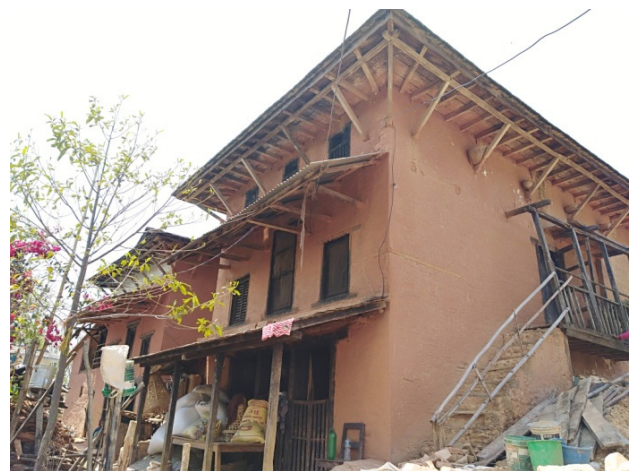
**Arghakhanchi:** stone and mud mortar masonry house of 2.5 storeys and therefore non-compliant.

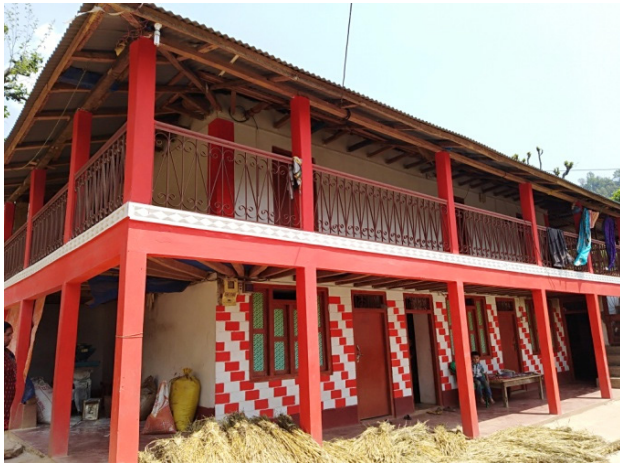
**Arghakhanchi:** hybrid structure using multiple materials.

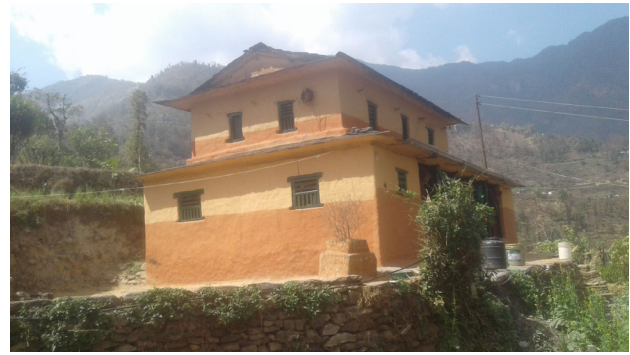
**Jayamuni Municipality (Ward-9), Baglung:** non-compliant stone and mud mortar masonry house constructed without technical guidance. The household have received the first tranche of the GoN housing reconstruction grant but they now need to apply corrections based on the Corrections and Exceptions Manual to receive the remaining tranches.

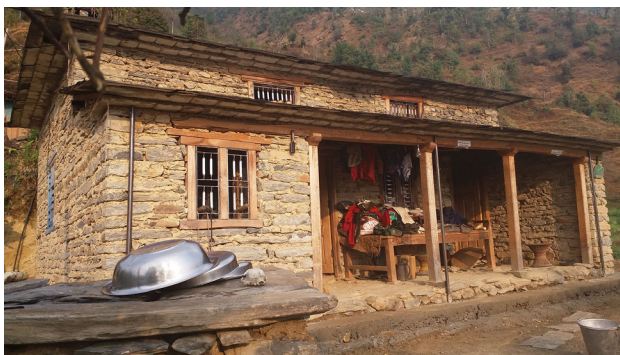
**Jayamuni Municipality (Ward-3), Baglung:** non-compliant stone and mud mortar masonry house constructed without technical guidance. The household have received the first tranche of the GoN housing reconstruction grant but they now need to apply corrections based on the Corrections and Exceptions Manual to receive the remaining tranches.

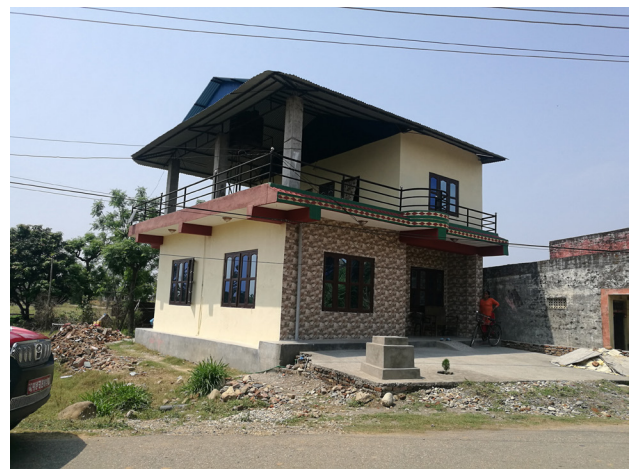
**Khairahani Municipality 2, Ladari, Chitwan:** home owner has received all three tranches of the GoN housing reconstruction grant.

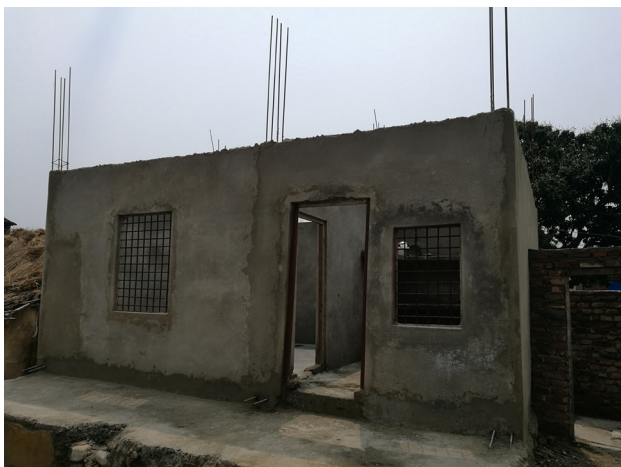
**Sunawal 9, Bankattiya, Parasi:** RCC frame structure house under construction. As per the comments from the DLPIU engineers during the visit the house will be eligible for next tranche immediately after the roofing is completed (third tranche does not require roof to be released).

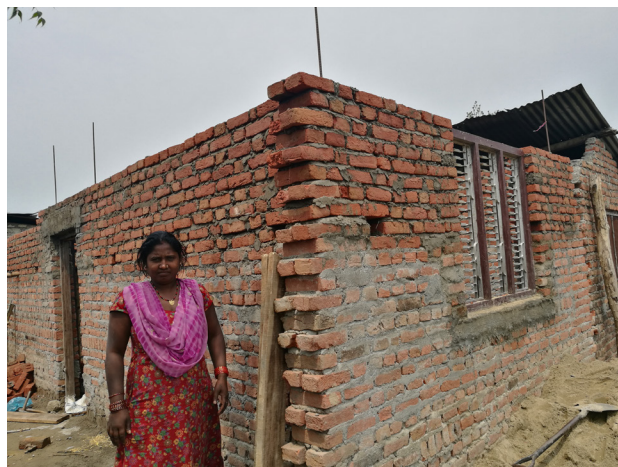
**Sunawal 2, Mukhiya Tole, Parasi:** the home owner has received the 2nd tranche but vertical and horizontal reinforcement has not been properly implemented and so the house has not been recommended for the third tranche. During the visit the DLPIU sub-engineer said they had been providing regular follow up to the household but the home owner has not been willing to follow the guidelines and their suggestions.

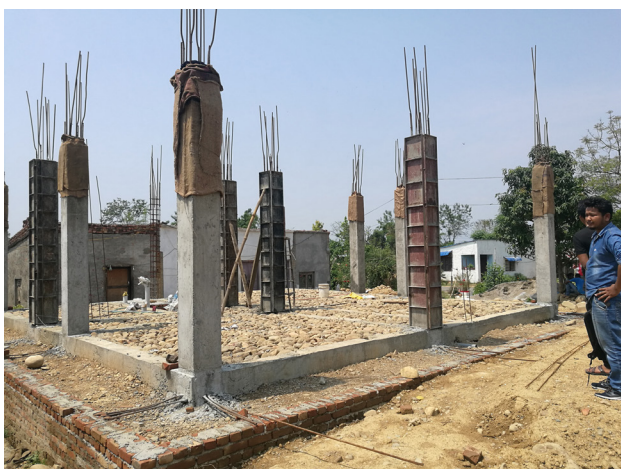
**Chitwan:** RCC frame structure under construction. The home owner has applied for the second tranche of the housing reconstruction grant and the application has been forwarded to the municipality.

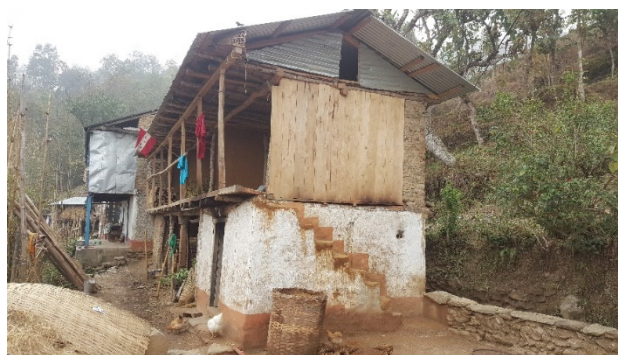
**Diktel Rupakot Majhuwagadhi Municipality ward-I, Khotang:** non-compliant hybrid structure with ground floor having stone and mud mortar masonry walls on three sides with one open side and the first floor walls are constructed with timber and CGI sheets. The home owner built the house in early 2017 with no technical support. They have applied for the second tranche of the reconstruction grant but will not be able to receive it without carrying out corrections.

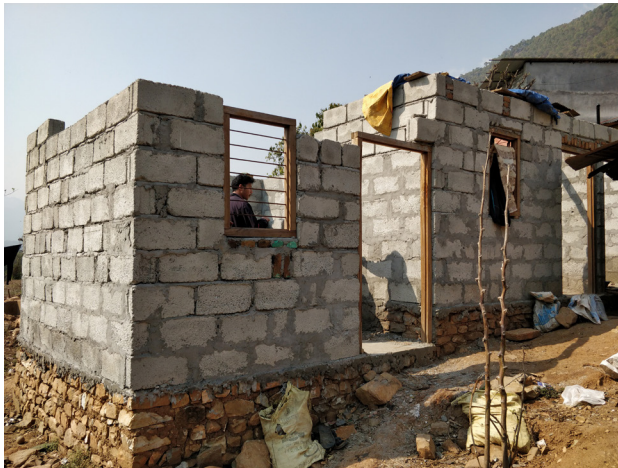
**Lekhnath Municipality, Pokhara, Kaski:** more than 600 houses have been constructed using hollow concrete blocks in Kaski. Households regularly ask the GoN engineers for designs and they have been providing the designs from the DUDBC Design Catalogue Volume 2, but households are not building according to these designs. There is a lot of hollow concrete block production in Kaski, with many of the biggest and oldest producers in the district. Blocks from Kaski are sent to Tanahun, Lamjung, Gorkha, and Parbat.

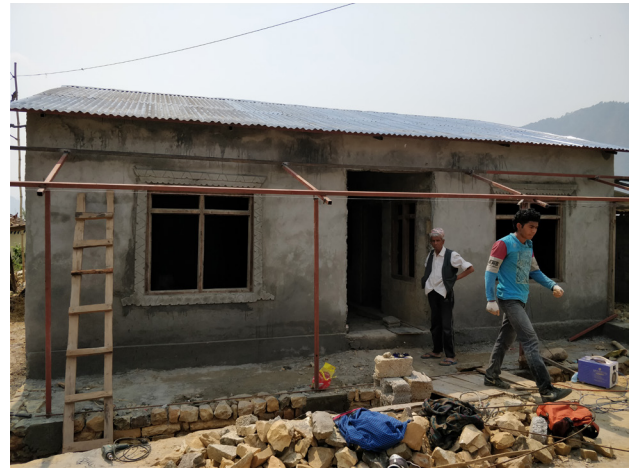
**Modi Rural Municipality, Ward No. 6, Parbat:** the home owner started construction of this 5-room house, with steel frame structure and hollow concrete blocks for the infill walls, just 1 month after the 2015 earthquake. He is still going through the grievance mechanism and he didn't know that this house would not be in line with government standards as there was no guidance available previously and the inspection engineers had just been deployed at the time of the visit.

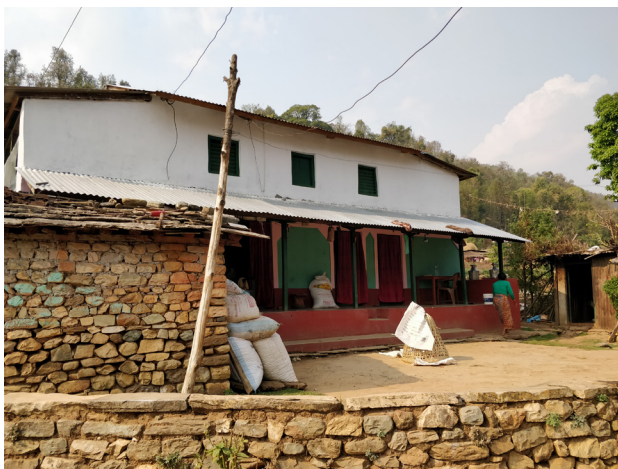
**Modi Rural Municipality ward-6, Parbat:** this two storey, stone and cement mortar masonry house is non-compliant and the home owner has only received the first tranche of the housing reconstruction grant. NRA, Building DLPIU engineers are facing challenges to provide correction solutions for these types of houses.

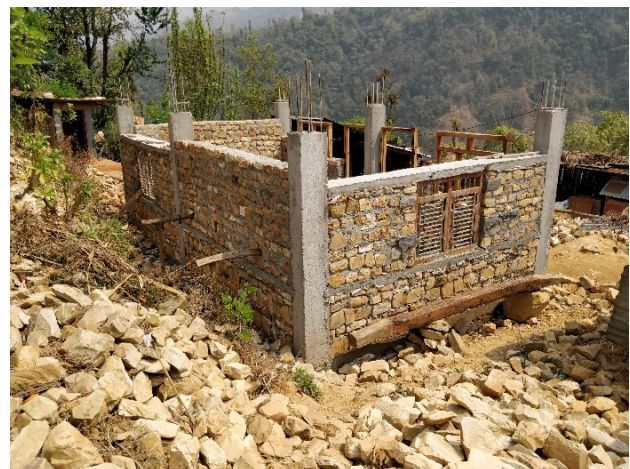
**Modi Rural Municipality ward-6, Parbat:** this hybrid structure has a semi-RC frame with 6 rebar in 9"x12" column and is a 2 room, 1 bay house. The home owner has been seeking technical support from the NRA, Building DLPIU engineers on whether to construct a rigid slab or flexible roof with CGI. People were very conscious after the earthquake of the need to construct a strong and safe house and some contractors influenced people to construct this type of house based on this. In this area 15-20 houses were built in this way.

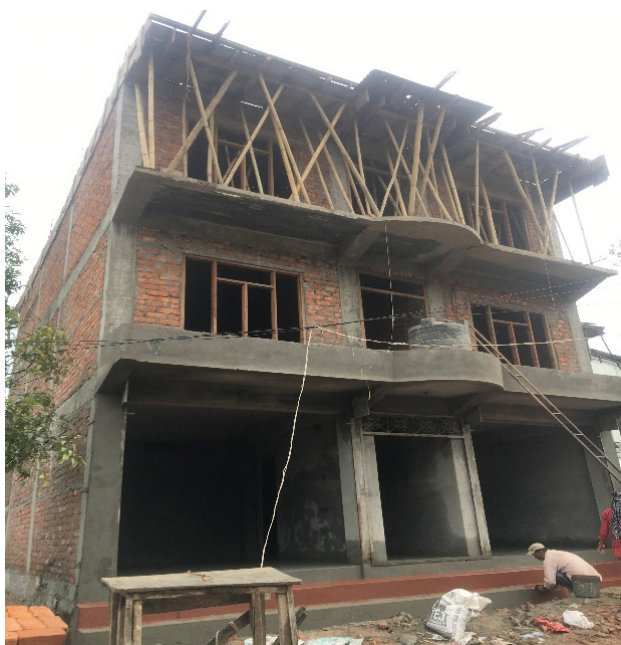
**Khandbari Municipality, ward-8, Sankhuwasabha:** RCC frame structure with 998 sq. ft. plinth area, and 16 nos 12" \*12" Columns. The house is 3 storeys with underground. The NRA, Building DLPIU engineers are confused about whether it is compliant or not but the structure has been approved by the municipality office.

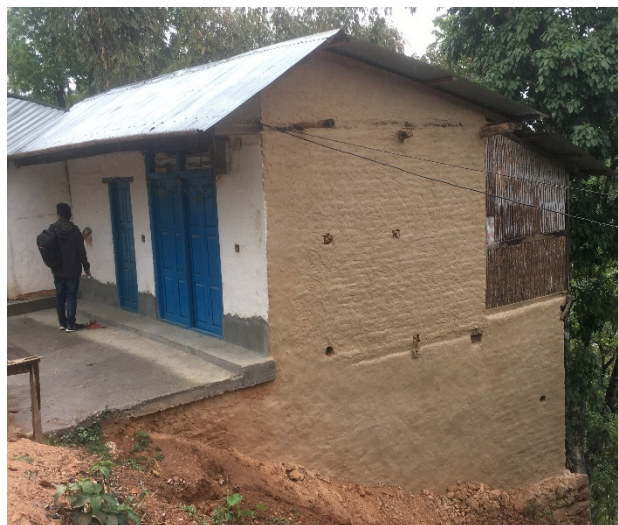
**Khandbari Municipality ward-8, Sankhuwasabha:** non-compliant house constructed with stone and mud mortar masonry on the ground floor and sun-dried bricks for the first floor. This house was constructed before technical assistance in the district. The home owner has received the first tranche and applied for the second.

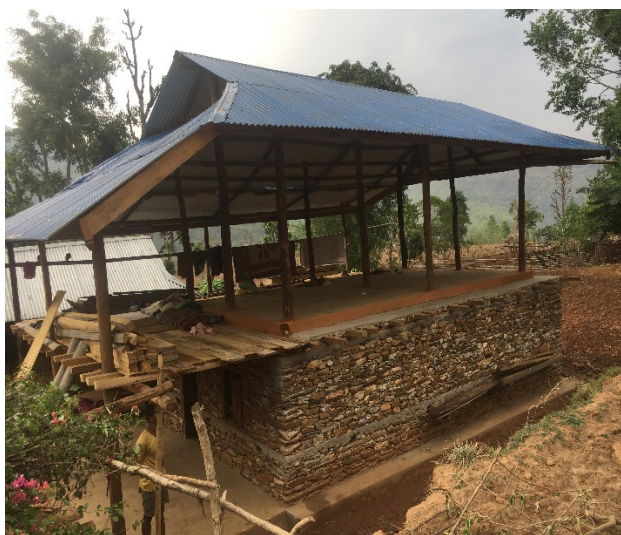
**Chainpur Municipality ward-II, Sankhuwasabha:** non-compliant Hybrid Structure with ground floor built in stone in mud mortar masonry and first floor with timber frame and open walls for now. The house was completed in early 2017 with no technical assistance. The home owner has received just the first tranche of the housing reconstruction grant.

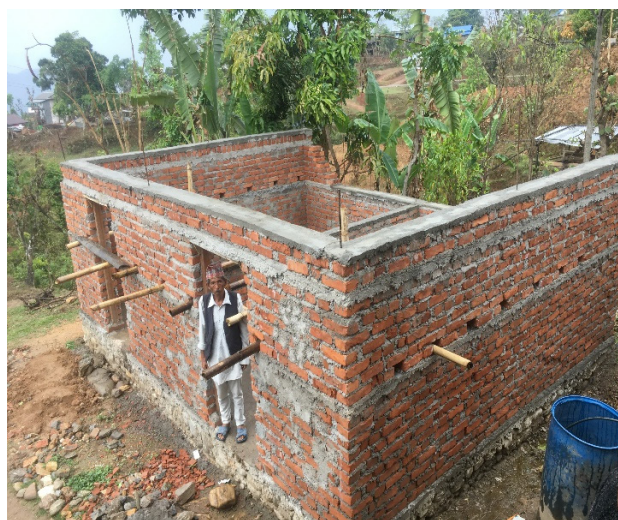
**Khandbari Municipality ward-8, Sankhuwasabha:** a brick and mud mortar masonry house with RC banding under construction. This house is being constructed under the supervision of NRA field engineer with the help of trained masons. The beneficiary has received the first tranche and is waiting for the second tranche. The house is considered compliant so they should receive the second tranche.

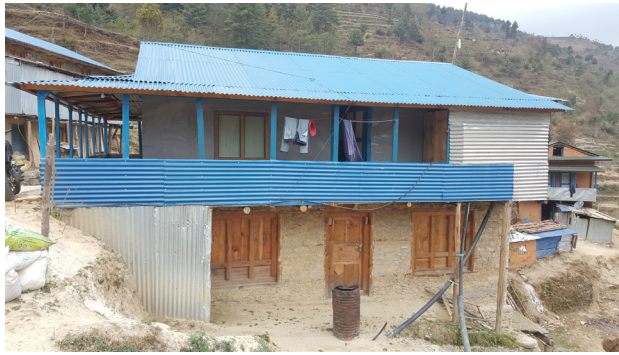
**Solu Dudhkunda Municipality ward-11, Tignasa Solukhumbu:** non-compliant Hybrid Structure built in early 2016 with no technical assistance. The ground floor is stone and mud mortar masonry and the first floor is timber frame with CGI sheets. RCC bands have been used at the plinth and timber bands at the lintel and sill level and the openings are not appropriate. The home owner has just received the first tranche of the housing reconstruction grant.

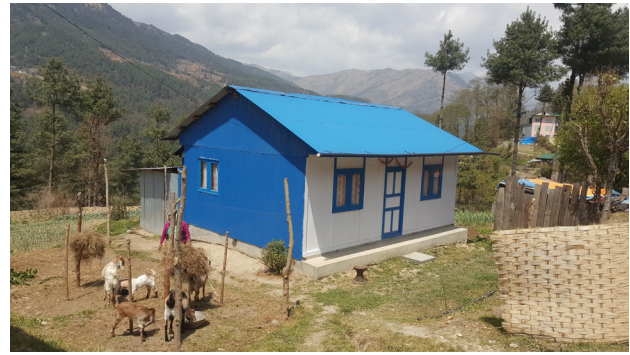
**Solu Dudhkunda Municipality ward-6, Dorpu Solukhumbu:** this two room, single storey house was built immediately after the earthquake with stone and mud mortar masonry foundation and walls of timber planks with timber frame. The design was approved by the municipality. The home owner has just received the first tranche. According to the engineer, the majority of houses in this area are built in this way.

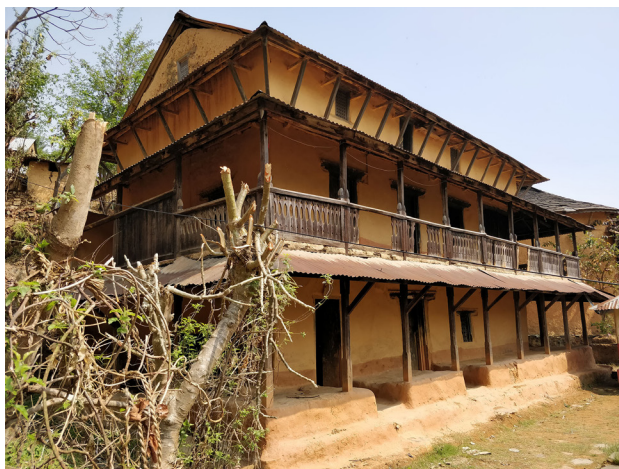
**Waling Municipality (ward-5), Syangja:** this stone and mud mortar masonry house has survived three earthquakes; one in 1990 B.S., one in 2045 B.S., and one in 2072 B.S. The house is still standing despite the earthquakes and being more than 80 years old. The construction quality is quite good with support from timber bands at floor and roof level i.e. 2 bandings per floor.

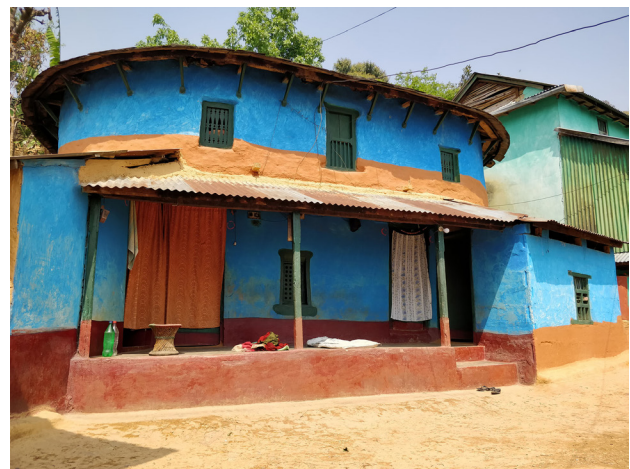
**Waling Municipality (ward-5), Syangja:** the home owner reduced their circular 3 storey house to one and a half storeys after it was damaged by the 2015 Gorkha earthquake. They are now planning to construct a new house and the government technical staff have said that the damaged house will have to be demolished before the third tranche of the GoN housing reconstruction grant can be released.

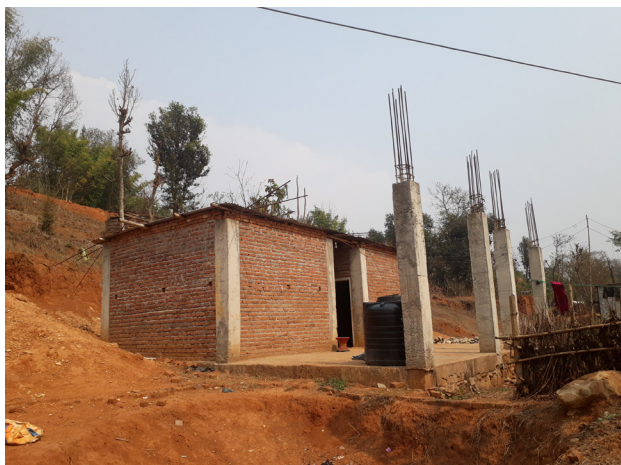
*Bhanu Municipality, ward-2, Tanahun: house reconstructed with RCC structure but due to road right of way conflict and formation of new municipality and its building requirements he home owner is not allowed to construct rigid floor and even they constructed RC frame structure beneficiaries were living by putting CGI roofs and brick infill walls.*

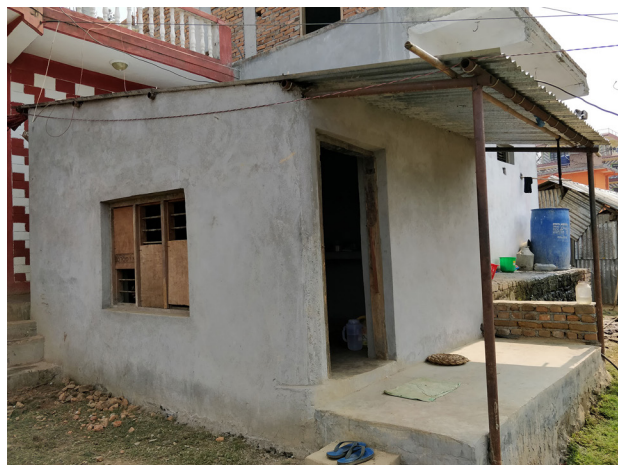
*Bhanu Municipality, Ward No. 2, Tanahun: Ujeli B.K. has received the first tranche of the GoN housing reconstruction grant and does not know anything about the process to receive the second tranche of the grant. He has already reconstructed this one room house with a steel frame and flexible roof structure and the house has not yet been inspected by the government engineers.*
