Housing Recovery and
Reconstruction Platform

Temporary Shelter Research Report

June 2018

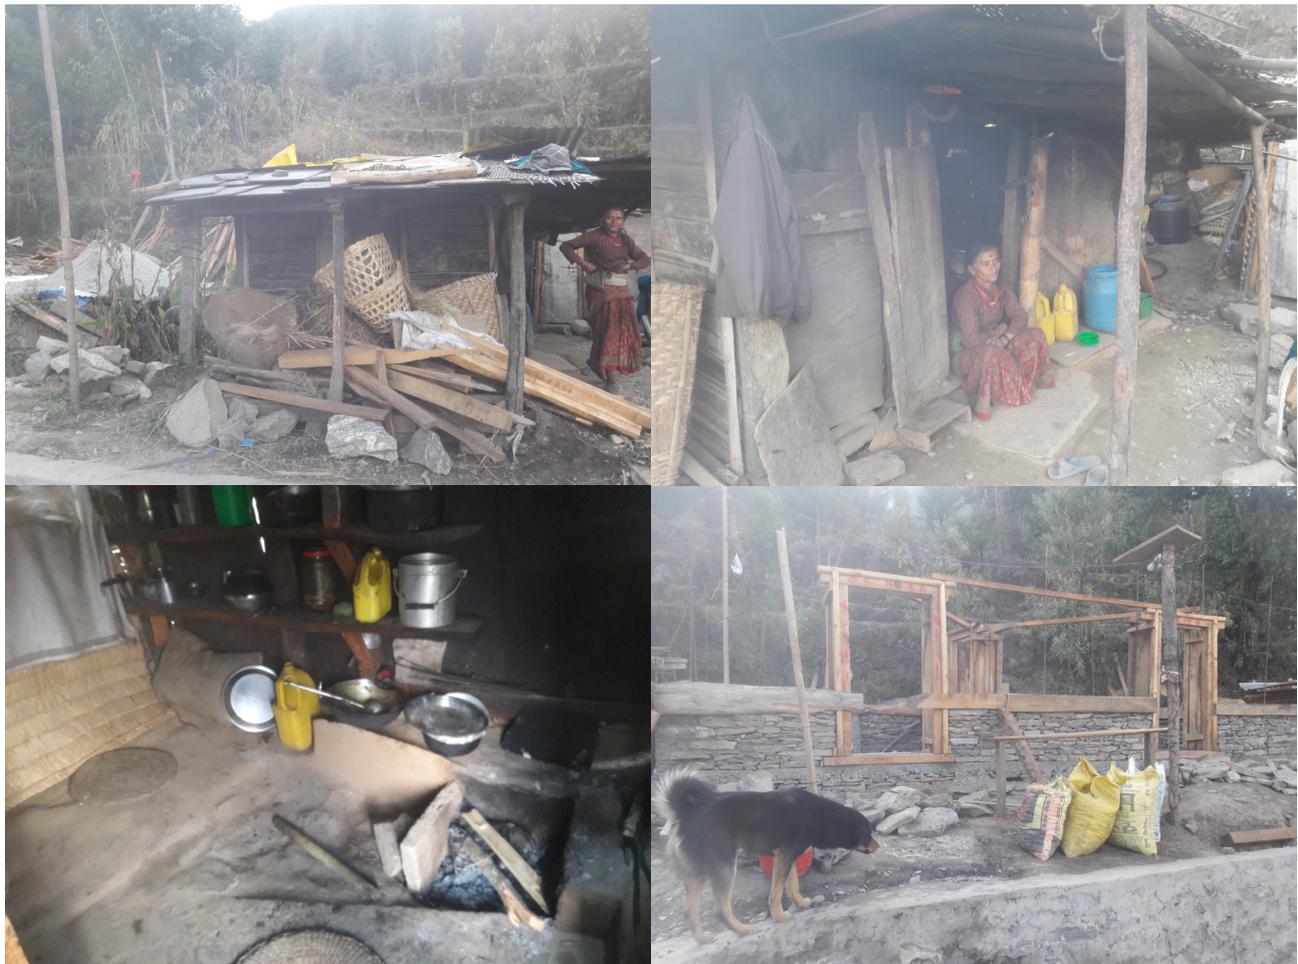
Top left and top right: Amrit outside her temporary shelter. Bottom left: inside Amrit's temporary shelter. Bottom right: Amrit's house under construction. Amrit Maya Budhathoki, and her husband Dan Bahadur Budhathoki, are over 60 years old and live in this shelter which is just 2.2m² in ward no. 3, Kalinchowk Rural municipality, Dolakha. Their income source is agriculture and livestock and they report that there has been no impact on their income / economic status because of the earthquake and living in a shelter. Neither Amrit or Dan have ever been to school. Their shelter is on the land that their home was on pre-earthquake. They are eligible for the GoN housing reconstruction grant and have received the first tranche and reported that their house is under construction. They reported that they did not receive temporary shelter support and have received no socio-technical assistance. They are aware of the GoN deadlines for disbursement of the second and third tranche.

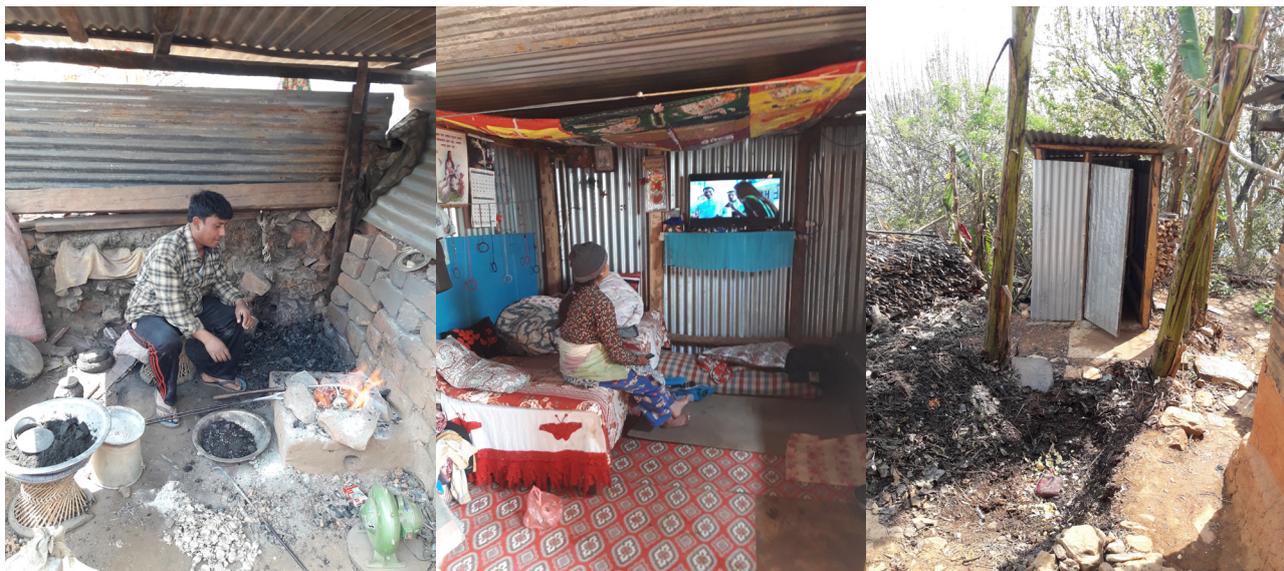
Buddha Lal Sunar's shelter in ward no. 8, Dakshinkali Municipality, Kathmandu; the kitchen (L), inside the shelter (centre), and the toilet (R). Buddha lives in the shelter with his three children and his wife. Their shelter around the average size of 20.5m² and is built on land that they own where their house used to be. They are eligible to receive the GoN housing reconstruction grant, and have already received the first tranche of 50,000 NPRs, but they have yet to start rebuilding their home as they are still saving to cover the cost of reconstructing and they have not had access to any technical assistance.

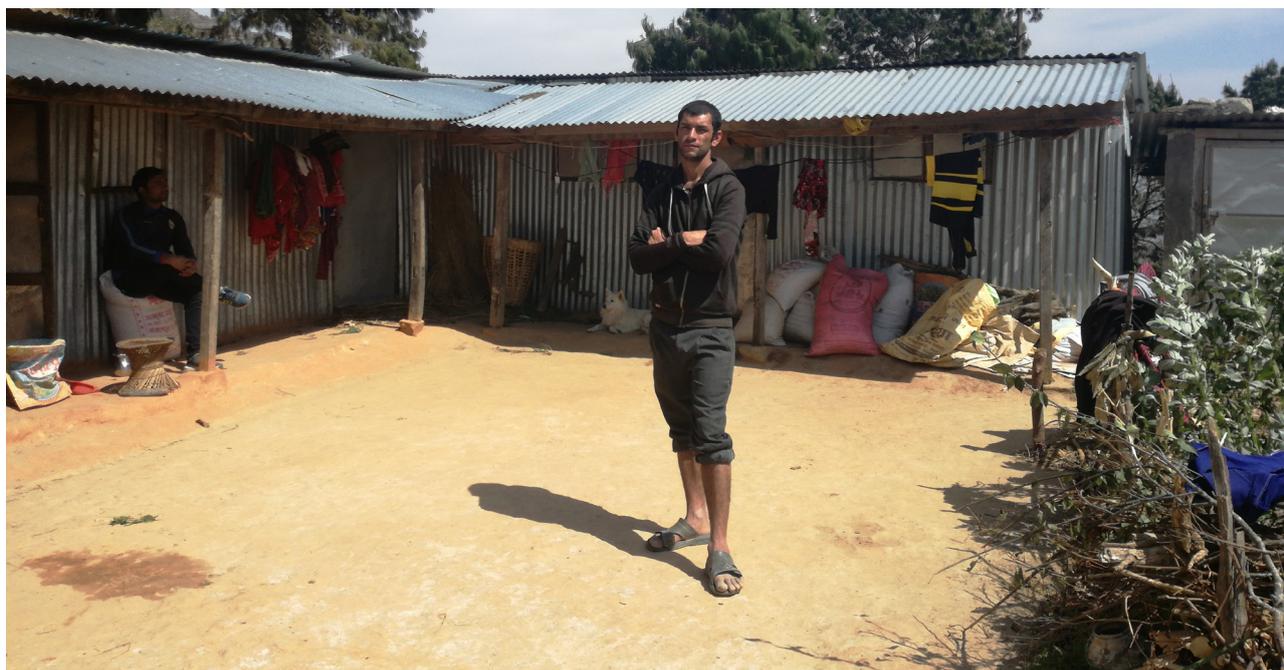
Uddab and Santa Bagjai live in this shelter, which is one of the largest at over 145m², in ward no. 3, Banepa Municipality, Kavre. They reported that their income was reduced after the earthquake when they moved into the temporary shelter and they have been displaced from their land and are now on public land. They have not been listed as eligible to receive the GoN housing reconstruction grant but have lodged a grievance and as a result they have yet to start their reconstruction.

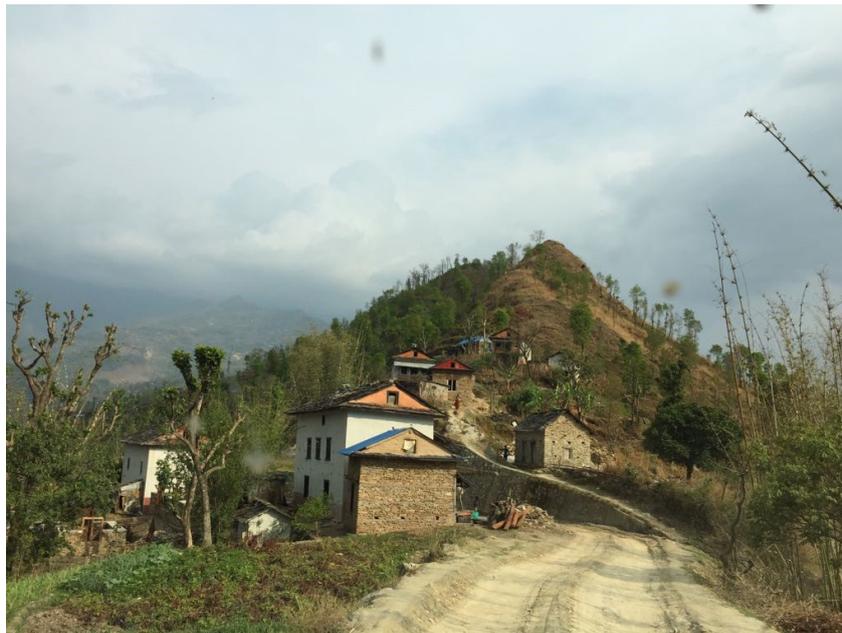
Poku, Ramechhap: the home owner has built a one room, one storey 'earthquake-safe' building next to their old, damaged house to access the GoN housing reconstruction grant. They continue to live in the old house because the new one is too small for the family. Photo Credit: Subash Karki/BBC Media Action¹²

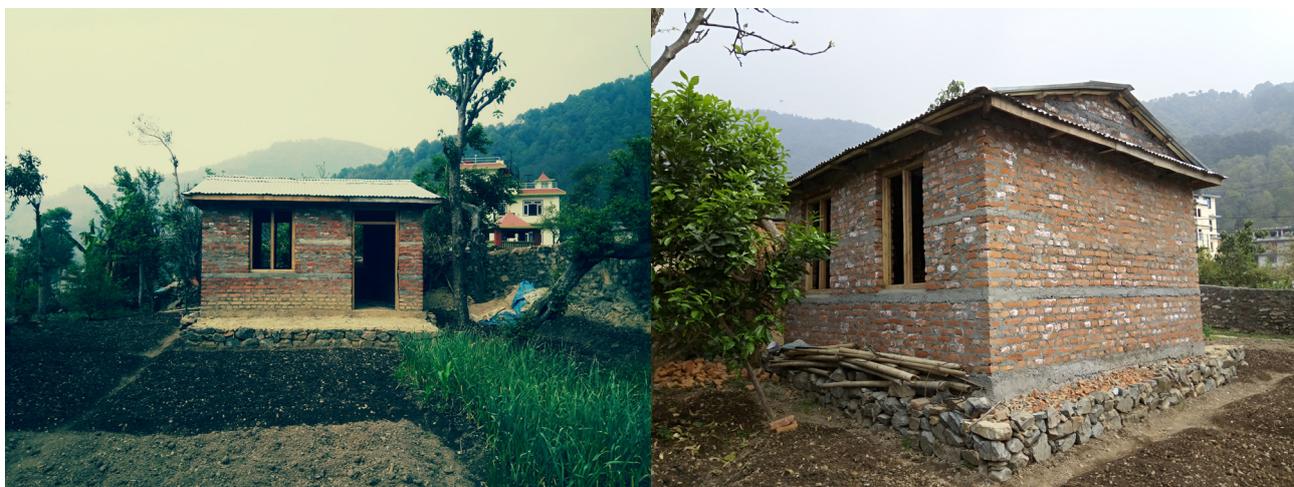
Sisneri, Ward No. 9, Lamatar Area, Mahalaxmi Municipality, Lalitpur: a one room, one storey, brick and cement mortar masonry house with CGI roof which is part of an ever-increasing trend of building tiny houses to access the GoN housing reconstruction grant but the houses do not meet families living requirements. The house owner did get the drawings for the house approved by the municipality and they have received the second tranche. During a recent joint monitoring visit by HRRP and MoUD CLPIU, the monitoring team identified difficulties getting into the house due to its small size¹³.

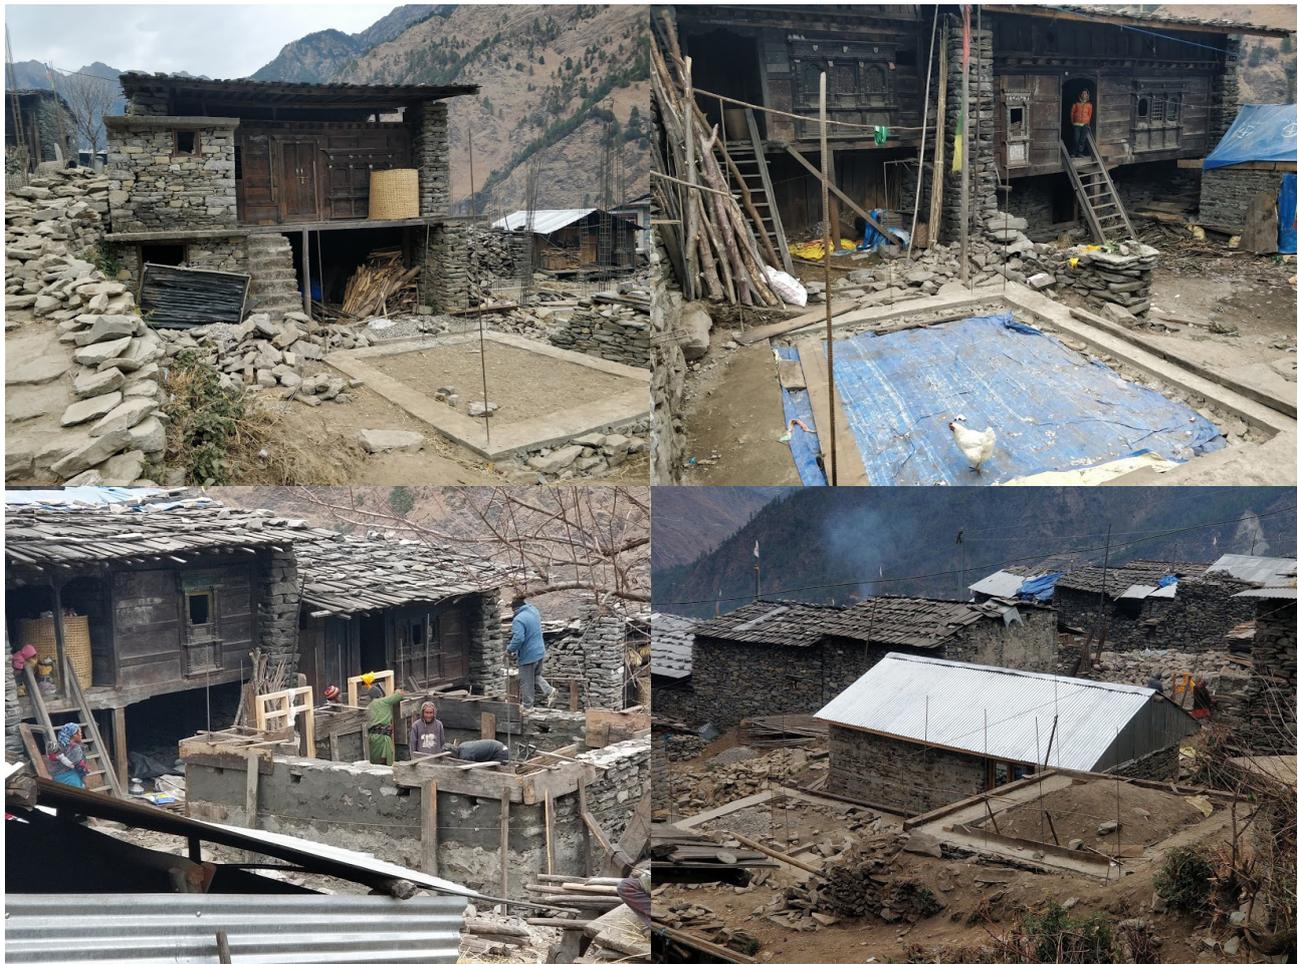
In Gatlang, Rasuwa new one room buildings are being constructed to access the GoN housing reconstruction grant but their traditional houses, mostly reconstructed in 2015, do not currently meet compliance requirements. Investment is required in research and testing to develop relevant corrections / retrofitting measures so that the traditional houses can be compliant – and most importantly strengthened to reduce risk from future earthquakes. Photo Credit: Magnus Wolfe-Murray/DFID Nepal¹⁴.
