Government of Nepal National Reconstruction Authority

For earthquake damaged houses that needs to be repaired and retrofitted under HOUSING RECONSTRUCTION PROGRAMME

Copyright: National Reconstruction Authority Version 1: June 2017 Printed copy: 5000pcs

REPAIR AND RETROFITTING MANUAL for MASONRY STRUCTURE

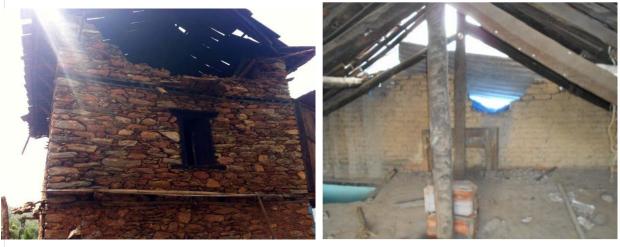
R1.Partial to heavy damage of Gable wall

Problem : Gable wall collapse

R1.1 Gable wall toppling

R.1.2 Gable wall toppling

Solution : Remove heavy material replace with the lighter materials

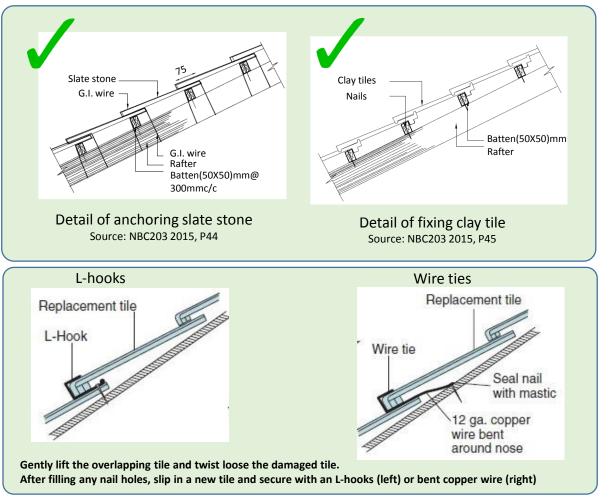
- Replace damaged tiles.
- Using appropriate correct fixing method for roofing materials.
- Connect the roof with the roof band by inserting reinforcement or GI sheet.
- Slatestone and clay tiles should be properly anchored to purlin as NBC.

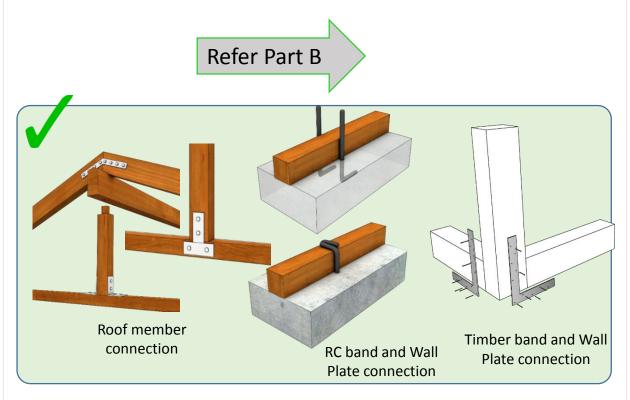
R.3:Roof connection failure

Problem : Inadequate roof connections or connections failure

R.3.1 Purlin detached from rafter due to inadequate nailing

- Use a continuous wall plate, ridge and purlins to tie the rafters or trusses together.
- Stiffening of roof
 - Diagonal straps with steel nut bolts or metal nails
 - Diagonal steel truss with steel nut bolts or metal nails
 - Timber bracing with metal nails or timber nails

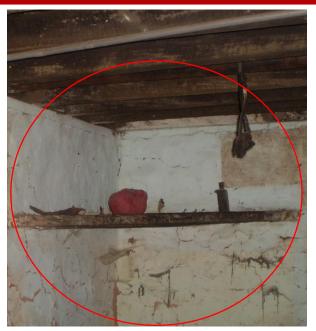
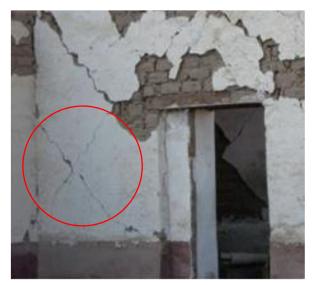
C.1:Minor Cracks

Problem : Minor In-Plane Cracks in the building

C1.1 Low strength masonry : Stone Masonry in Mud mortar

Definition of Damage		
Damage Grade	Damage level	Description of damage
DG1	Slight damage	Hairline cracks

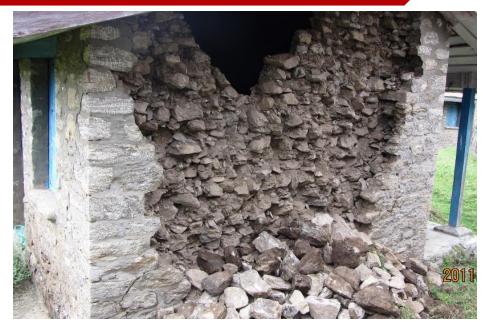
C.4 :Delamination of walls

Problem : Wall-wythes separation

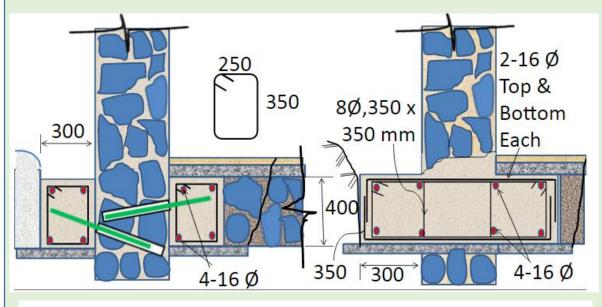
Refer : Schematic view of foundation strengthening with RC :

- Before strengthening the existing foundations, the walls are first consolidated by grouting (cement or soil or stabilized soil.

To avoid disturbance to the integrity of the existing wall, during the foundation strengthening process, proper investigation & design is necessary

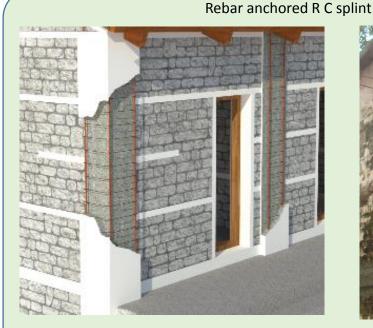
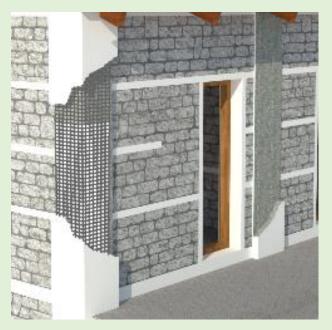
Option 1: anchored splint (using RC elements with rebar or G.I. wire mesh) at corner or T-Junction in both side of wall with proper connection between new and existing walling material should be done.

G I wire mesh anchored R C splint

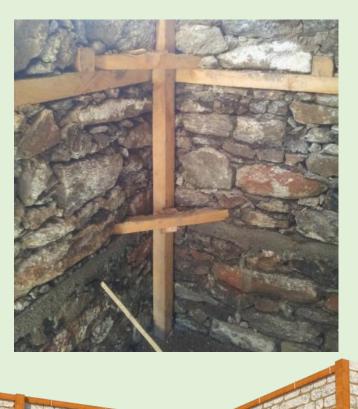
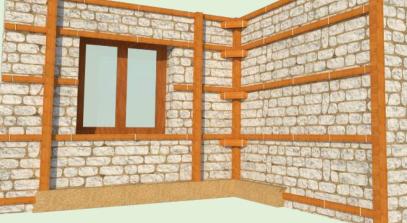
Option 2: anchored splint (using wooden elements) at corner or T-Junction in both side of wall with proper connection between new and existing walling material should be done.

Installation of wooden vertical member from inside of the wall

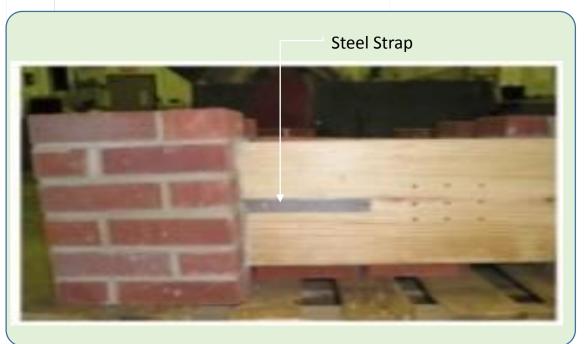
Option 1: Metal Strap :

When it is not possible to transport concrete and steel to the site:

Note : Minimum four numbers of 50 mm long nails (Fe250) with Floor member and Minimum four numbers of M16 grade expansion bolts with walling material

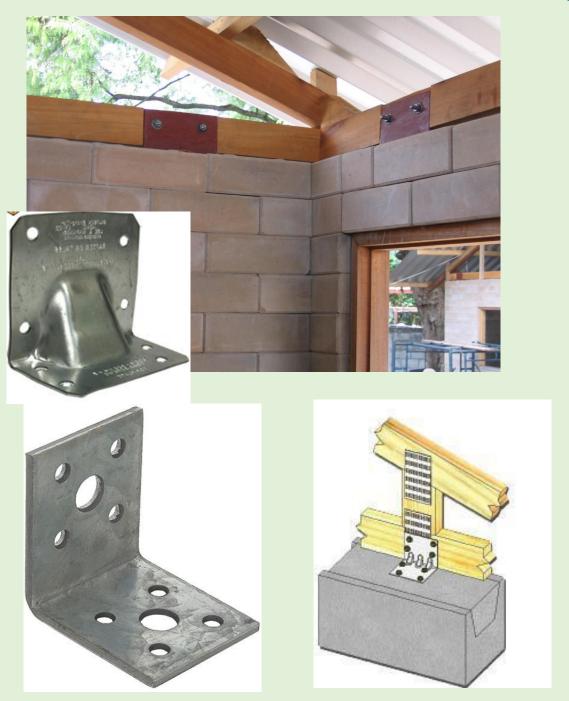
Option 1: Metal Strap at the top of wall:

Note : This is not required separately if retrofitting is done simultaneously. Splint is connected to the floor joist and roof rafters.

3 mm thick Height and depth : 45mmx45mm, M12 of 4 number, M16 of one number in each face @ 3.00 mat centres

Details of Anchor plate

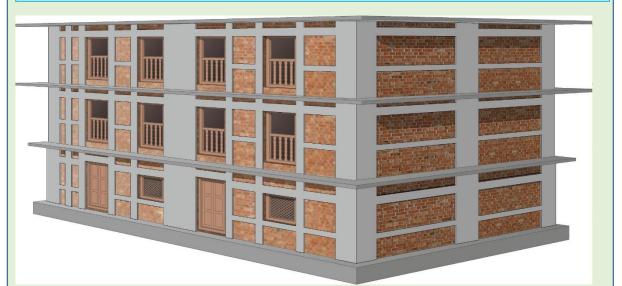
Option 1: Retrofitting using RC splint-bandage (For preventing global failure) and GI wires in remaining part (for Local failure)

Retrofitting using rebar with concrete Splint-bandage and GI wire mesh Jacketing (Brick Masonry)

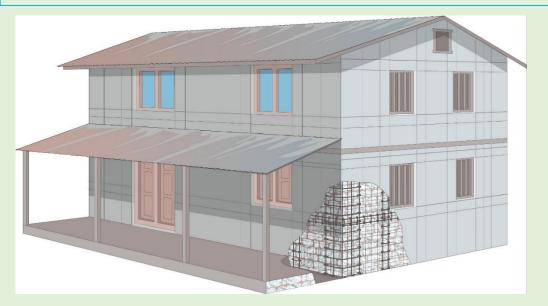
Option 1: Retrofitting using RC splint-bandage (For preventing global failure) and GI wires in remaining part (for Local failure)

Retrofitting using rebar with concrete Splint-bandage and GI wire mesh Jacketing (Stone Masonry)

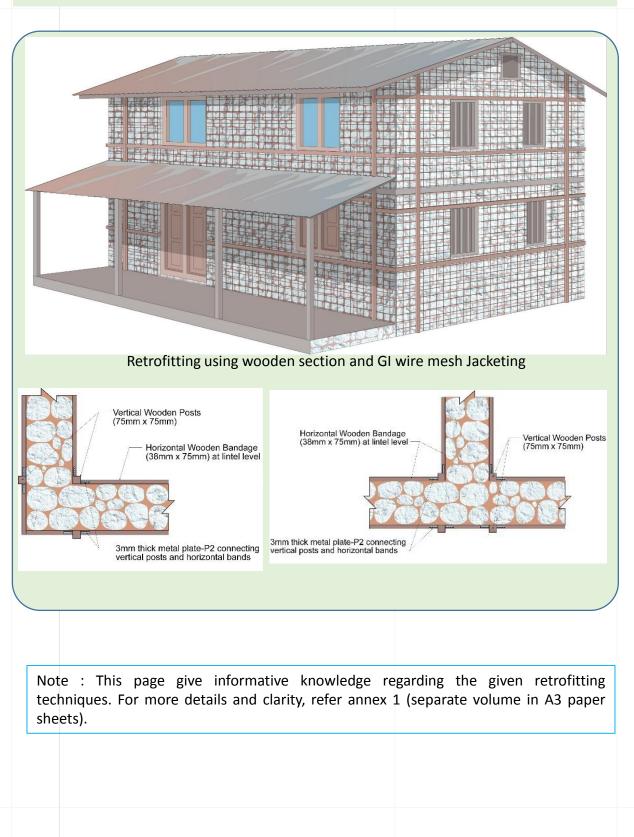
Option 4: Retrofitting using wooden splint-bandage (For preventing global failure) and GI wires in remaining part (for Local failure)

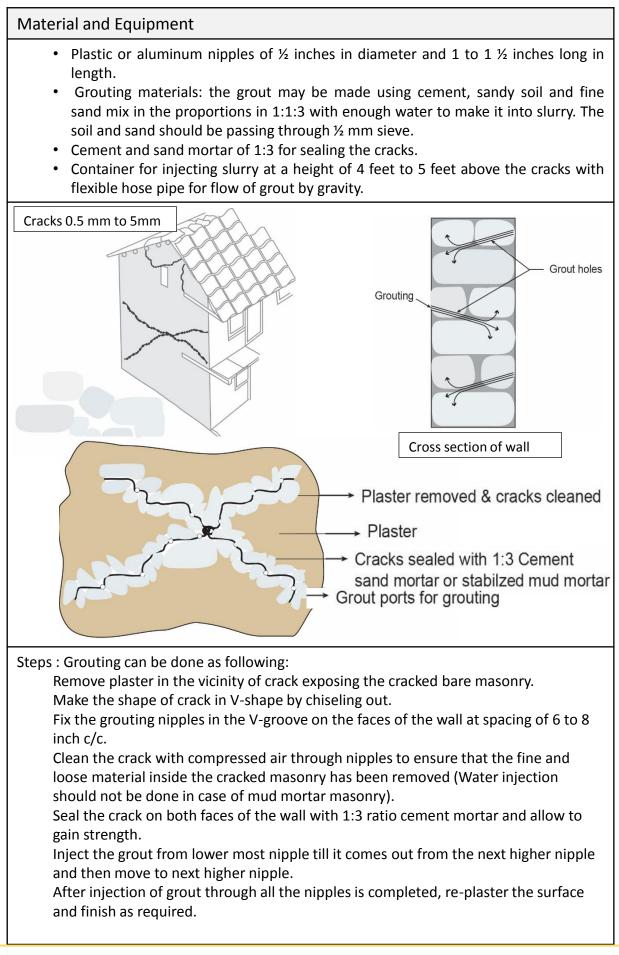
Action # 1: Repair Minor To Cracks Using Grouting

- 1:3 cement-sand mortar for sealing of cracks and plastering.
- Galvanized steel wire mesh (with wires of 16 to 14 gauge i.e. 1.5mm to 2.03 mm diameter) 1 inch x 1 inch mesh size.
- Galvanized steel wire of 12 gauge i.e 3.15 mm diameter, 4 inch long nails.

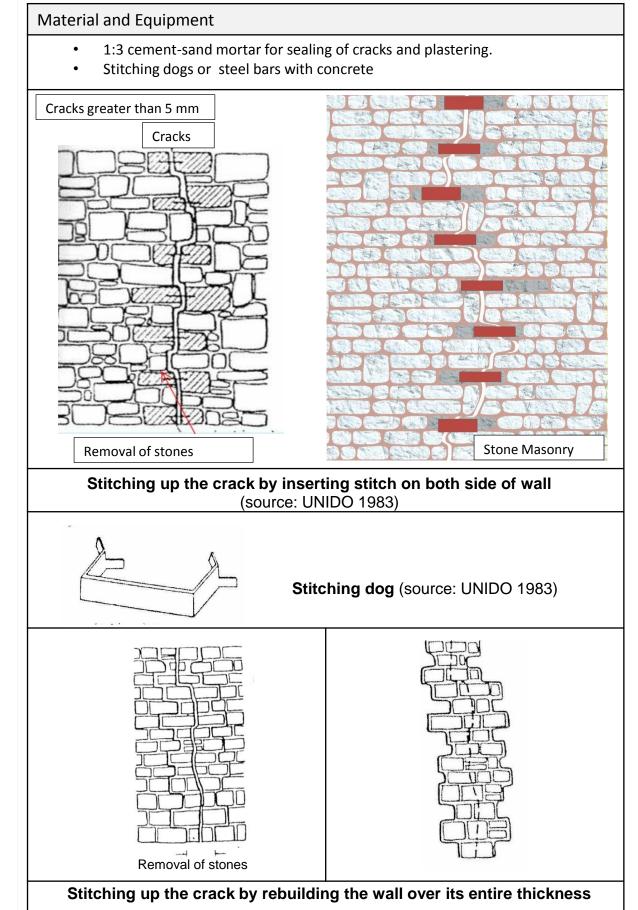
Steps : Major Cracks (crack width greater than 5 mm) can be repaired by stitching as following :

- Remove the plaster in the vicinity of crack exposing the cracked bare masonry upto around 6 inch width at both sides of the crack.
- Make the shape of crack in the V-shape by chiseling out.
- Remove the alternate loose stones adjacent to the cracks.
- Clean the crack with compressed air.
- Add stitching dogs or steel bars with concrete on removed loose stones.
- Alternatively, stones can be removed from a zone about 6" to 9" along a vertical cracks and the wall can be reconstructed using elongated stones.
- Fill the crack with 1: 3 ratio cement mortar with necessary water from both sides as deep as feasible.
- Plaster the exposed area with cement sand mortar of 1:3 with minimum of 1/2 inch thickness.

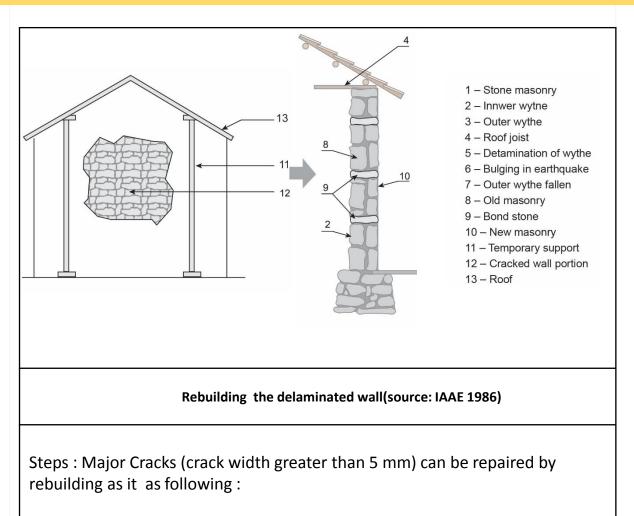
Action #4: Repair Of Damaged Wall By Rebuilding..

- Extensive damage may occur to stone walls which require a portion of the wall to be removed and reconstructed.
- In such case, it is important to promptly install temporary shoring to support the floors and walls above that depends on the extent of damage of wall.
- When portions of the walls have permanent lateral distortion or humping throughout the width of the wall, the distressed portion of the wall must be completely removed and reconstructed.
- If the wall has a spread or humped on only one face, complete reconstruction can be avoided if the vertical face is stable enough to be used as formwork after the humped side has been taken down. Header are placed in the rebuilt wall using concrete or cement grout to completely fill all voids.
- The new portion of the wall should be constructed using the same mortar as that used in the existing construction.
