**IDENTIFYING EARTHQUAKE-UNSAFE SCHOOLS
AND
SETTING PRIORITIES TO MAKE THEM SAFE**

A Case Study In Gujarat, India

February 3, 2005

GeoHazards International

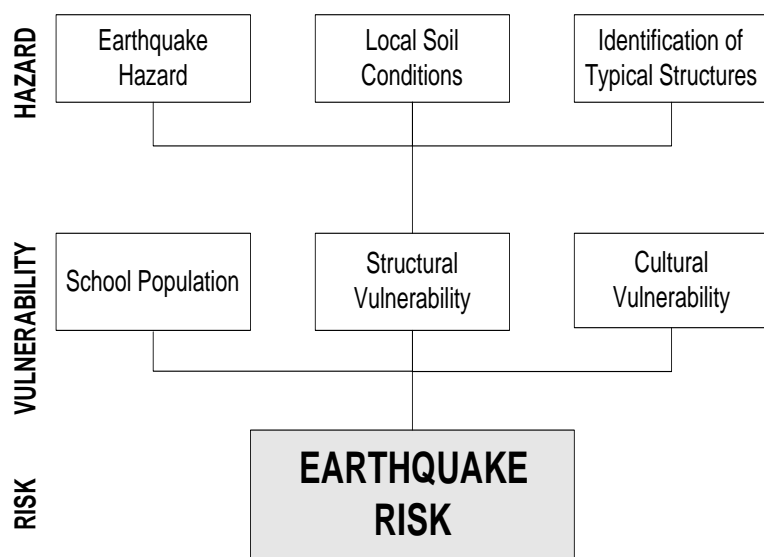
Figure 3. Method for assessing earthquake vulnerability

The method used by GHI to assess the earthquake risk to schools is diagrammed in Figures 3 and 4. This method is particularly suitable when economic resources are scarce, the stock of school buildings is large, and priorities are needed to implement earthquake risk mitigation actions.

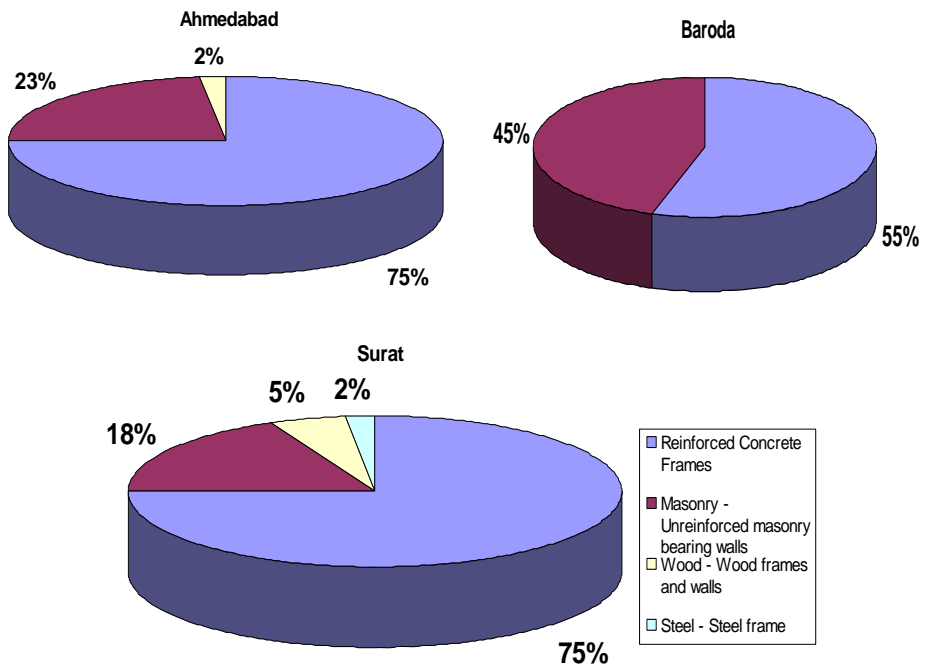
Figure 5 illustrates the study sample of school buildings according to building type for the three cities. In Ahmedabad 75 percent of the school buildings are concrete frame, 23 percent masonry, and 2 percent wood. In Baroda 55 percent of the school buildings are concrete frame, and 45 percent masonry. In Surat 75 percent of the school buildings are concrete frame, 18 percent masonry, 5 percent wood, and 2 percent steel.

Figure 5. School building types in Ahmedabad (above, left), Baroda (above, right) and Surat (below)

GHI identified four typical school building types in Ahmedabad, Baroda, and Surat. Two types (Figure 5) dominated: reinforced concrete frame buildings and unreinforced masonry buildings. Very few wood and steel structures were identified because this region does not have many buildings with these structural systems. Therefore, this report will address only reinforced concrete frame and masonry structures.

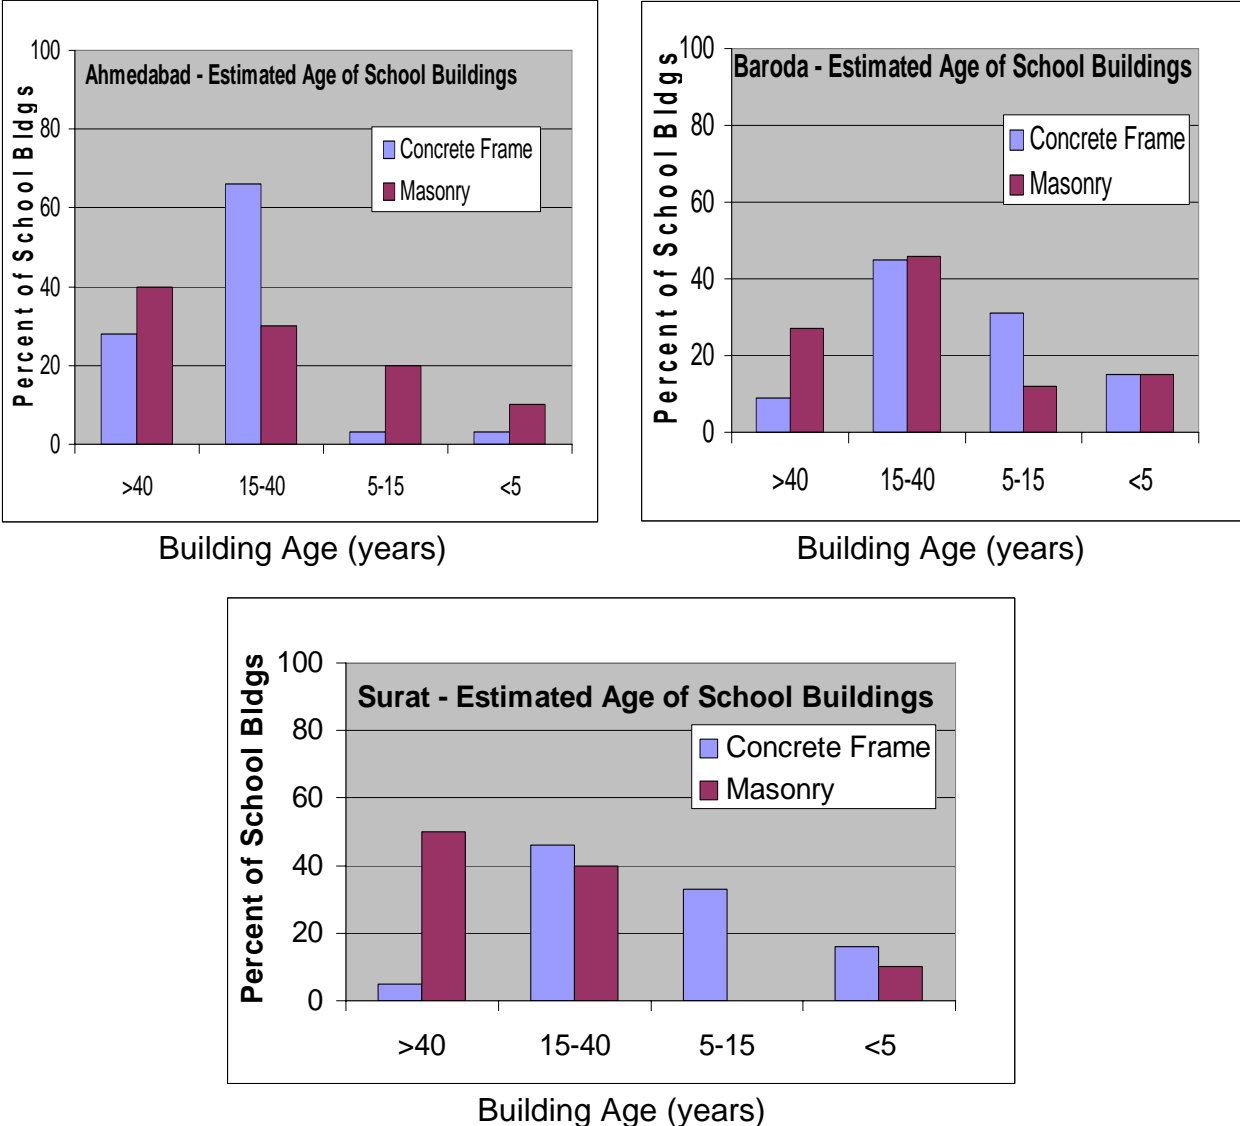
Figure 6 displays the distribution of concrete frame and masonry school buildings according to four ranges of age; i.e., older than 40 years (>40), between 40 and 15 years (15-40), between 15 and 5 years (5-15), and under 5 years old (<5). Ahmedabad has the greatest proportion of older concrete frame school buildings (>40 and 15-40); 28 percent are over 40 years old and 67 percent are between 40 and 15 years old. Surat has the greatest proportion of the older masonry structures, where 50 percent of the masonry buildings are over 40 years old, and 40 percent between 15 and 40 years old.

Figure 6. Distribution of concrete frame and masonry school buildings according to 4 ranges of age (40+, 40-, 15-, and 5- years old) for Ahmedabad (above, left), Baroda (above, right) and Surat (below)

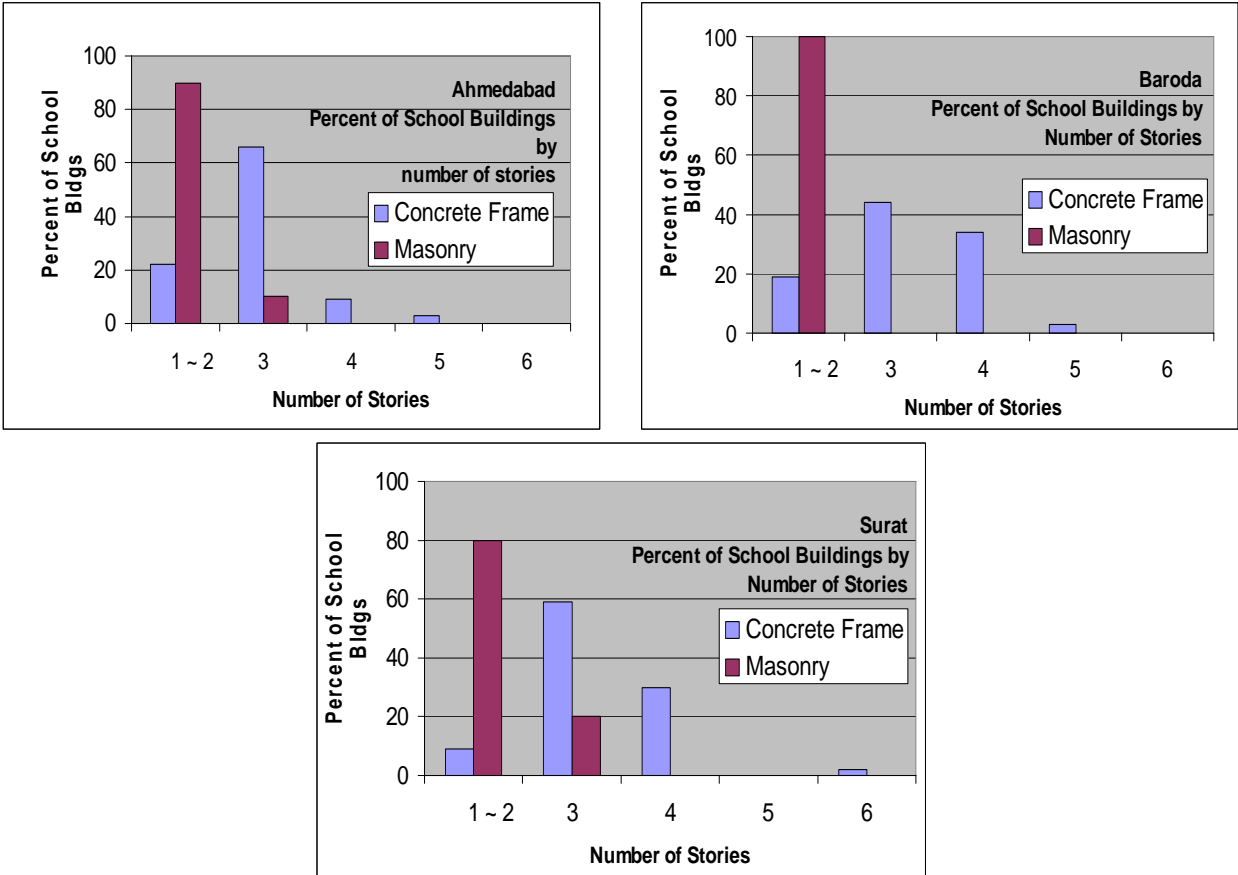
Figure 7 displays the distribution of school buildings according to number of stories observed in the three cities. Masonry school buildings are predominantly 1- or 2-story structures, and concrete frame buildings are usually 3-story structures. In Ahmedabad, 90 percent of the masonry school buildings are 1- or 2-stories and 10 percent are 3-stories; 65 percent of the concrete frame buildings are 3-stories, 22 percent are 1- or 2-stories, and a few are higher than 3 stories. In Baroda, all masonry school buildings are 1- or 2-stories; 45 percent of the concrete frame buildings are 3-stories, 34 percent are 4-stories, and around 20 percent are 1- or 2-stories. In Surat, 80 percent of the masonry buildings are 1- or 2-stories and 20 percent are 3-stories; about 60 percent of the concrete frame buildings are 3-stories, 30 percent are 4-stories, and a few are 6-story structures.

Figure 7. Percent of school buildings by number of stories for Ahmedabad (above, left), Baroda (above, right) and Surat (below)

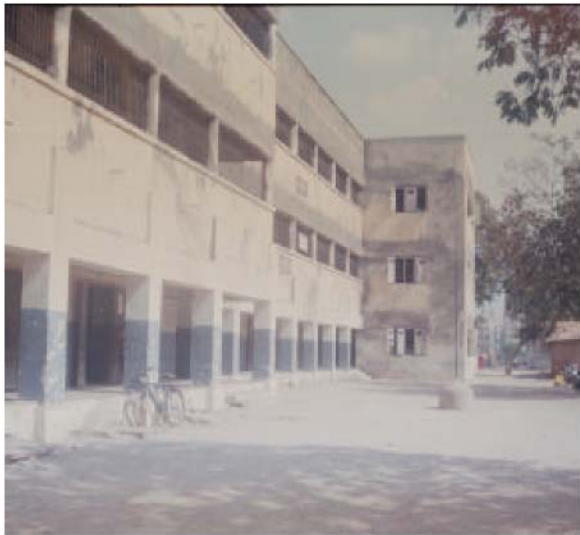
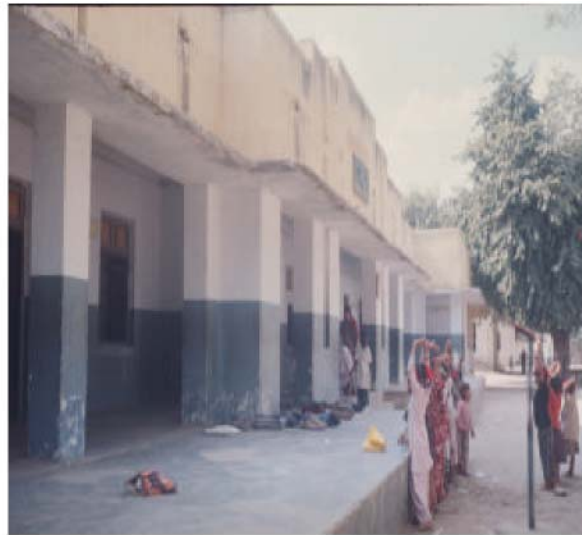
(a) Ahmedabad. Concrete frame (left) and masonry (right) school buildings

The visual assessment inventories school buildings and identifies those that are potentially seismically vulnerable. It requires minimally trained inspectors (who need not be civil engineers or architects) and a digital camera. Figure 8 shows typical structures in the three cities.

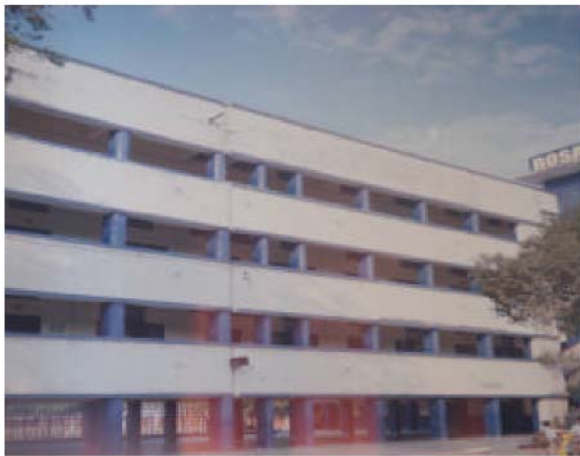
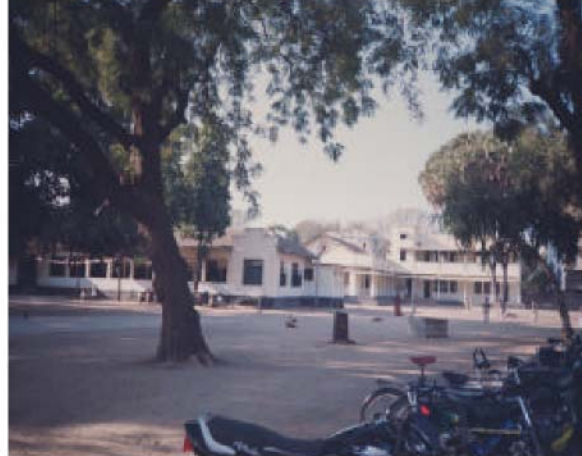
(b) Baroda. Concrete frame (left) and masonry (Right) school buildings

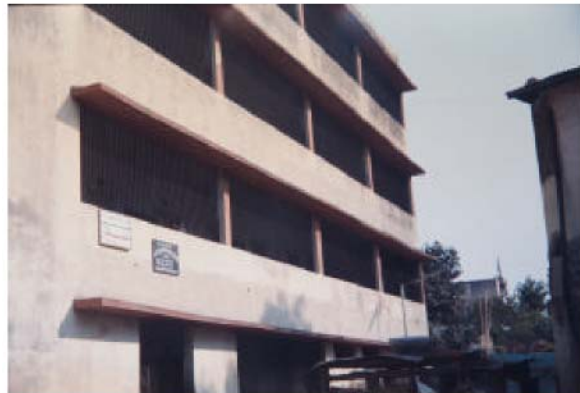
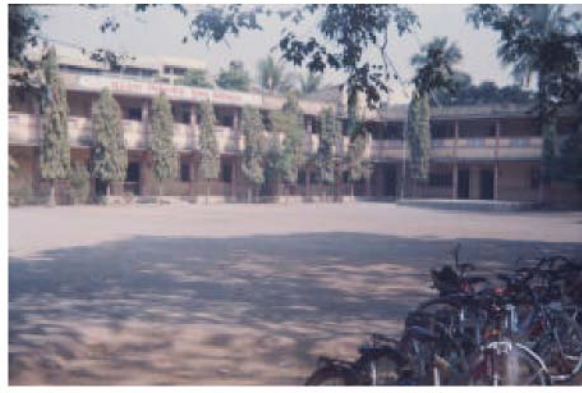
(c) Surat. Concrete frame (left) and masonry (right) school buildings
Fig. 8 Typical school buildings in Ahmedabad, Baroda, and Surat

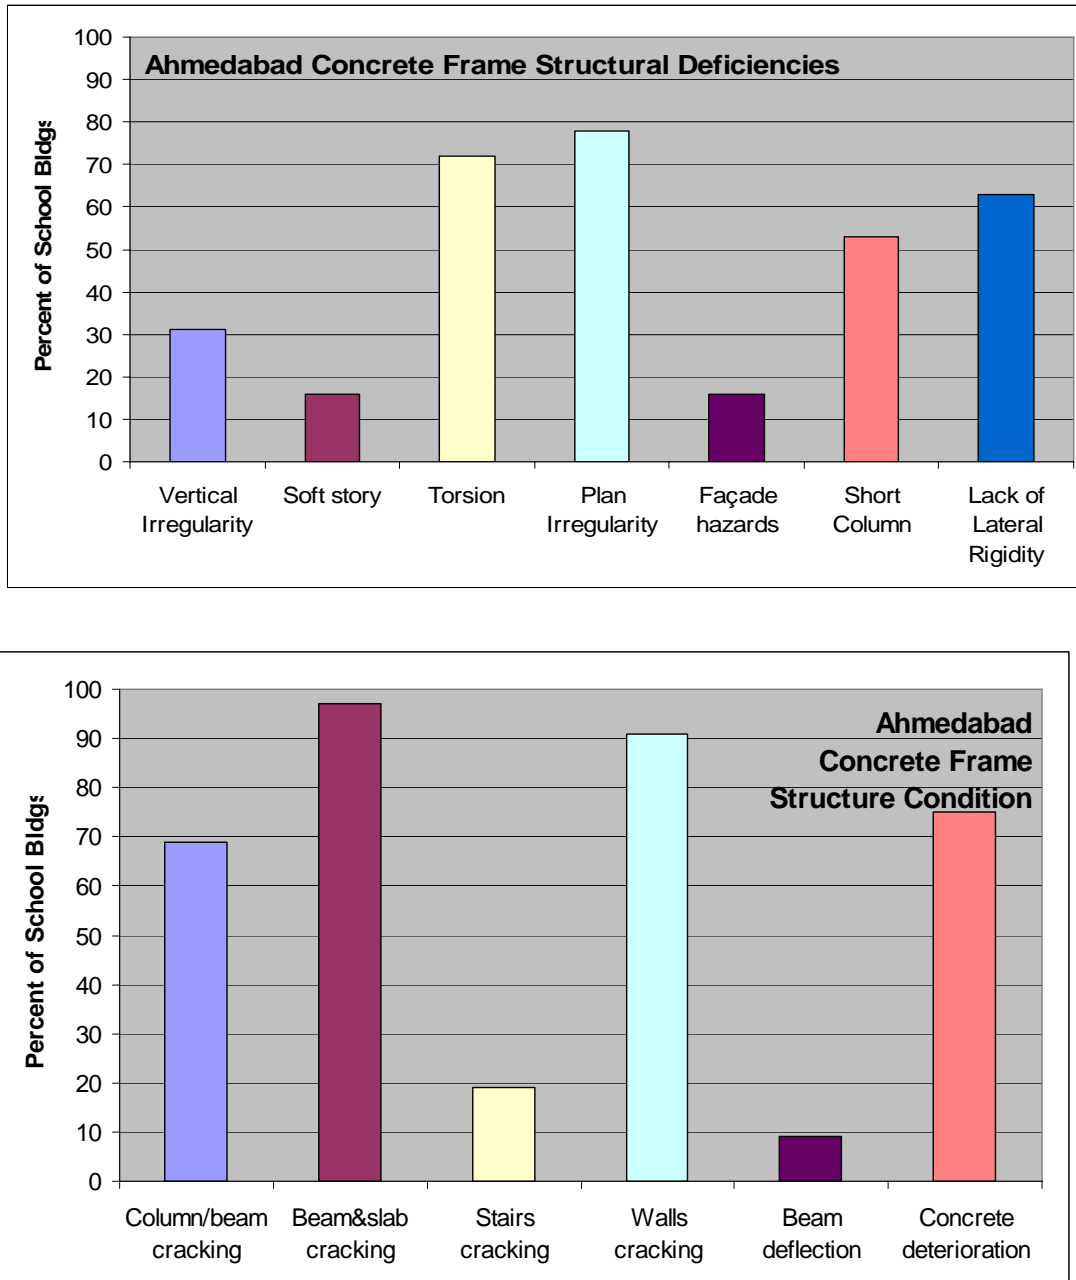
Figure 9 summarizes the findings of the visual assessment of school buildings in Ahmedabad. Plan irregularity (78 percent), torsion (72 percent), lack of lateral rigidity (63 percent) and short columns (53 percent) are the most frequent features that adversely affect seismic performance of concrete frame school buildings. Structure condition is reflected by buildings with cracking in beams and slabs (97 percent), cracking in walls (91 percent), spalling of concrete and steel corrosion (74 percent), and cracking in column/beam connections (69 percent).

Figure 9. Frequency of concrete frame structural deficiencies and condition for Ahmedabad

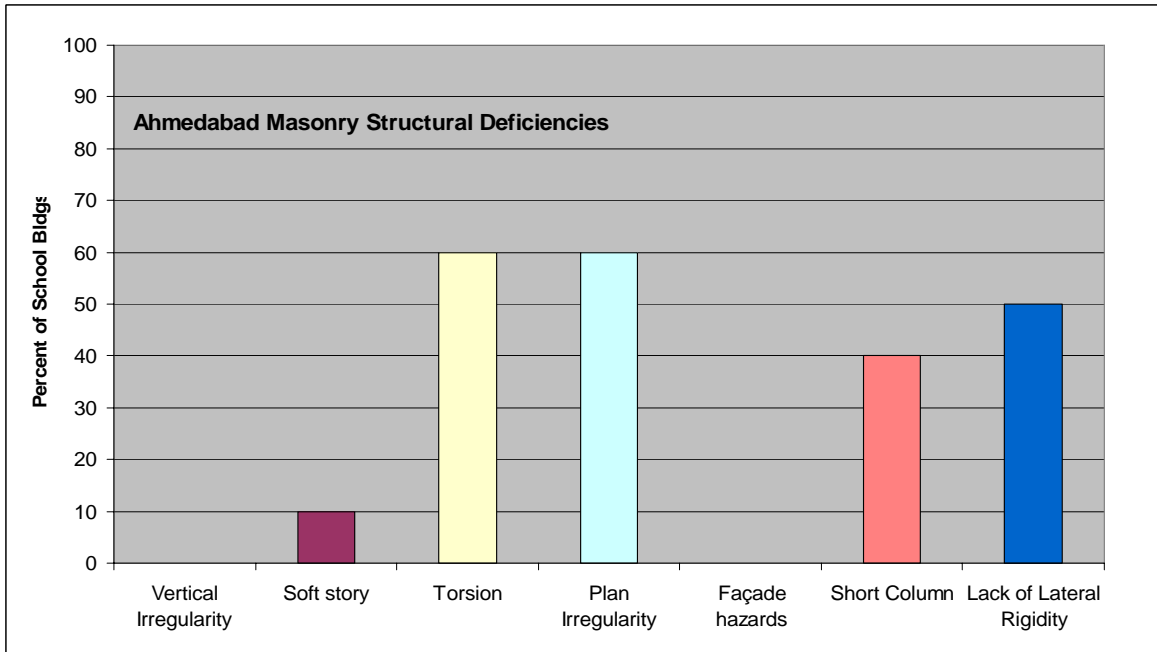
Figure 10 summarizes the results of the visual assessment of masonry school buildings in Ahmedabad. Plan irregularity (60 percent), torsion (60 percent), lack of lateral rigidity (50 percent) and short columns (40 percent) are the most common features that adversely affect seismic behavior. Structural condition is reflected by buildings with cracking in walls and beams and slabs (90 percent), cracking in column/beam connections (80 percent), and concrete deterioration (60 percent).

Figure 10. Frequency of masonry structural deficiencies and condition for Ahmedabad

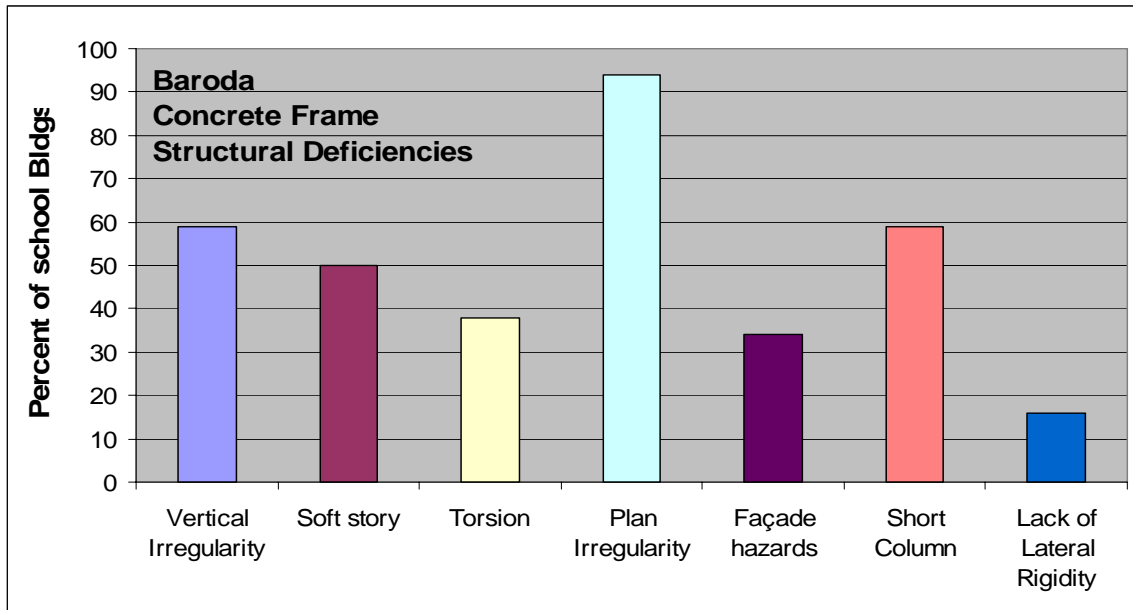
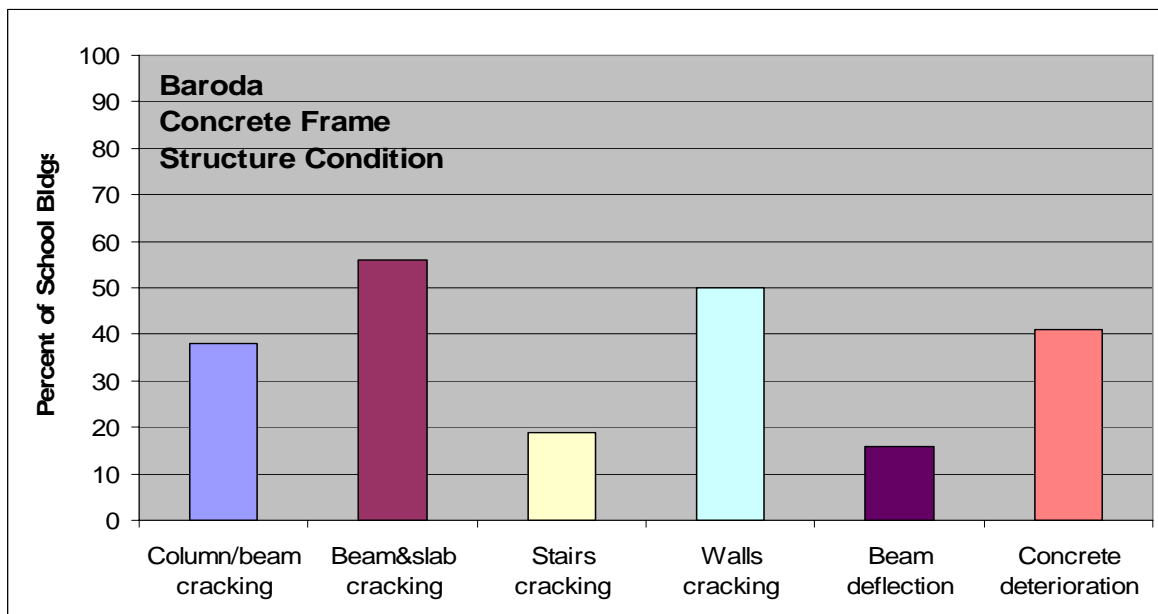
Figure 11 summarizes the results of the visual assessment for concrete frame school buildings in Baroda. Plan irregularity (93 percent), short columns (58 percent), vertical irregularity (58 percent) and soft story (50 percent) are the most frequent features that adversely affect seismic performance. Façade hazards were found in more than 30 percent of the school buildings. Structure condition is reflected in cracking in beams and slabs (56 percent), cracking in walls (50 percent), reinforced concrete deterioration such as spalling of concrete and steel corrosion (40 percent), and cracking in column/beam junctions (38 percent).

Figure 11. Frequency of concrete frame structural deficiencies and condition for Baroda

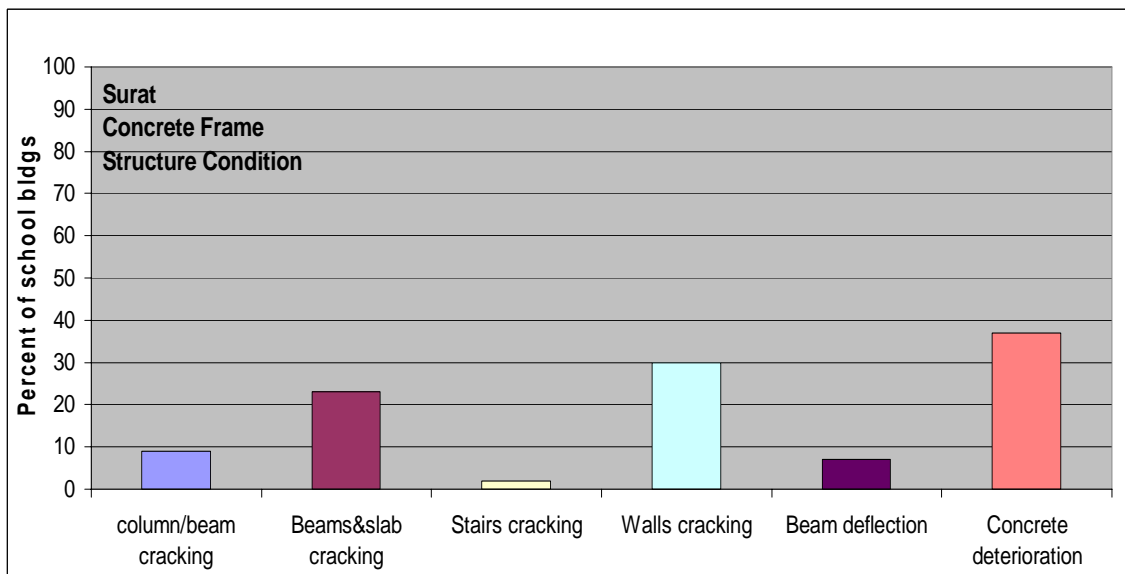
Figure 13 summarizes the findings for concrete frame school buildings in Surat. It clearly shows that plan irregularity (65 percent), torsion (60 percent) and short columns (58 percent) are the leading structural deficiencies that may adversely affect the seismic behavior of these school buildings. Around 30 percent of schools have façade hazards. The structural condition indicates that around 38 percent of the schools show concrete deterioration, 30 percent cracks in walls and 23 percent cracks in beams and slabs.

Figure 13. Frequency of concrete frame structural deficiencies and condition for Surat

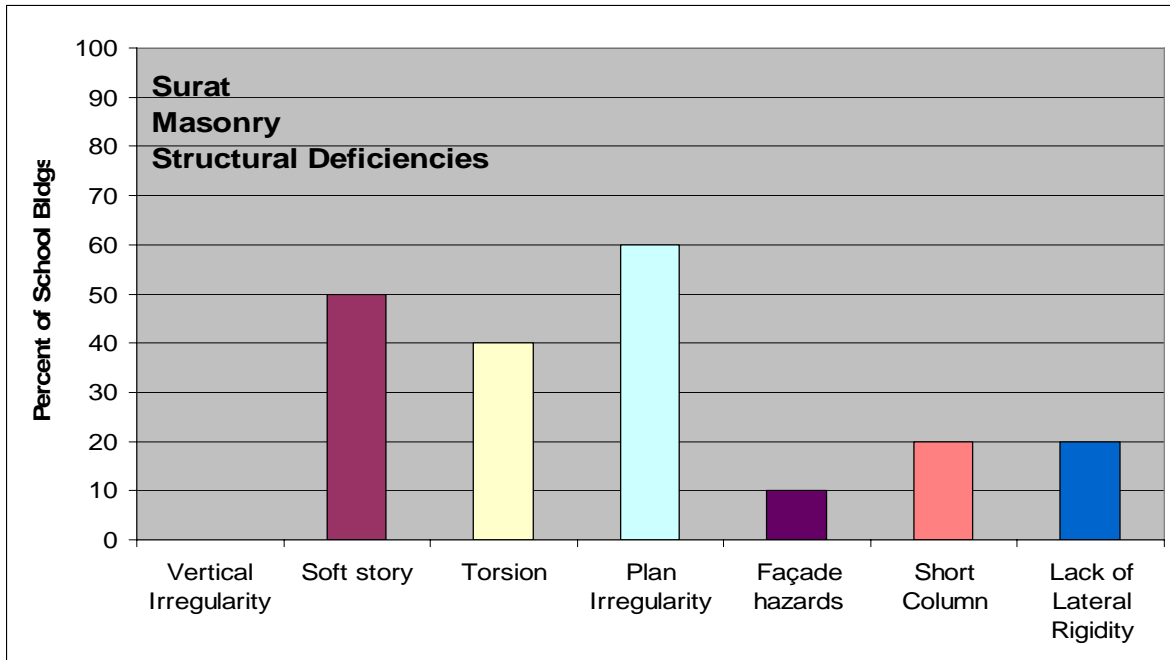
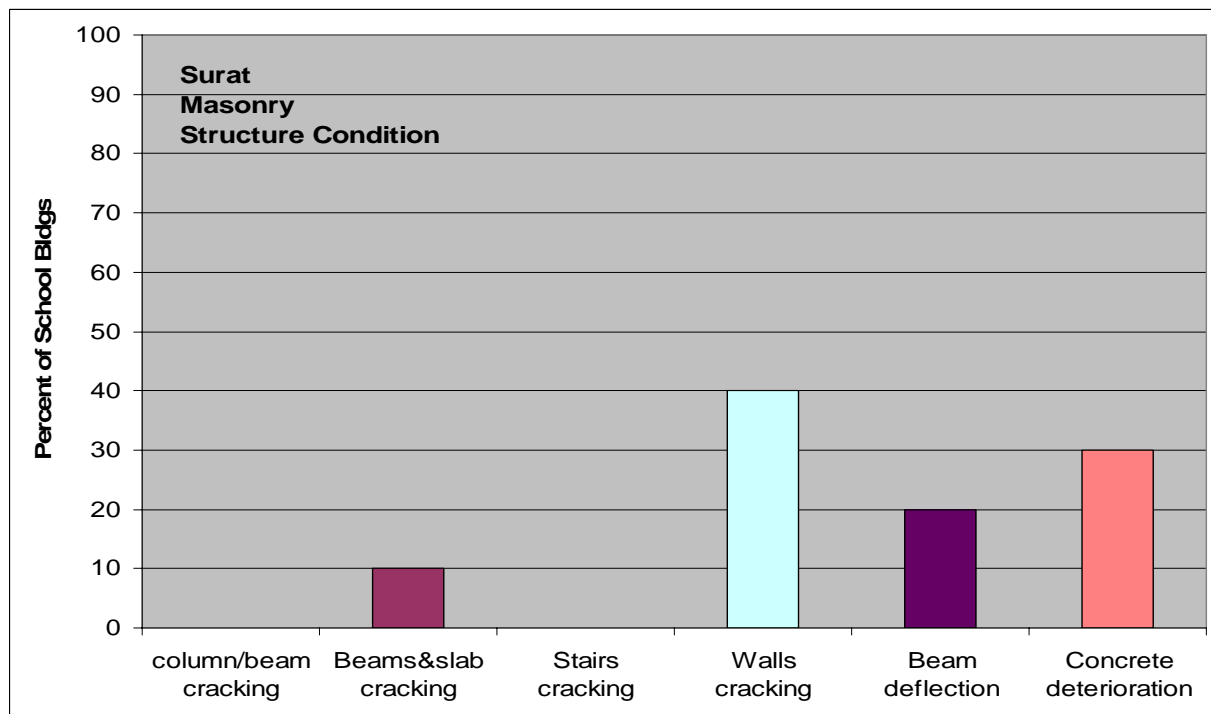
Figure 14 summarizes the findings of the visual assessment of masonry school buildings in Surat. It shows that plan irregularity (60 percent), soft story (50 percent) and torsion (40 percent) are the most frequently observed structural deficiencies. Structural condition is indicated by wall cracks in 40 percent of the schools, concrete deterioration in 30 percent and beam deflection in 20 percent.

Figure 14. Frequency of Masonry structural deficiencies and condition for Surat

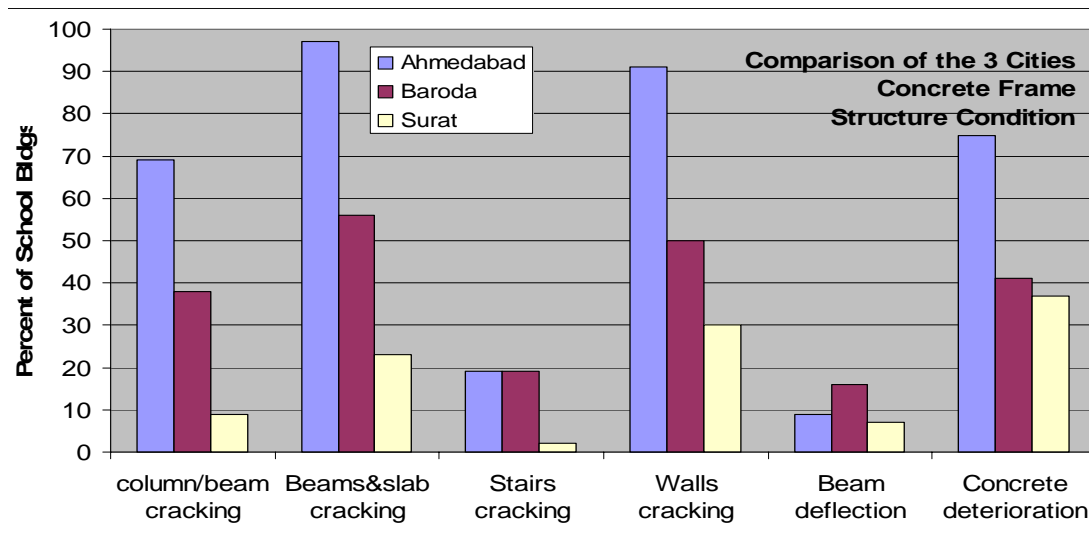
Figure 15 compares observed structural deficiencies and conditions for the three cities. Plan irregularity is the most common structural deficiency in the three cities; this defect affects over 90 percent of school buildings in Baroda, almost 80 percent in Ahmedabad, and over 60 percent in Surat. Short columns are found consistently in the three cities at an average of 55 percent of schools. Schools in Baroda have the highest proportion of buildings with vertical irregularities and soft stories. School buildings in Ahmedabad have the largest proportion of buildings with torsional and lateral rigidity deficiencies. School buildings in Surat have the largest proportion of torsion problems.

The condition of concrete frame building in Ahmedabad is worse than buildings in Baroda and Surat. The poor condition of concrete frame school buildings in Ahmedabad should be considered when prioritizing mitigation actions.

Figure 15. Frequency of performance modification factors for concrete frame buildings

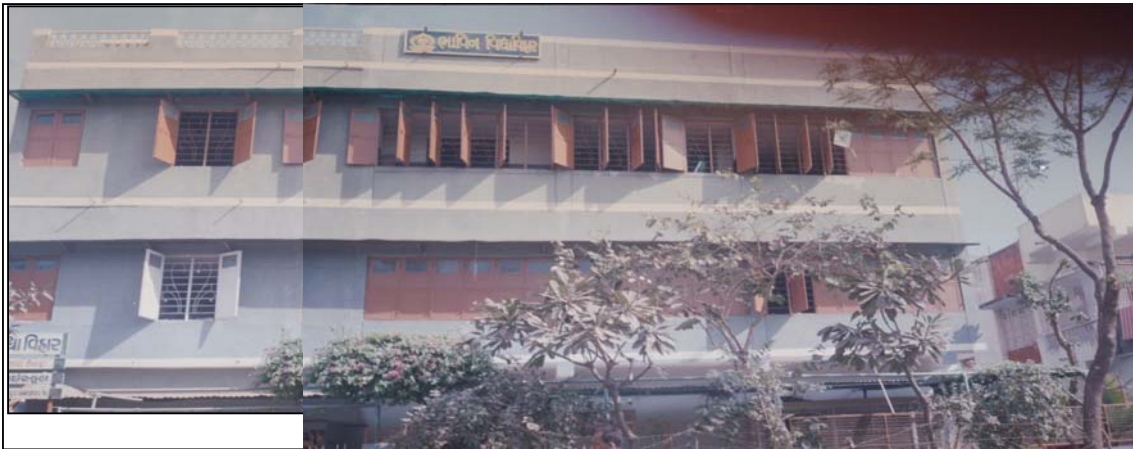
BUILDING 1

FRONT VIEW OF THE SCHOOL BUILDING (F.F. AND S.F.)

II	STRUCTURAL DEFICIENCIES		Gr. Floor	FIRST FLOOR	OTHER FLOORS
	HEIGHT RISK		0	0	0
	VERTICAL IRREGULARITY		0	0	0
	SOFT STORY		0	1	1
	TORSION		0	0	0
	PLAN IRREGULARITY		0	0	0
	POUNDING		0	0	0
	FAÇADE HAZARDS		0	0	0
	SHORT COLUMN		0	0	0
	BEAM C/S>COLUMN		0	0	0
	UNSUPPORTED COLUMN		0	0	0
	LATERAL RESISTANCE CAPACITY		0	0	0
	PLINTH BEAMS MISSING?		0		
III	NOTICEABLE DISTRESSES				
	COLUMNS				
	CRACKING IN COLUMN-BEAM JUNCTION		0	0	0
	CRUSHING		0	0	0
	SLABS AND BEAMS				
	SHEAR CRACKS		0	0	0
	DEFLECTION IN BEAMS		0	0	0
