The Kashmir Earthquake of October 8, 2005

A Quick look Report

Mid-America Earthquake Center
University of Illinois at Urbana-Champaign

MAE Center Report No. 05-04

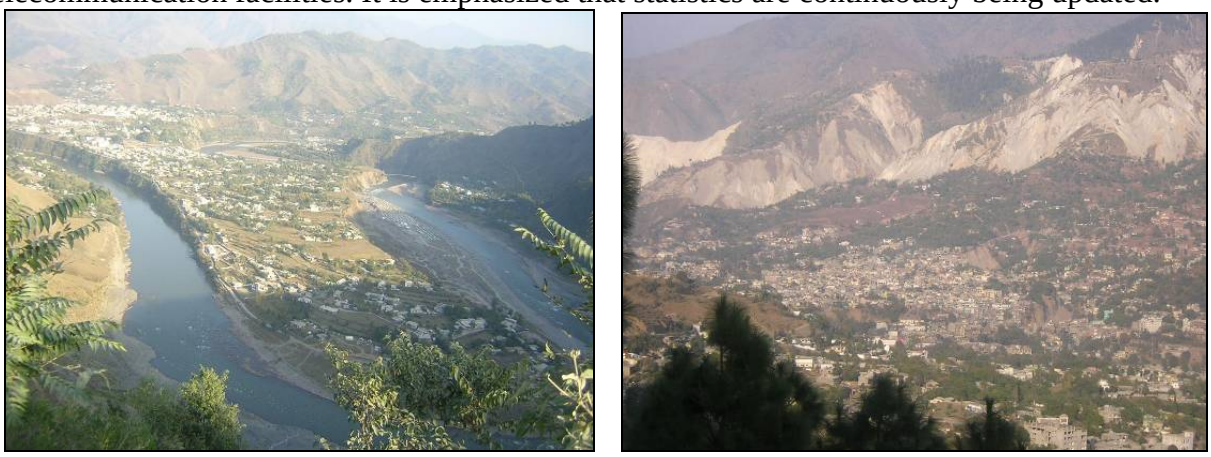
Figure 2.2 Muzaffarabad, (a) view from the south and (b) residential areas in the north (note landslides in (b))

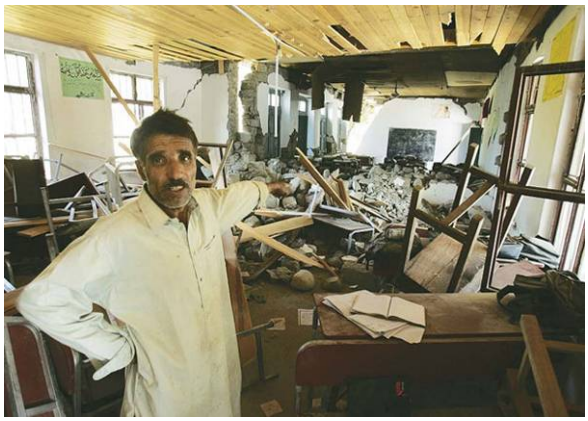
Figure 4.10 shows the punching of a column through the roof slab, and collapse of a hotel building, respectively. Figure 4.11 and Figure 4.12 show the collapse of urban school buildings with a typical out-of-plane failure of unreinforced masonry walls.

Figure 4.11 Failure of an Urban School Building

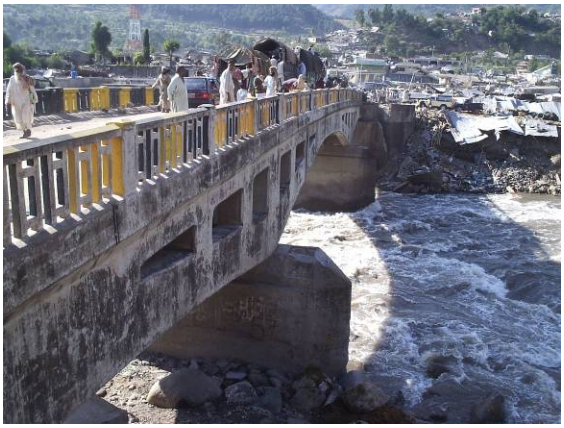
Damage to the mountainous roads is largely due to landslides precipitated by the earthquake, as described in more detail in subsequent sections of this report. Figure 4.13 (a,b) show the Balakot Bridge on the Kunhar River which was knocked off its bearing supports. Lack of lateral restraints allowed sliding of the bridge that resulted in one outer girder hanging freely (Figure 4.14 a), and other girders left with minimal bearing over their supports (Figure 4.14 b). Preliminary analysis of the bridge indicates that vertical motion may have played a significant role in reducing the vertical force on the bearings, leading to the large observed lateral displacement. Further detailed analysis will be included in the MAE Center full report. Figure 4.15 shows a Muzaffarabad bridge that also lacked lateral restraints, and was shifted from its supports. Figure 4.16 shows a simply supported bridge over a culvert in the epicentral zone where one of the abutments moved more than 8 feet with respect to the other.

Figure 4.15 Lateral sliding of the Balakot Bridge.

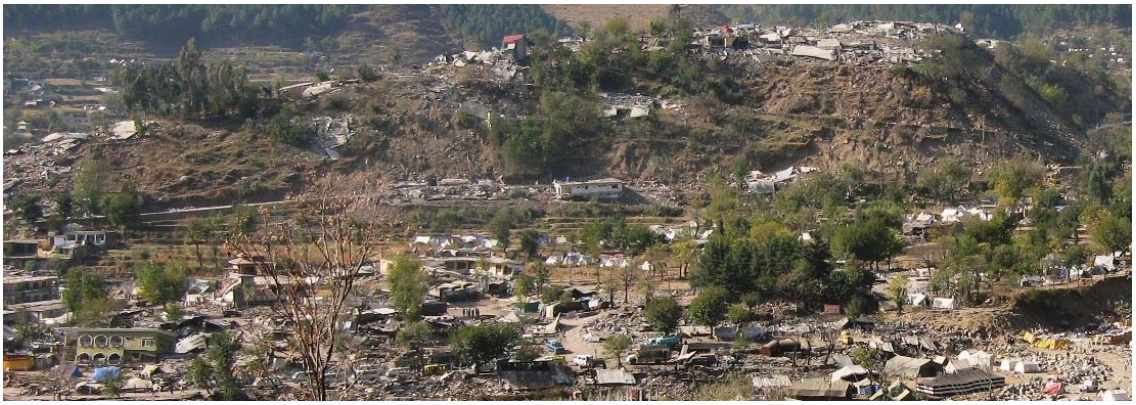
Permanent ground deformations due to land-sliding undermined the foundations of many structures including buildings and bridges and resulted in extensive damage. Figure 5.3 shows wide spread damage at Nisar Camp north of Muzaffarabad where over 300 structures were severely damaged or destroyed along a ridge. Cracks are clearly visible along the edges of the ridge as slopes along the edges have displaced laterally. This type of permanent ground deformations due to land-sliding is in part responsible for the widespread damage in Balakot as shown in Figure 5.4 and Figure 5.5.

Figure 5.5 Collapsed structures along ridge in Balakot, note land-sliding along the rims.

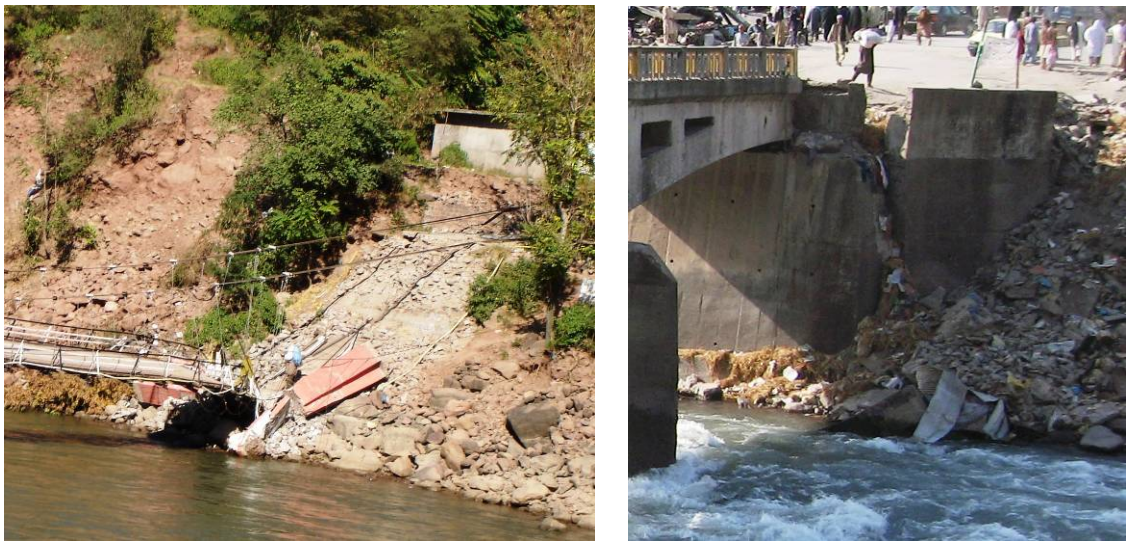
Figure 5.7 Damage to bridge abutments: (a) Collapsed pier/abutment of a suspension bridge, Pushee, Jhelum River, courtesy of S. Saeed, (b) sheared wing-wall for bridge abutment in Balakot.

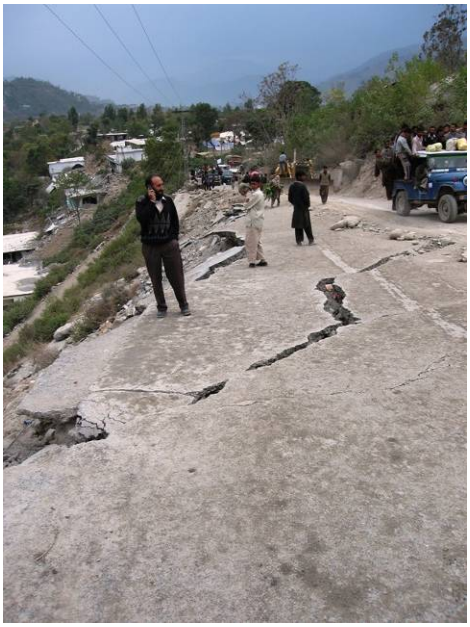
Along the roads leading to Balakot and Muzaffarabad there was ample evidence of cleared landslides that blocked these roads. The occurrence of these surficial landslides along the rather steep slopes is not unexpected. Figure 5.9 shows a close-up of typical damage to a paved roadway. Numerous transverse and longitudinal road ruptures were observed in the affected area. Figure 5.10 indicates that the measured horizontal and vertical movements of road ruptures were about 30 cm.

Figure 5.9 Cracked roadway due to land-sliding, north of Muzaffarabad.

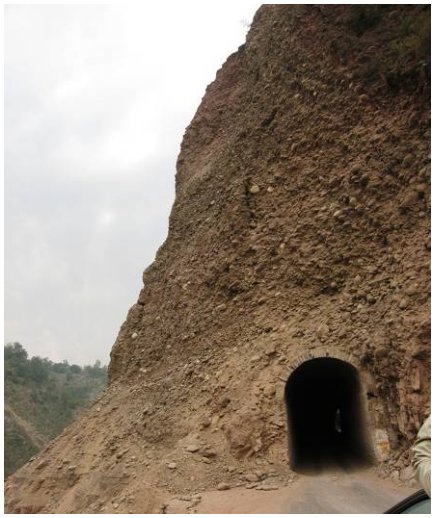
Only one tunnel was encountered along the road between Murree and Muzaffarabad. The tunnel was originally used for northbound traffic while a bypass road along the side of the hill was used for southbound traffic, Figure 5.11. The bypass road was lost due to land-sliding in a predominantly colluvium slope. The tunnel portals were blocked due to land-sliding as well. The tunnel was lined with unreinforced masonry that appears to have remained intact starting from the south portal for about 2/3 of the tunnel length. The northern portion of the tunnel was unlined. It was not readily apparent whether the lining collapsed, or the tunnel was originally unlined.

Figure 5.11 Land-sliding in colluvium, blocked rock, tunnel relatively intact, South of Muzaffarabad
