# 東日本大震災・津波の記録

Record of 2011 Great East Japan Earthquake/Tsunami

March 2015 年 3 月

Joint Project by 政策研究大学院大学・建築研究所共同事業  
National Graduate Institute for Policy Studies (GRIPS) DM  
Program & International Institute of Seismology and Earthquake  
Engineering (IISEE) of the Building Research Institute (BRI), JAPAN

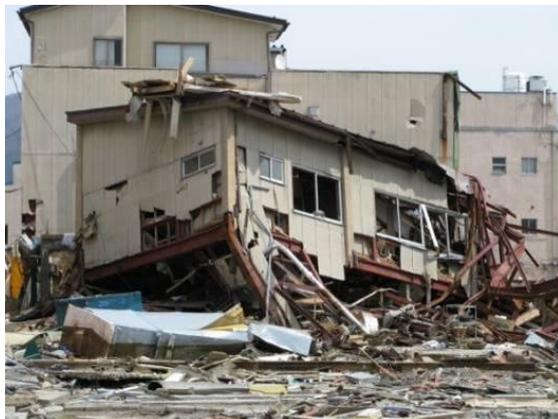
Photo 2-10: Story collapse of first floor in a 2-story steel building

Skeleton collapse including story collapse of the first floor was seen in a 2-story steel building (Photo 2-10). Partial collapse of a warehouse was also seen on the coast.

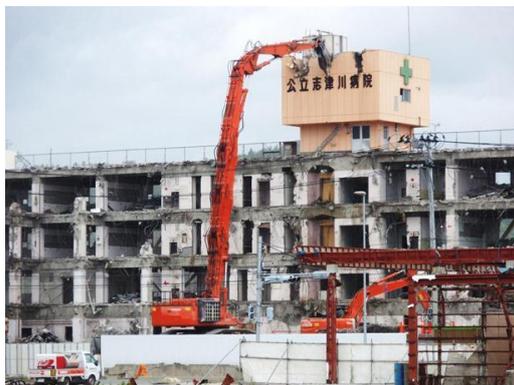
Before the 2011 Tohoku Earthquake (Great East Japan Earthquake), tsunami evacuation buildings were designated in the affected regions in Iwate, Miyagi and Fukushima prefectures. Most of them functioned against tsunami and saved many surrounding residents' lives. The photo 1 shows a tsunami evacuation building in Minami-sanriku town was a public hospital with five-story and although even fourth floor was inundated, many people evacuated fifth or top floor. However, municipality of Kamaishi city retracted the designation even for a remained building with eight stories. It seems that heavily affected municipalities tend to be more circumspect to designate tsunami evacuation buildings again.

**Photo 1:** (left)  
 Demolished  
 Tsunami Evacuation  
 Building in Minami-  
 Sanriku, Miyagi  
 June 2012 (S. Ando)

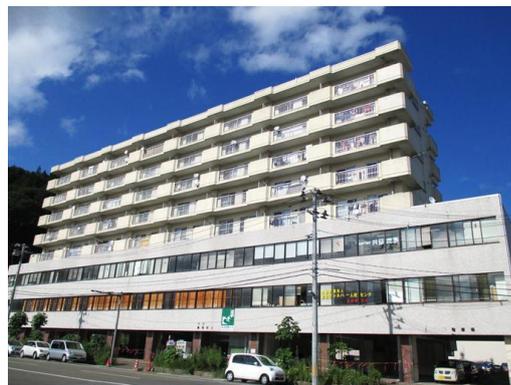
**Photo 2:** (right)  
 Tsunami Evacuation  
 Building remained  
 but retracted its  
 designation in Iwate  
 Aug. 2013 (S. Ando)
