# **BUILDING PERFORMANCE: HURRICANE ANDREW IN FLORIDA**

**OBSERVATIONS, RECOMMENDATIONS,  
AND TECHNICAL GUIDANCE**

**FEDERAL EMERGENCY MANAGEMENT AGENCY  
FEDERAL INSURANCE ADMINISTRATION**

**DECEMBER 21, 1992**

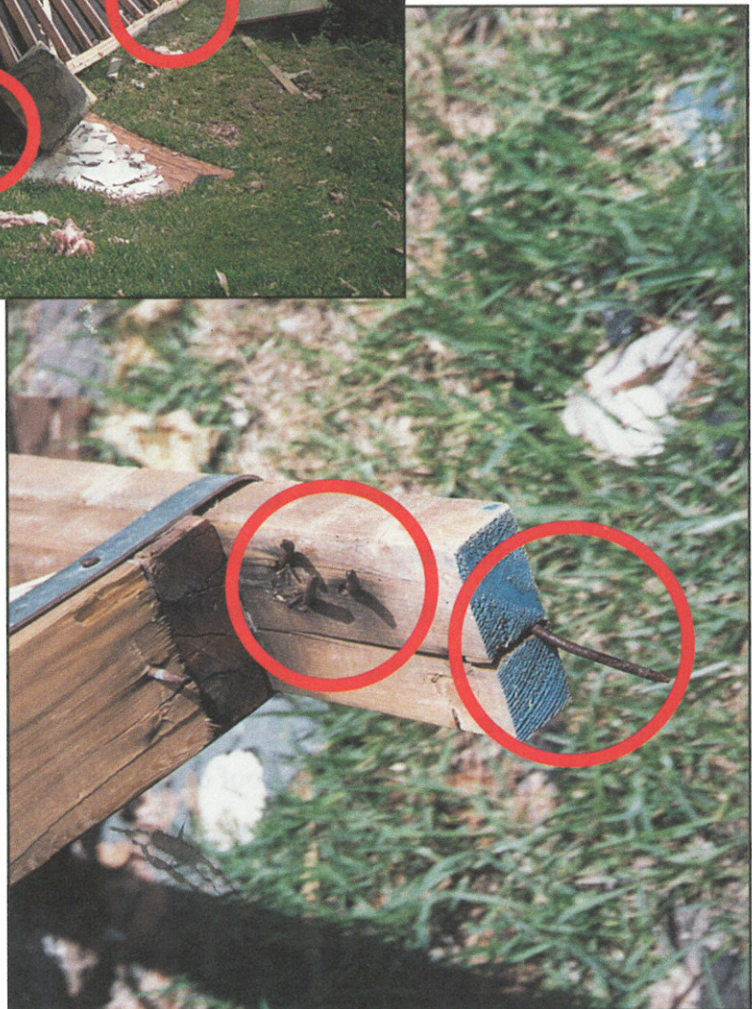
An absence of or improper installation of framing connections, load transfer straps, or bracing from non-loadbearing walls to connecting wall and roof components was noted. This condition contributed significantly to the primary failure of the framing system (SEE FIGURES 4 AND 5).

FIGURE 4.  
*Exterior wood-frame  
non-loadbearing wall.  
Transfer of wind forces  
from wall to adjoining  
structure was not  
sufficient.*

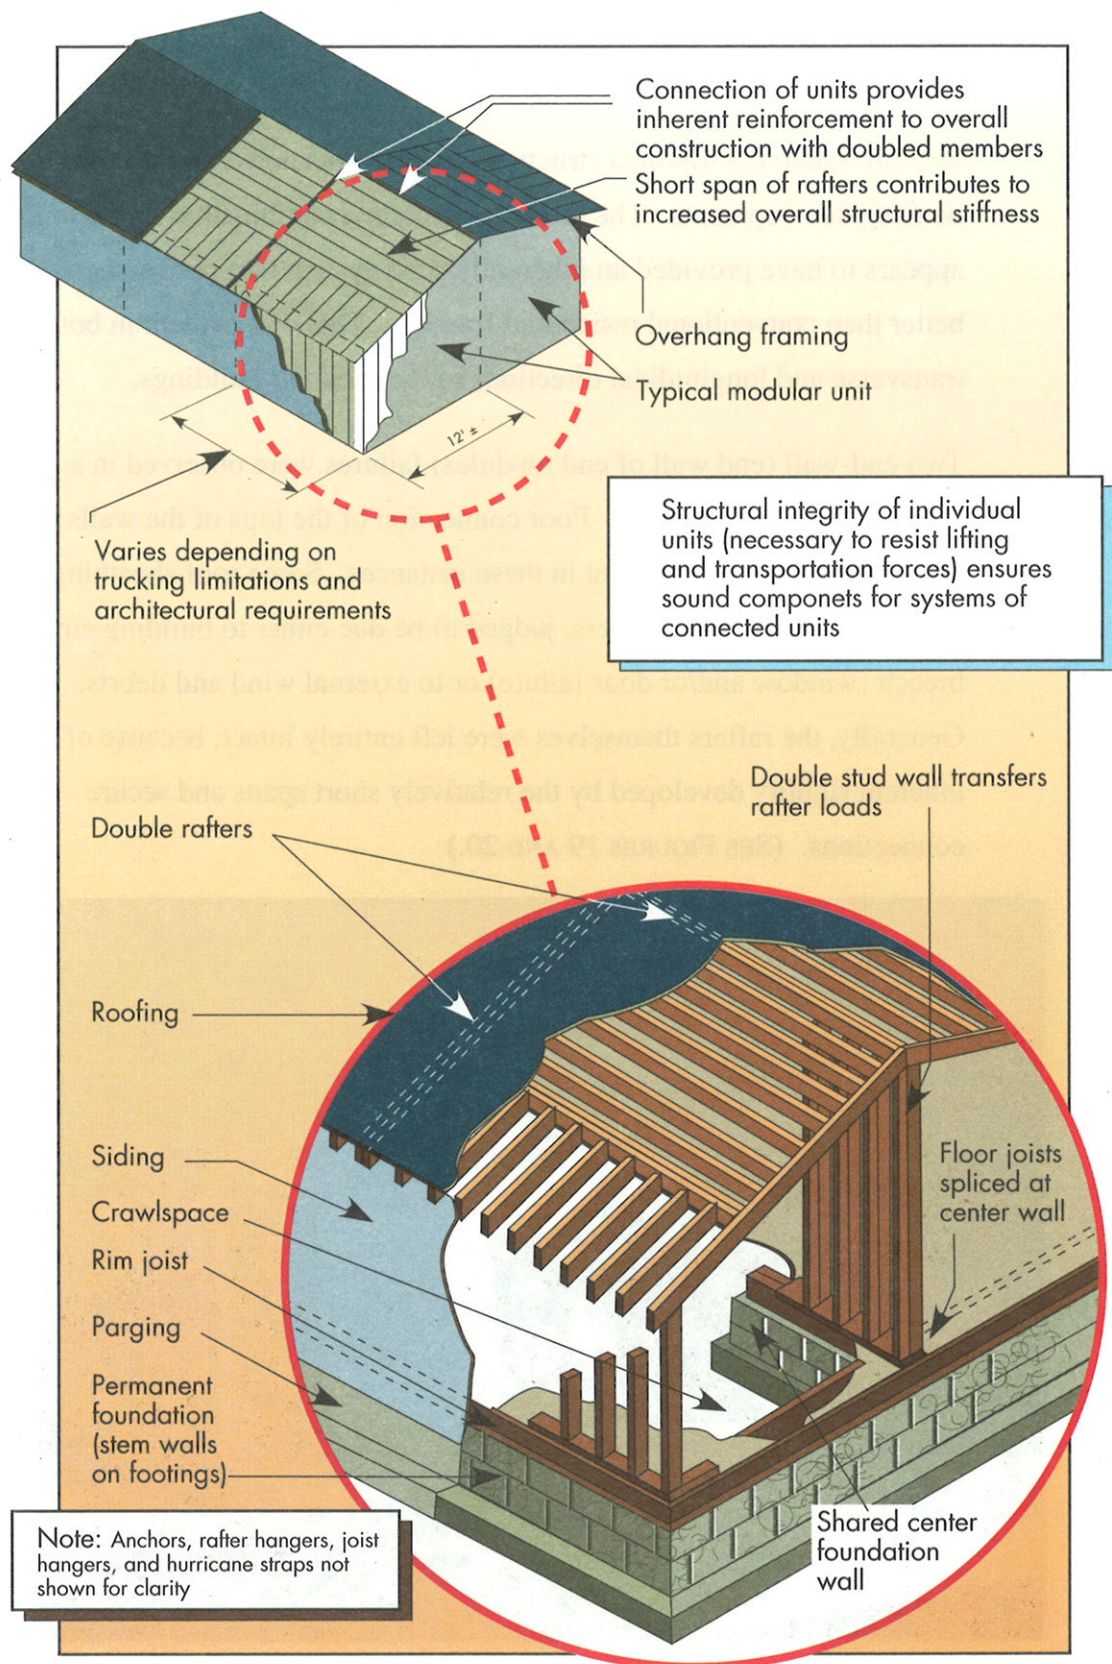
FIGURE 20. *Inherent structural strength of modular construction.*

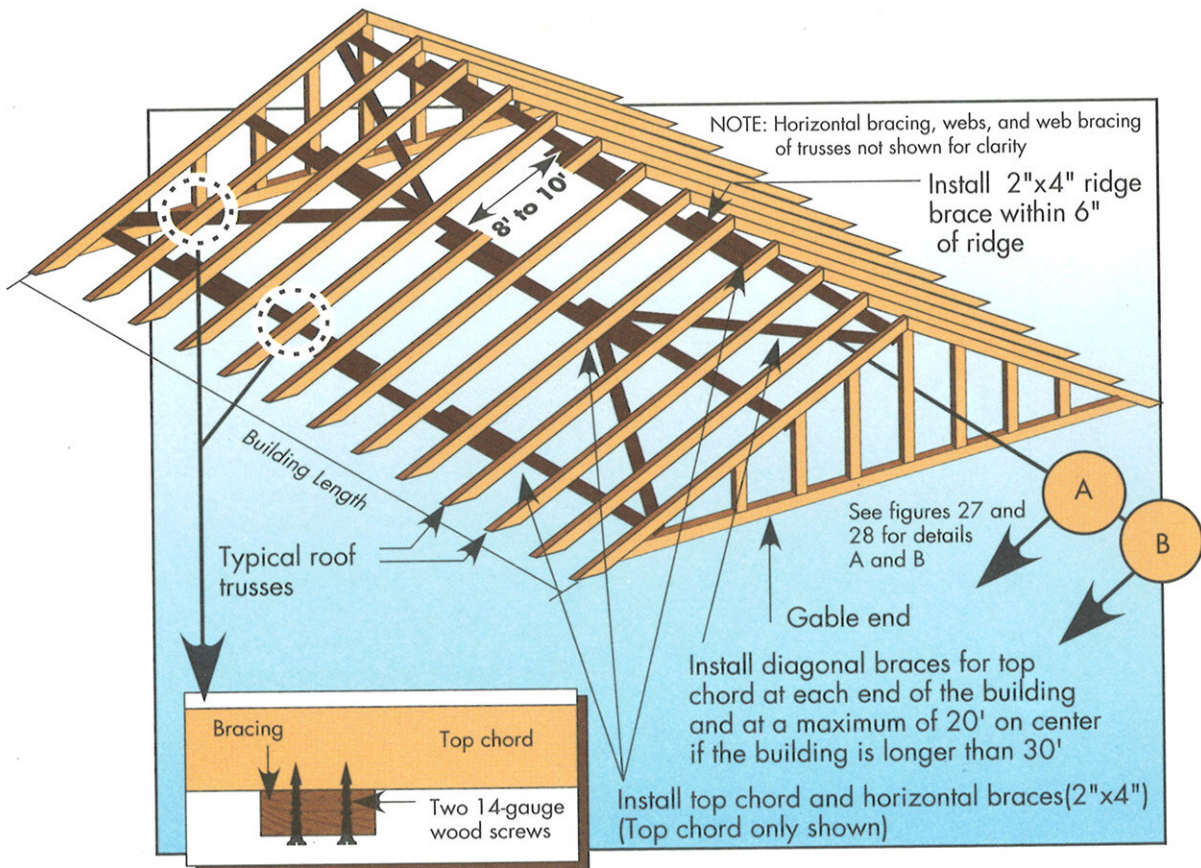
FIGURE 26. Typical roof truss top chord bracing.

1. In addition to the existing program of systematic framing inspections, a specific roof bracing and sheathing inspection should be required prior to installation of roof underlayment (SEE FIGURES 26-29). Note the extra bracing recommended for gable ends in particular.

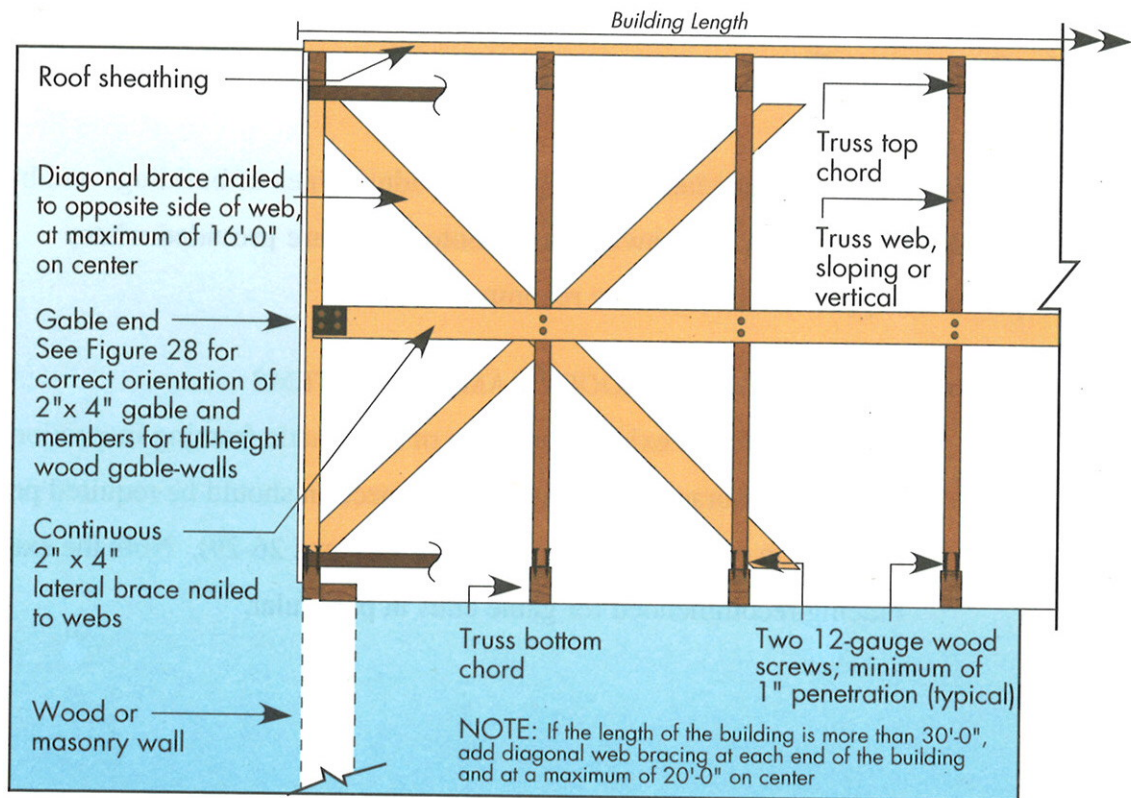
FIGURE 27. Detail A — Typical truss web bracing. Diagonal web bracing as shown, at each gable end of building.

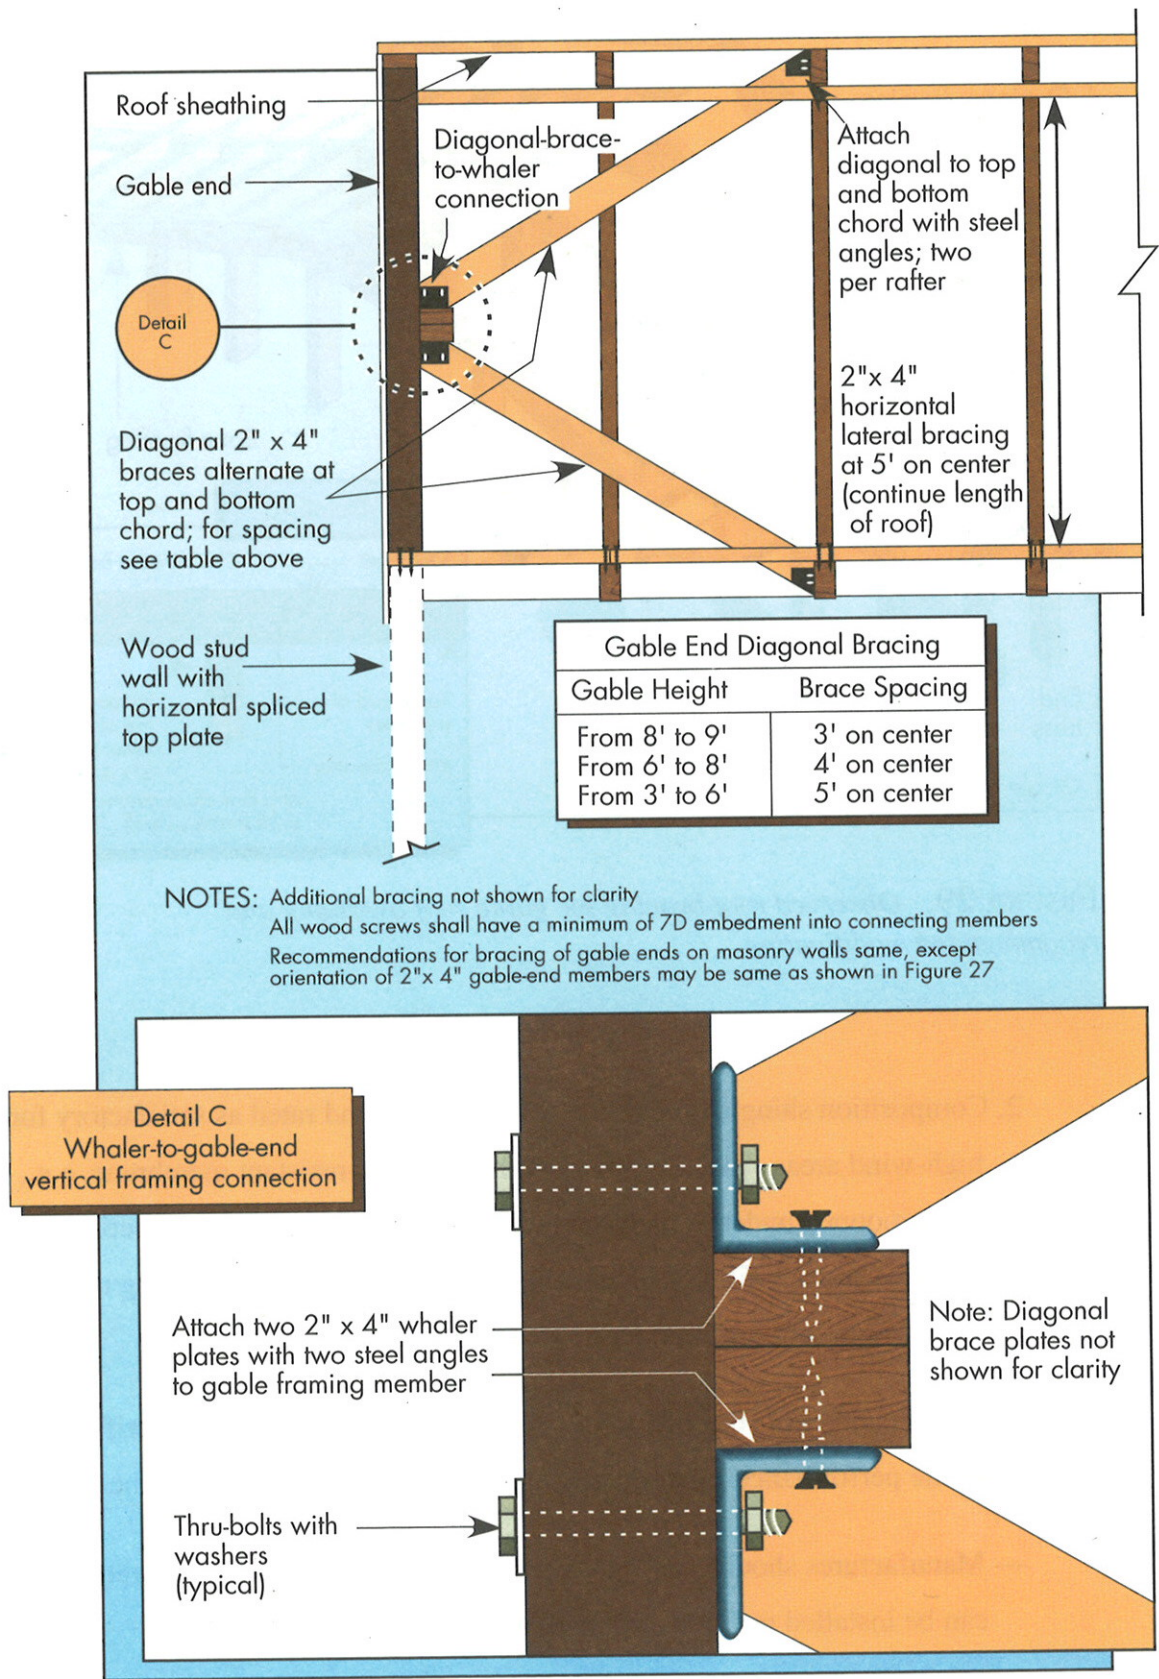
FIGURE 28. *Detail B — Typical wood gable-wall bracing.*

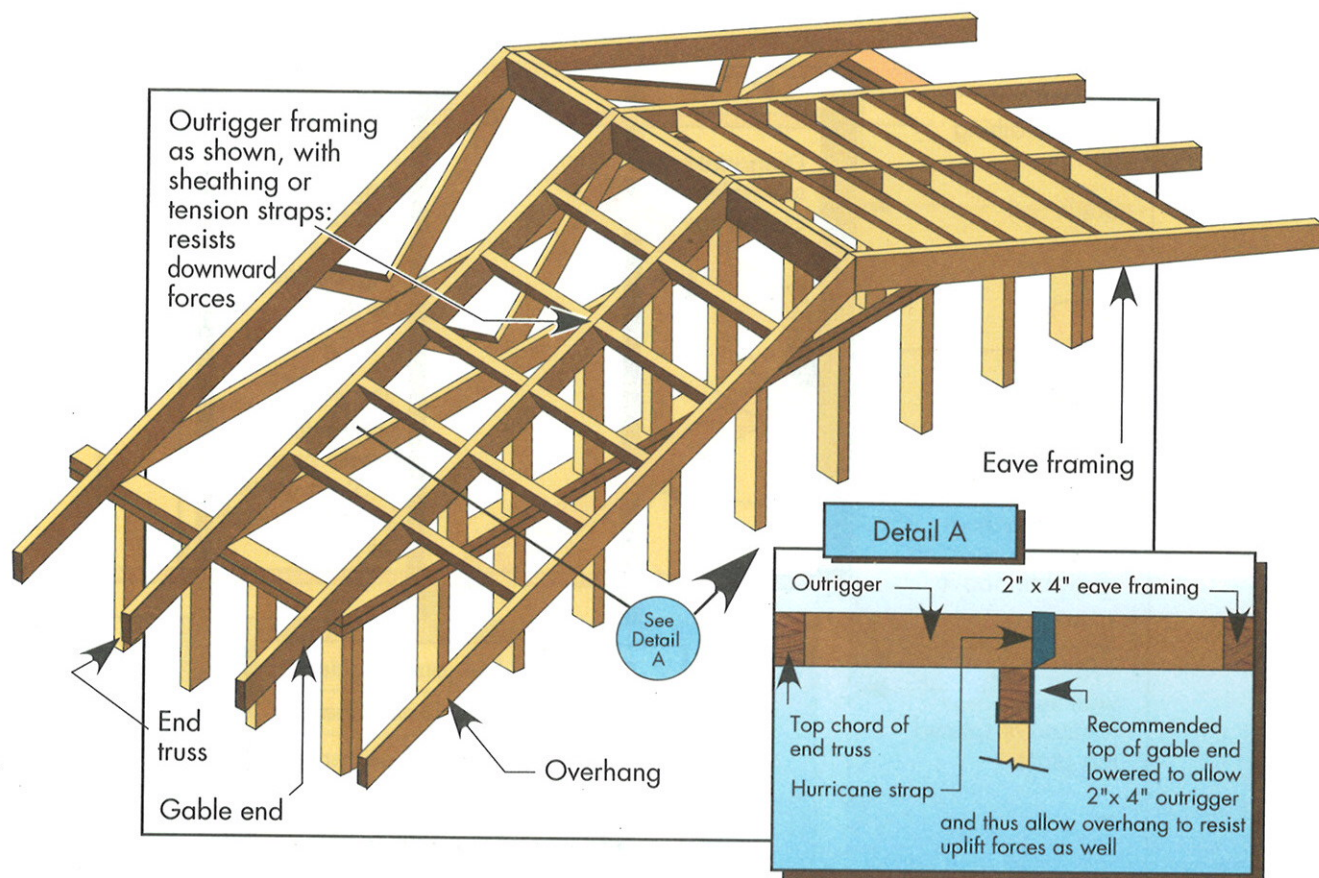
FIGURE 29. *Observed roof bracing for gable roof overhang and recommended modification.*

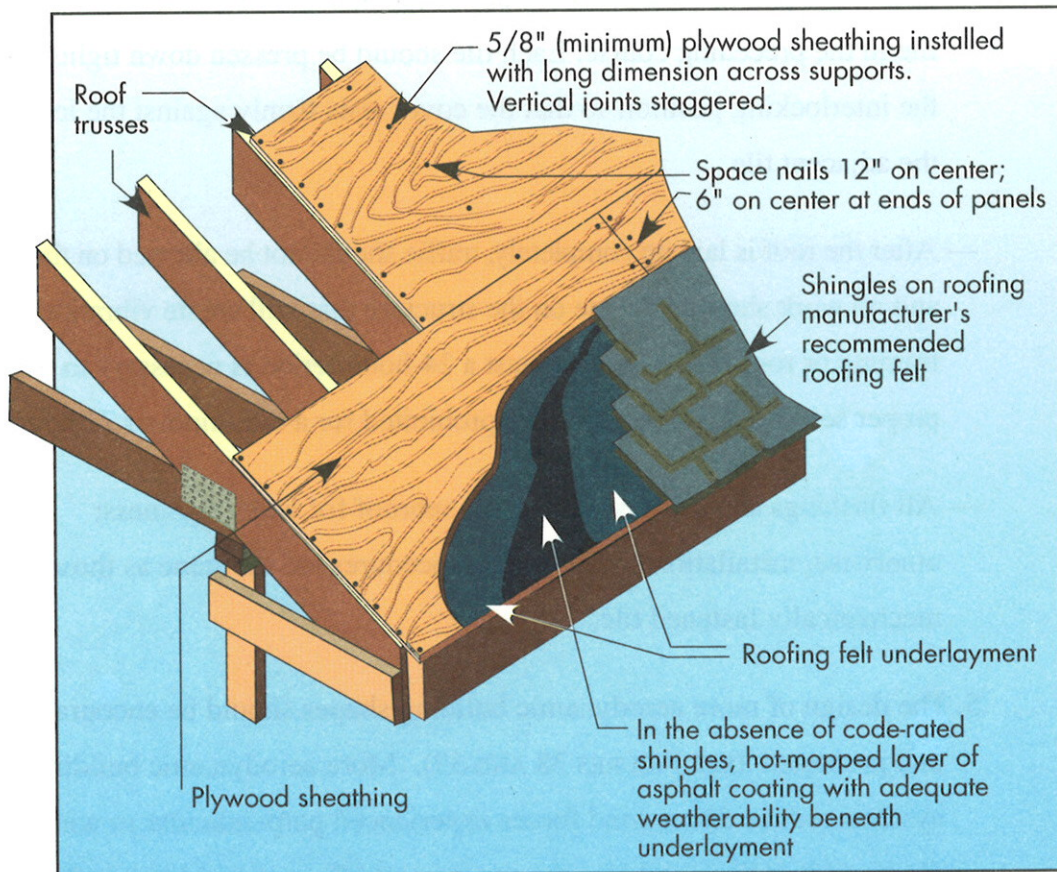
FIGURE 31. *Composition shingle roofing system showing sheathing and hot-mopped underlayment.*

2. Composition shingles should be manufactured and rated as satisfactory for high-wind areas. In the absence of this, a water-resistant membrane, e.g., a hot-mopped underlayment, should be installed to provide protection from the water infiltration that may result from the loss of roofing material during high-wind storms (SEE FIGURES 30 AND 31).
  3. Manufacturers of roof tile products should provide testing and verification of tile performances under realistic conditions (as addressed by the Code).
- Manufactures should verify that mortar used with extruded concrete tiles can be installed to Code requirements.

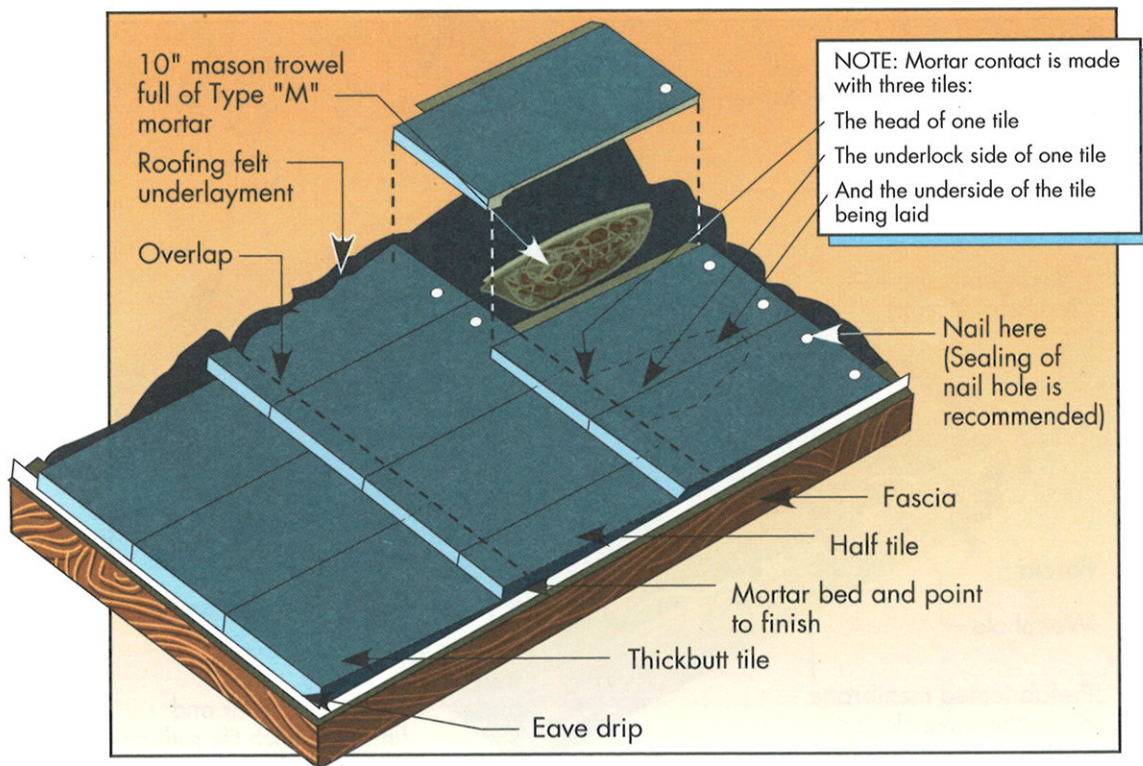
FIGURE 33. *Recommended tile and mortar placement for extruded concrete flat tile roofing system.*

4. Quality control of roof tile installation should be improved by ensuring both consistent mortar pad placements and installation in accordance with manufacturers' requirements, as specified by the Code. (SEE FIGURES 32-37). Though this would improve the survivability of roof tile systems, continued debris impact will result in damage occurring from future wind storms.

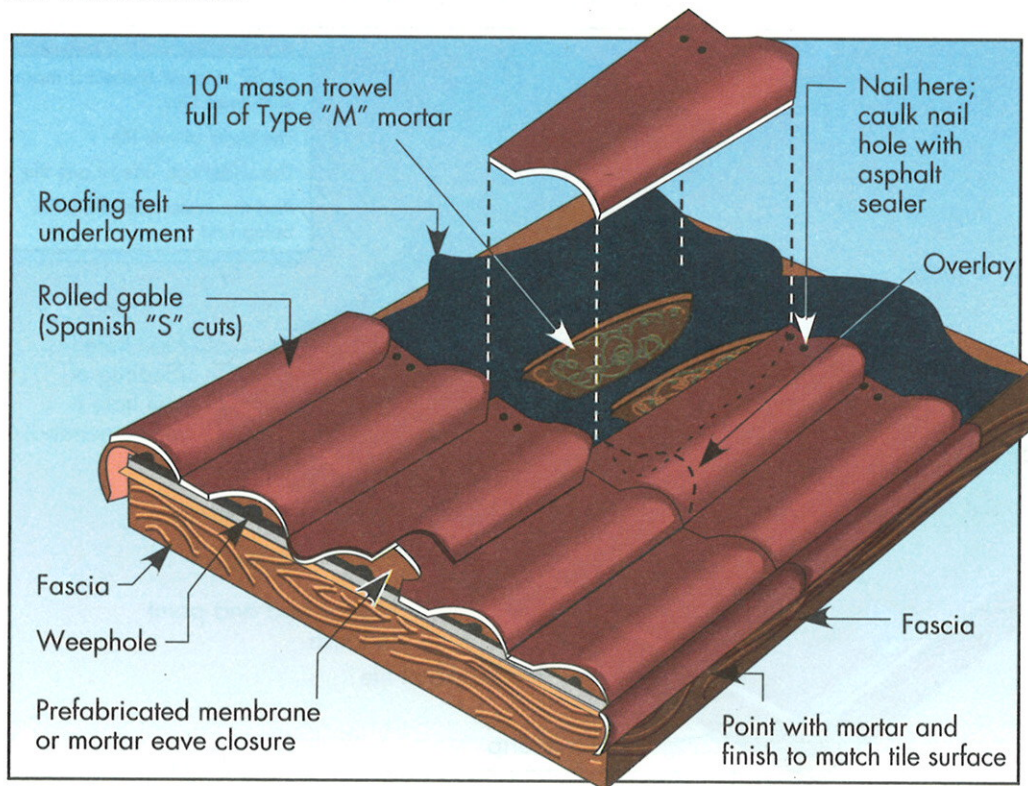
FIGURE 35. *Recommended tile and mortar placement for "S" tile roofing system.*

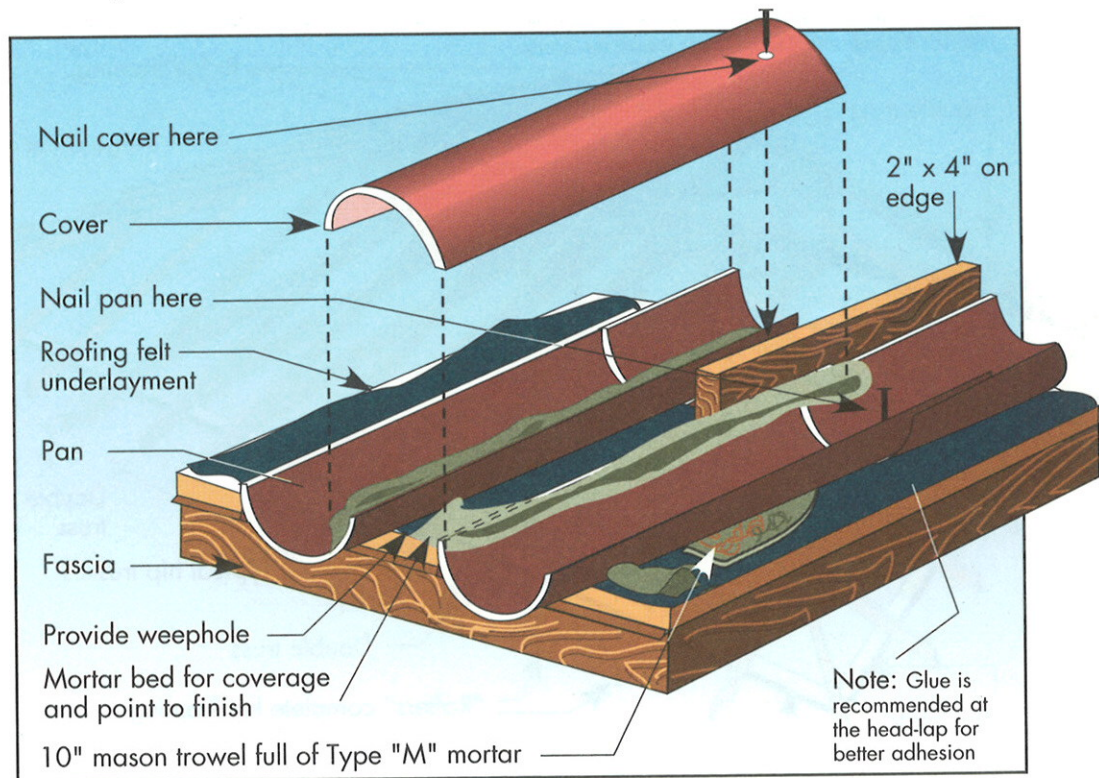
FIGURE 37. *Recommended tile and mortar placement for barrel tile roofing system.*

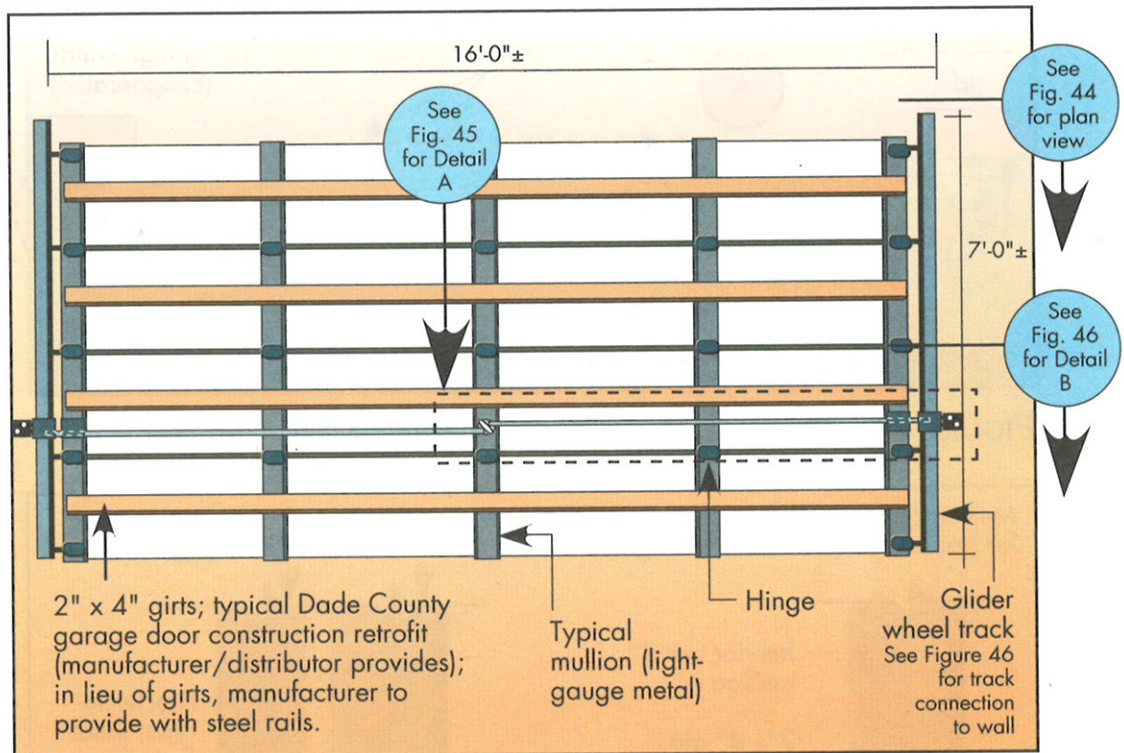
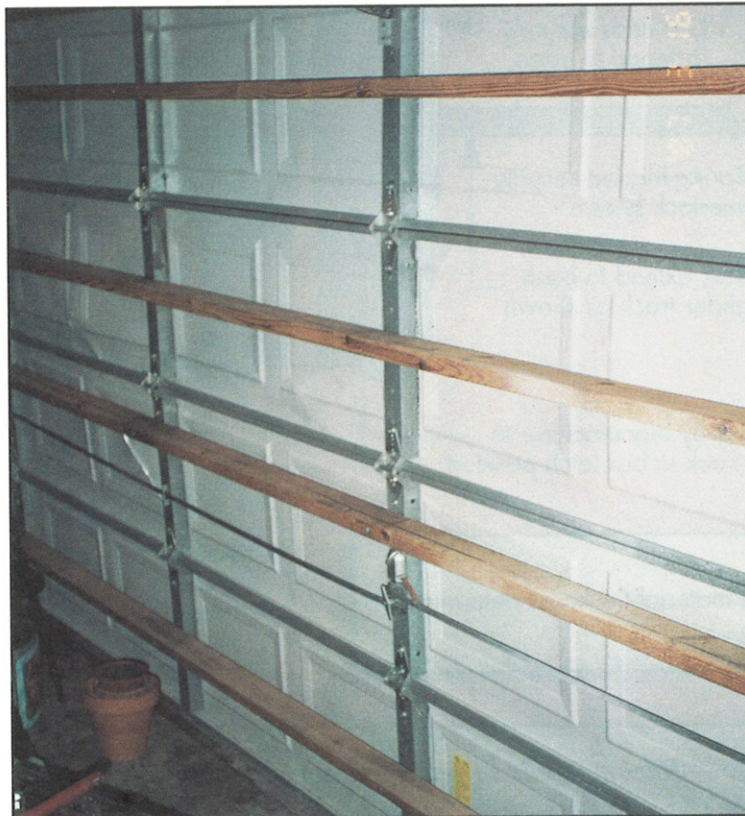
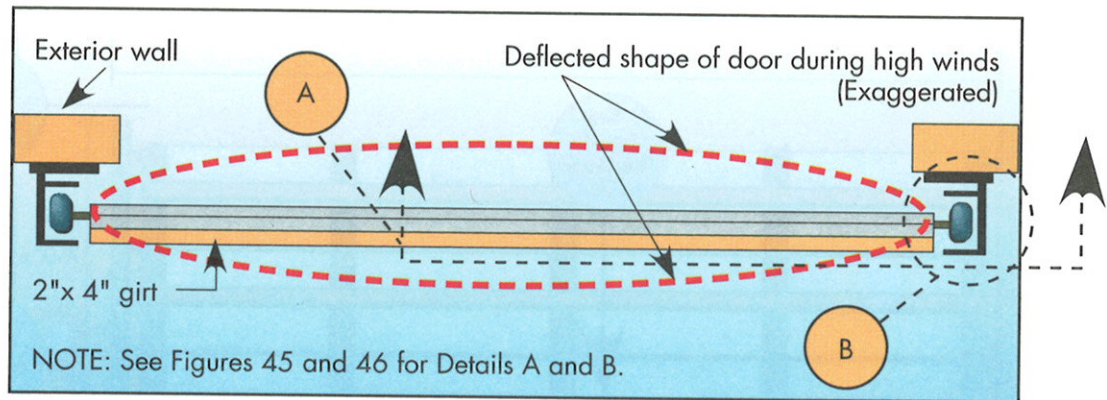
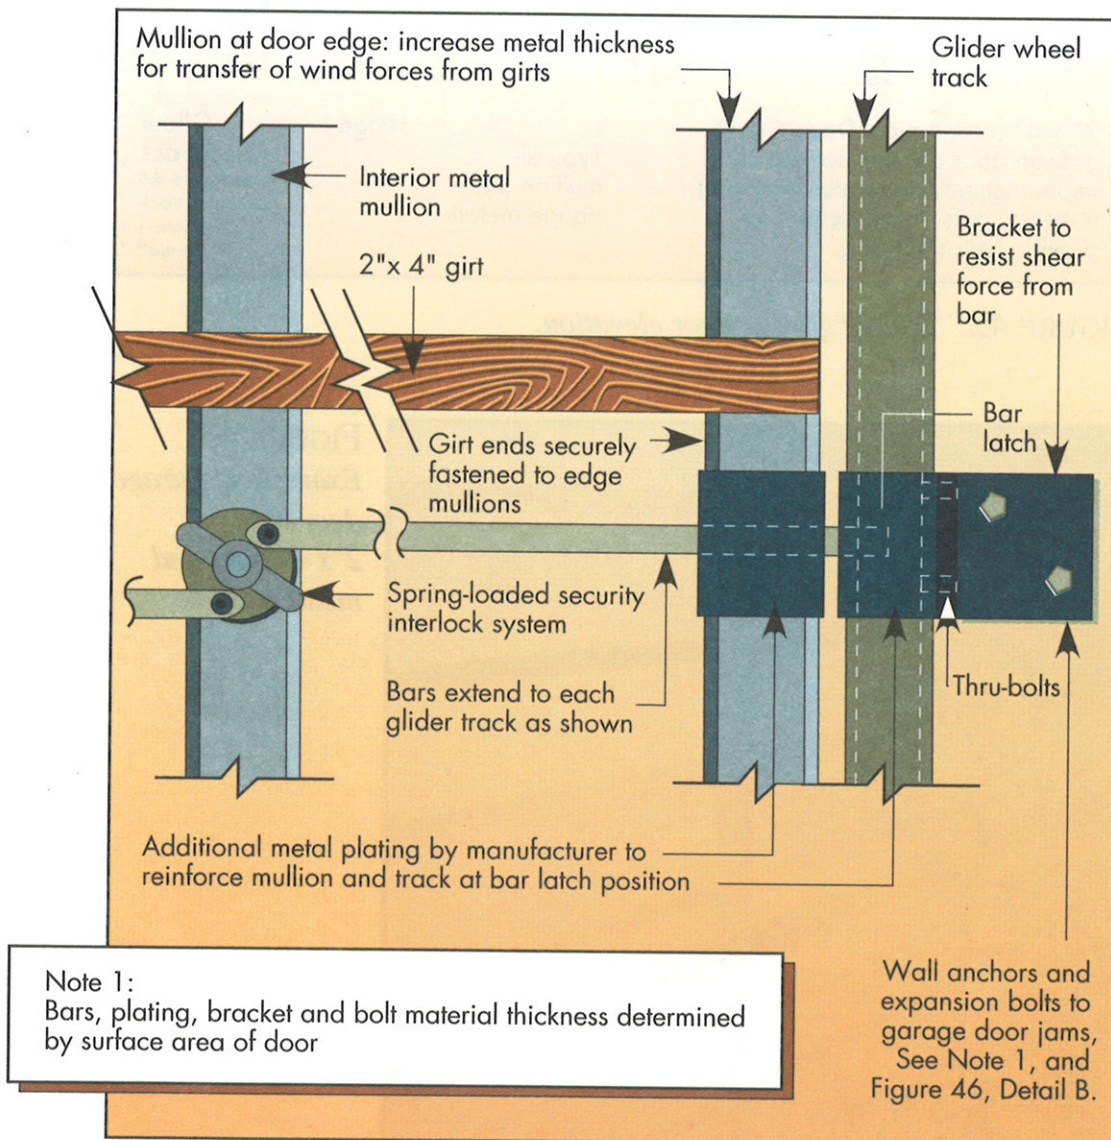
FIGURE 42. Typical garage door elevation.

FIGURE 43.  
Example of garage door with 2"x 4" girts and metal mullions.

FIGURE 44. Plan view of typical garage door.

FIGURE 45. Detail A — Recommended reinforced horizontal latch system for garage door.

2. The installation of entire garage door assemblies should be reevaluated for strengthening to resist wind and flood loads.
- In order to reduce the effects of the wide spans of two-car garage doors, the doors should be manufactured to include mullions and girts. Also, manufacturers should reinforce both the security locking system, to provide a wind-force-resistant latch, and the chain of the door pin to glider track connections, to reduce rotation of the door along its edges. (SEE FIGURES 42-45).

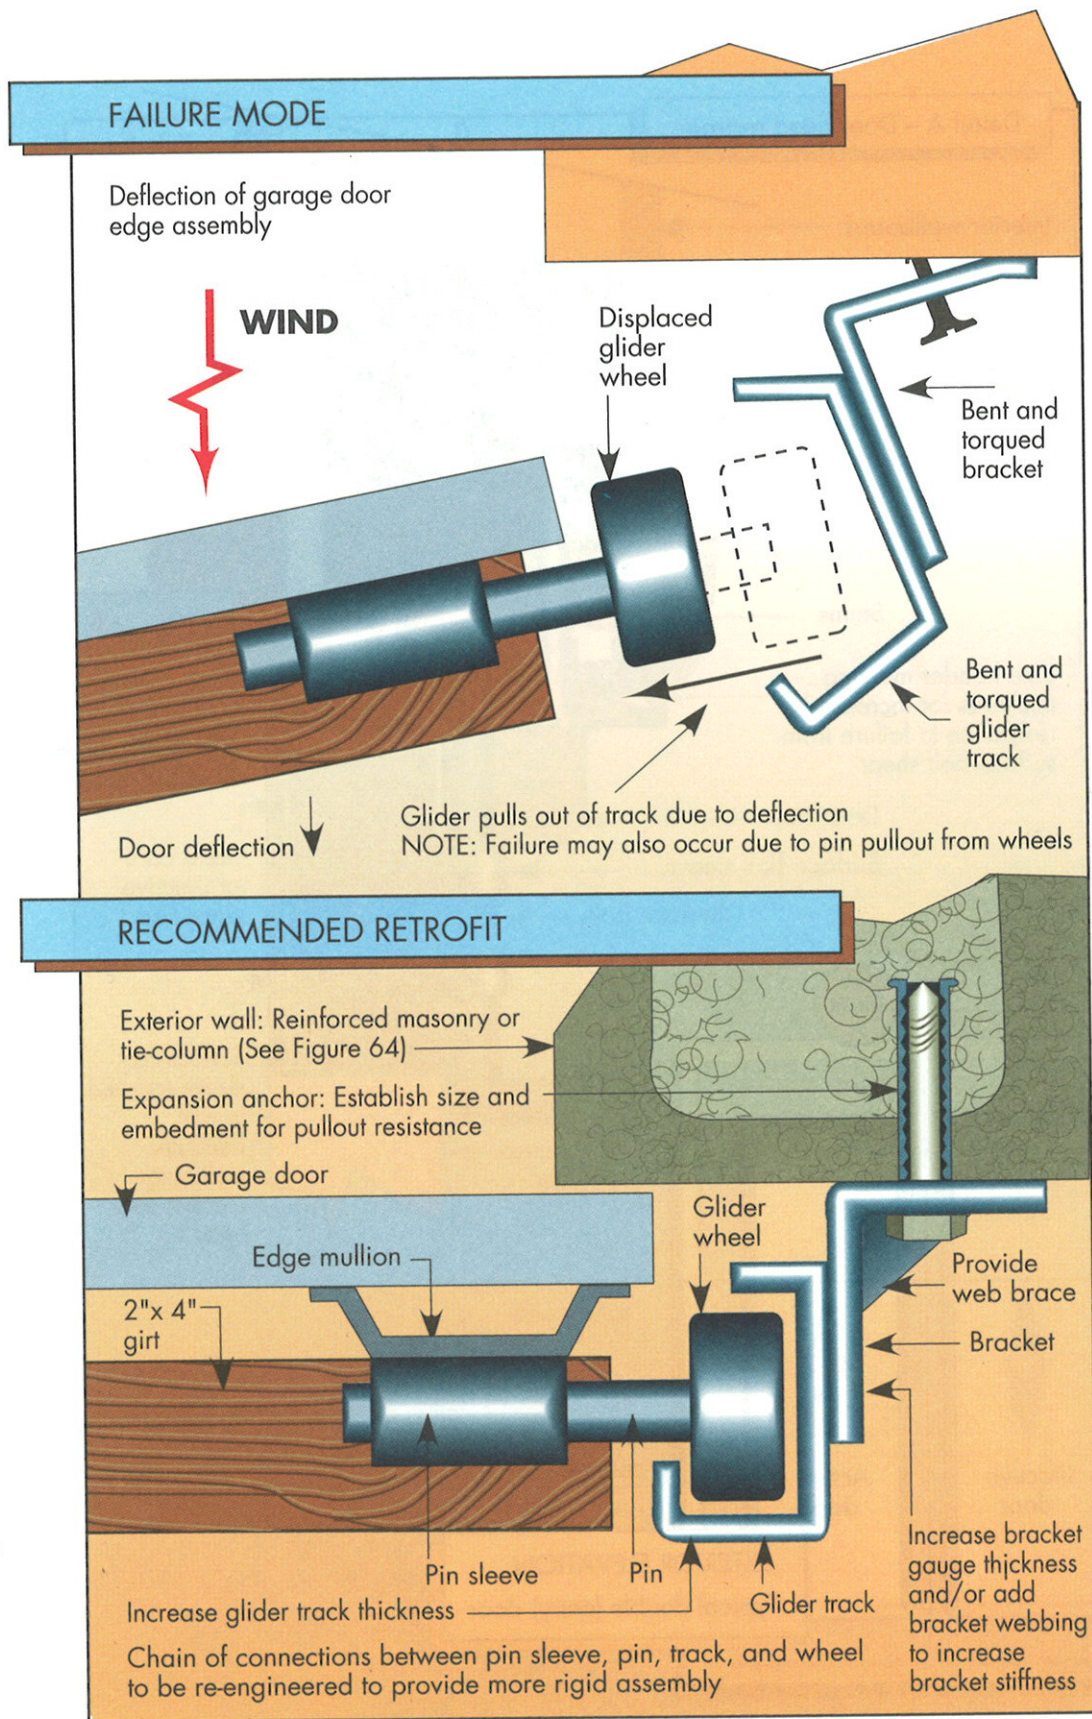
FIGURE 46. Detail B—Garage door failure at edge and recommended assembly improvements.

- Glider tracks and track supports should be strengthened to prevent failure caused by door deflection under wind loads (SEE FIGURE 46).

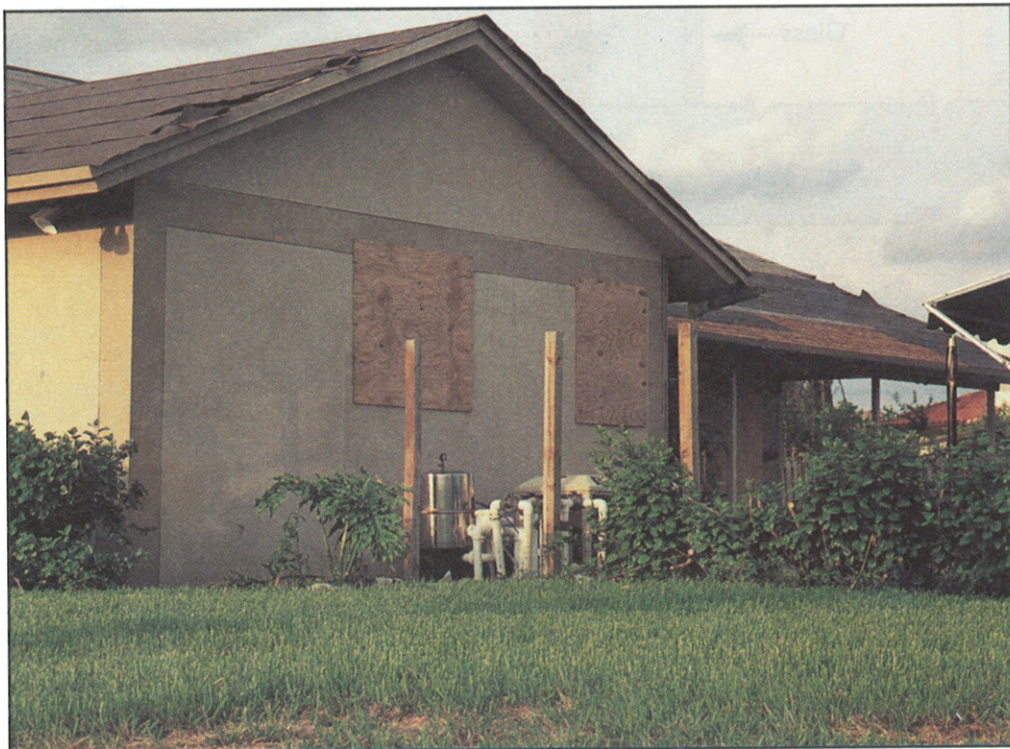
FIGURE 51. *Plywood used as openings protection installed. See Figures 52 and 53 for details.*

4. Window design and protection standards should be developed that require a standard system of design and protection for windows in new buildings. These should include, but not be limited to, consideration of using shutters (SEE FIGURES 40 AND 49) and precut plywood (SEE FIGURES 50-53). The protection of windows in existing buildings should be encouraged. Providing cost incentives through the insurance rating process should be considered.

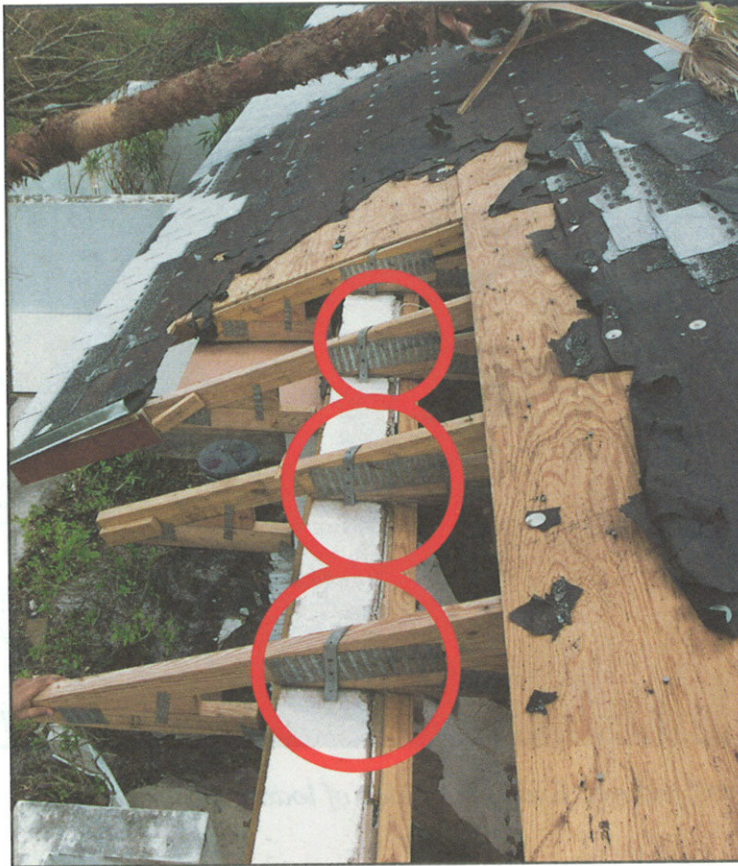
FIGURE 56.  
*Properly placed  
hurricane straps  
from masonry  
tie-beams to  
roof trusses.*

1. Designers and plan reviewers should pay greater attention to lateral load transfer mechanisms because of high lateral loads generated by hurricane winds (SEE FIGURES 9, 10, AND 54-58).
  2. At the construction stage, greater attention must be paid to the proper installation of all lateral load transfer mechanisms inherent in conventional building framing, especially hurricane straps and clips (SEE FIGURES 59-62).
- Manufacturers of metal connectors for wood framing currently provide on-site demonstrations and workshops for training purposes. These workshops should be structured to provide certificates of participation to builders and should be encouraged by the home-buying community.

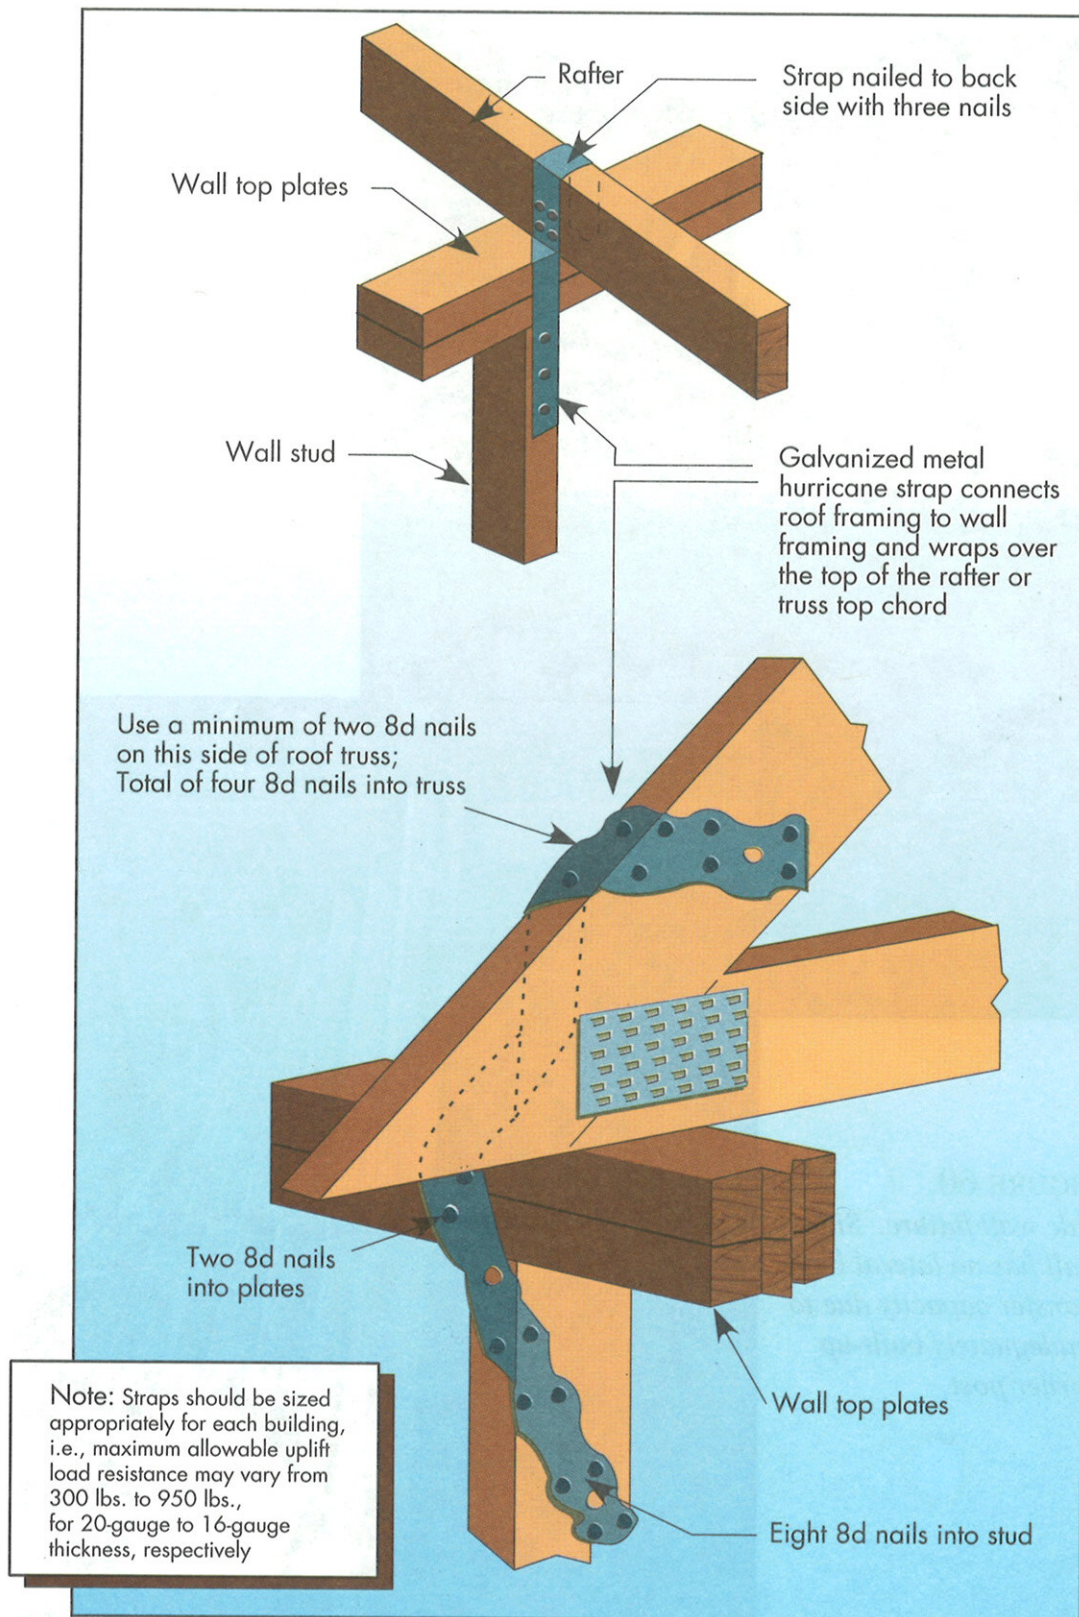
FIGURE 61. *Typical hurricane strap to roof framing detail. Rafter or prefabricated roof truss.*

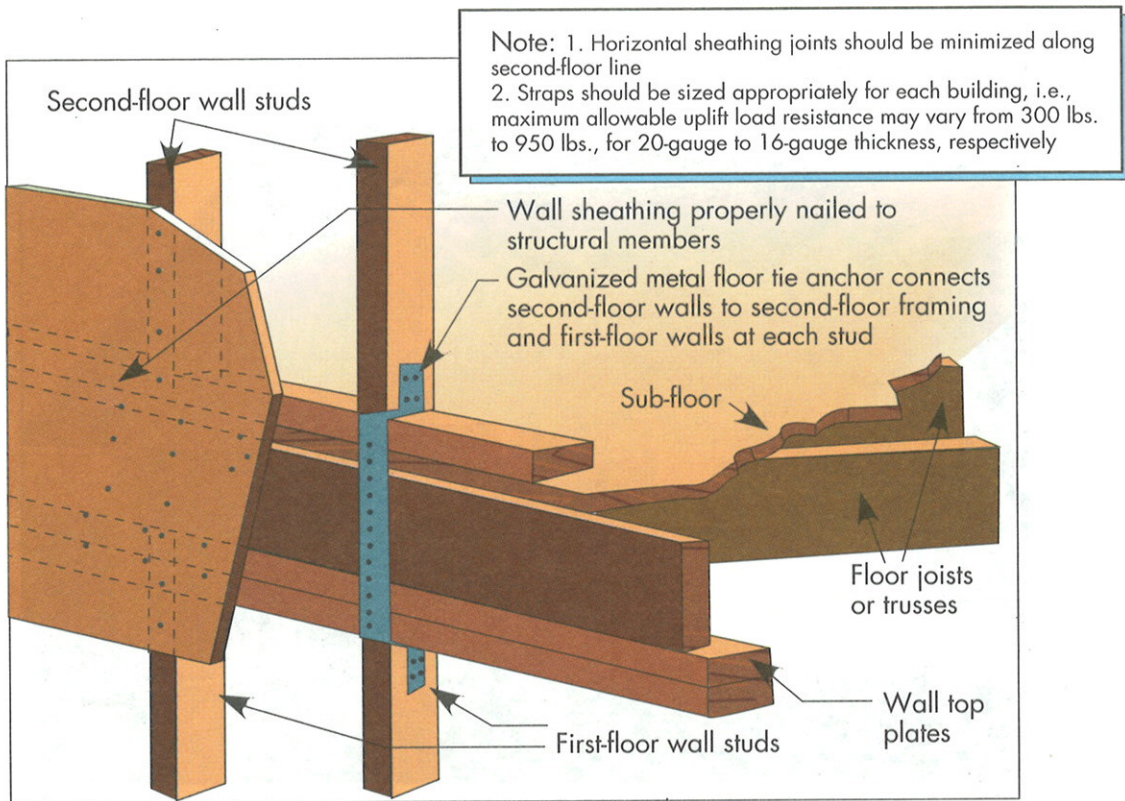
FIGURE 62. *Upper-floor tie to lower floor for two-story building. Floor tie anchor and nailed wall sheathing.*

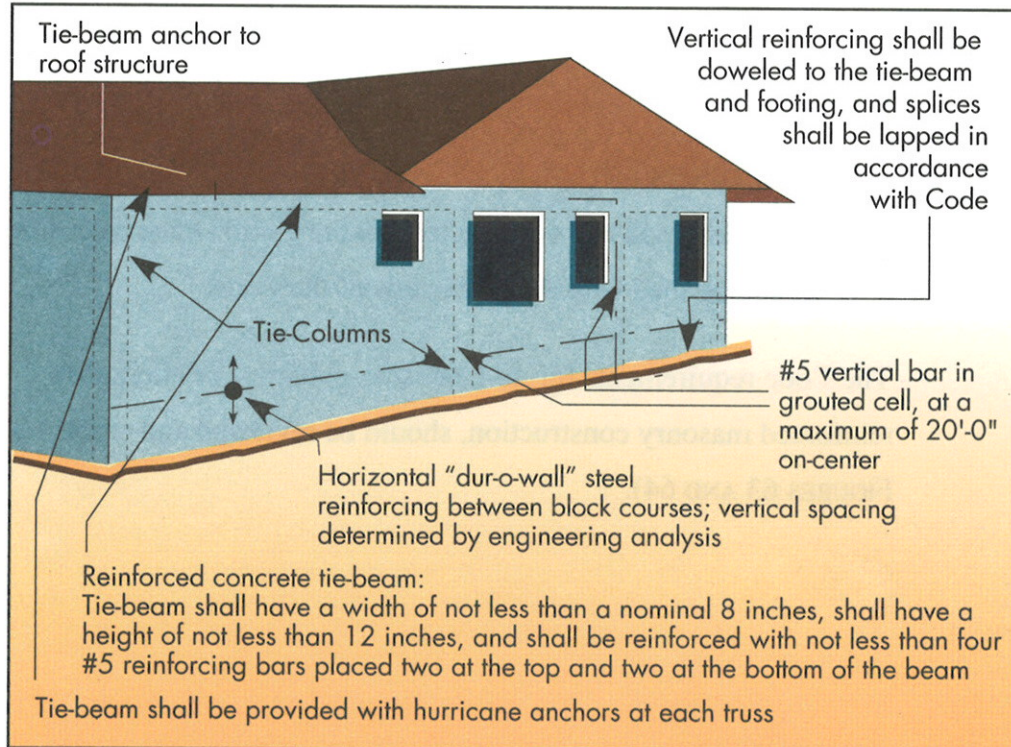
FIGURE 64. *Adequately designed and constructed tie-beam/tie-column masonry wall.*

— The Code requirements for tie-beams/tie-columns, or alternative reinforced masonry construction, should be reviewed and enforced (SEE FIGURES 63 AND 64).

- A tie-beam of reinforced concrete should be placed in all walls of unit masonry, at each floor or roof level, and at such intermediate levels as may be required to limit the vertical heights of the masonry units to 16 feet.
