# **BUILDING PERFORMANCE: HURRICANE ANDREW IN FLORIDA**

**OBSERVATIONS, RECOMMENDATIONS,  
AND TECHNICAL GUIDANCE**

**FEDERAL EMERGENCY MANAGEMENT AGENCY  
FEDERAL INSURANCE ADMINISTRATION**

**DECEMBER 21, 1992**

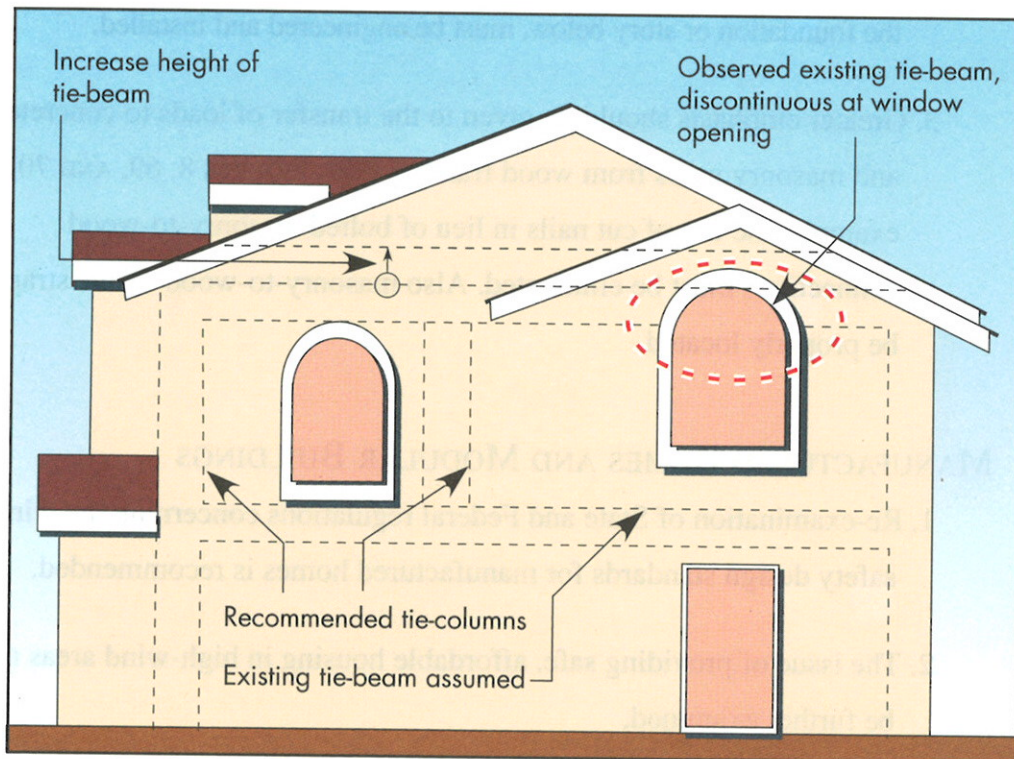
FIGURE 66. *Individualized architectural systems require designs for structural support.*

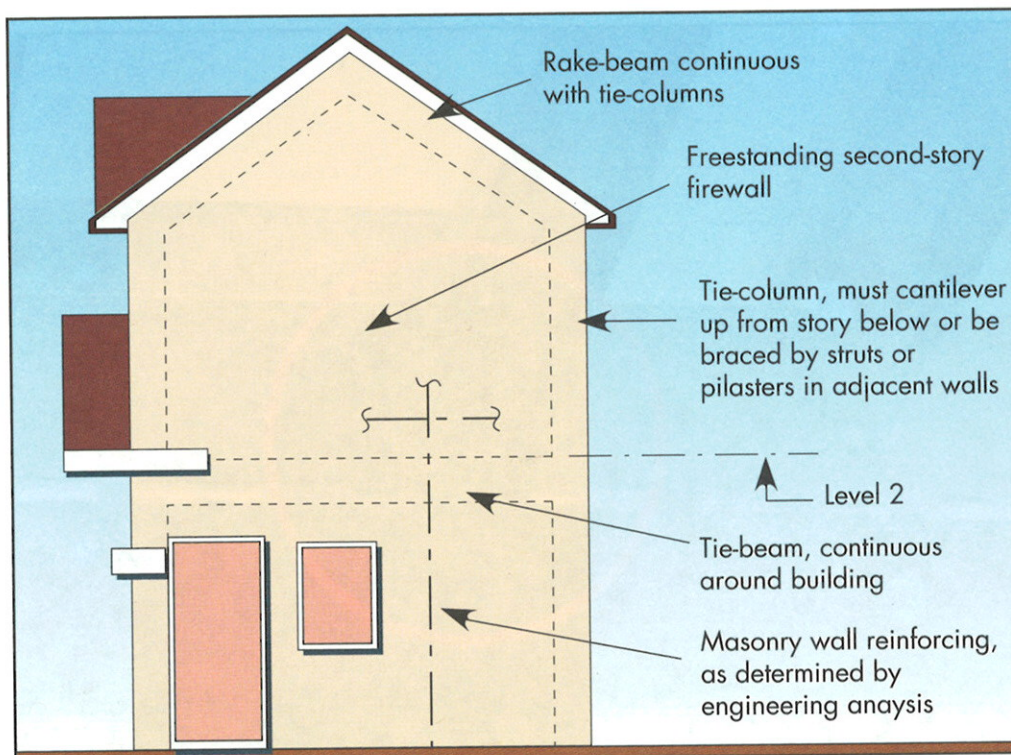
FIGURE 68. *Adequately designed and constructed freestanding cantilevered wall system.*

- Bracing with struts or pilaster columns in walls perpendicular to the free-standing walls, or adequate reinforcing in the walls sufficiently anchored in the foundation or story below, must be engineered and installed.

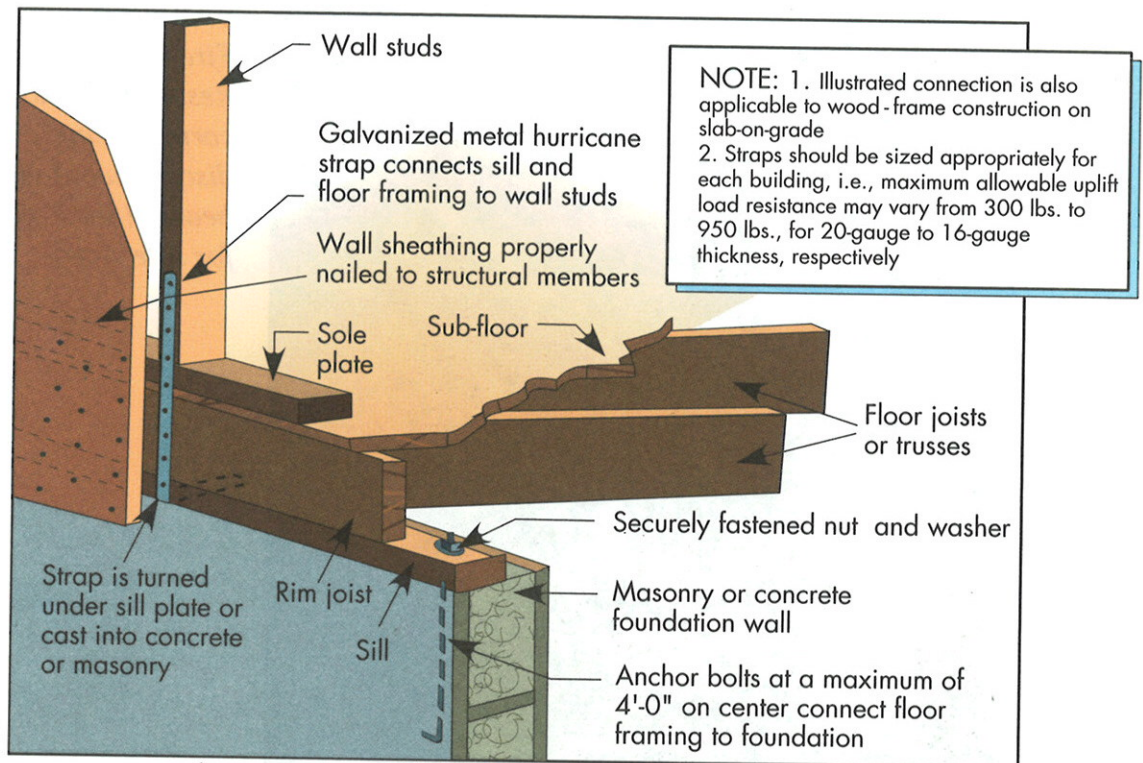
FIGURE 69. Lower-story wall anchorage to masonry (or concrete) base. Straps properly nailed at wall studs.
