Event Report

# Kocaeli, Turkey Earthquake

August 17, 1999 3:01 a.m. M7.4 40.7N 29.9E 17km depth

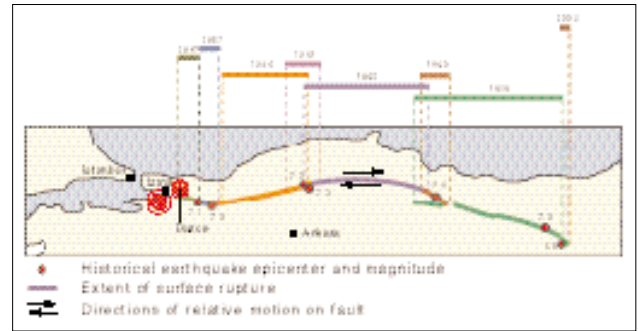
*The August 17 and November 12 earthquakes add to the westward progression of ruptures along the North Anatolian Fault that began in 1939. (Original source: U.S. Geological Survey, 1993)*

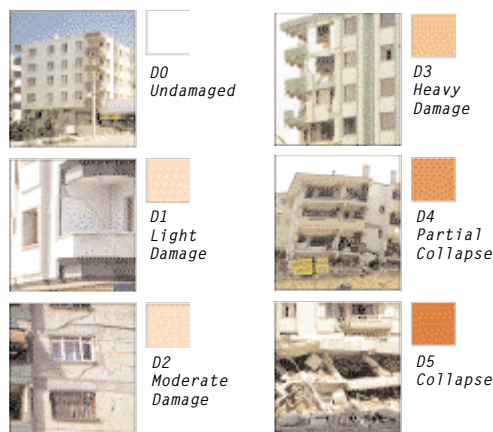
*RMS' rapid quantitative survey of the damage states of reinforced concrete apartment buildings showed the extent of losses to residential property and illustrated the spatial distribution of the earthquake's intensity.*

RMS carried out a rapid quantitative survey on more than 2,200 *beskat* structures during its 5-day mission shortly after the earthquake. Team members conducted surveys of the external damage state of each building. A damage state value, ranging from D0-No Damage to D5-Total Collapse, was assigned to each building, and the percentage distributions of each value at a location were then used to assess damage distributions and to map intensity across the region.

In some areas, over 75% of the apartment buildings were destroyed (D3-Heavy Damage to D5-Total Collapse). Collapse rates of 40% or more are rare in buildings built with more modern methods of construction. The only other recent example was when thousands of precast concrete buildings collapsed in the 1988 Spitak, Armenia earthquake.

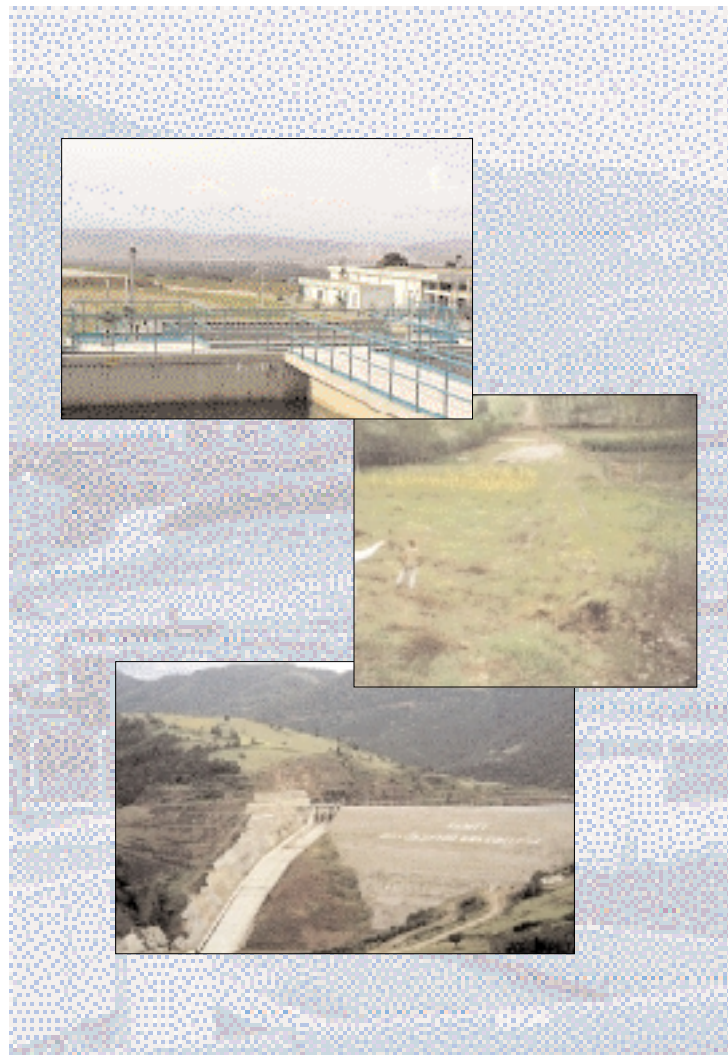
damage, but the fault rupture near Kular severed the main trunk line leading from the regional water treatment plant to the distribution network circling Izmit Bay. Water reservoir distribution sites throughout the region were drained empty by leaks in heavily damaged local distribution systems. Water had to be trucked from reservoirs to damaged towns, and repairs are expected to take considerable time and resources.

*Underground water piping systems sustained heavy damage, and water trucks made several trips a day delivering water from the Izmit treatment plant to epicentral communities. Local residents also took advantage of water leaking from damaged washouts along the region's main trunk line.*

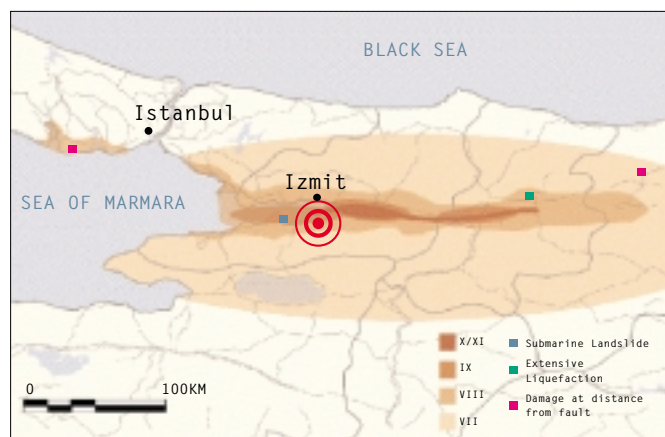
*Preliminary intensity map developed by RMS, two weeks after the Kocaeli earthquake, and based on the "beshkat" survey. It was used to develop a preliminary insured loss estimate.*

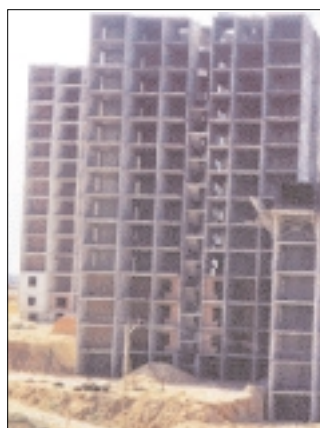
*Housing development pressures continue, and recently built structures vary greatly in seismic quality and code compliance.*
