# THE BAM, IRAN EARTHQUAKE OF 26 DECEMBER 2003

*Field Investigation Report Prepared By:  
Dr. Ali Reza Manafpour, Halcrow Group Limited*

## The Bam Earthquake of 26th December 2003

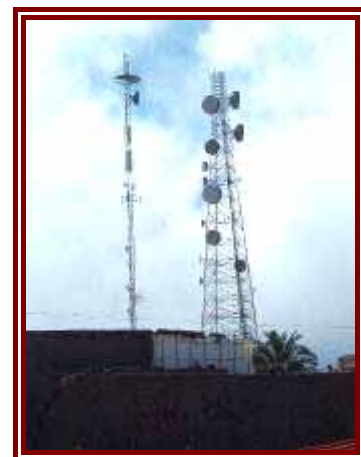
Power transmission, electricity and telecommunication networks, and water distribution system also suffered minor damage. Figure 9 shows one of the main telecommunication towers in Bam. Many electricity poles within the city were damaged due to the collapse of adjacent buildings, however at the time of the visit the electricity had been restored. There were also reports of damage to the wells, underground water storage tanks and pipelines providing water to the city. Some elevated water tanks were observed standing with only minor damage to their columns.

**Figure 9: One of the main telecommunication towers in Bam which survived the earthquake**

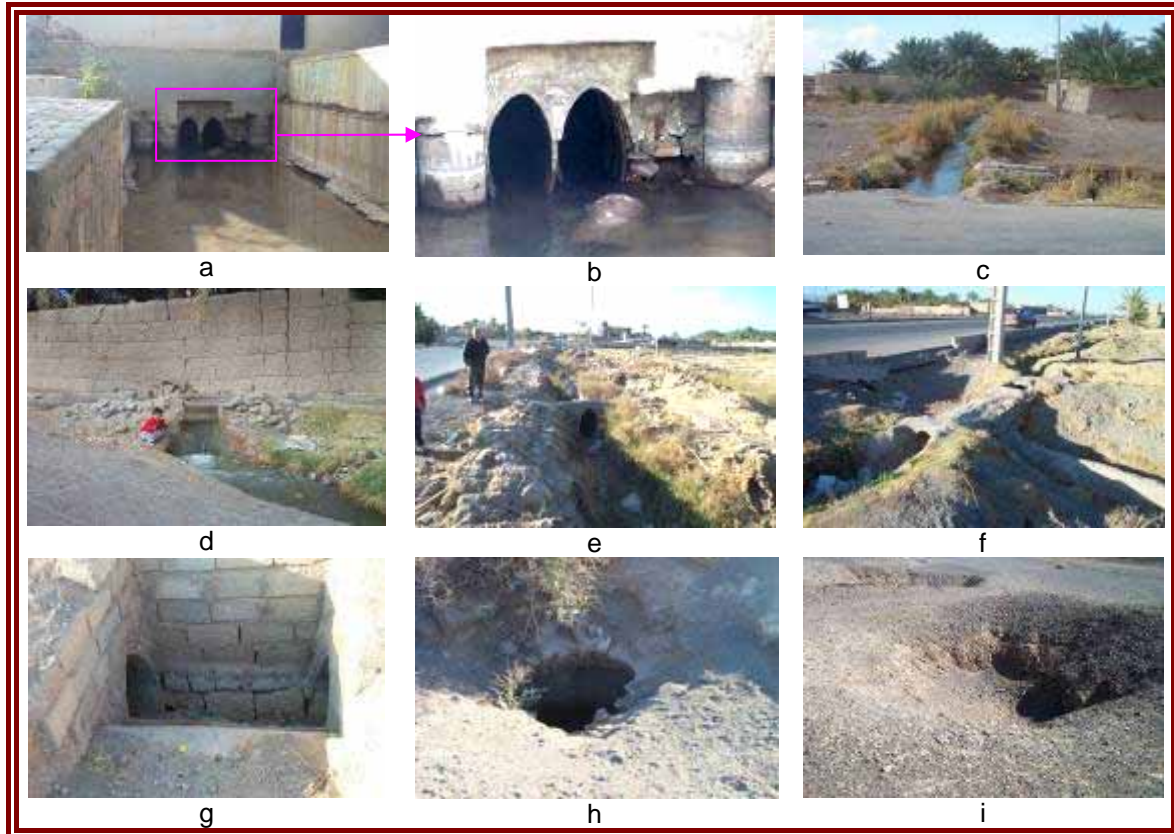
Figure 12 shows an active qanat in Bam and in Nartij village in northeast of Bam and a dried qanat in Baravat at the time of visit to the region.

**Figure 12: (a,b) An active qanat in Bam city showing the outlet below a residential building standing after the earthquake (c,d) an active qanat in Nartij village, northeast of Bam, (e-h) A dried qanat in Baravat with outlet to an open channel, distribution point, access facility at street level and the access shaft further up in a nearby field (i) Access Shaft for an old qanat near Nartij Village**

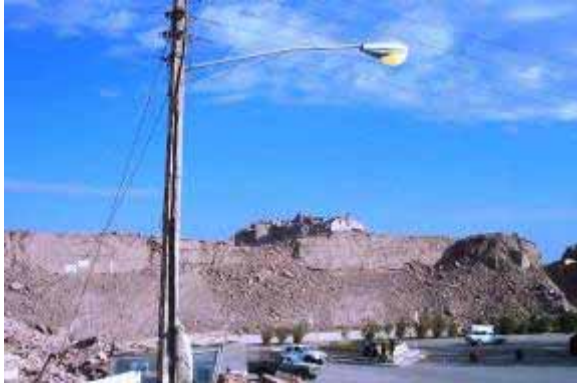
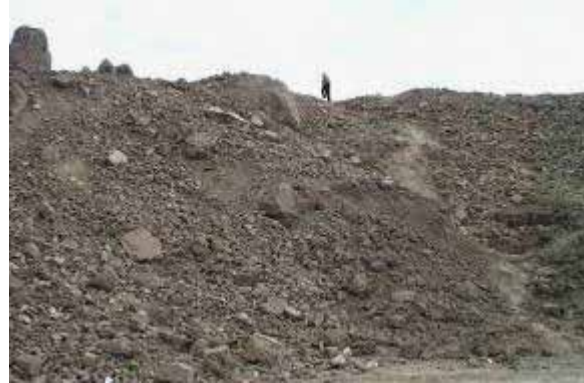
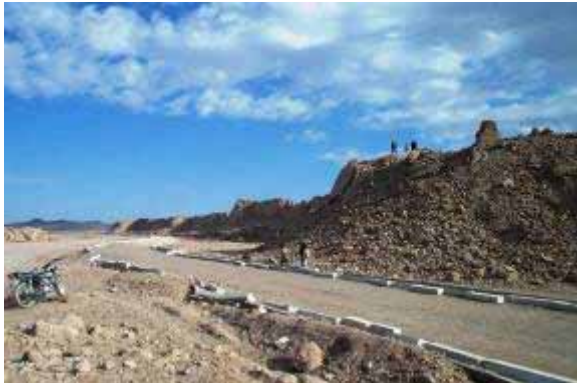
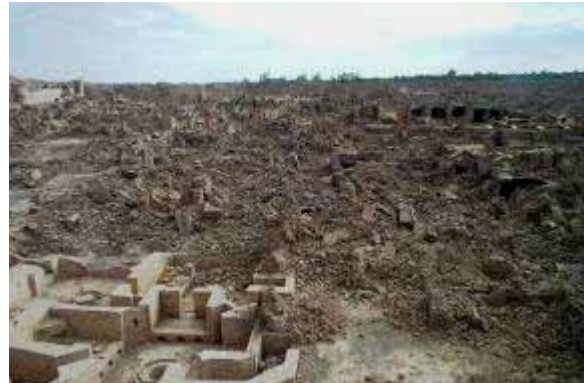
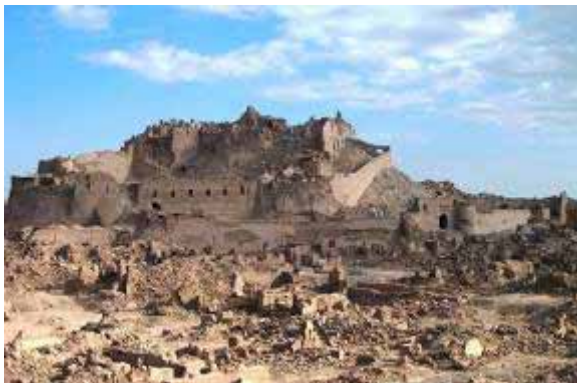
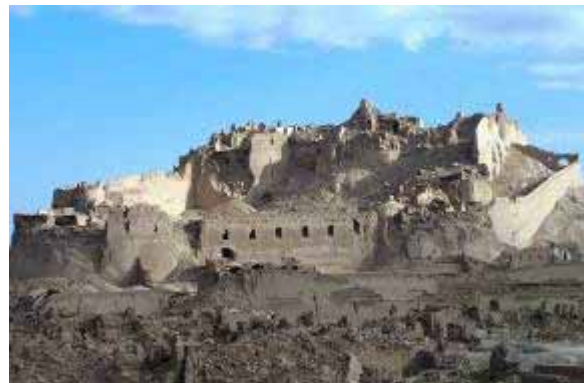
Despite the known weaknesses of unreinforced adobe construction under large earthquake forces, the causes and the type of damage observed at Arg-e Bam have yet to be studied in depth. The fact that this structure had been standing undamaged for around 2000 years has been taken by some [1, 22] as evidence that the Bam region had not experienced any earthquake of a similar intensity to the Bam earthquake during this period. However, initial conclusions from some other studies indicate that the extensive conservation operations undertaken in recent years prior to the Bam earthquake, might have contributed to the extent of the damage experience by the original structure. Langenbach [21] notes that "those structures that had not been recently maintained or restored survived with significantly less damage than did those that had been restored and even strengthened in recent years". Figure 17 shows damage to Arg-e Bam after the Bam earthquake.

Main entrance to Arg (south view)

West wall from outside

View from the top of west wall to main courtyard

View from southwest to governmental sector

Close up view of governmental sector

**Figure 17: Damage to the Arg-e-Bam after Bam Earthquake**

Due to the historical importance of Arg-e Bam, restoration studies have been started. It is anticipated that seismic resistant considerations will play a major role in any restoration plan with recent studies [25] in other parts of the world providing valuable recommendations and guidance on improving the seismic performance of adobe construction. However because of its unique architectural characteristics and cultural value, special seismic studies would appear to be inevitable for Arg-e Bam.

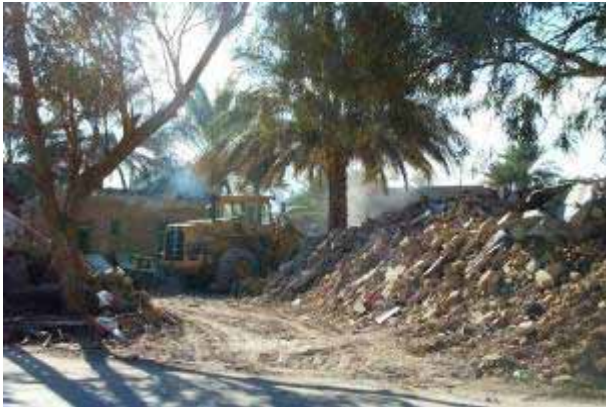
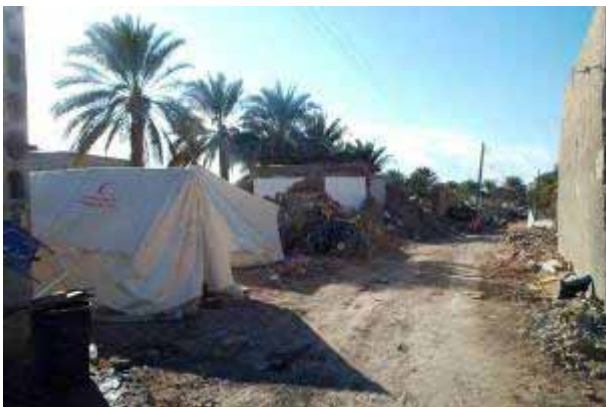
Figure 22 to Figure 25 show damage to adobe buildings in the Bam earthquake observed at the time of visit. Severe damage to total collapse was seen in Bam city and Esfikan village while in Nartij village (see Figure 18 for locations) most of the buildings were standing with only moderate damage (Figure 21) with a smaller proportion suffering collapse (Figure 23). Although most of the buildings with vaulted roofs collapsed within the city, few had performed well and remained standing after the earthquake with only moderate damage. Vaulted roofs were also seen in fired brick masonry buildings, again in some cases with good performance. From those vaulted roof mud brick buildings that did not collapse it could be seen that most of the vault infills and end walls, perpendicular to the direction of vault axis, had collapsed. In some cases these infills and end walls were non-load bearing facade walls often made from fired-bricks and probably with a poor connection to the main structure (Figure 24). This suggests that the deformation mode of the vaulted roofs and their supports differs from those of the perpendicular walls, and the lack of a shear transfer mechanism between these two parts resulted in the separation and subsequent collapse of the walls.

Figure 22: Bam's old district, examples of total collapse of mud-brick buildings

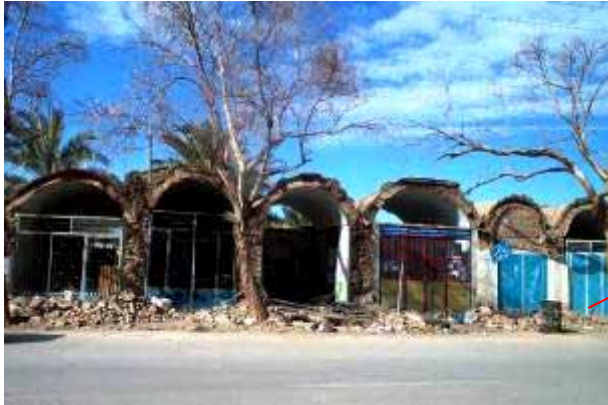
Local shop buildings in Bam, near to Emamzadeh Ali Ebn-Hassan, with a barrel vaulted roof system. The buildings are standing but all facades, made from fired bricks introduced later and covering the front of the thick walls and roof have separated from main mud brick structure and collapsed.

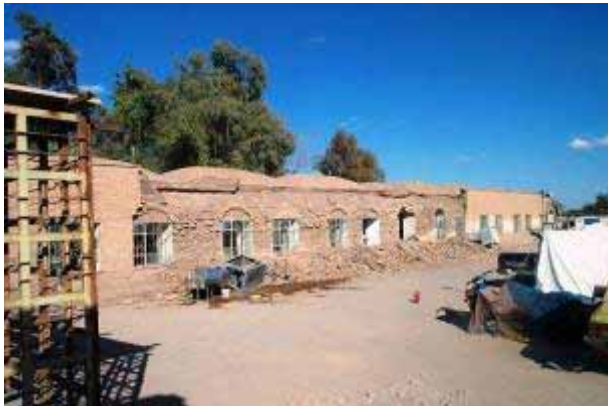
Another example of adobe building with double spanned vaulted roof, standing after the earthquake showing damage to the fired brick facade

**Figure 24: Apparent weakness of vaulted roof structural systems in Mud-brick buildings**

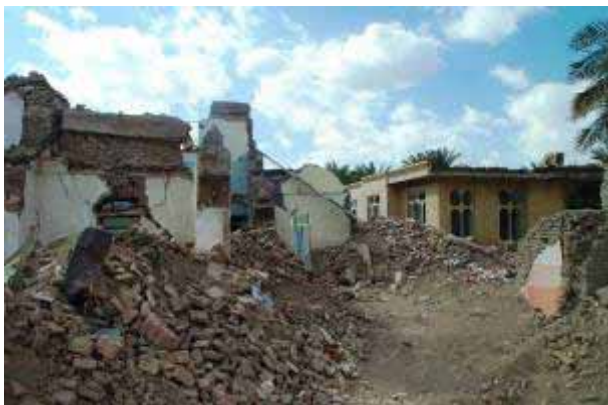
Figure 25 shows damage to adobe buildings contrasted with that of modern masonry and braced steel frame structures in the old district of Bam. Though a relatively small number compared to all the building stock, there were many examples of these modern buildings which survived without collapse or even major damage. This shows that most of the lives in Bam city could have been saved, if good construction practice had been followed.

**Figure 25: Damage to adobe buildings in contrast to other types of construction in the old district of Bam (left: a modern masonry building standing without major damage. Right: a steel structure with braced frame system with minor non-structural damage).**

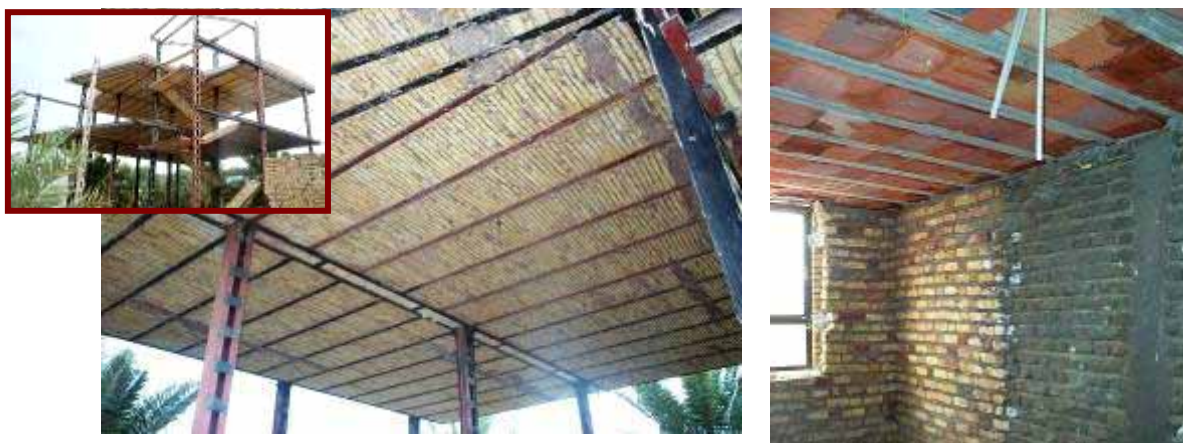
**Figure 27: Jack-arch flooring system in a steel frame structure (left) which is very common throughout Iran, and hollow brick-RC joist floor system in a masonry building the other common alternative (right). Pictures from Bam.**

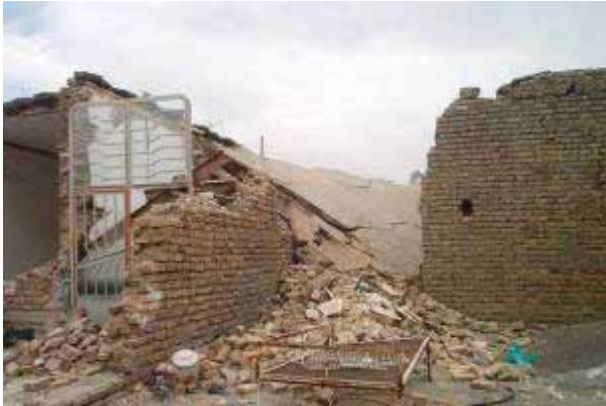
**Figure 28:** A residential masonry building without ties in Baravat in the same alleyway as Bagheri primary school in Figure 35. Construction finished about 6 months before the earthquake with a roof system of steel joists and brick arches with no structural system providing overall integrity. Heavy roof slippage over the walls resulted in collapse of walls and the whole structure. Poor materials and construction led to the collapse. The mortar used is lime-sand. Fortunately, the whole family escaped by being vigilant and sleeping outside after the initial pre-shock. Many other buildings of similar construction had completely collapsed in the same alleyway. Another example is shown in the lower right photograph.

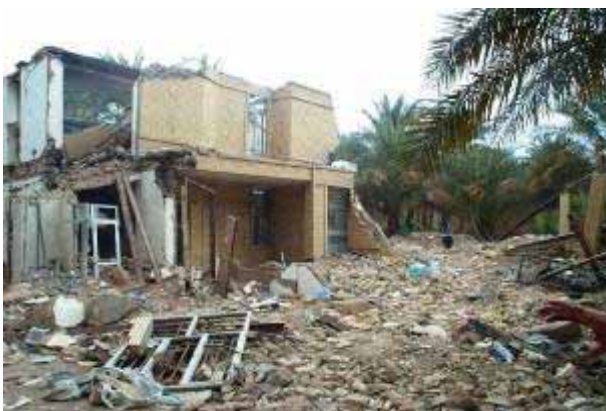
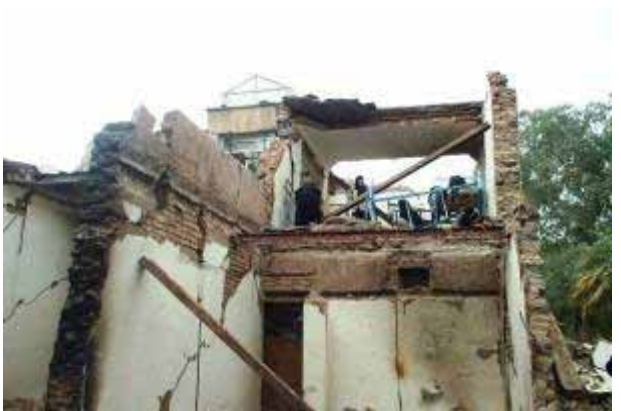
**Figure 29:** Student's dormitory in Bam city centre. Many of the students were killed. The family is helping a student, who was injured during the earthquake, to collect her remaining belongings from a dangerously unstable building.

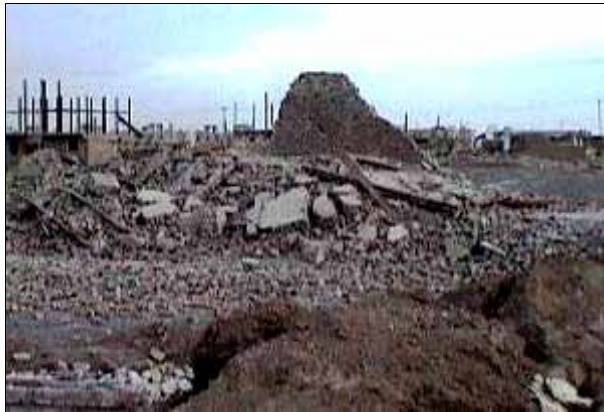
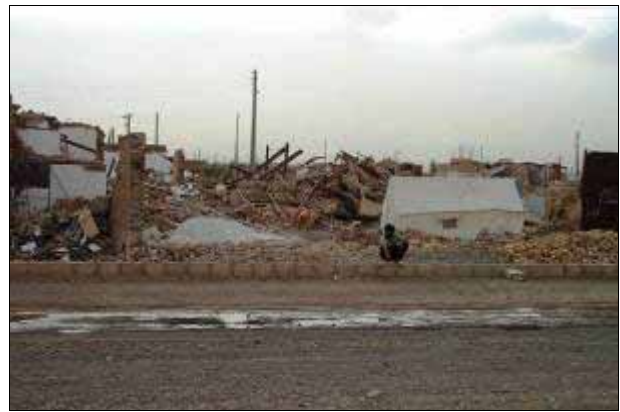
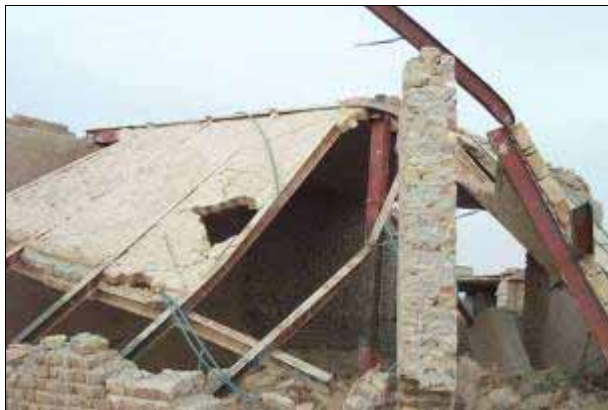
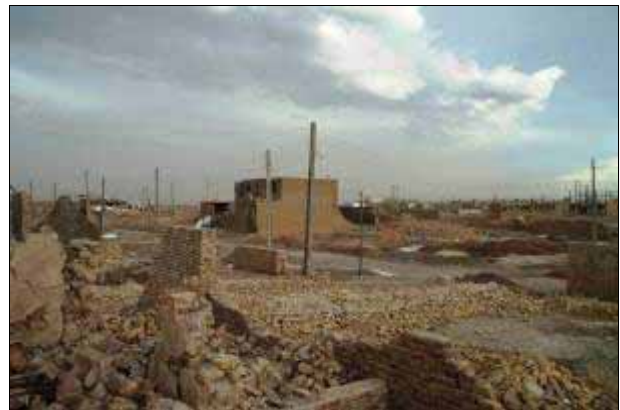
**Figure 30: Razmandegan district of Bam. All the buildings in the district had recently been constructed, most of them consisting of masonry buildings with a jack-arch roof system without any ties. The majority of the buildings collapsed. In the building that can be seen standing in lower right corner photograph, horizontal ties could be clearly seen. This shows how proper construction practice could have made a difference to the outcome of this earthquake.**

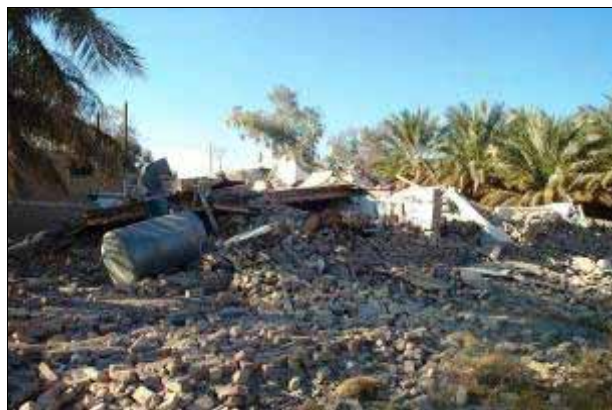
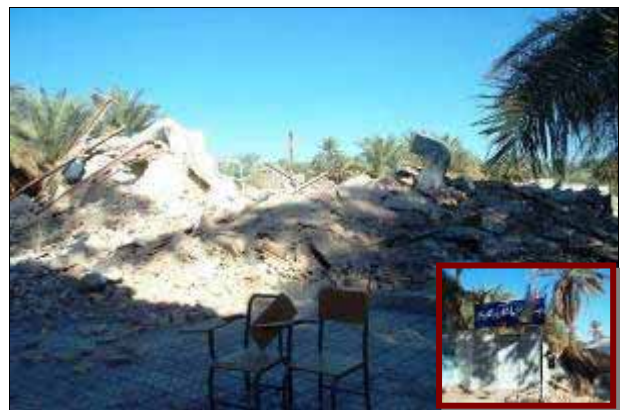
**Figure 31: Kharazmi High school in Bam. Masonry building with a jack-arch roof system without ties that suffered total collapse.**

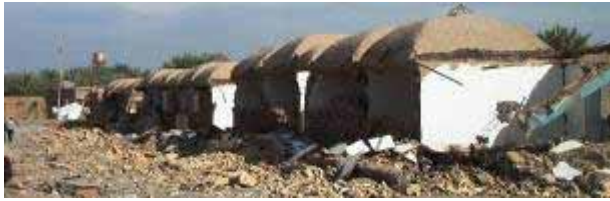
General view

**Figure 34: Local market in Baravat, Masonry construction with vertical and horizontal RC ties. The longitudinal wall collapsed mainly due to the poor connection with the perpendicular walls and the very poor connection between horizontal ties at roof level. Note the poor quality of the concrete and construction of ties.**

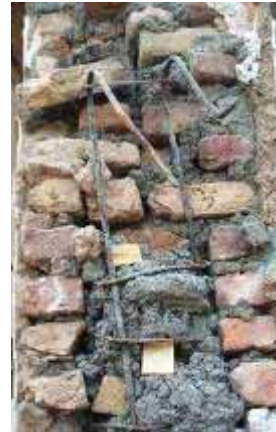
Details of poor materials and workmanship

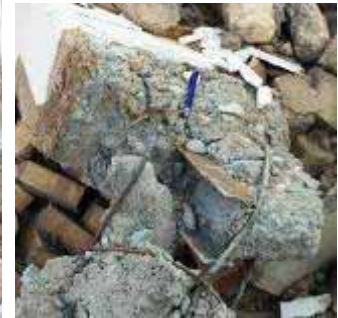
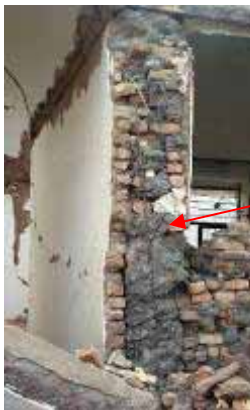
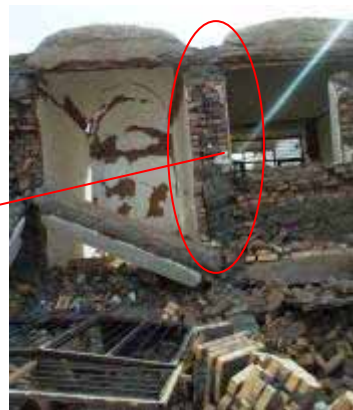
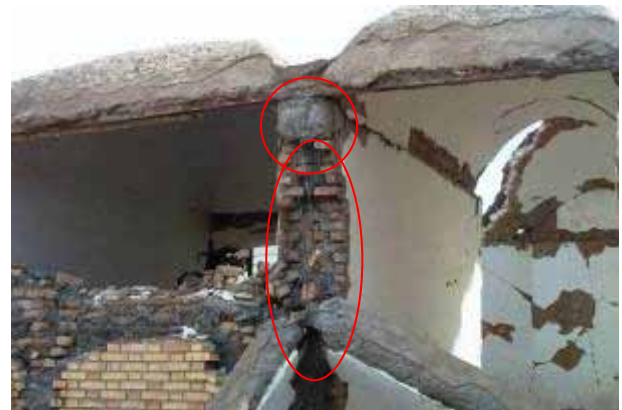
Poor workmanship: Note the vertical bar that starts at one corner of the base and goes to opposite corner at top.

Concrete material no longer present in the vertical RC tie. Horizontal bars have also pulled out of horizontal RC tie.

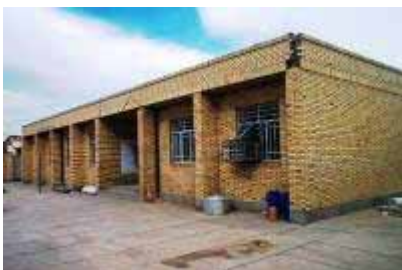
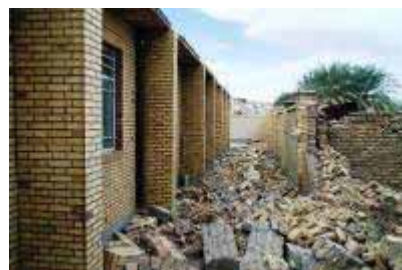
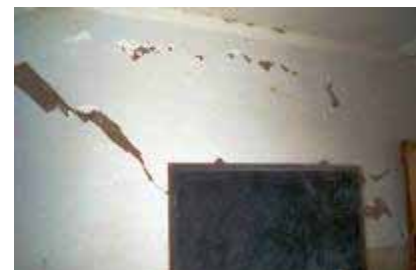
**Figure 35: Bagheri Primary School in Baravat, One storey masonry building with ties. Standing without major damage. Parapets at the back of the building and a part of the surrounding wall have collapsed due to collapse of a building on the other side of the wall. Minor damage on inside walls.**

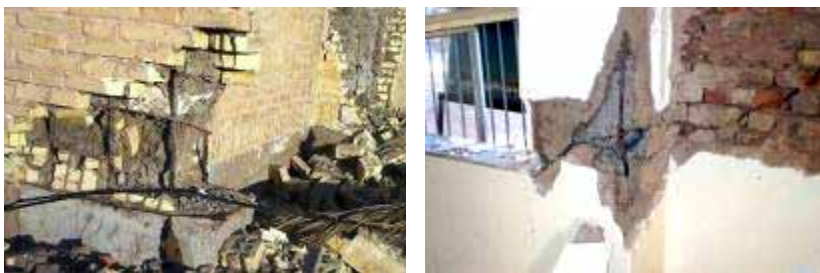
Figure 36: Management office of Bam electricity (continued from previous page)

**Figure 36: Management office of Bam electricity: Masonry building with horizontal and vertical ties. Extensive damage to the walls in first floor with most of them showing diagonal or horizontal shear cracks. Damage at the second floor level was relatively minor and mainly non-structural. The rooftop staircase structure had collapsed totally due primarily to not connecting the beams to the middle column at second turning level. (further photographs on the next page).**

Details showing the poor concrete quality in vertical RC ties and generally bad workmanship

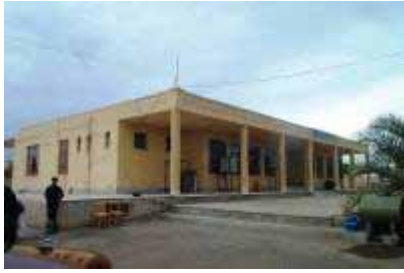
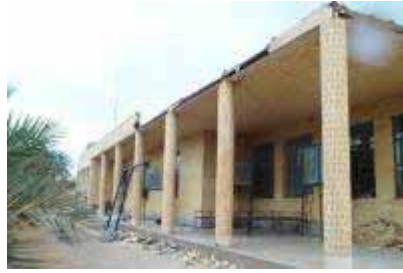
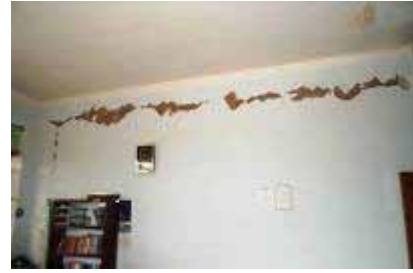
Bonyad-Shahid masonry office building in Bam showing damage to parapets and inside the building. Overall moderate damage

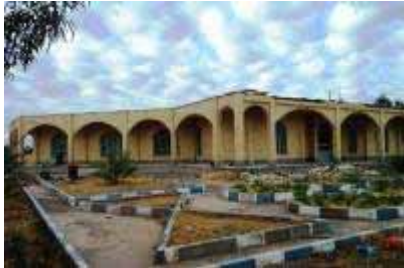
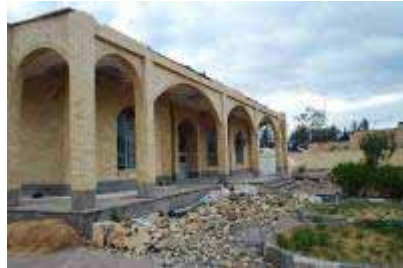
Housing and Urban Development Organisation's Bam office. Another masonry building with a jack-arch roof system and ties experiencing collapse of parapets and moderate damage inside the building.

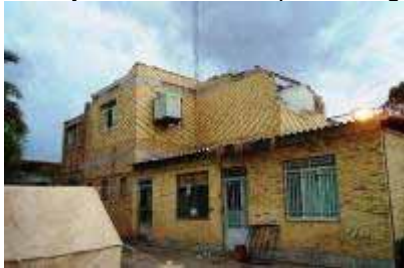
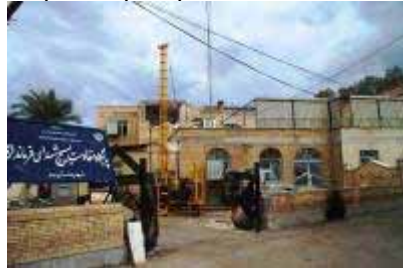
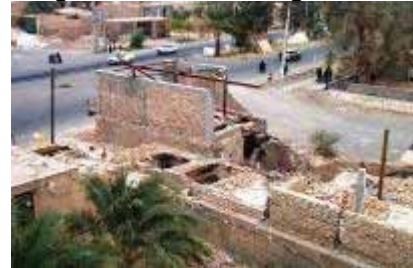
Governor's office building in Bam. Masonry with horizontal ties, Apparently no vertical ties had been used in this building. Bam's accelerometer was based in this building before the earthquake.

A masonry building in Baravat under construction. No vertical ties at the first storey were observed

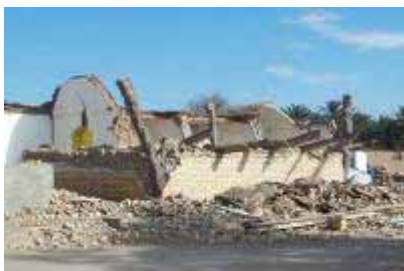
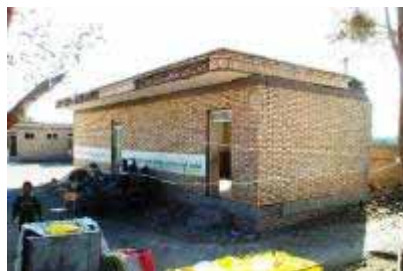
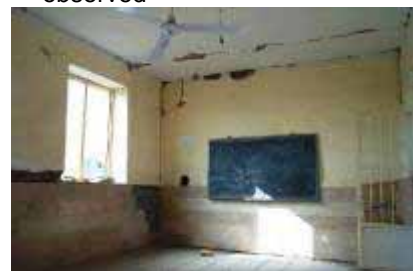
Esfikan Guidance school with 3 separate masonry buildings incorporating horizontal and vertical ties. One building completely collapsed (left) with the vertical ties standing and separated from the collapsed walls. Two other buildings are damaged but standing (middle), the internal damage is shown on the right.

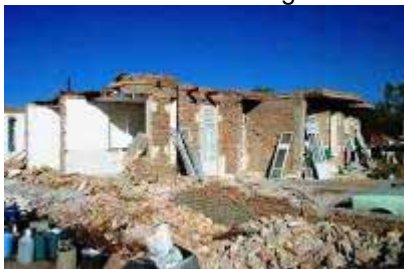
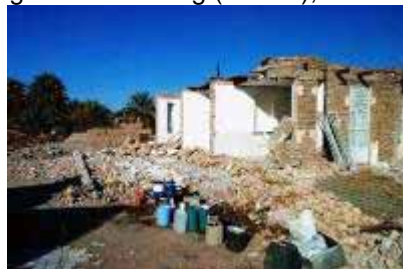
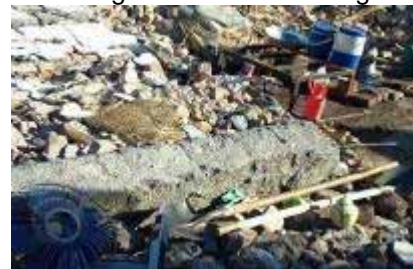
A masonry building in Bam incorporating vertical and horizontal ties but with poor concrete quality.

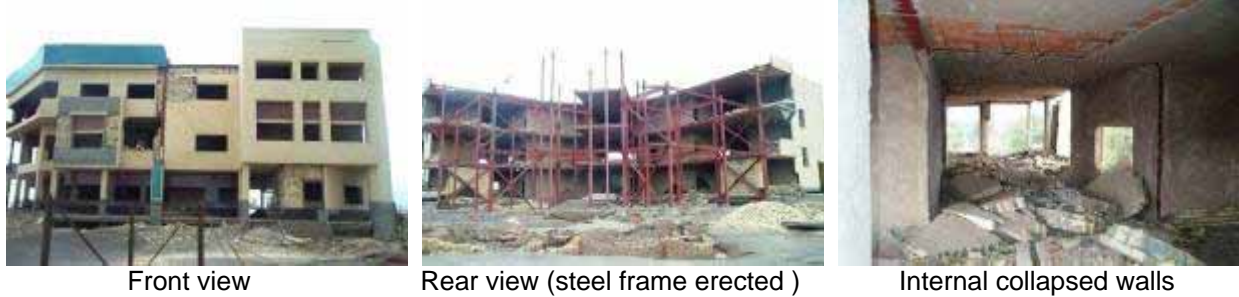
**Figure 41: Art and Cultural Complex building in Bam, under construction at the time of the earthquake. Braced steel frame structure in 3 storeys and one basement level, with hollow brick-concrete joist floor system. Severe non-structural damage to façade, infill and partition walls. Also at least one of the columns in the basement has buckled.**

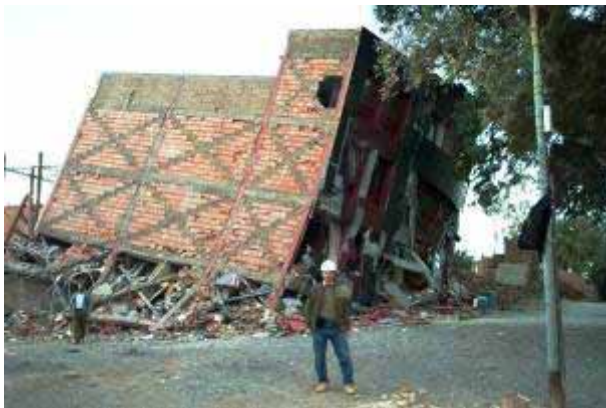
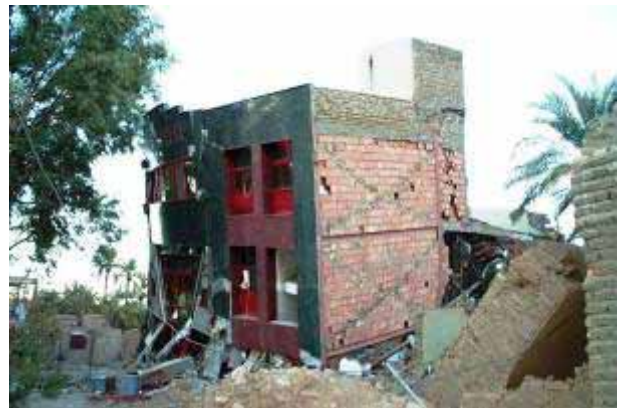
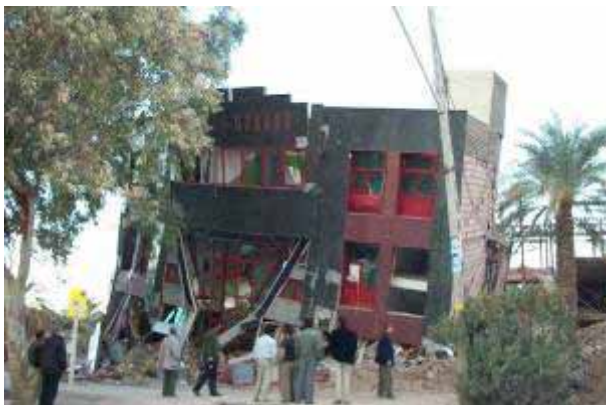
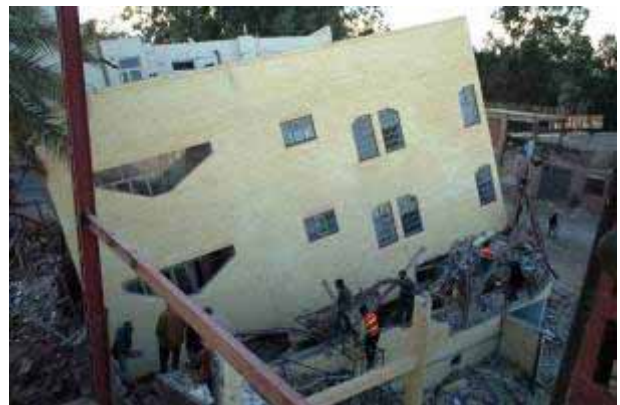
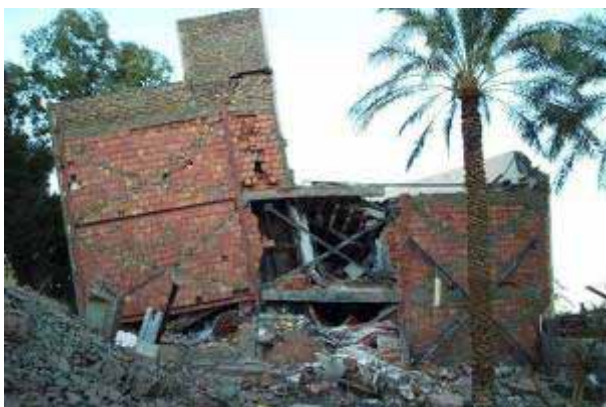
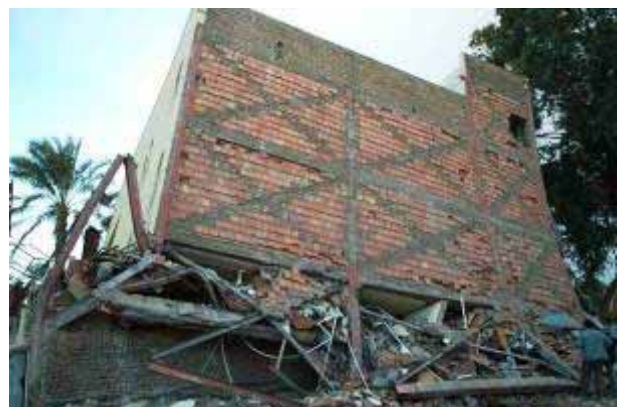
**Figure 42: Kimia building in Bam. A braced steel frame structure with a maximum of five stories above ground level towards the front of the building (see Figure 43 for more details).**

As it collapsed the building experienced a large lateral displacement, approaching 1/3 of the building dimension, toward the west (front). This can be seen in the view from the south (Figure 42), with the cross bracing seen in lower left corner of the view, actually being the bracing for the middle bay of the first storey in the original building configuration and now shown standing freely in front of the end bay. Also the size of this bracing compared to the others seen in the figure confirms that the building had a higher first storey. The building had also rotated in plan towards the north. Poor quality of welding is one of the main reasons attributed to earthquake damage observed in steel structures in Iran. For this specific building this is possibly one of the main reasons, however from the displacement mode of the collapse it is likely that the aforementioned irregularities of mass and stiffness also played a significant role.

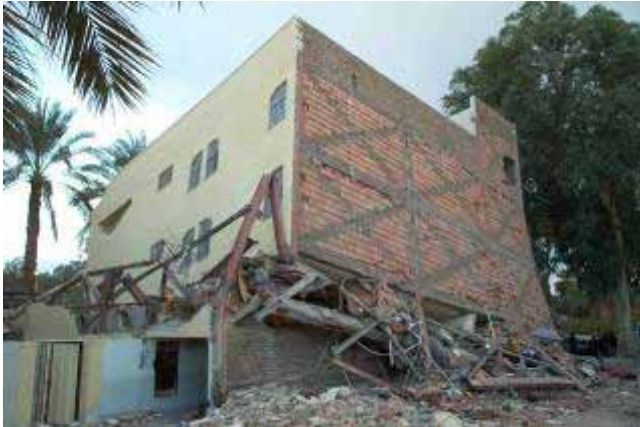
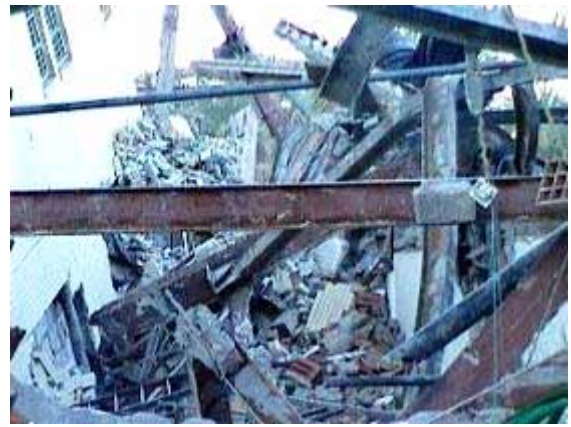
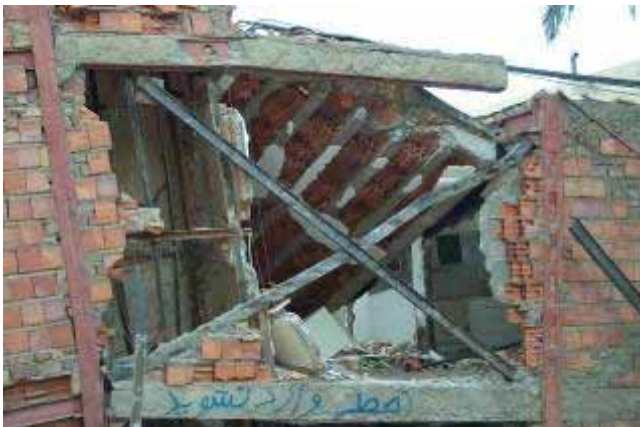
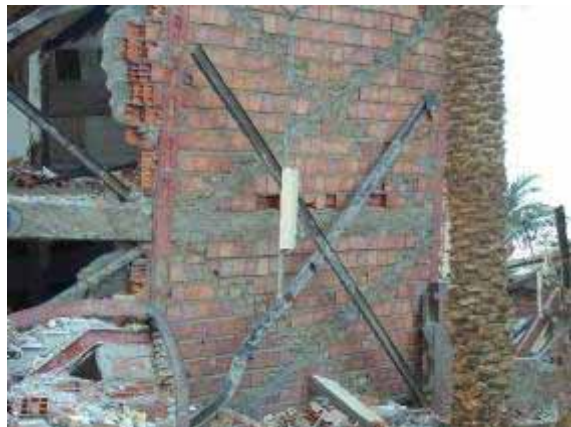
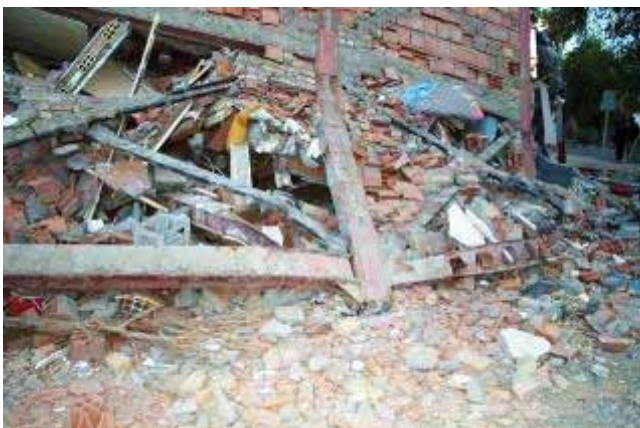
**Figure 43: Kimia building in Bam. A braced steel frame with a maximum of five stories above ground level towards the front of the building (see Figure 42 for different views).**

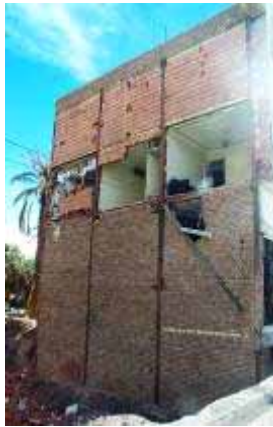
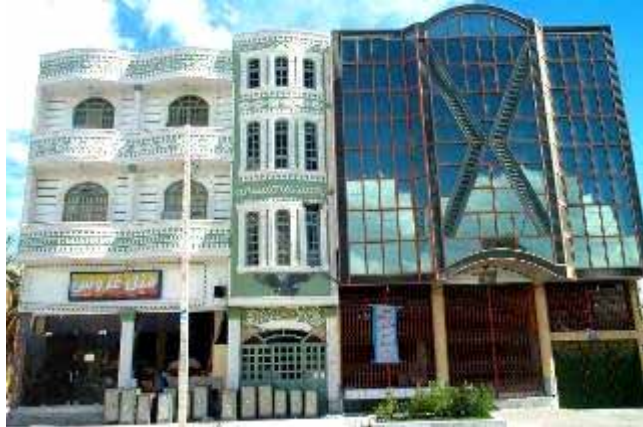
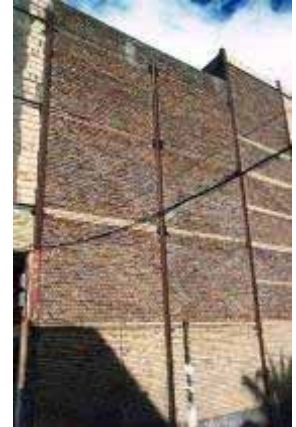
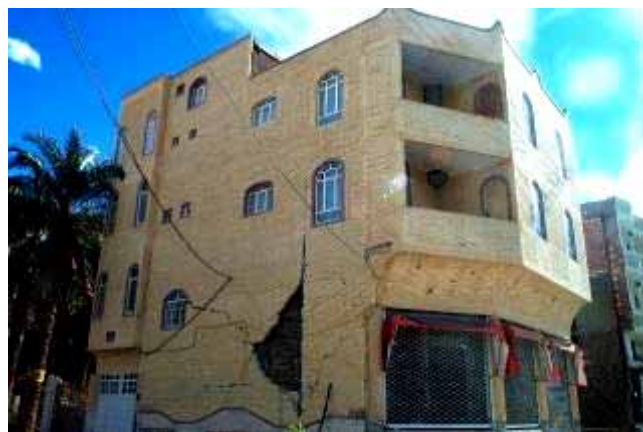
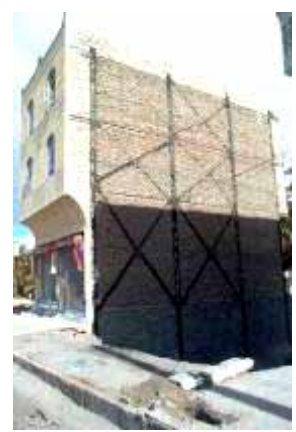
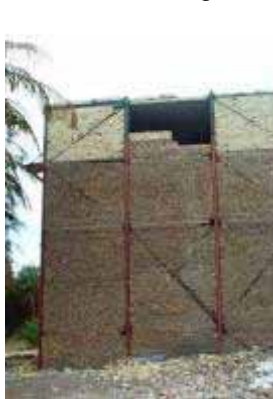
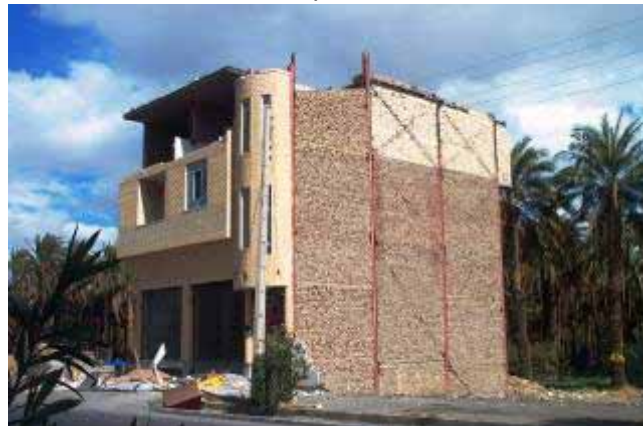
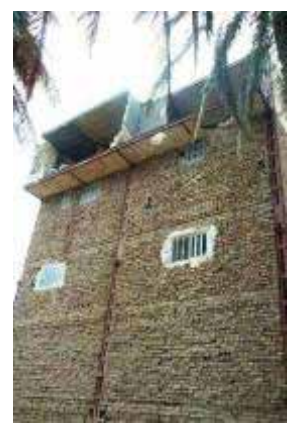
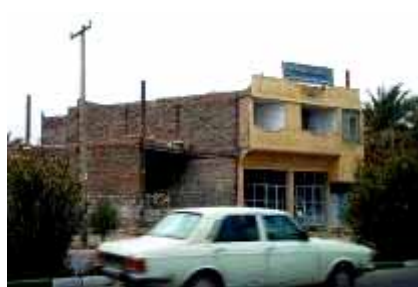
Figure 44: Good performance of some steel structures with a braced frame structural system opposite the Imam hospital in Bam (various views of the same building in each row, except lower row). Bracing in top left has buckled out of plane of the wall and detached from the top joint.

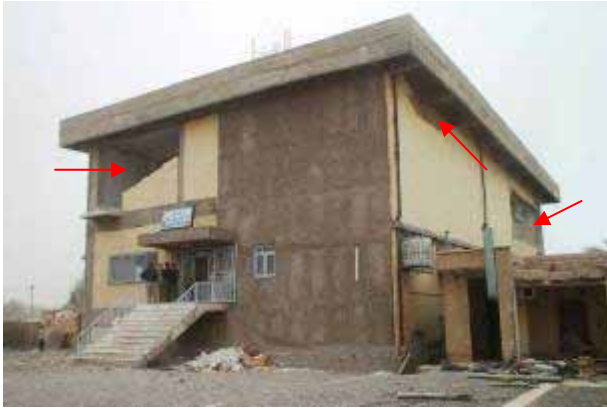
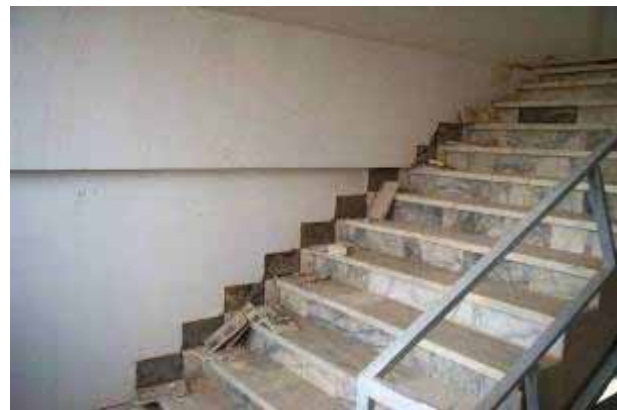
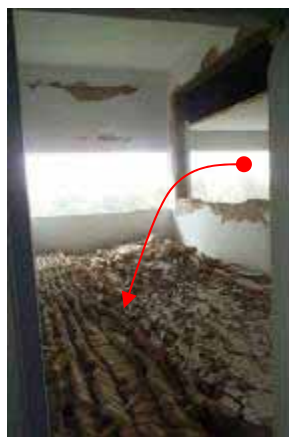
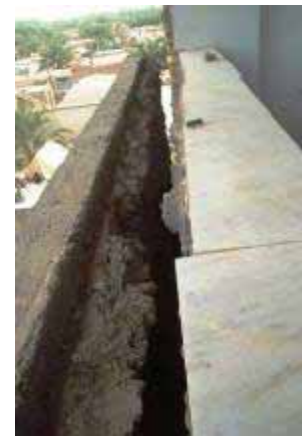
Separation of tiles in stairs

Damage inside the structure on the upper floor

**Figure 48: Baravat Telecommunication office- a three story RC frame structure, the damage is mainly non-structural. Most of the infill walls have worked with the frame to provide a lateral load path and suffered some moderate cracking with some collapsing during the earthquake.**

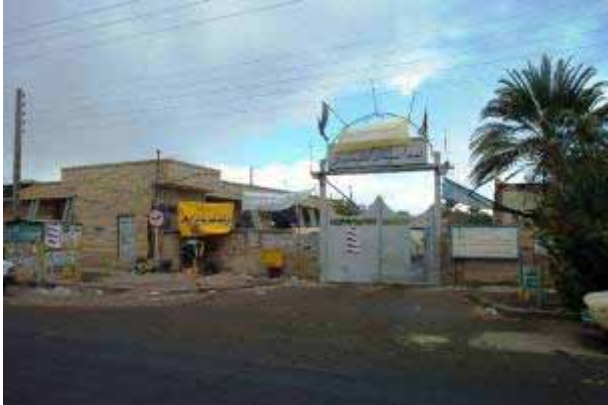
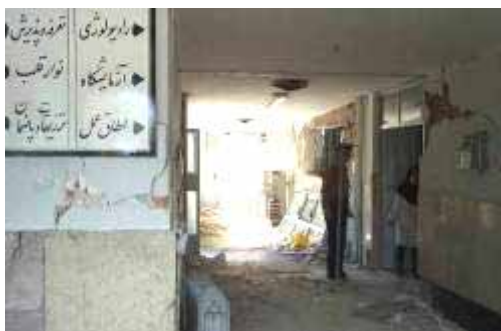
**Figure 49: Imam Hospital in Bam, a single storey masonry building with a jack-arch roof system and inclined steel columns on the perimeter. Most of the building collapsed or was severely damaged. The Accident and Emergency Building collapsed due to the disproportionately thick and heavy roof, that buckled the external wall (left in 1<sup>st</sup> and 2<sup>nd</sup> row). Three roof insulation layers can be seen (3<sup>rd</sup> row left).**

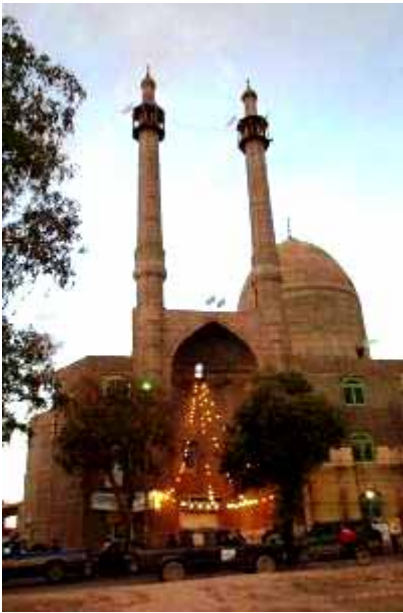
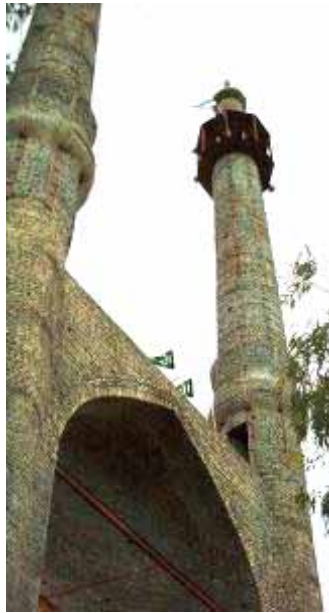
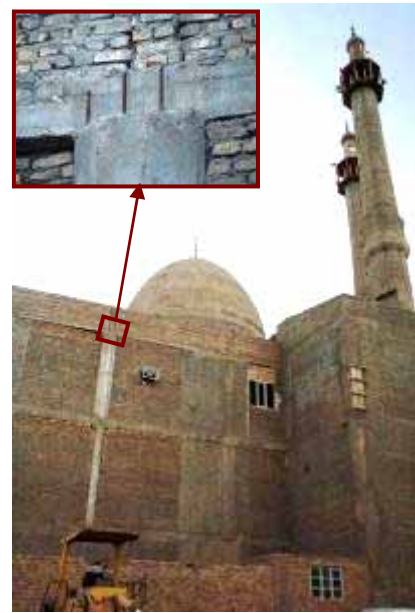
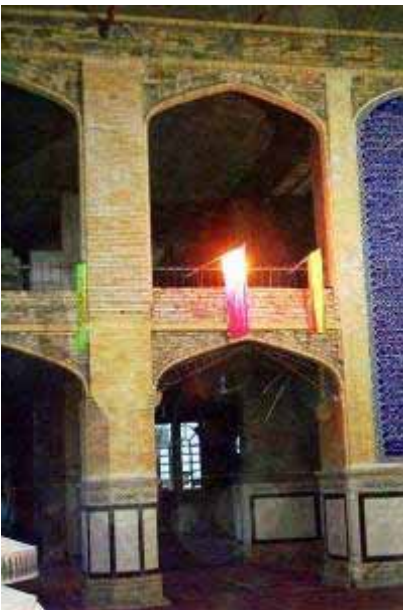
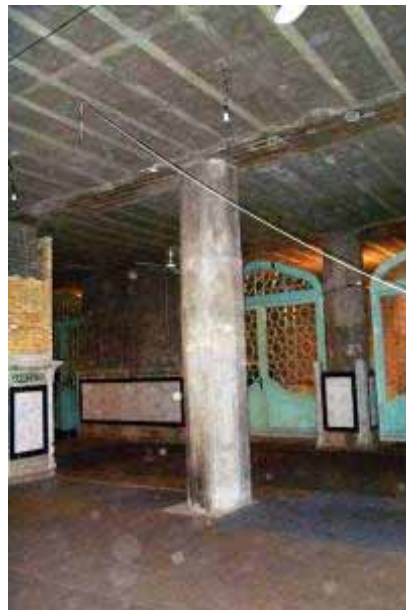
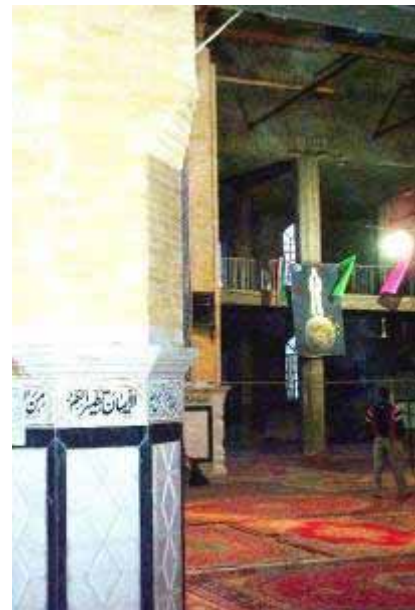
**Figure 51: Jame Mosque in Bam. Reinforced concrete frame with joist and hollow brick RC slab roof and masonry infill walls. The central dome has a steel frame structure and is built from fired bricks. No sign of significant damage either on the interior or on the exterior of the structure or minarets.**

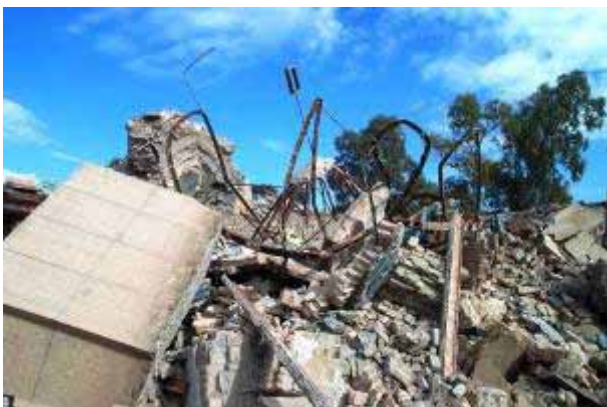
Figure 52: Mausoleum of Emamzadeh Ali Ebn Al-Hossain In Bam. Complete collapse of the main dome and its supporting old walls in the interior part of the mausoleum. These walls were mainly made from mud bricks. A steel frame envelops the building with a jack-arch roof system extending from the frame to interior masonry walls. The collapse of the main building appears to be the main cause of damage to the roof and external frame.

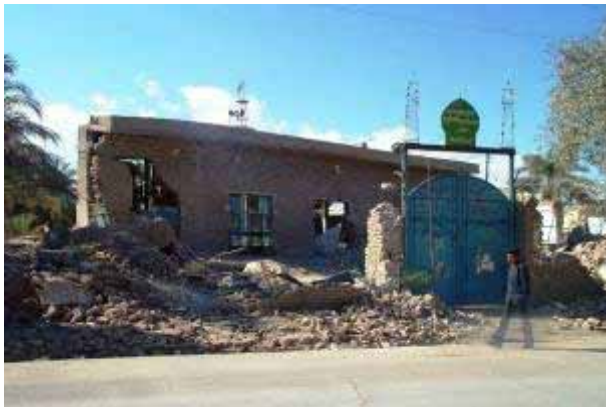
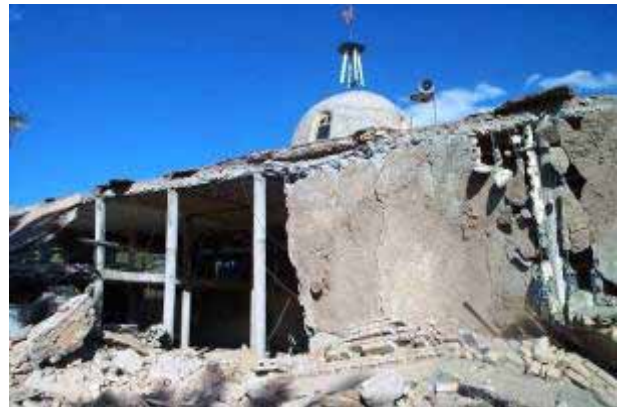
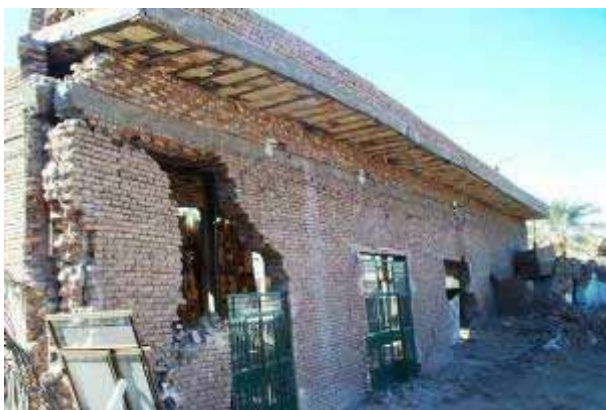
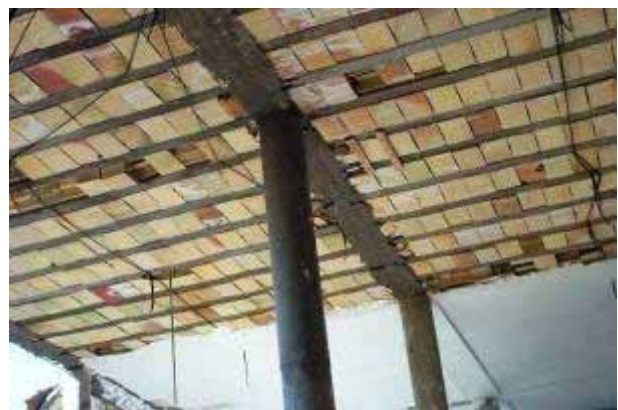
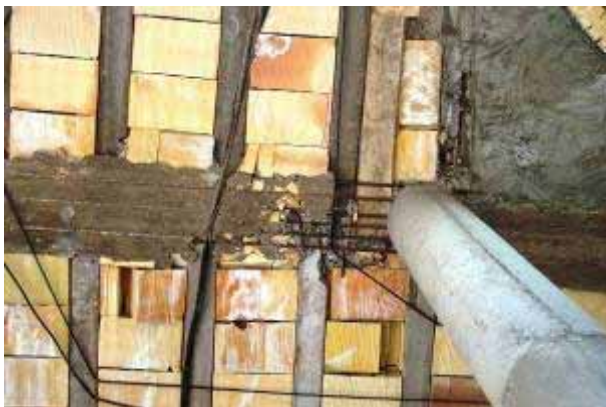
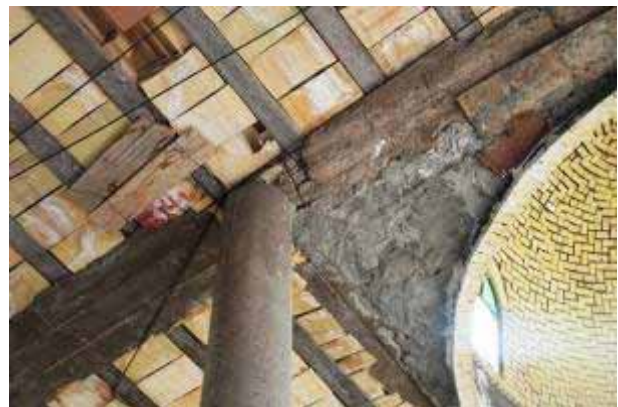
**Figure 53: Imam Sadegh mosque in Bam: New construction with reinforced concrete beams and columns in the middle and load bearing masonry for the external walls. The wall at the back has collapsed as well as the part of roof which was supported by the wall. Very poor construction of reinforced concrete members and in many locations the reinforcement of the beams was left without any cover.**

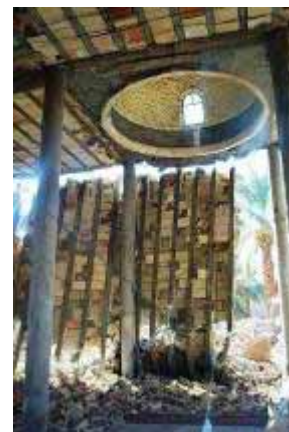
Figure 54: Emamzade Zied in Bam. Extensive damage to the sides of the main building which appear to be an extended part of an older section of the structure. The main building has not collapsed.
