# THE BAM, IRAN EARTHQUAKE OF 26 DECEMBER 2003

*Field Investigation Report Prepared By:  
Dr. Ali Reza Manafpour, Halcrow Group Limited*

## The Bam Earthquake of 26th December 2003

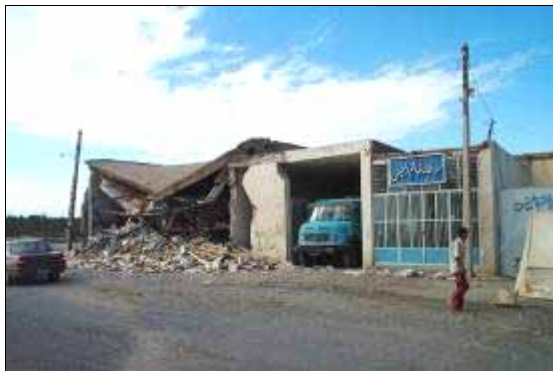
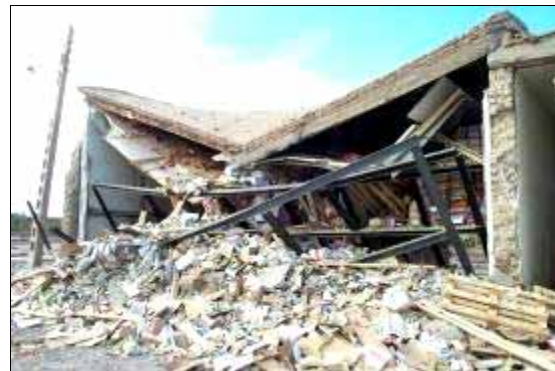
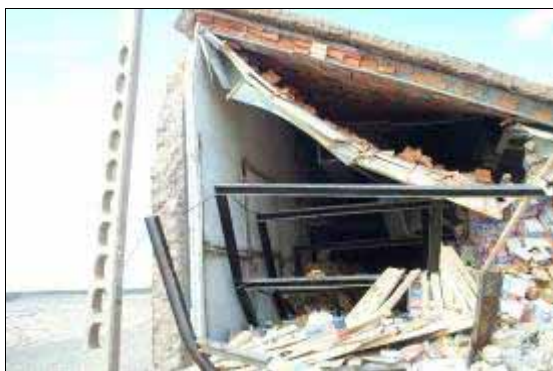
Figure 55: Khatam-Al Nabiein Cool Storage-North of Bam, located on the other side of the Posht Rod river across Bam's main bridge. The roof system is hollow bricks with reinforced concrete joists and slab. Internal steel frames providing shelving to the date packages were not properly designed for the heavy load of date packs. It is constructed from several independent two storey frames extending between the main walls with no positive connection tying them to each other or to the walls. The shelving floors are made from lumber, sitting on the steel beams. The shelving frame collapsed in its weaker out of plane direction due to inertia forces from the earthquake. The collapse of these shelving frames removed the support from the front of the building and resulted in building collapse.

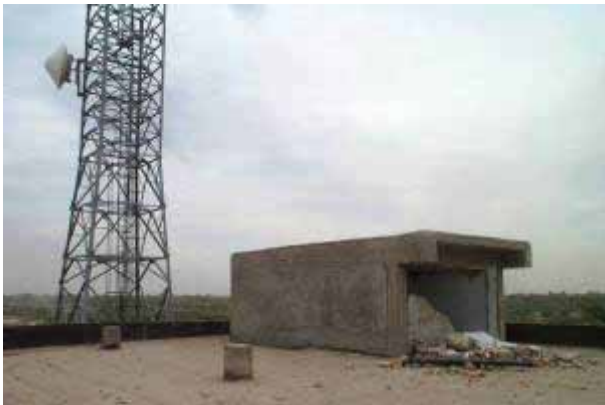
Baravat Telecommunication office

**Figure 56: Examples of the performance of staircase extension structures in Bam earthquake. Good behaviour for reinforced concrete structures and collapse in masonry buildings.**

Due to the importance of the staircase structures in providing safe evacuation from buildings, and since failure in these structures was a common occurrence in the Bam Earthquake the issue of proper design of these structures and the provision of clear design guidance needs to be considered by local authorities.

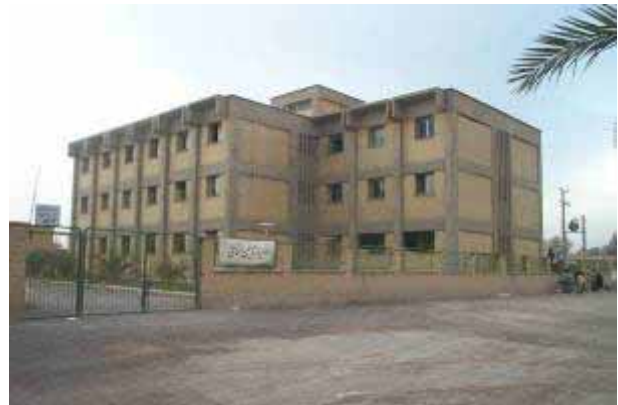
Undamaged in a reinforced concrete building

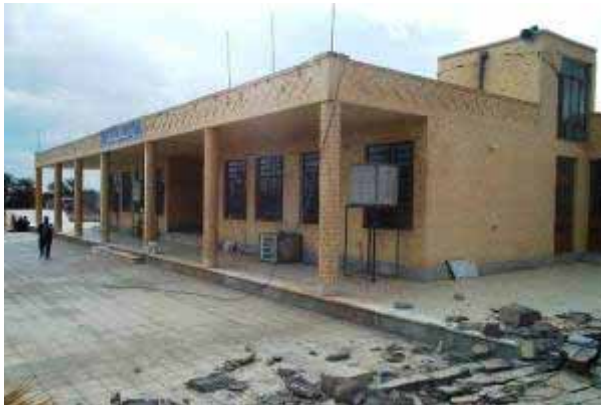
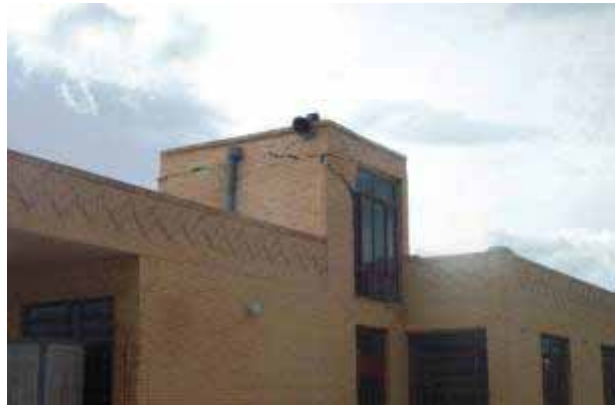
Bonyad-Shahid building in Bam

**Figure 57: Examples of the performance of staircase extension structures in the Bam Earthquake for Masonry buildings**

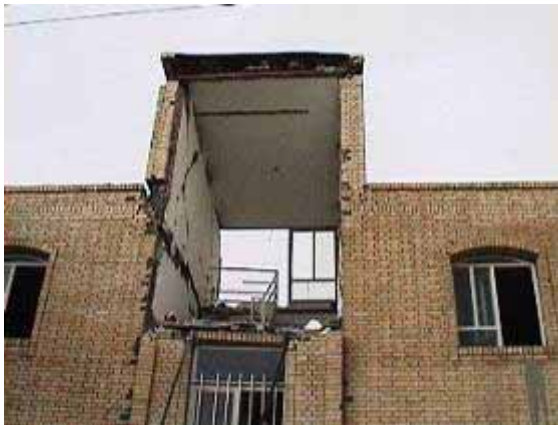
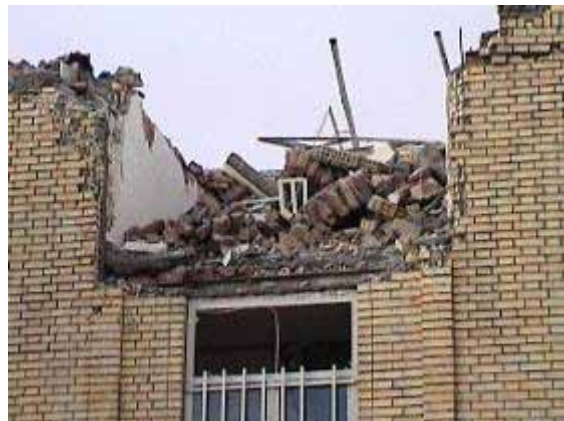
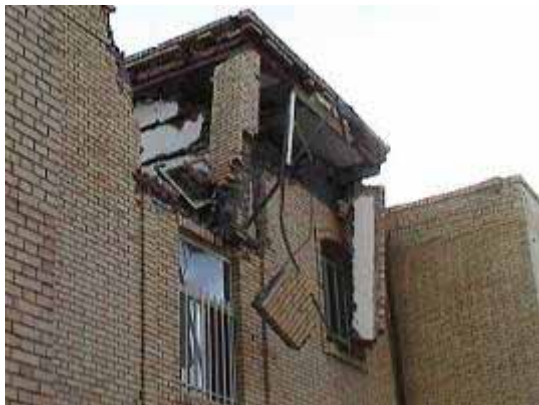
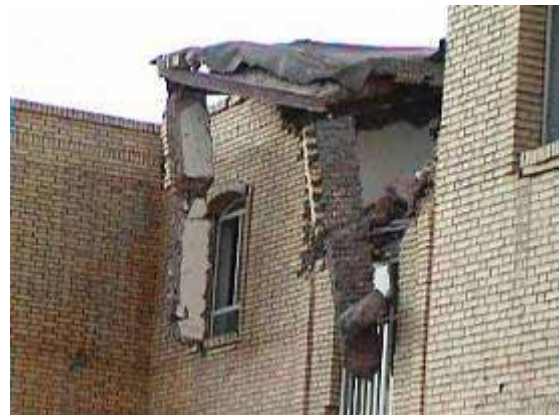
**Figure 58: Examples of the performance of staircase extension structures in Bam Earthquake for Masonry buildings: Housing and Urban Development Organization’s new ‘build to rent’ project. There were a large number of collapsed staircase extension structures in this project, only some examples are shown here.**
