MCEER SPECIAL REPORT SERIES  
Engineering and Organizational Issues Before,  
During and After Hurricane Katrina

Damage to Engineered Buildings and Lifelines  
from Wind, Storm Surge and Debris in the  
Wake of Hurricane Katrina

**Damage to Engineered Buildings and Lifelines from  
Wind, Storm Surge and Debris in the Wake of  
Hurricane Katrina**

MCEER-07-SP03

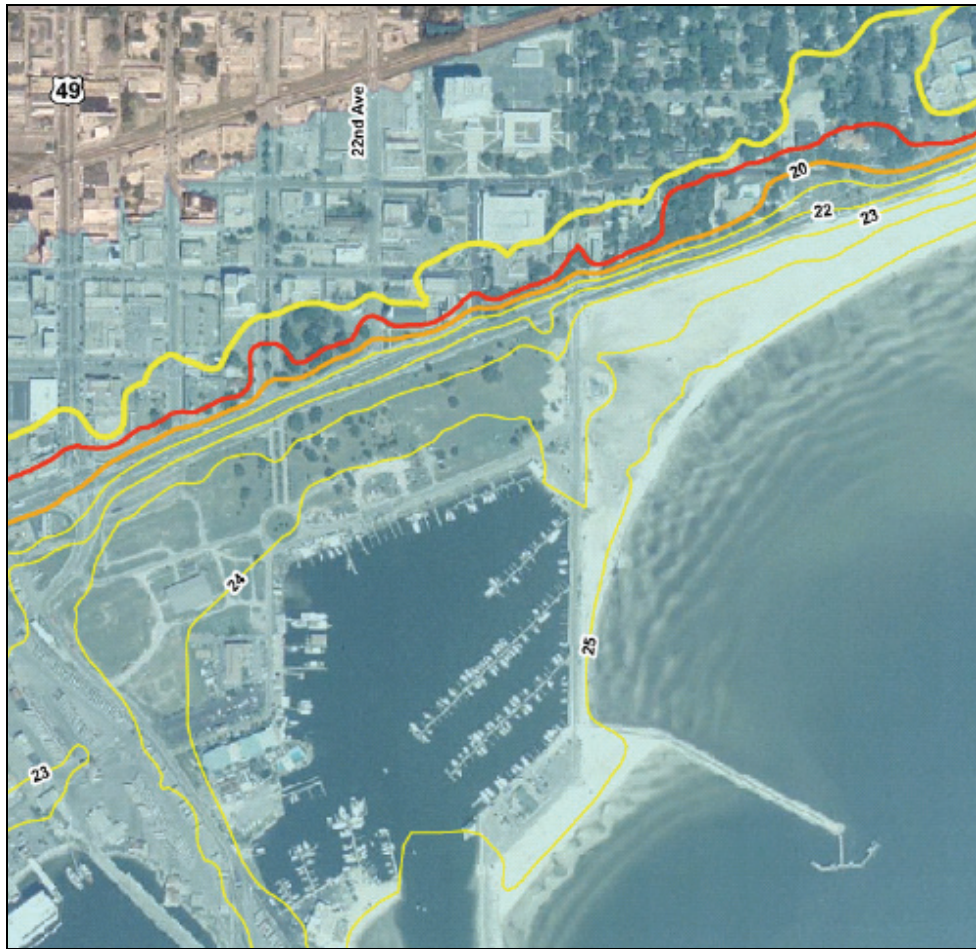
Loading from storm surge and surge-borne debris did appear to exceed conditions provided for in building codes. For example, storm surge appears to have reached farther inland than advisory base flood elevations, even including Katrina among flooding statistics (Figure 2-5). Furthermore, impact from objects transported by floodwaters (surge-borne debris) is only superficially treated by modern building codes (e.g., ASCE 7-05 [2006] Sec 5.4.5, which simply calls for impact loads to "be determined using a rational approach as concentrated loads acting horizontally at the most critical location at or below the DFE"), but in several cases such impact appears to have caused serious damage.

*Figure 2-5. Extract of map showing surge inundation in Hurricane Katrina (blue shading) and advisory base flood elevations including wave effects (heavy yellow line), from FEMA (2006). Inundation in Katrina reached farther inland than 1% annual chance (100-year) stillwater elevations plus estimated wave effects.*
