THE L'AQUILA, ITALY EARTHQUAKE OF 6 APRIL 2009

A PRELIMINARY FIELD REPORT BY EEFIT

The L'Aquila (Italy) Earthquake of 6th April 2009

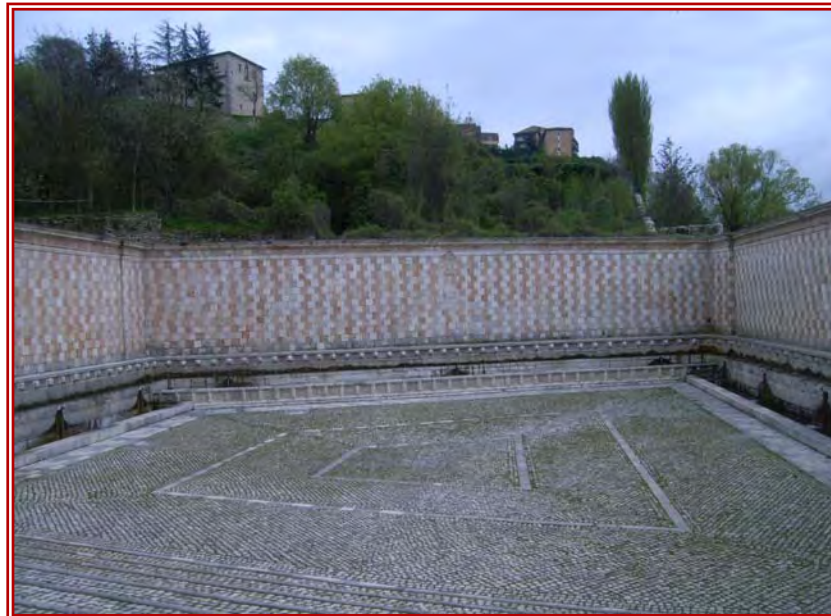
Another important landmark is the 13th Century Fontana della Riviera. The fountain of 99 taps is one of the most ancient monuments in Aquila and is considered a symbol of the city. The fountain was not damaged by the earthquake.

Figure 9: The Fontana della Riviera after the 6th April 2009 earthquake

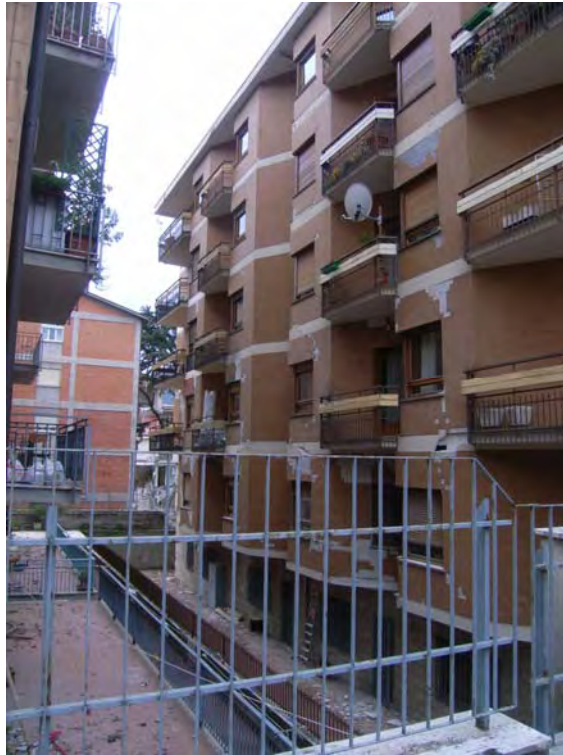
Figure 11: An example of a pre-1975 concrete frame reinforced concrete apartment block in L'Aquila, typically 5-8 storeys

In areas near to the walled city boundary, some housing is composed of reinforced concrete multi-storey frames, built from the 1970's to 1990's (Figure 11). Most such buildings suffered damage to infill walls, and three complete collapses were observed (see section 4.1).

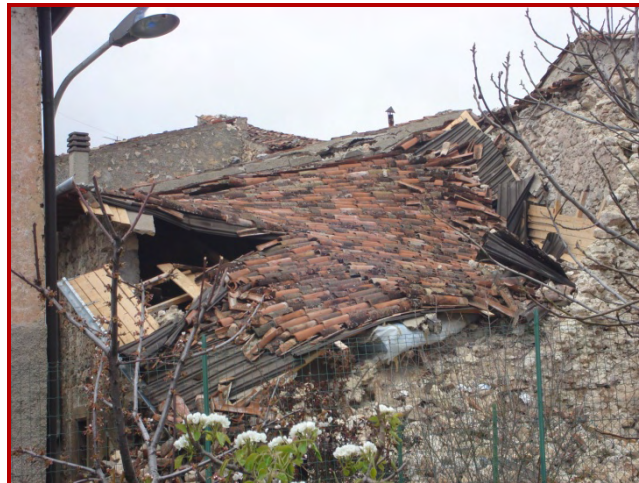
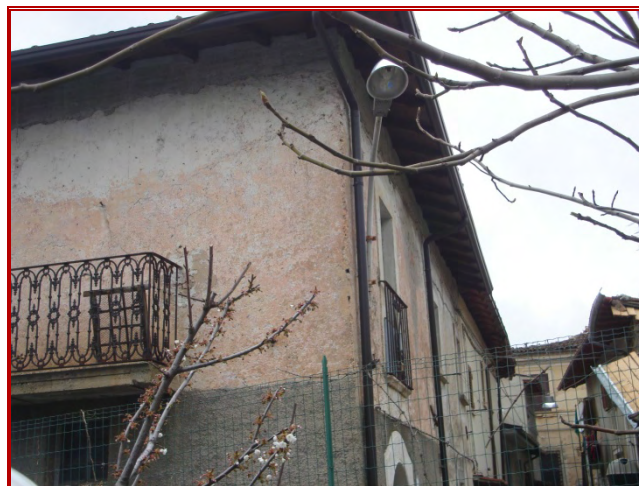
Barisciano is located on the route SS17 southeast of L'Aquila. It has a population of 1400 and sustained 3 injuries and no deaths. This is consistent with the extent of damage observed within the town. The town centre is composed of 2-3 storey masonry buildings, with wythes made of uncut stone and filled with smaller rubble ("a sacco"). The damage seen on most of the buildings ranged from slight cracking to falling plaster. Very few modern residential buildings were observed in the town, however many of the old masonry buildings had been restored and strengthened with ring beams or ties. These seemed to be effective for the level of ground shaking experienced in Barisciano, as is shown in Figure 18 where a partially collapsed building that has not been strengthened (Figure 18a) stands beside a undamaged building that has been retrofit with a ring beam at roof level (Figure 18b).

Figure 18: Partially collapsed stone masonry, 2-storey, residential building (a), besides a similar undamaged building with reinforced concrete ring beam at roof level (b).

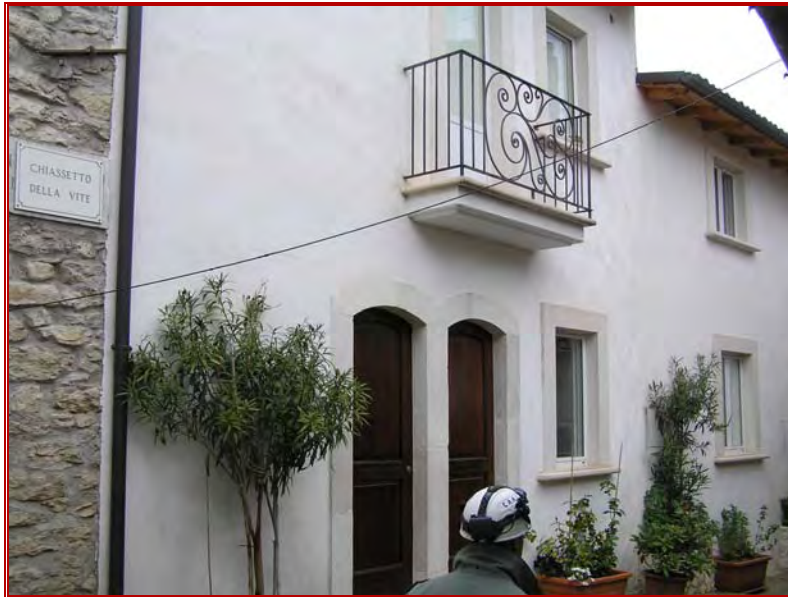
Figure 24: Recently restored masonry house in central Paganica that sustained no damage

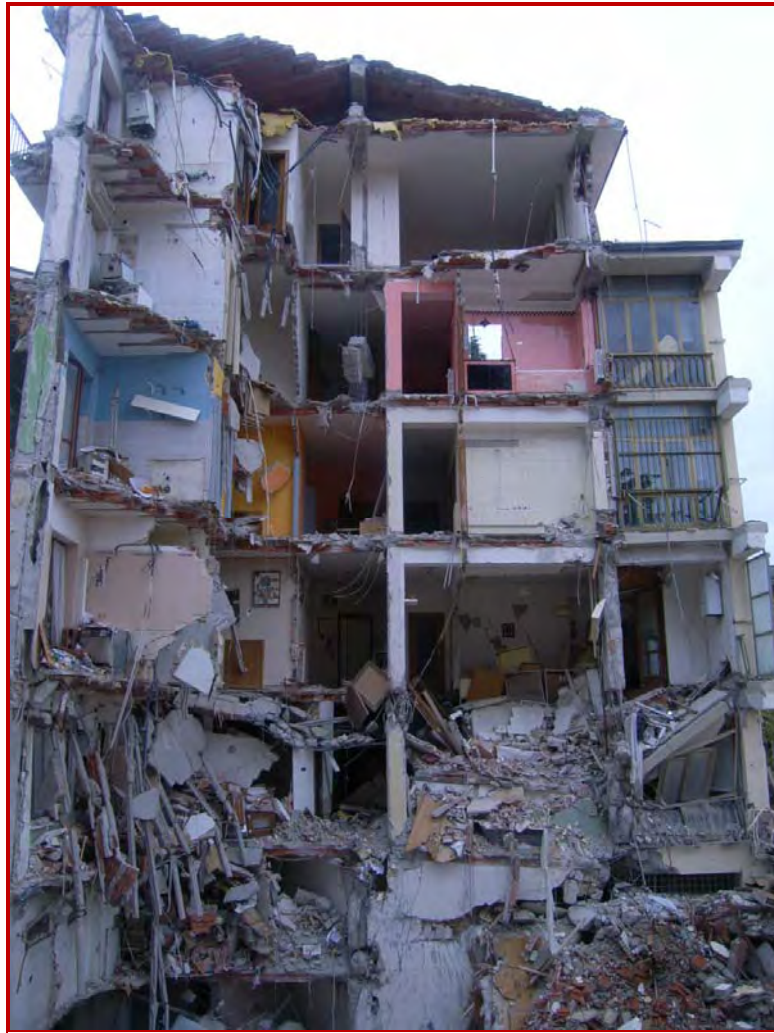
Three major failures to RC frames were also observed by the EEFIT Team in Aquila Centre: the Aquila University halls of residence, a 5 storey (with basement) residential building (Figure 31) and the Hotel Duca degli Abruzzi (Figure 29). In all cases the buildings were constructed in the late 1970's, just after the introduction of the first seismic code for RC buildings was introduced in Italy. In each case a section of the building underwent total collapse indicating a lack of robustness and redundancy of members. The Hotel degli Abruzzi seems to have failed through a combination of soft-storey mechanism formation exacerbated by sloping topology. Poor detailing of column reinforcement was observed with smooth reinforcing bars and inadequate confinement steel (Figure 30) that seems incongruent with the requirements of the 1974 code. In the case of the halls of residence, it was not possible to identify the failure mechanism due to site clearance for rescue. However, from exposed connections and rubble, smooth reinforcement was again present. In the residential building one of the main problems is seen to be the lack of transverse reinforcement in columns and connections. Columns seem to have failed in compression before beam yielding. Despite these collapses, the majority of RC frame buildings in Aquila town centre were not structurally damaged but sustained extensive non-structural damage.

Figure 31: Residential building in Aquila on Via XX Settembre.

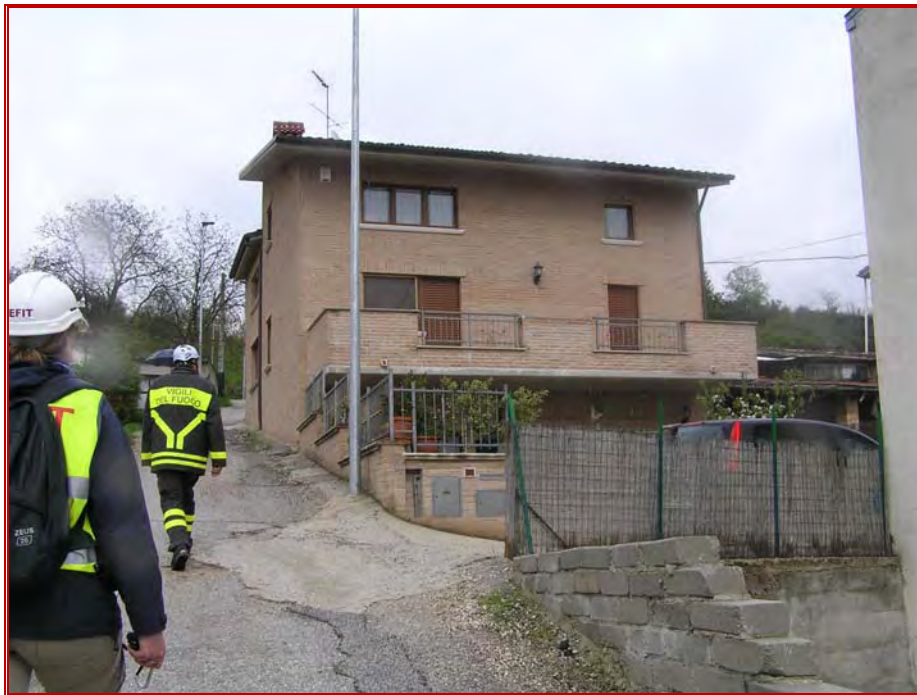
An example of modern good detailing was observed above the town of Paganica. A series of modern 3 storey residential houses were virtually undamaged by the strong ground shaking, despite being located near Paganica old town centre that suffered 90% damage to its masonry buildings. Figure 32 shows a three storey RC Frame with clay full brick infill that was built in 2001. Evidence of strong ground shaking was observed through falling objects in the house as well as radiator pull-out from wall and wardrobe pounding (Figure 33). However, the house suffered only minimal hairline cracking between infill and frame.

Figure 32: RC 2001 residential two-storey above Paganica Undamaged

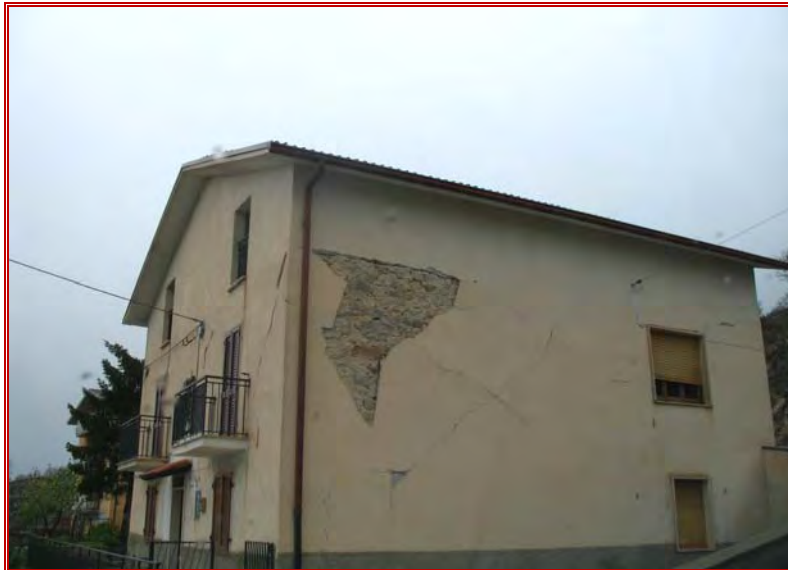
Figure 35: Building typologies - building in Poggio di Roio with concrete slab roof. Falling render shows how the presence of concrete roof and slabs exists with stone masonry wall loadbearing walls

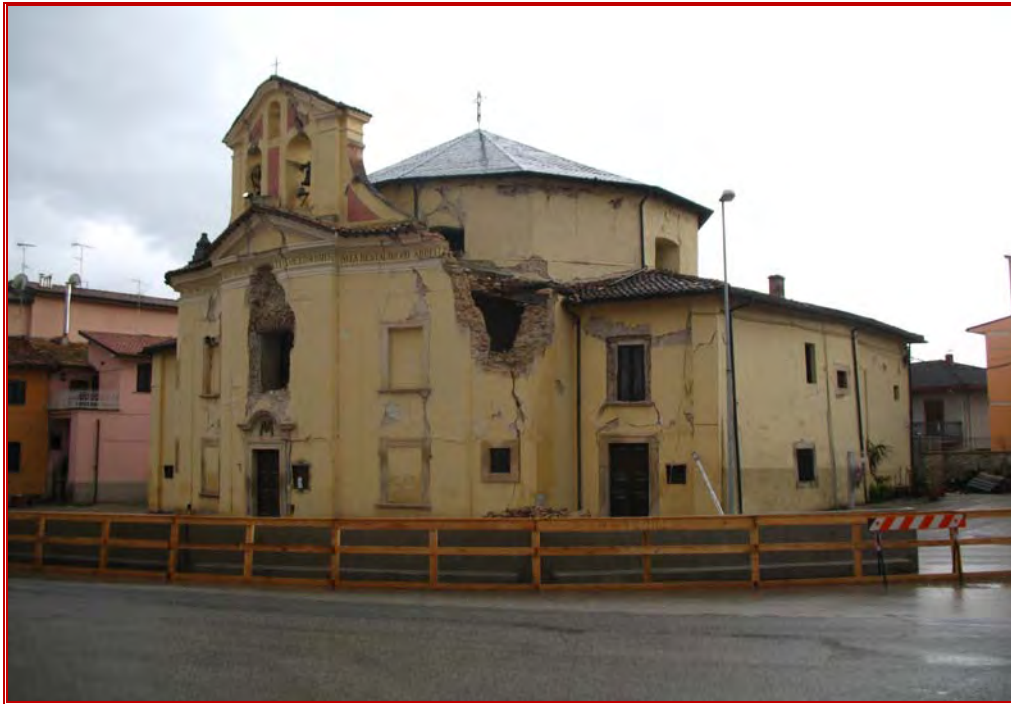
In massive buildings and monuments of L'Aquila, the tension forces that initiate collapse of masonry could only form in the upper storeys of the buildings, so parapets, top corners, and church timpani were the most severely damaged

Figure 26: Church in Paganica

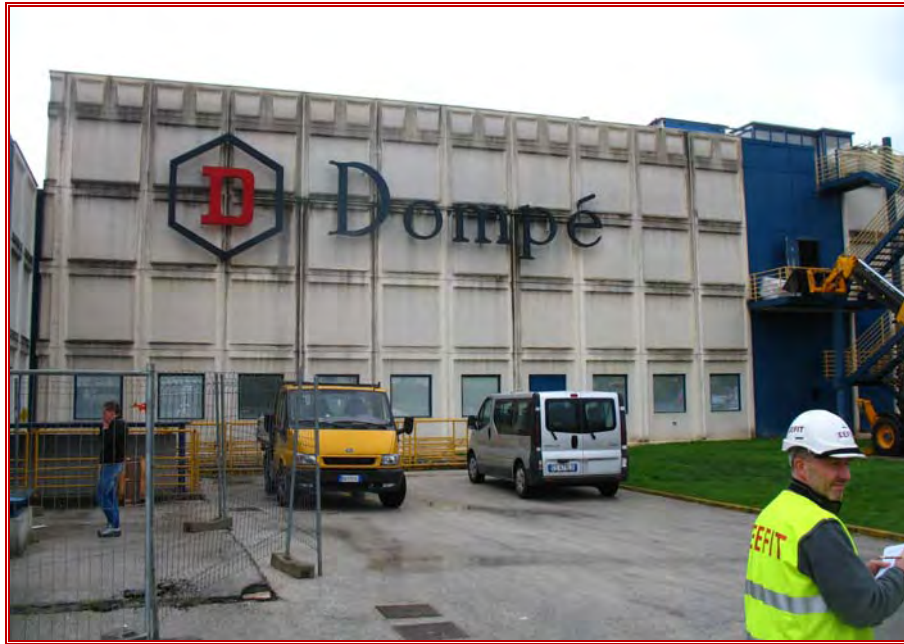
There are two industrial estates in the L'Aquila area: a few kilometres West of the City lies the Pile Nucleo Industriale and to the East of the city, off the SS17 the larger Bazzano industrial estate. Industrial sheds are built with precast RC frame and precast planks. There were no major collapses to these structures, and few cases of cladding collapse were observed other than in two industrial facilities. It is however stressed that the EEFIT survey in this case was not extensive and carried out from the roadside, Accounts from a local consulting engineer indicate that up to 20% of the structures suffered minor damage in the form of collapse to cladding panels. The EEFIT team was able to carry out a detailed visit to the Dompé pharmaceutical company in the Pile industrial estate where the worst reported damage to industrial buildings occurred. The building construction is in situ concrete frame and precast planks or T-beams. The major form of structural damage consists of short-column failure. The total cost of repair works are initially estimated to exceed €10 million

Figure 40: Dompe' Pharmaceutical Plant in Pile

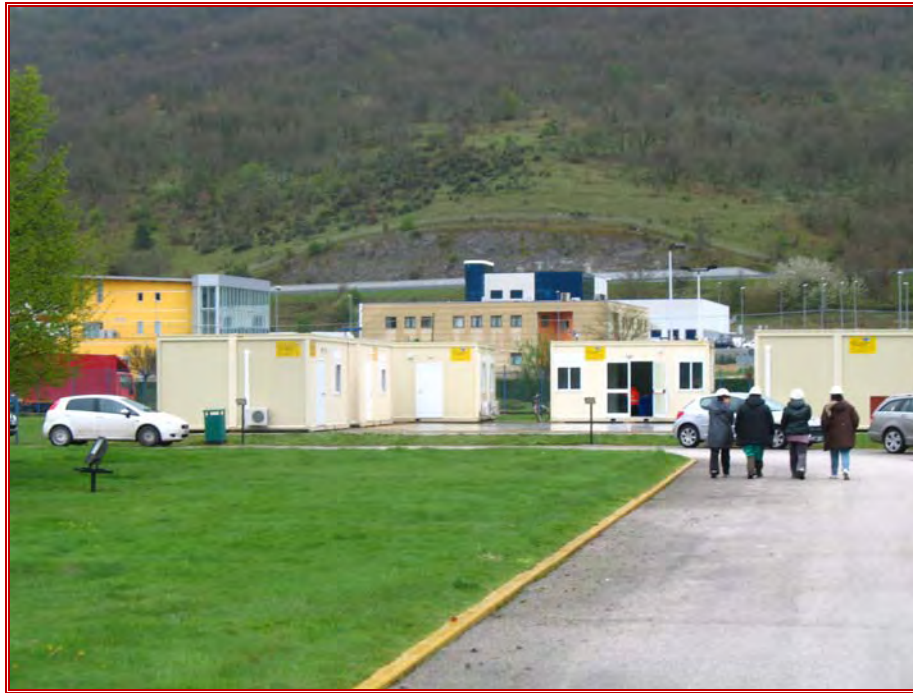
Figure 42: Temporary office housing in Dompe' Pharmaceutical Plant

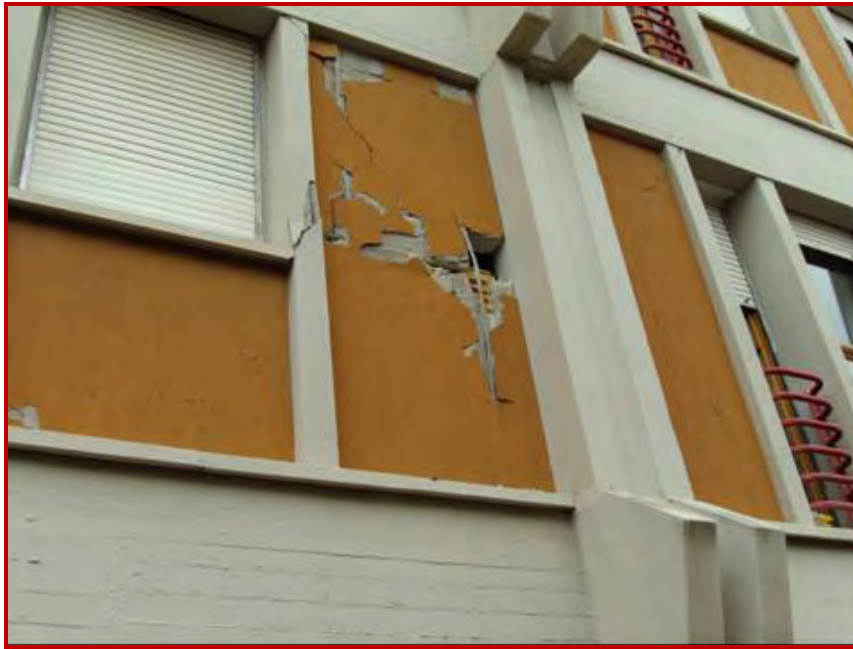
Vertical sheet steel strips were observed to bridge between structural beams at the external face of infill walls. These seem to have been put in place in order to prevent out of plane displacement of infill if broken (Figure 45). However, the extent and frequency of this type of reinforcement could not be assessed.

Figure 45. Detail of reinforcement of an infill wall by means of steel strips

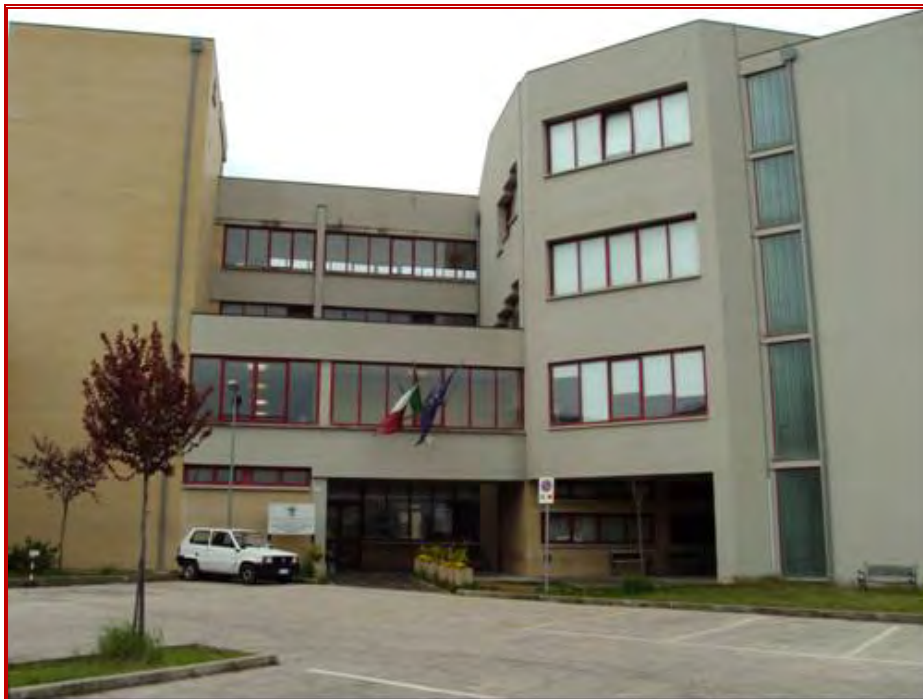
The faculty of Medicine and Surgery of Aquila University (Figure 46) is located to the northwest of the hospital complex. In this case the system seems to correspond to concrete shear walls, that although irregular in plan, behave much better than the hospital complex, with no structural or architectural damage observed.

Figure 46. The Faculty of Medicine and Surgery building of Aquila University, located northwest of the Aquila hospital. The structure is formed of shear walls and withstood the earthquake without any visible damage.

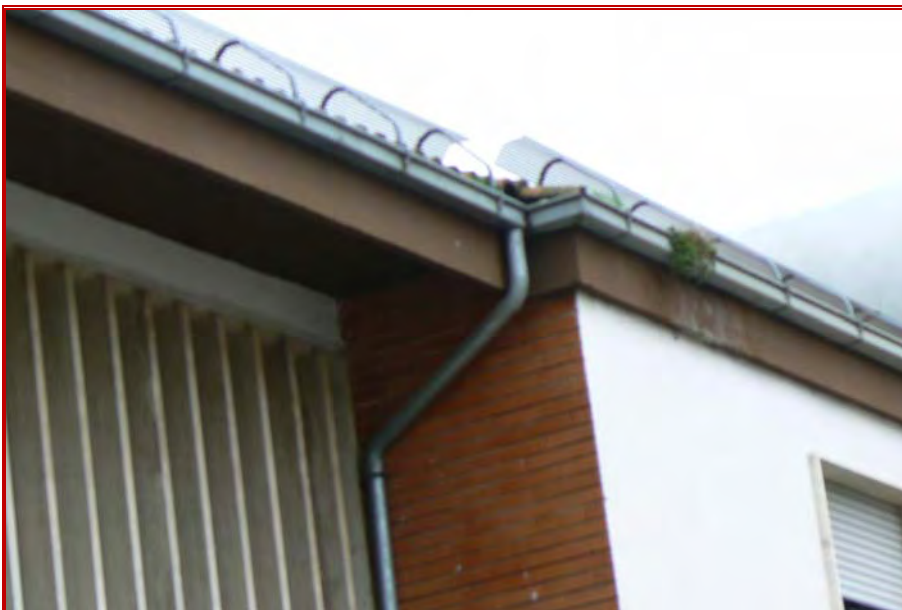
The EEFIT team observed several schools in the affected area. These were of both masonry and reinforced concrete construction. All schools observed by the EEFIT Team suffered less than grade 3 damage (e.g. Figure 47). One school in Lucoli was observed to have brackets and mesh placed at gutter level to stop any loosened roof tiles from falling (Figure 48). On the 22nd April, the newspaper “Il Centro” reported that of the 294 schools in Abruzzo 209 were open, 78 were closed and 12 were partially open. 2709 children below the age of 18 are living in temporary accommodation.

Figure 48: Detail of a school in Lucoli where brackets and wire mesh had been placed to prevent falling of roof tiles.

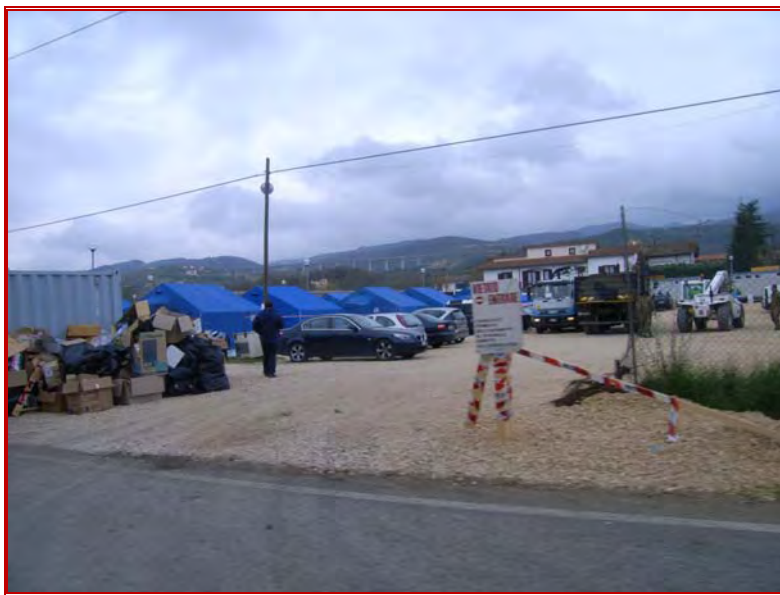
Many of the major roads pass over multi-span viaducts with expansion joints at each support. These roads were open to traffic with no evidence of any damage. There were no signs of damage to the bridge decks near expansion joints, nor any spalling of concrete at the beam ends, which would have been indicative of seismic pounding. Many road tunnels were present in the area but were all open, seemingly unaffected by the earthquake.

Figure 49: View of elevated highway in background.

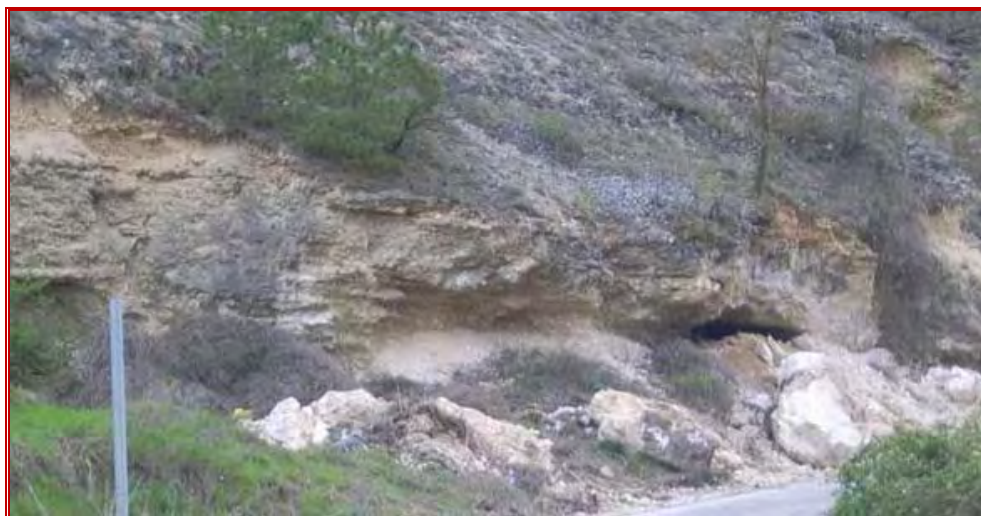
The ground conditions within the valley comprise alluvium, underlain by lacustrine deposits and bedrock at depth. The bedrock is predominantly limestone and dolomitic limestone. (APAT, 2005). On the valley sides the ground conditions comprise slope deposits of conglomerate and breccia with limestone clasts that have been re-cemented and underlain by older limestone and dolomitic limestone formations (Figure 56). Local deep soil ground conditions within the valley appear to have amplified ground motions. The distribution of the level of strong ground motion is briefly discussed in Section 2 and analysis is ongoing. The amplified ground motions are reflected in the higher levels of damage encountered with the valley when compared to the valley side slopes where the thickness of soil is less. The distribution of earthquake intensities are also elongated mirroring the shape of the valley.

Figure 56: Re-cemented outcrop of slope deposits close to Lago Sinizzo

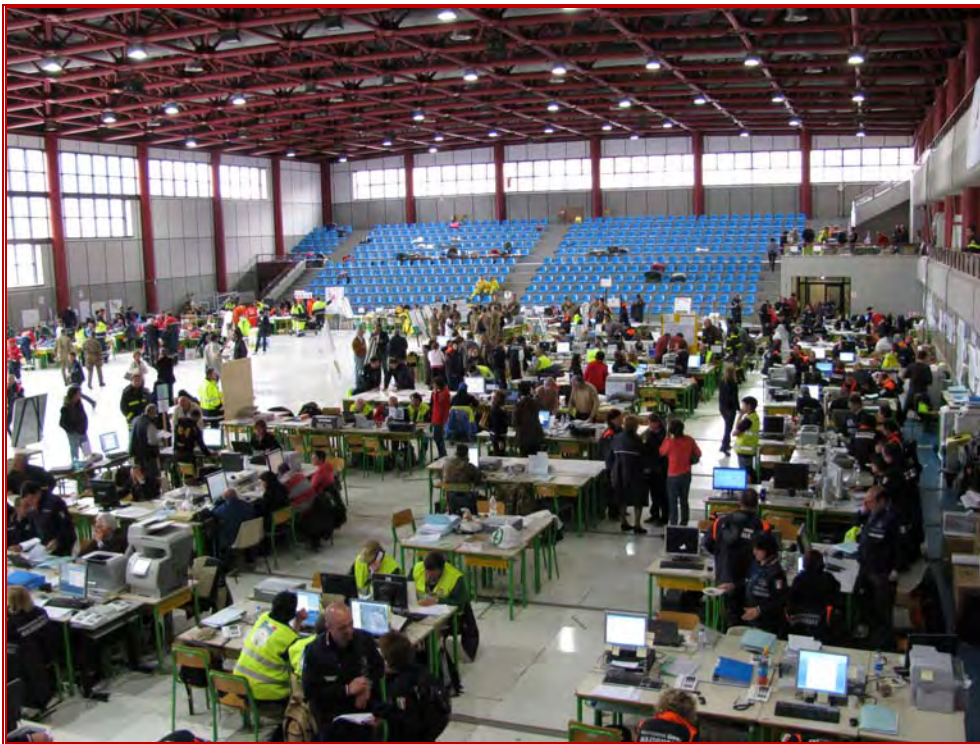
Figure 61: Photograph of the disaster management coordination centre at the Command Centre of the Finance Police

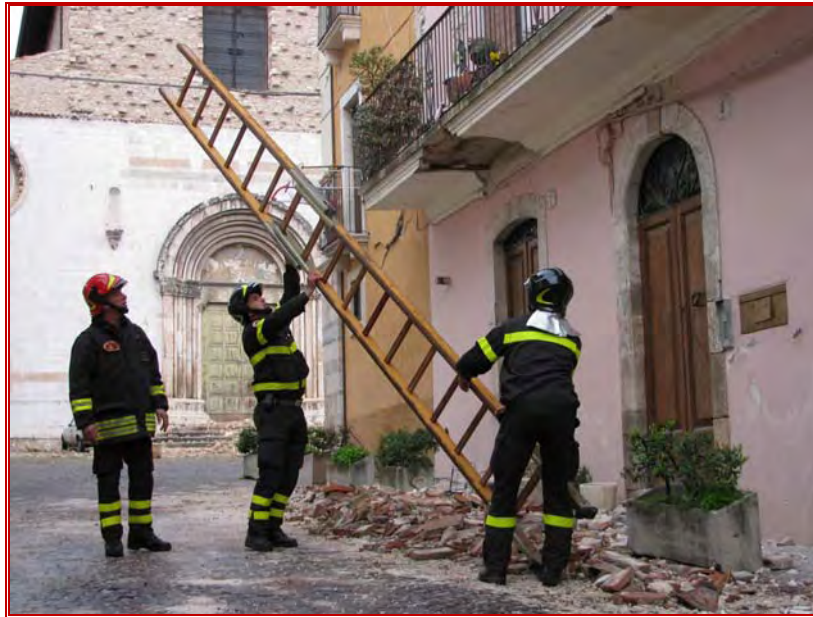
Figure 62: Fire-fighters from around Italy have been involved in search and rescue operations and in escorting residents into their homes in affected areas

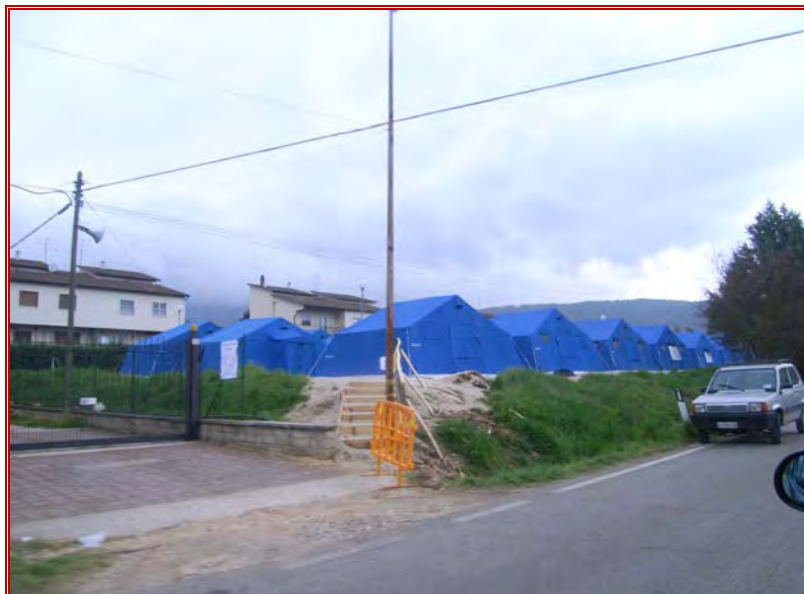
Figure 63: A camp outside the village of Tempera housing local residents evacuated from the town

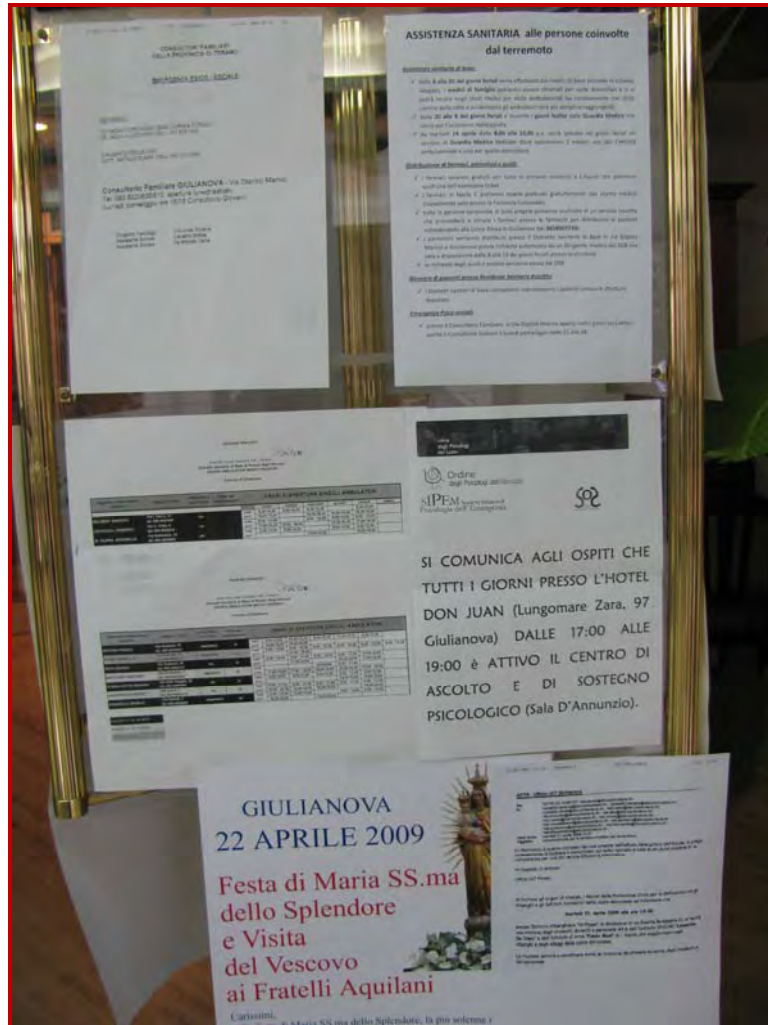
Figure 64: Notices posted at the lobby of the Parco dei Principi Hotel in Giulianova. In particular the notice in the middle on the right notifies the hotel residents of the location of a support centre for those affected by the earthquake in a nearby hotel.

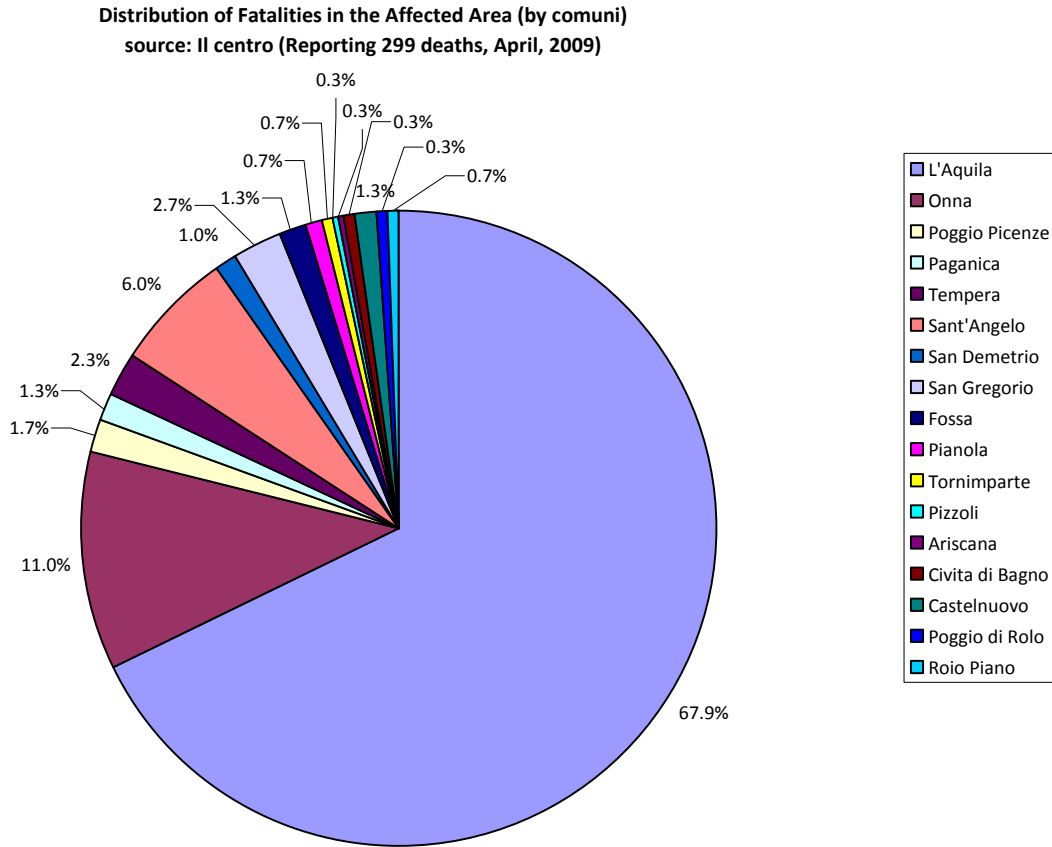
Overall, there are 299 reported fatalities and over 1,500 injuries. A breakdown of the fatalities by town is shown in the pie chart below:

Figure 65: Graph showing the number of deaths in each commune (i.e. town district) in the L'Aquila region (source: Il Centro newspaper on 22nd April 2009)
