# From Code to Practice

## Challenges for Building Code Implementation And the Further Direction of Housing Earthquake Safety

Records and outcomes of  
International Symposium 2008 on Earthquake Safe Housing  
28–29 November 2008, Tokyo, JAPAN

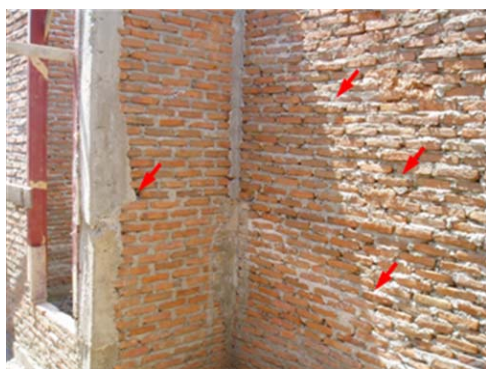
**Figure 1.** Poorly built new houses caused by poor quality materials and poor workmanship (left); Simeulue earthquake, February 20, 2008 revealed houses built are not earthquake resistant (right).

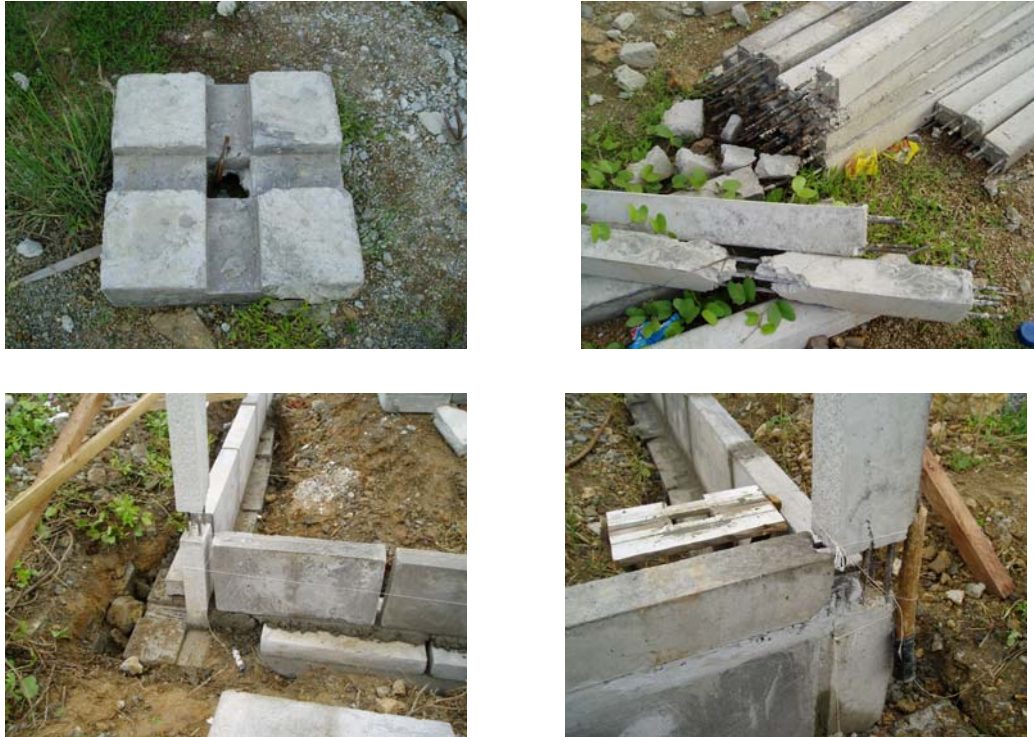
**Figure 5.** Pre-cast construction using wet joints and reinforcement splices of approximately 10 cm as the connections (Aceh)

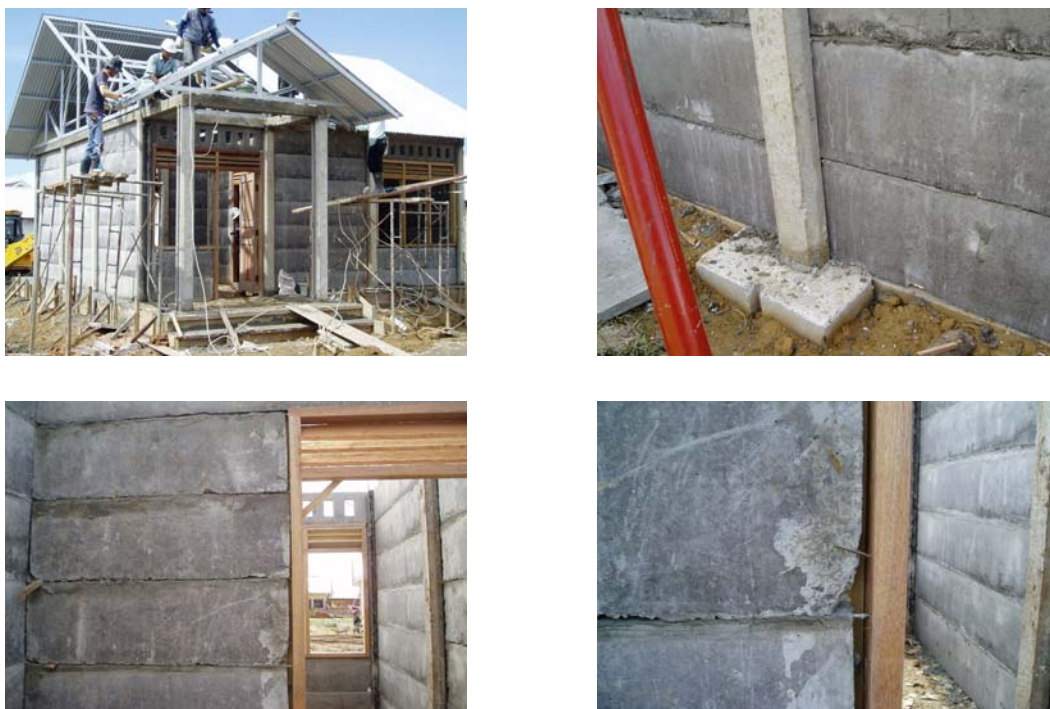
**Figure 6.** Walls using extra large size blocks with poor connections

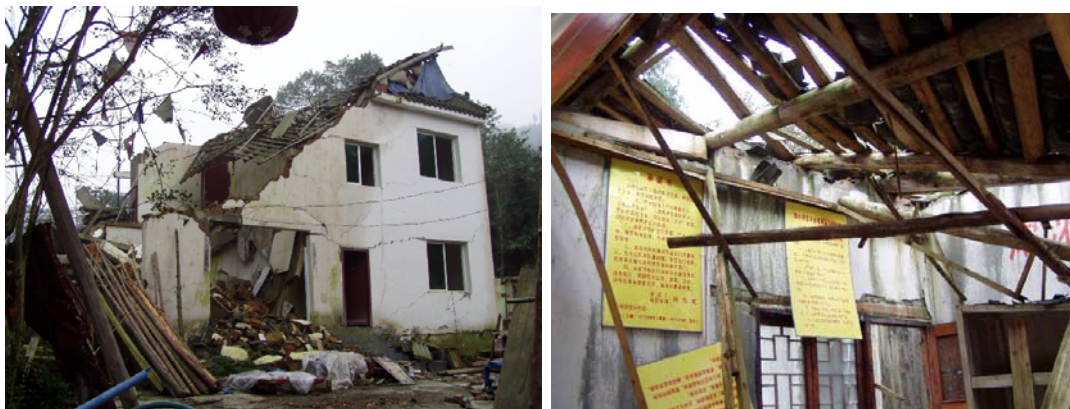
**Figure 1.** Un-reinforced brick masonry houses in Hongkou, Dujiangyan, Chengdu City, Sichuan Province, China

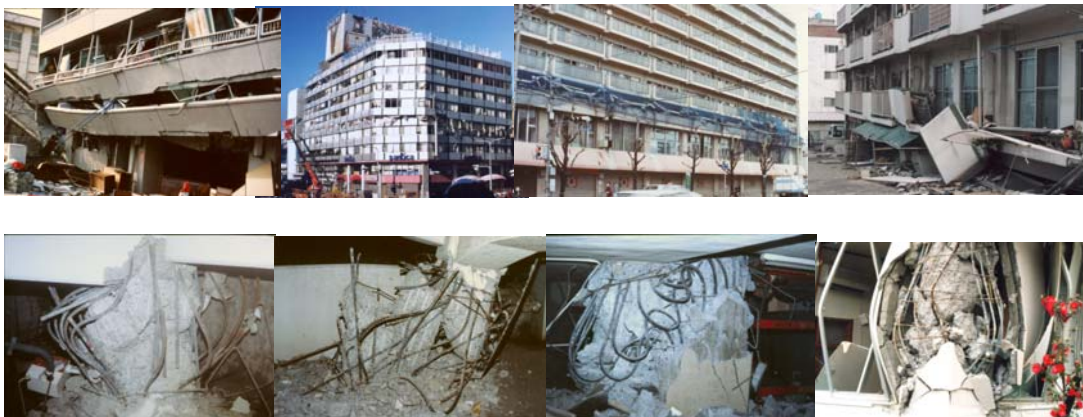
**Figure 8.** Reinforced concrete buildings in the 1995 Kobe disaster

Most common type of failure in earthquakes was the collapse of the soft first-story construction, in which the lateral stiffness and resistance of the first story were significantly reduced from those of the upper stories by removing structural walls in the first story for building usage (garage and commercial use). The collapse took place in the first story in the form of brittle shear failure of columns because all lateral forces acting in upper floors had to be resisted in the first story. Figure 10 compares the damage rate of soft first-story buildings with construction age. It can be noted that a significant improvement in the safety of the soft first-story buildings with the revision (improvement) of the design code. Almost one half of those soft first-story buildings constructed before the 1971 revision suffered severe damage or collapse. The current design code is not sufficient to prevent soft first-story construction from collapsing.

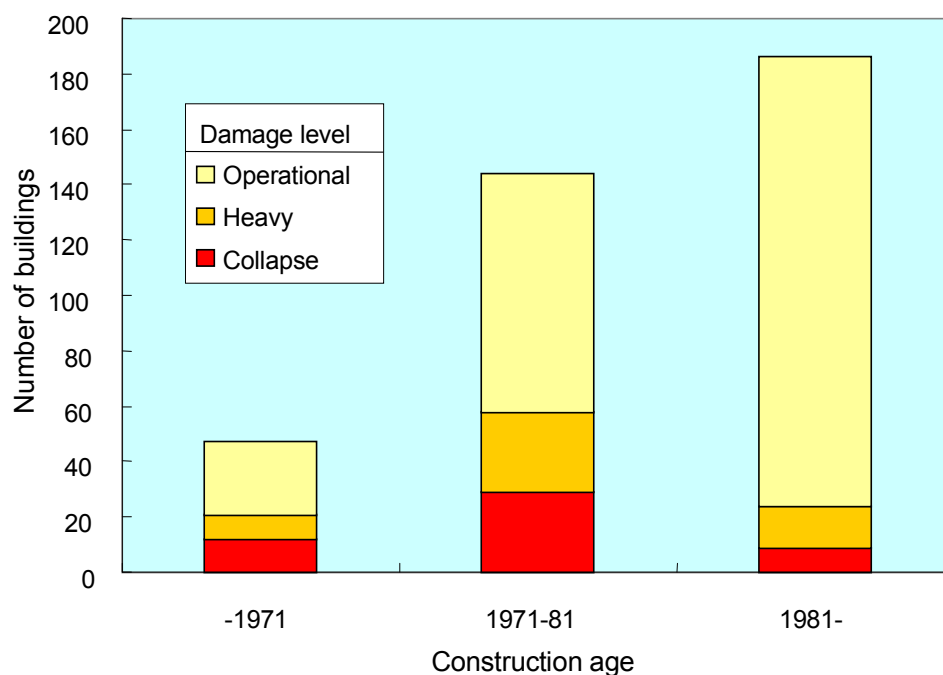
**Figure 10.** Damage of soft first-story buildings with construction age

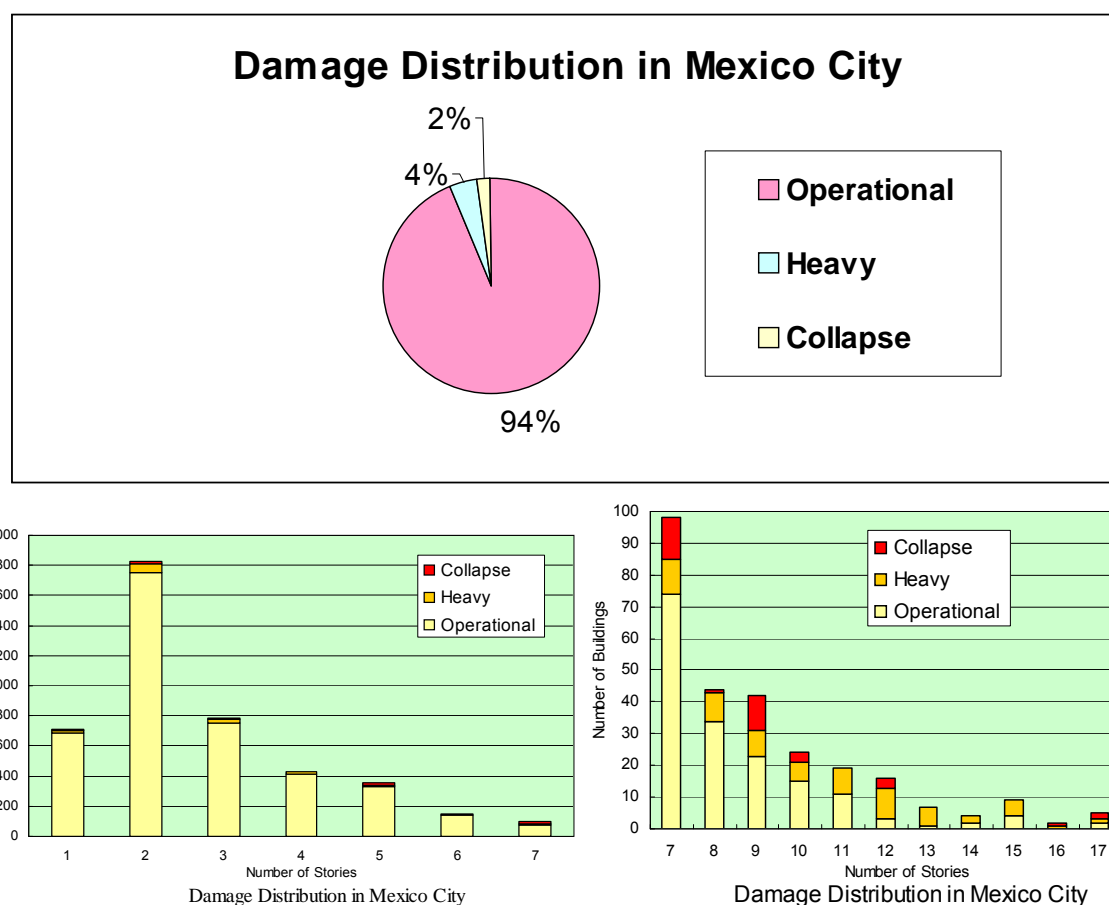
**Figure 12.** Damage Distribution in Mexico City

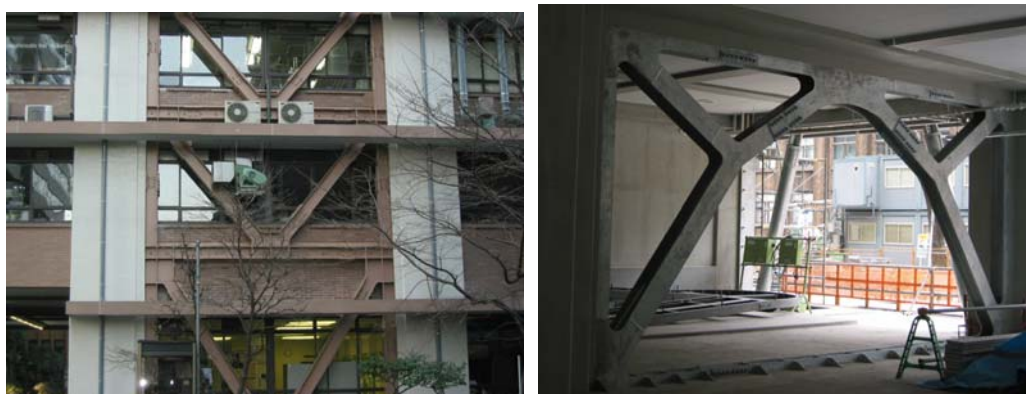
**Figure 14.** Placement of steel bracing (Japanese Schools)
