## CASE STUDY 10:

### Building Resilience to Earthquakes in Chile

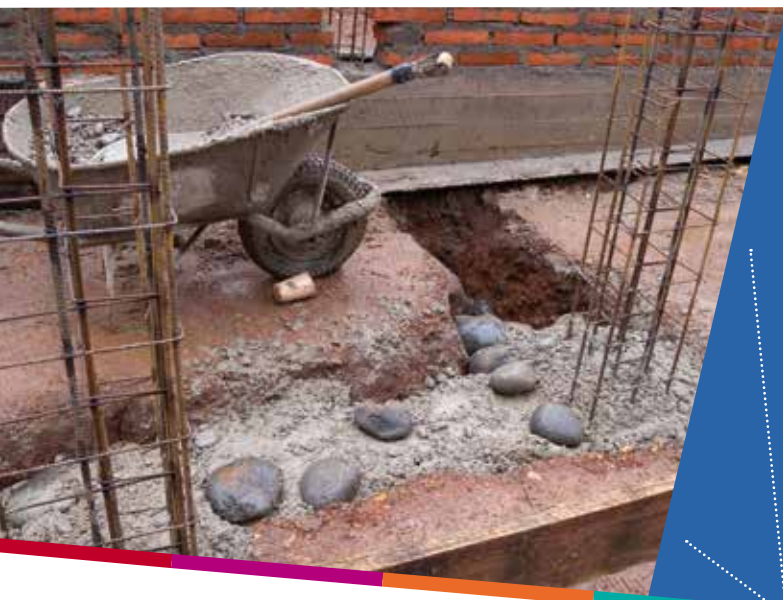
**Image 1:** Tie-column reinforcement cages extending from foundations of a new building; these are a key feature of 'confined masonry' construction. Source: Brzev, Astroza and Yadlin, 2010<sup>1</sup>.

For instance, buildings constructed in the 'confined masonry' style, have been designed to withstand earthquakes better than buildings built with other, more traditional building techniques<sup>5</sup>. 'Confined masonry' buildings are characterized by masonry walls combined with reinforced concrete confining elements, such as tie-column and tie-beam reinforcement cages (Image 1), and, in some cases, concrete bands through walls<sup>6-8</sup>.

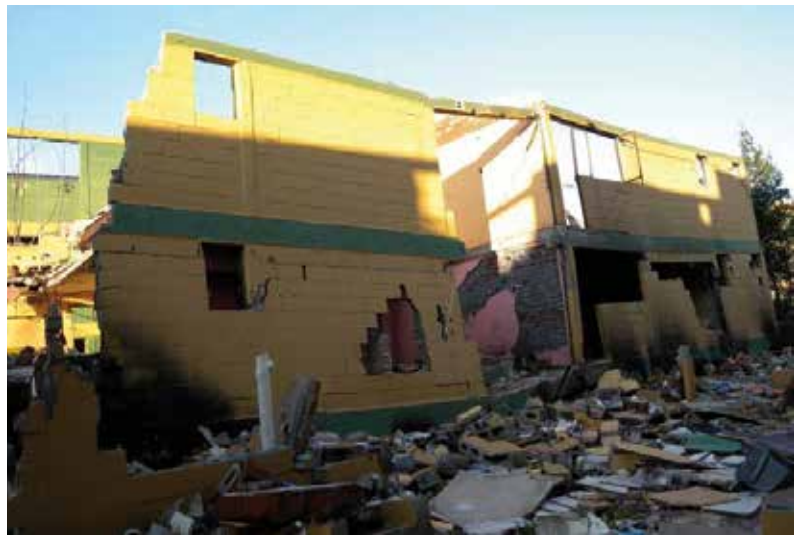
**Image 2:** A building with a collapsed ground floor as a result of the February 2010 earthquake in Chile. Source: Brzev, Astroza and Yadlin, 2010<sup>22</sup>.

February 2010, only around 300 people lost their lives due to collapsed buildings<sup>23</sup> (Image 2). Well-enforced, science-based seismic building codes have been suggested as a major reason for the low number of casualties in the Chile earthquake<sup>24, 25</sup>. The earthquake was the most severe since the 1930s and produced significant ground-shaking over a large area of the country. Despite this, 'confined masonry' buildings of all sizes performed very well and it is estimated that only about 1% of the total building stock in the affected area was damaged<sup>26</sup>. Similarly in Pakistan, buildings constructed in line with seismic codes have survived several moderate and strong earthquakes over the past five decades with no or only minor damage<sup>27, 28</sup>. In this way, integration of science into building practice can and does save lives and livelihoods.
