Benny Kuriakose

HABITAT MAPPING OF CHINNANGUDI

**A Study of Chinnangudi Village in Connection with
Tsunami Reconstruction Project**

June 2006

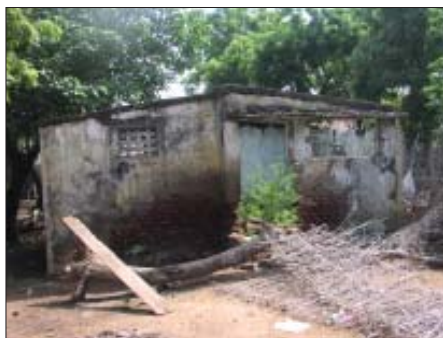
Government Colony House

The Tamil Nadu Government carried out a colony housing scheme in the village in the early nineteen eighties. More than two hundred houses were built using brick and cement for the walls and reinforced concrete (RCC) for the roof.

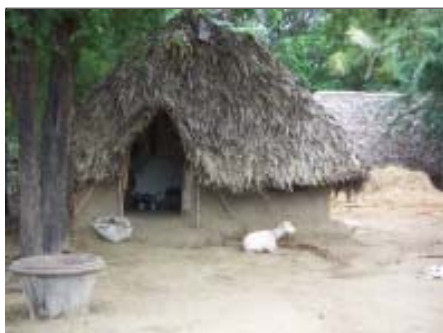
Low Mud Wall and Palm Thatch Roof

In the case of mud walls, the load of the thatched roof is usually taken by the bamboo poles which are hammered deep into the ground. The low mud walls which may be from one and a half feet to three feet high give the privacy required inside the houses. The use of mud walls (without ramming, or using sun dried bricks) is common among the poor. Mud mortar is also used in many buildings constructed with burnt bricks.

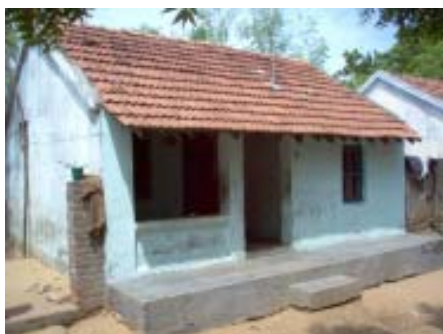
Mangalore Tiled Roof

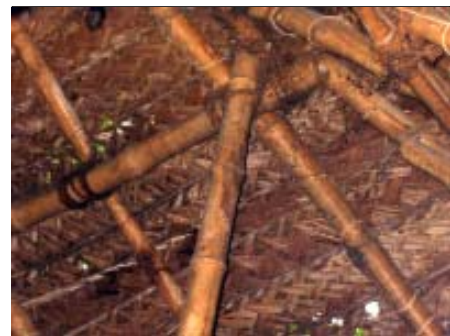
Timber is the predominant roofing material. Bamboo and palm timber are used in abundance. Coconut thatch lasts only for a year, while palm thatch lasts for about four years. Tiled roof

Bamboo Roof

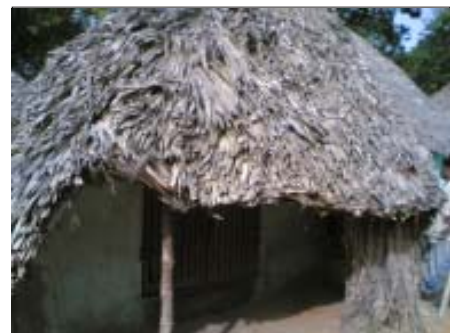
Palm Thatched Roof

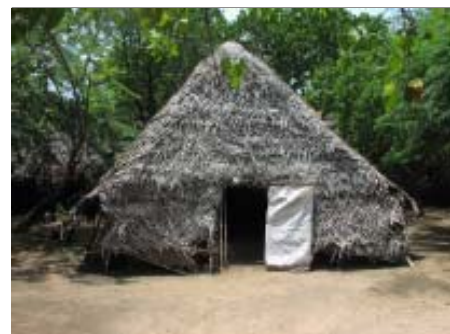
Coconut Thatch as Walling and Roofing Material

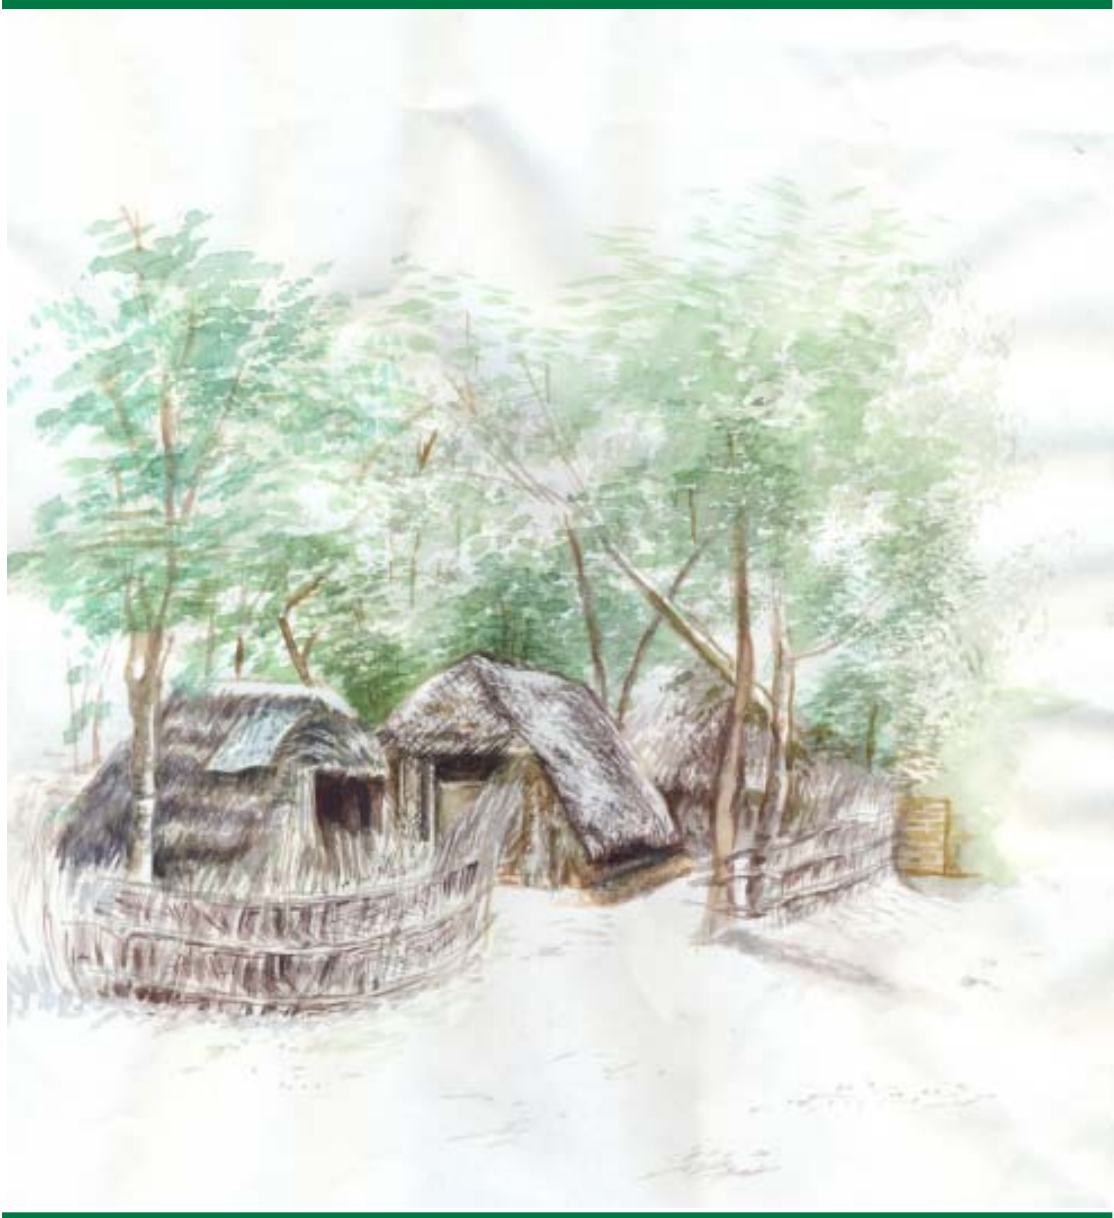
Local Materials such as Bamboo, Coconut Thatch and Mud are used for Construction

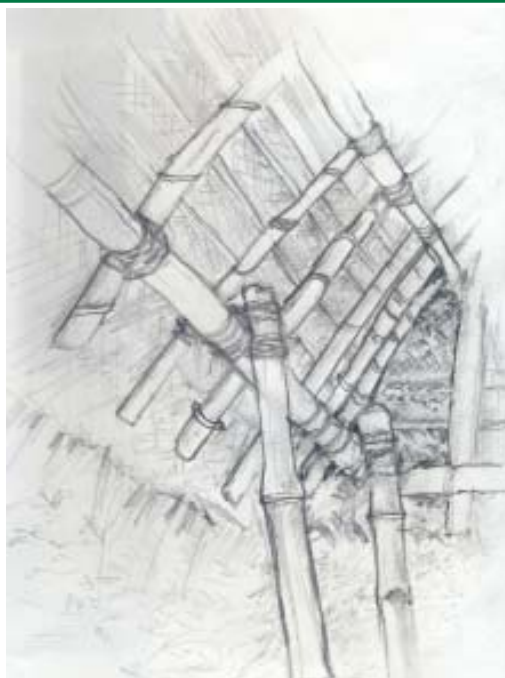
Construction Techniques of Thatched Roof

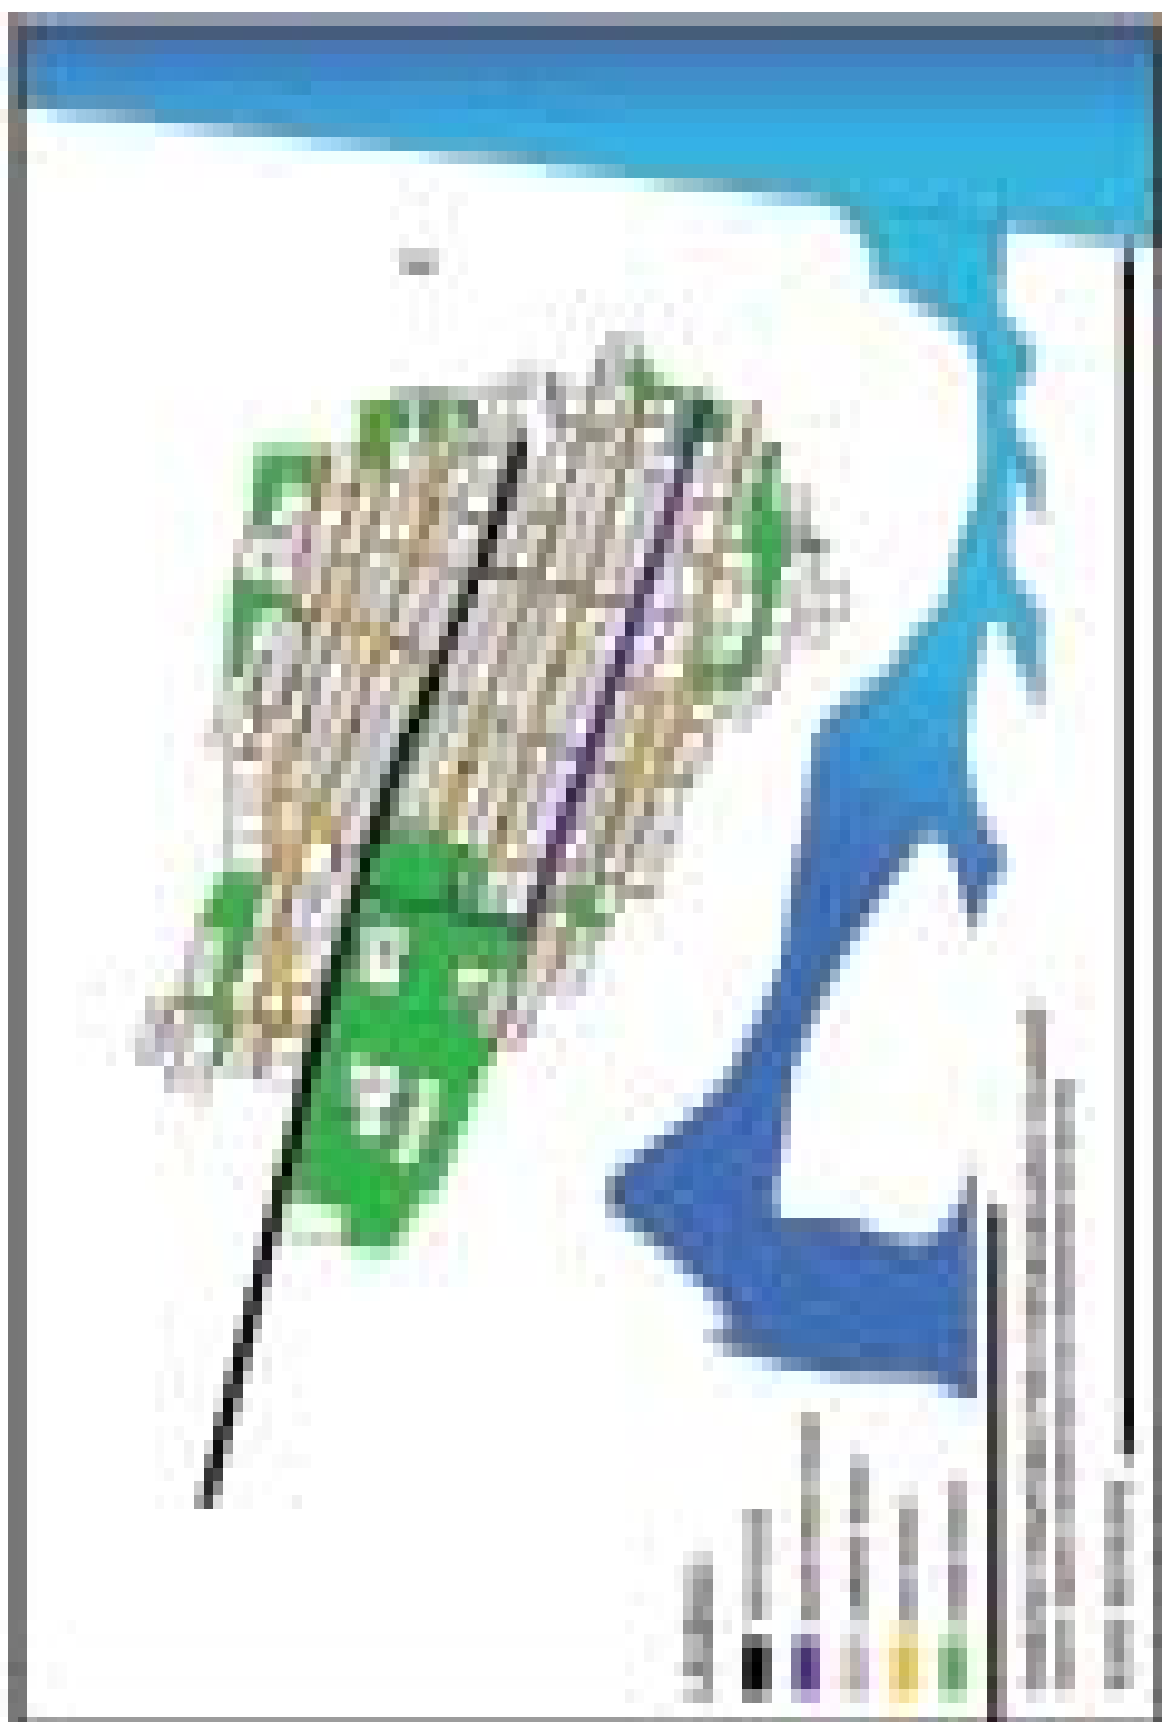
Map 2.2
Network of Roads and Paths

The streets in Chinnangudi are perpendicular to the beach in the east-west direction. The tarred arterial road connects the village

with the nearby towns. The village has expanded on both sides of the road. (Map 2.2 – Network of roads...)

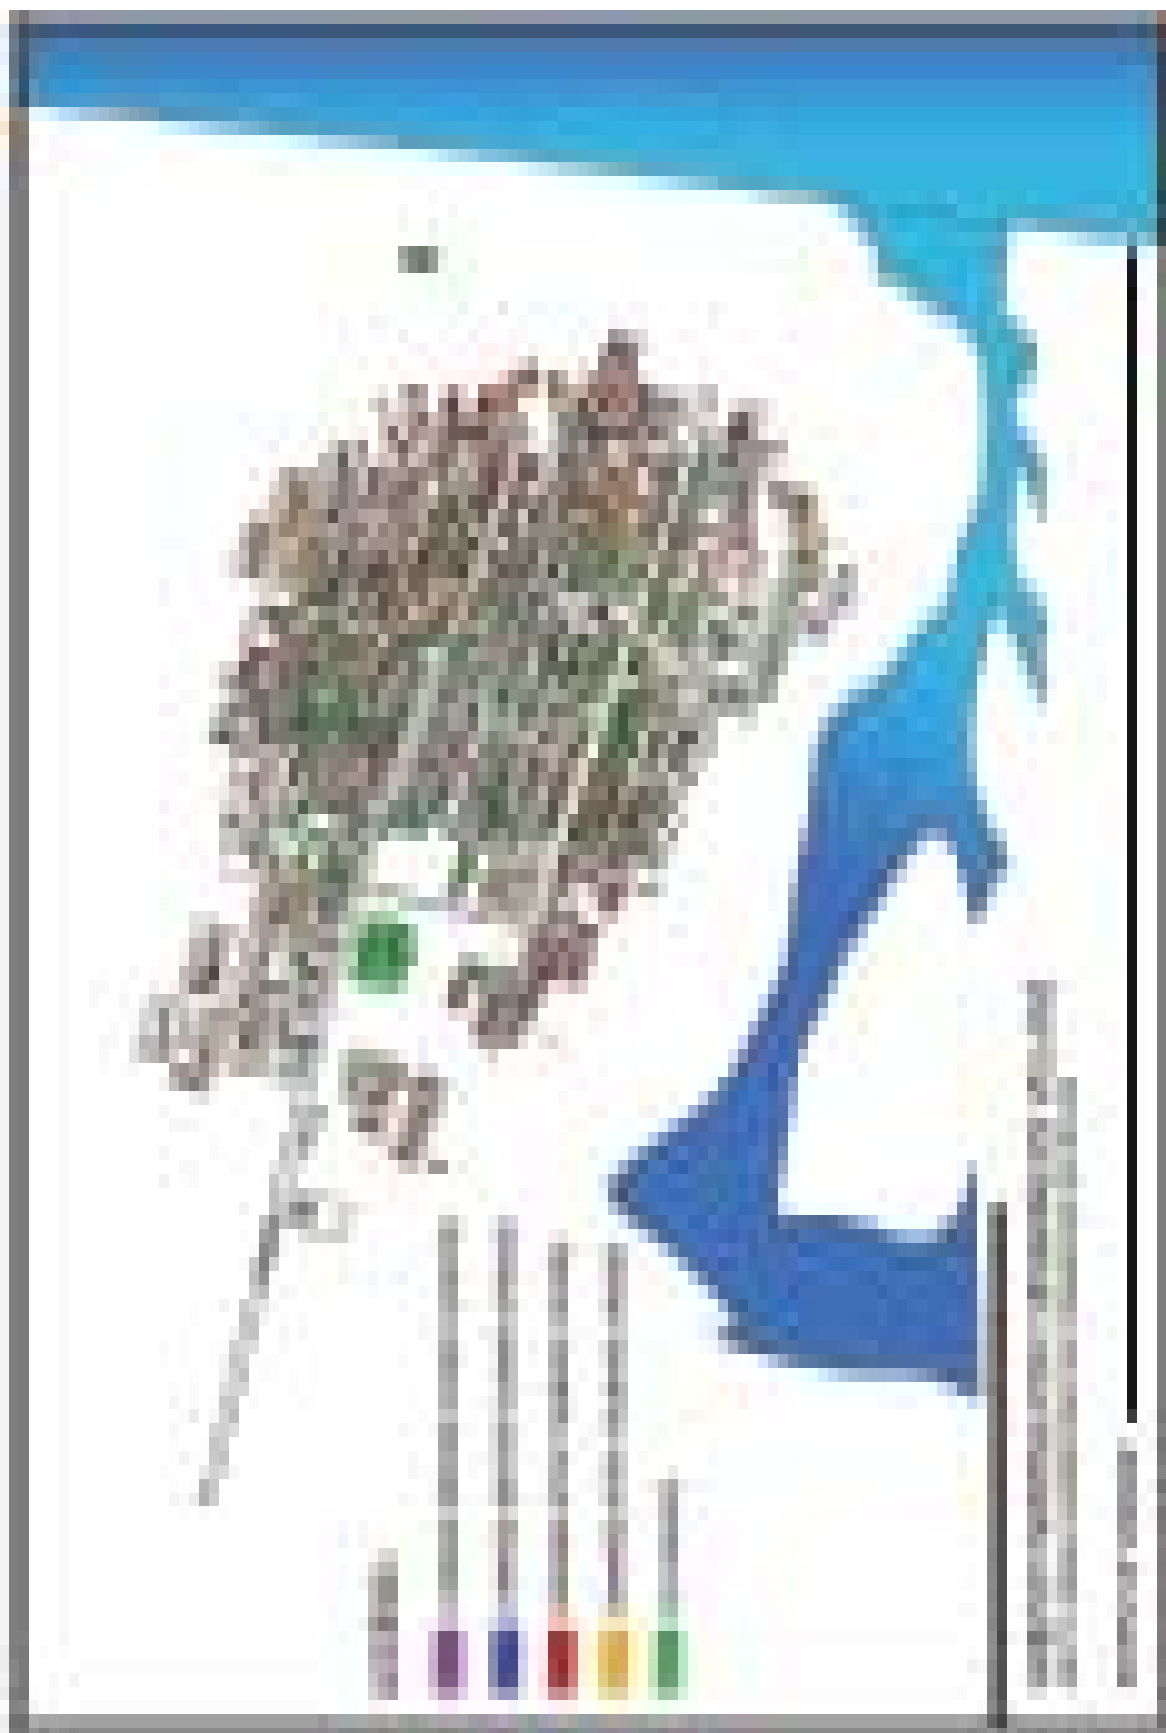
Map 3.1
Extent of Damge

The water flow pattern of the tsunami was dictated to a large extent by the topography of the land. The core of the village is on higher ground compared to the peripheral areas of the village, and this caused the wave to rush in faster around the northern and southern peripheries of the village. These waters

came in with great force (unimpeded, due the flat profile of the land and the lack of any obstruction in the form of vegetation or man made structures) and met each other at the far end of the village (close to the temple) causing great damage to life and property (Map 3.1).

The houses that were fully damaged and/or have suffered major damage were mostly those close to the beach on the eastern, northern and western sides of the village, where the elevation is low compared to the rest of the village. Houses closer to the beach are at higher risk from wave action.

The houses on the southern side that are close to the river have survived with no damage, since they are elevated above the ground level with a raised plinth compared to other houses. The southern side of the village gets flooded from the Amman River frequently. People living in those areas took extra precautions while building houses by raising the plinth. Even here, those houses which did not have raised plinths were badly damaged by the tsunami.

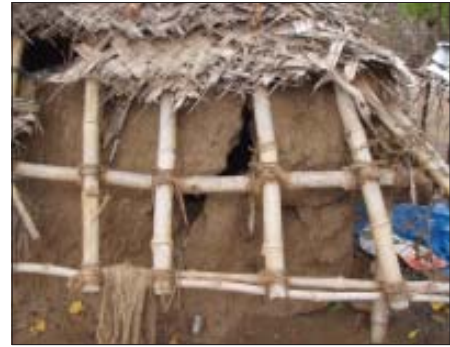
Damaged Wall and Roof

The degree of damage varying from house to house even within a small area seems quite puzzling at first glance. An analysis based on the field work and the study makes many things clear. The thatched houses were supported by strong bamboo poles rooted deep inside the ground. The low mud walls which form the perimeter offered little resistance to the rushing waters and were washed away whereas the brick walls of the RCC roofed houses, being the load bearing members, gave direct resistance and as a result, collapsed, bringing the roof down.

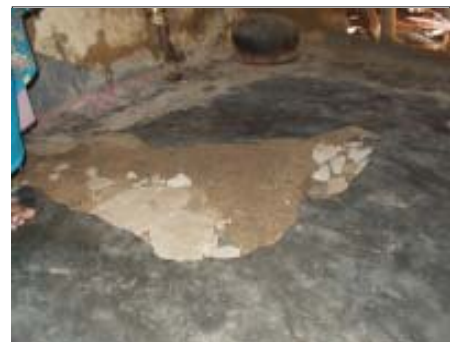
Damaged Flooring Material

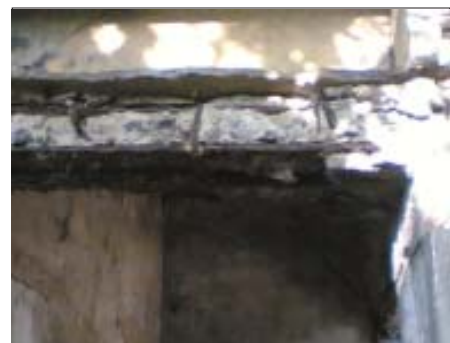
Damaged Roof Beam

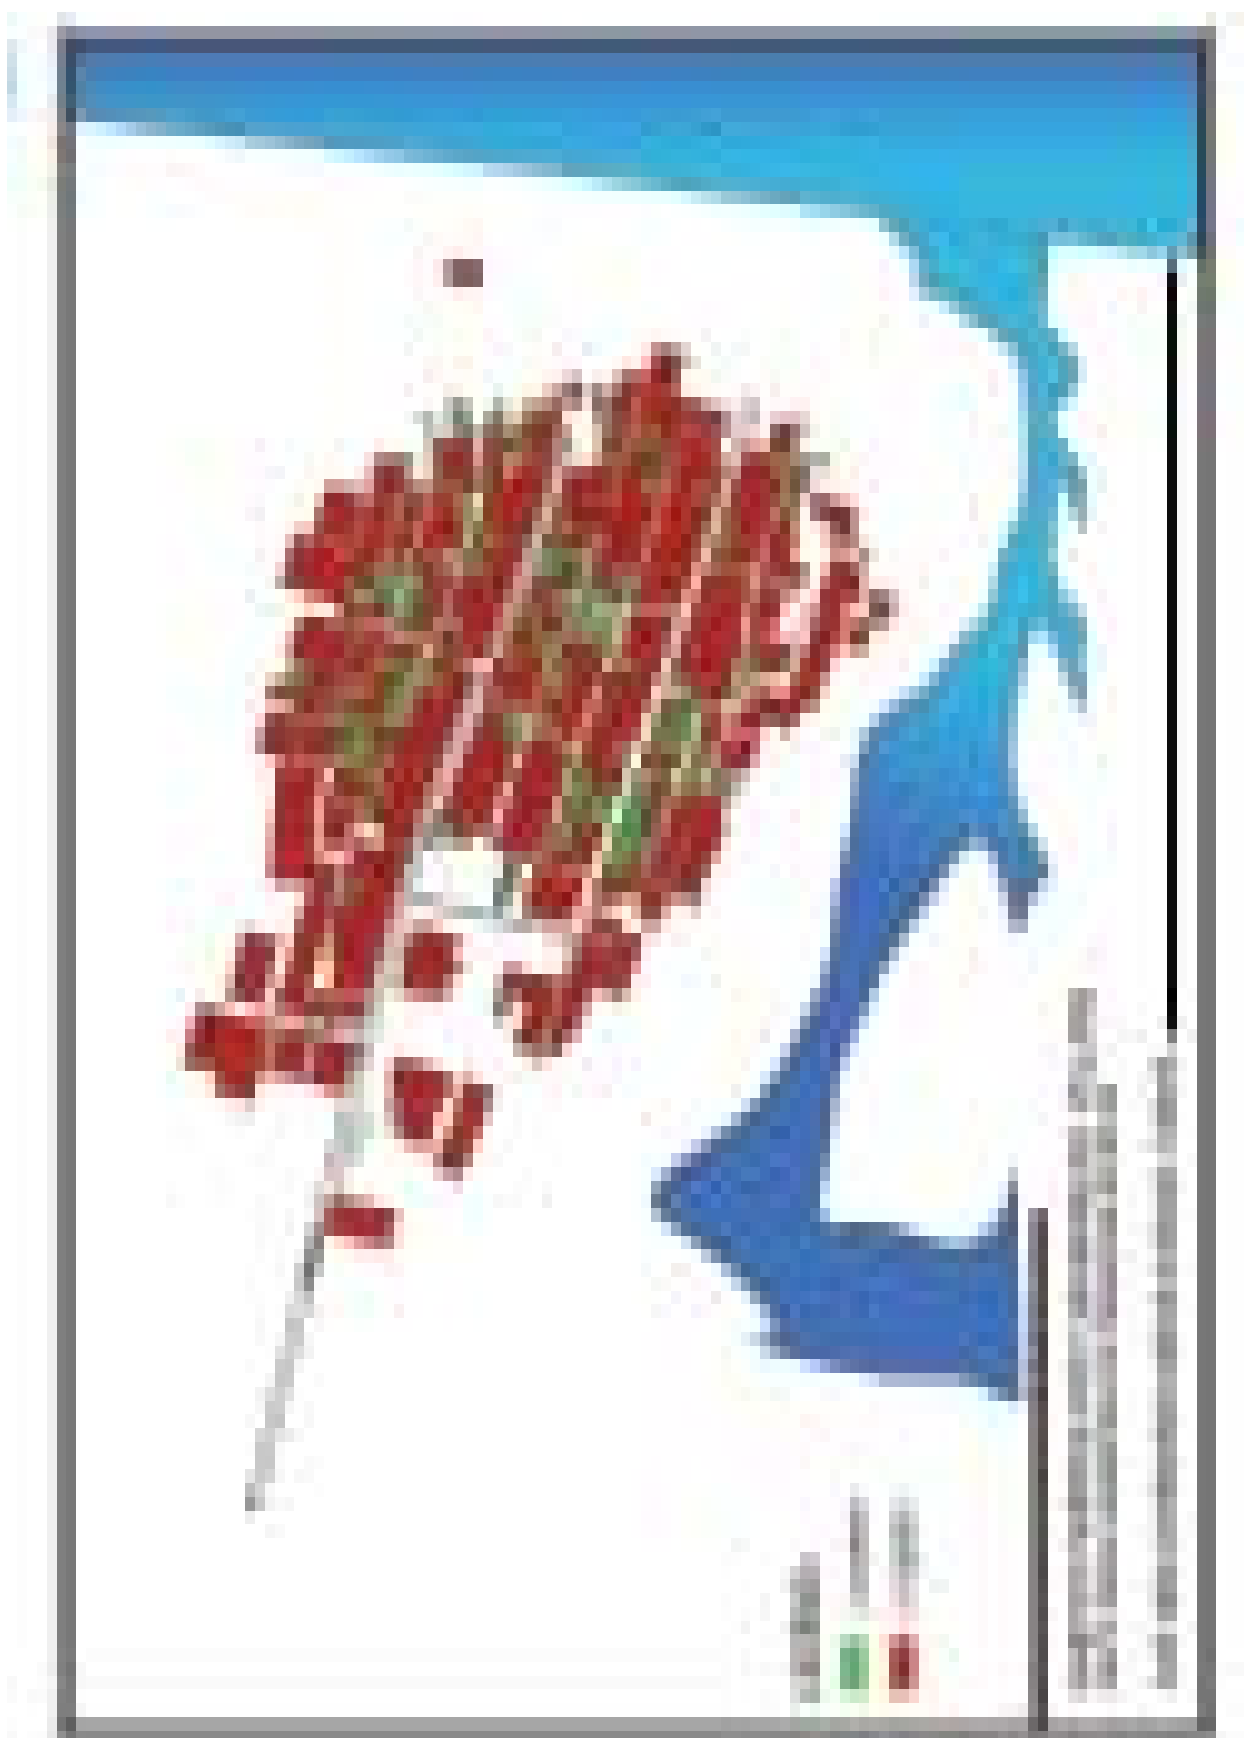
Map 5.1
Plot Area Comparison

Map 5.1 shows the distribution of plot areas above and below three cents. Chart 5.1 shows that 77% of the households have a land holding of more than the three cents (120 square metres) that is going to be provided by the Government as part of the

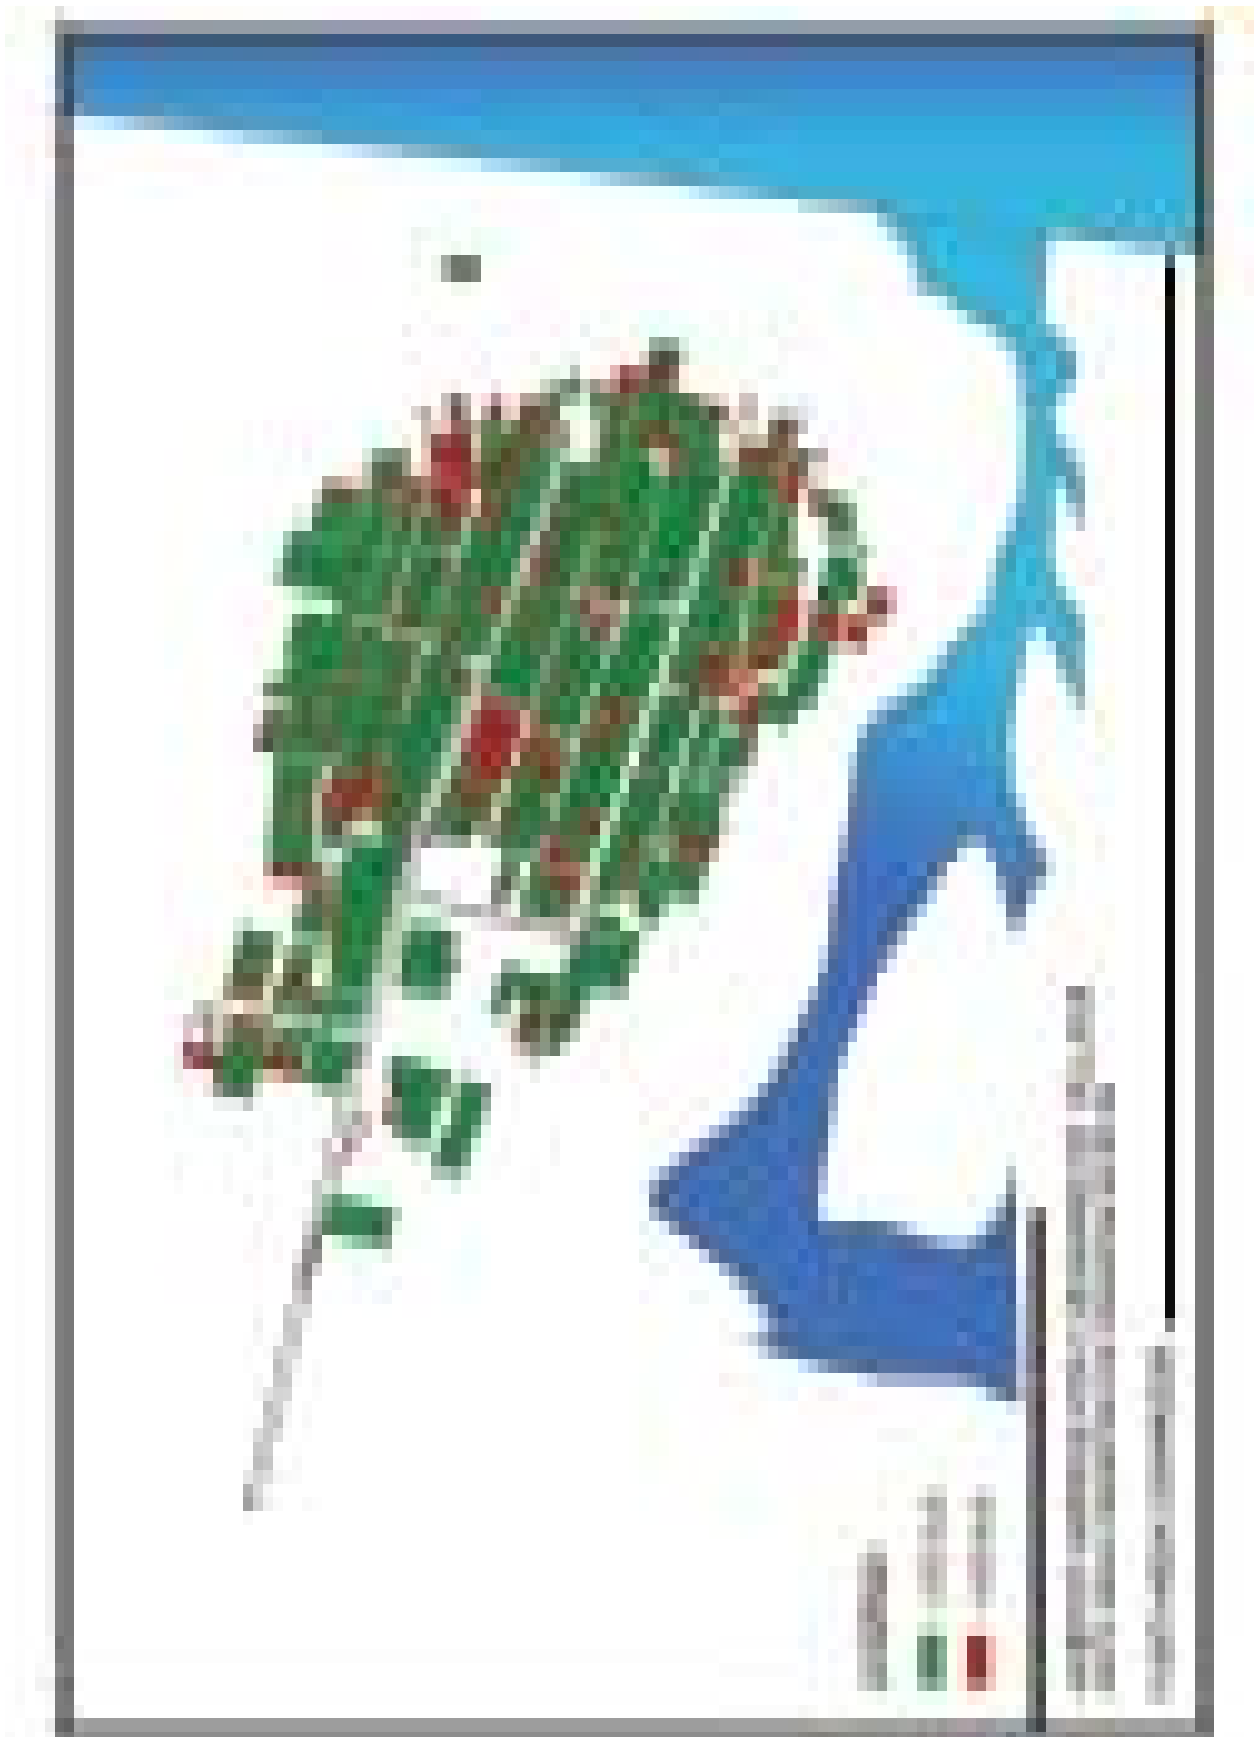
Map 5.2
Plinth Area Comparison

Chart 5.2 shows that 59% of the houses have a plot area more than three cents with plinth area greater than 325 sq ft. Only 9% of the houses have plinth area less than 325 sq ft and less than three cents in plot area. Map 5.2 compares the plinth area (less than or greater than 325 sq ft). Map 5.3 compares the plinth area with the plot area. Map 5.4 shows the usage of various buildings in Chinnangudi.

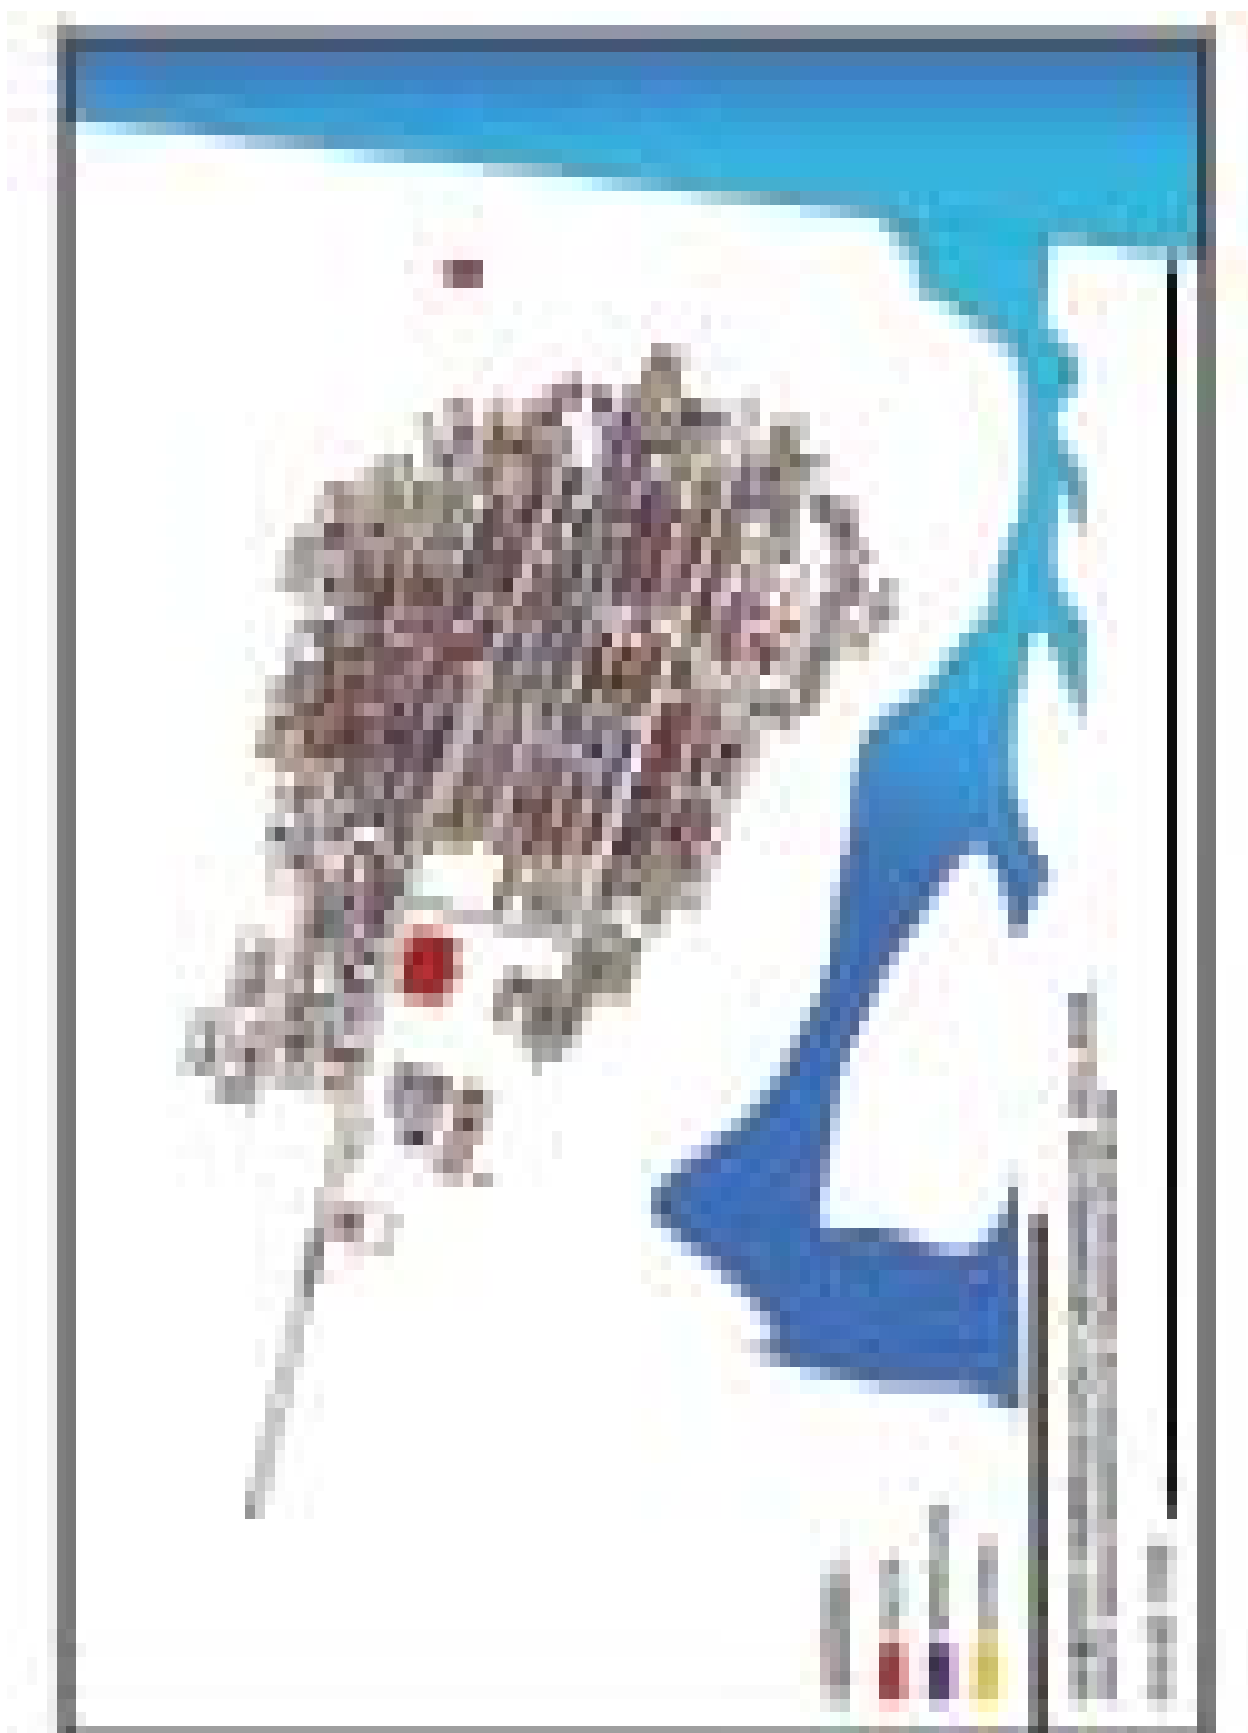
Map 5.5
House Types

Map 5.5 shows the distribution of house types in the village. According to Chart 5.3, 41% of the houses are *pucca* and 28% are *kutch* houses. *Pucca* houses have both the walls and the roof of permanent building material – brick walls and tiled or RCC roof. In *Kutch* houses, both the walls and the roof are of impermanent building material such as thatch and bamboo (Chart 5.3).

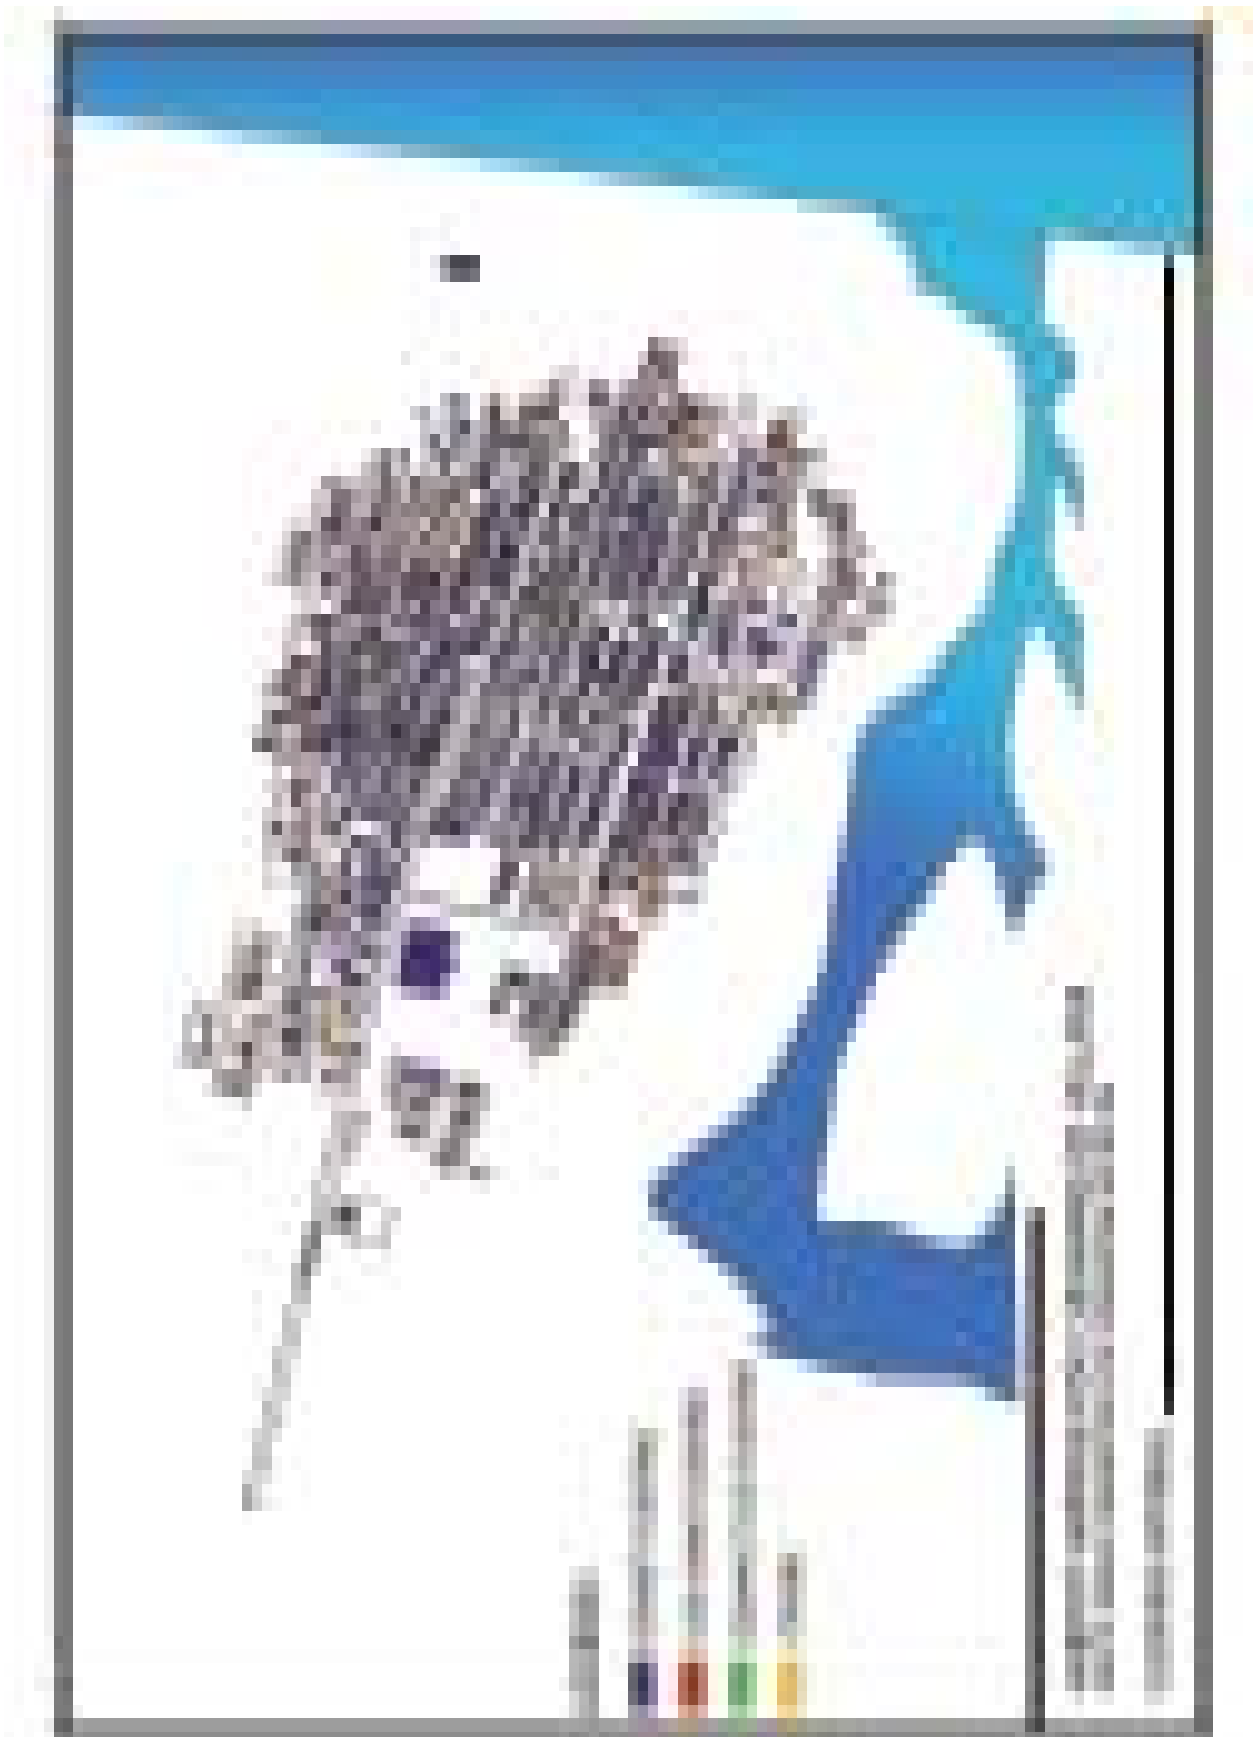
Map 5.6
Flooring Material

The most common type of flooring is cement based. In the less affluent houses, the flooring is of beaten earth, polished with cow dung at regular intervals of time. In many traditional buildings, the original beaten earth-cow dung flooring had been changed to cement flooring.

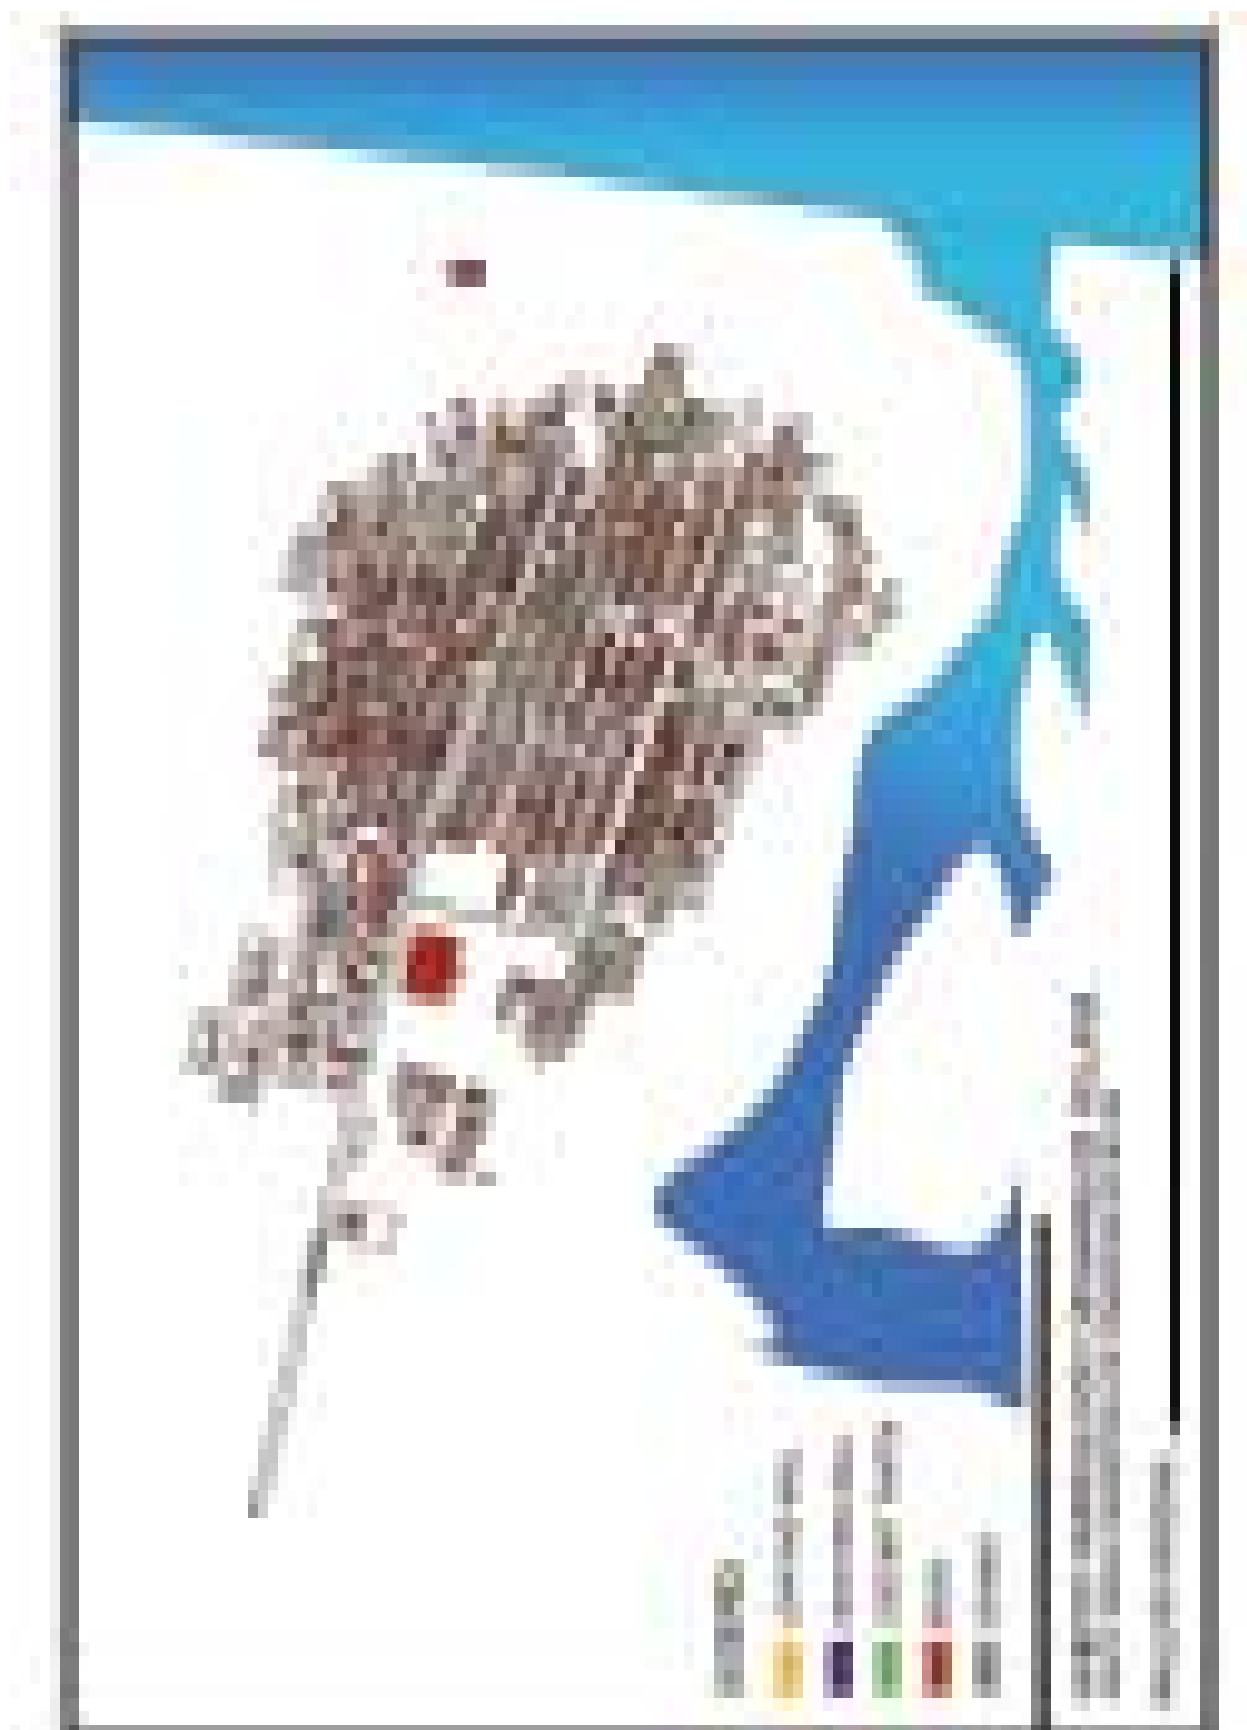
Map 5.7
Walling Material

For the load bearing masonry, the foundations are usually built with burnt bricks. For the superstructure, brick in mud mortar as well as brick in cement or lime mortar is quite common.
